Remediation Strategy

Dobfield Road

Rochdale

**Report A5182/22/RMS**

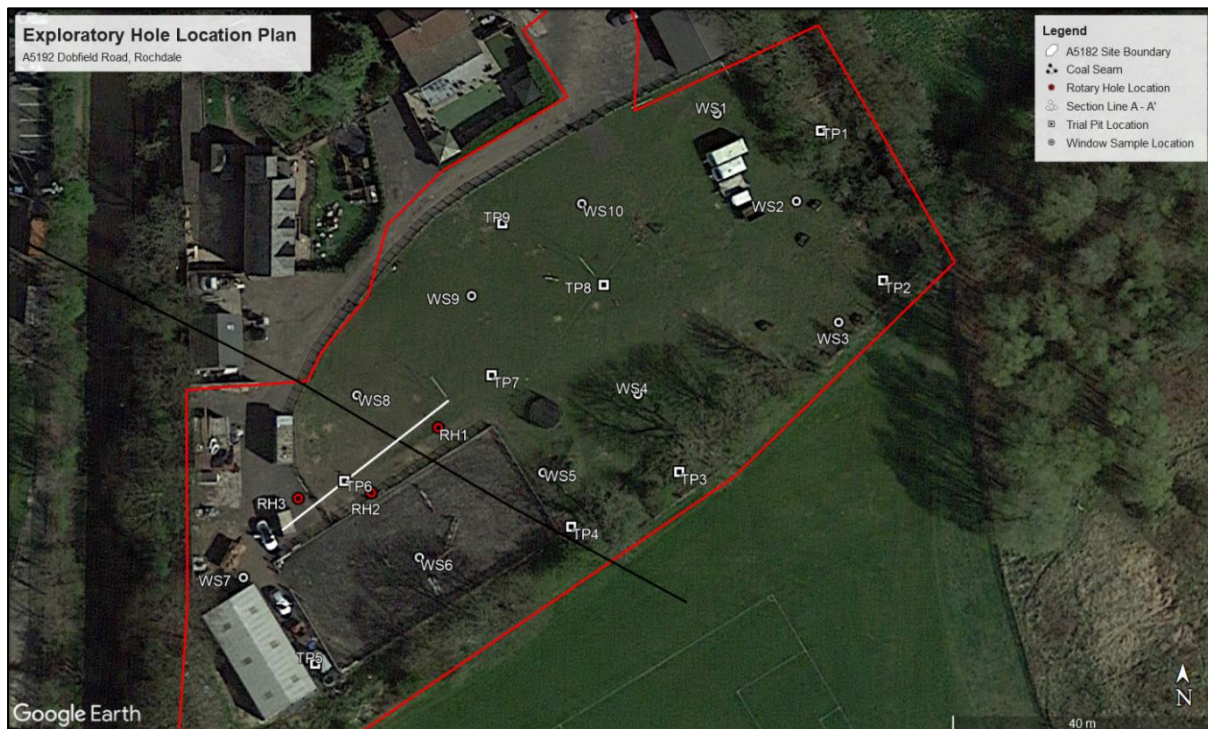
**Figure 3: Exploratory Hole Location Plan (A5182/22/SI/V3)**

An exploratory hole location plan is presented as Figure 3, overleaf.

- Stiff, slightly sandy, slightly gravelly CLAY, containing gravel of sandstone.
- **Pennine Lower Coal Measures** was encountered in all rotary open hole boreholes comprising interbedded mudstone and hard sandstone. Coal was encountered in each rotary location between 8.20m - 8.40m in RH1, 8.80m - 9.00m in RH2 and 10.00m - 10.30m in RH3.

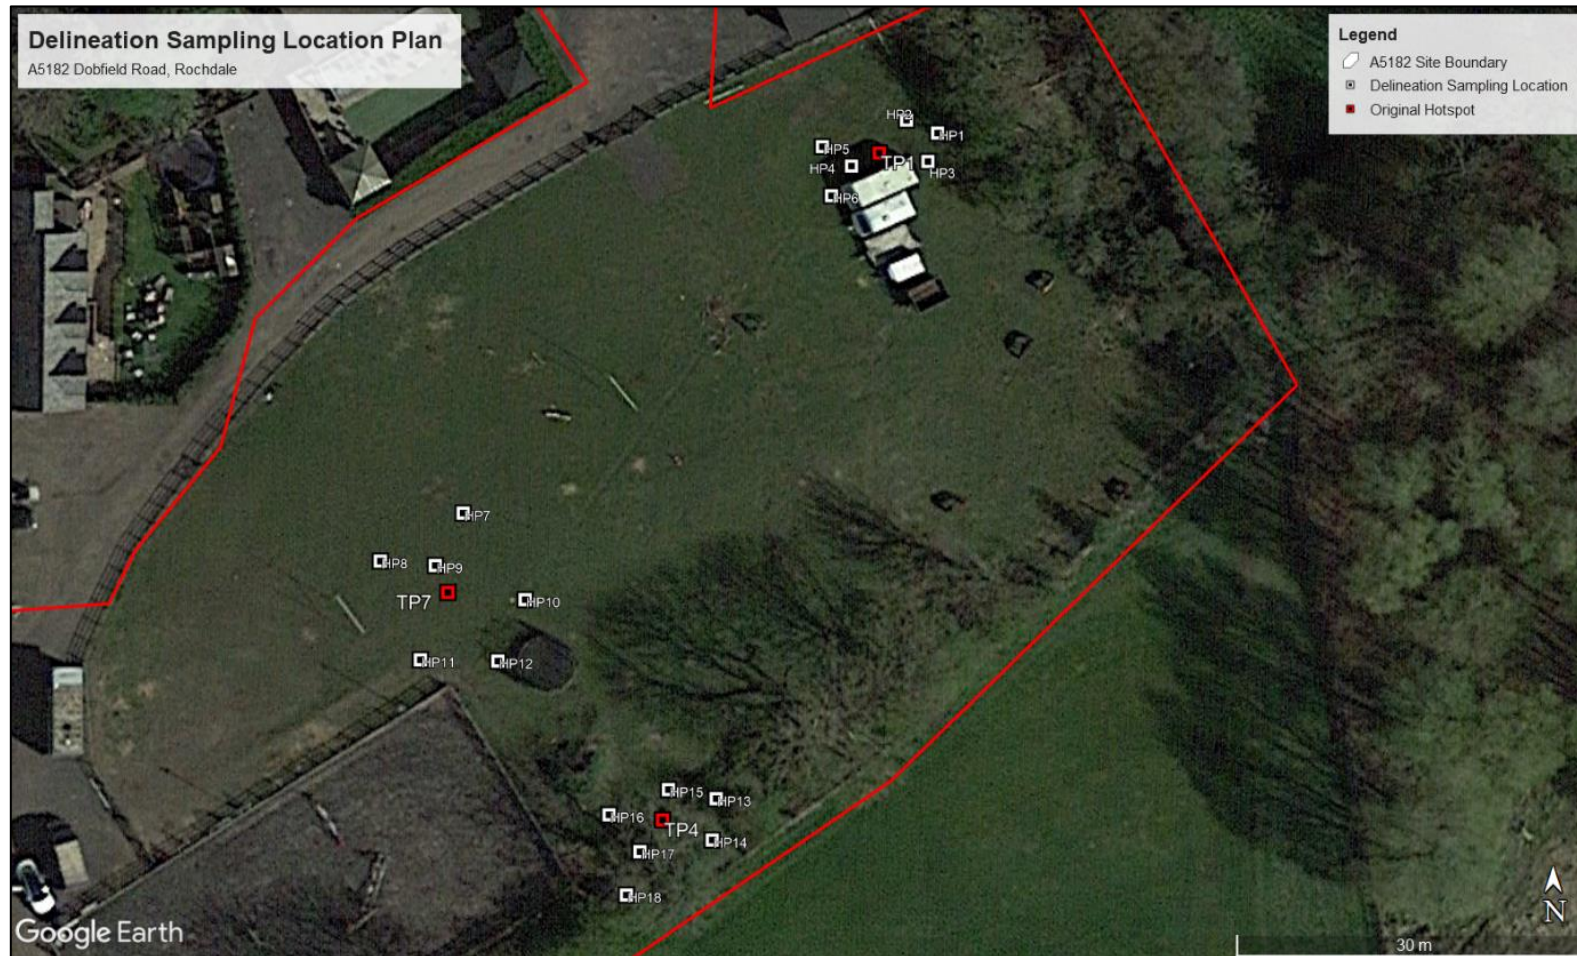
**Figure 5: Delineation Sampling Location Plan**

A delineation soil sampling location plan is presented as Figure 5, overleaf.

- **Topsoil** was encountered in all exploratory holes, excluding HP1, comprising:
  - Slightly sandy slightly gravelly CLAY containing sandstone.
- **Made Ground** was encountered in exploratory hole location HP1 only, comprising:
  - Slightly sandy, gravelly CLAY, containing gravel of red brick, sandstone, concrete, and tarmac.
- **Clay** was encountered in exploratory hole locations HP7, HP8, HP11 to HP14, HP16, to HP18 comprising:
  - Sandy CLAY.
- **Sand** was encountered in exploratory hole location HP13, comprising:
  - Gravelly SAND containing sandstone.

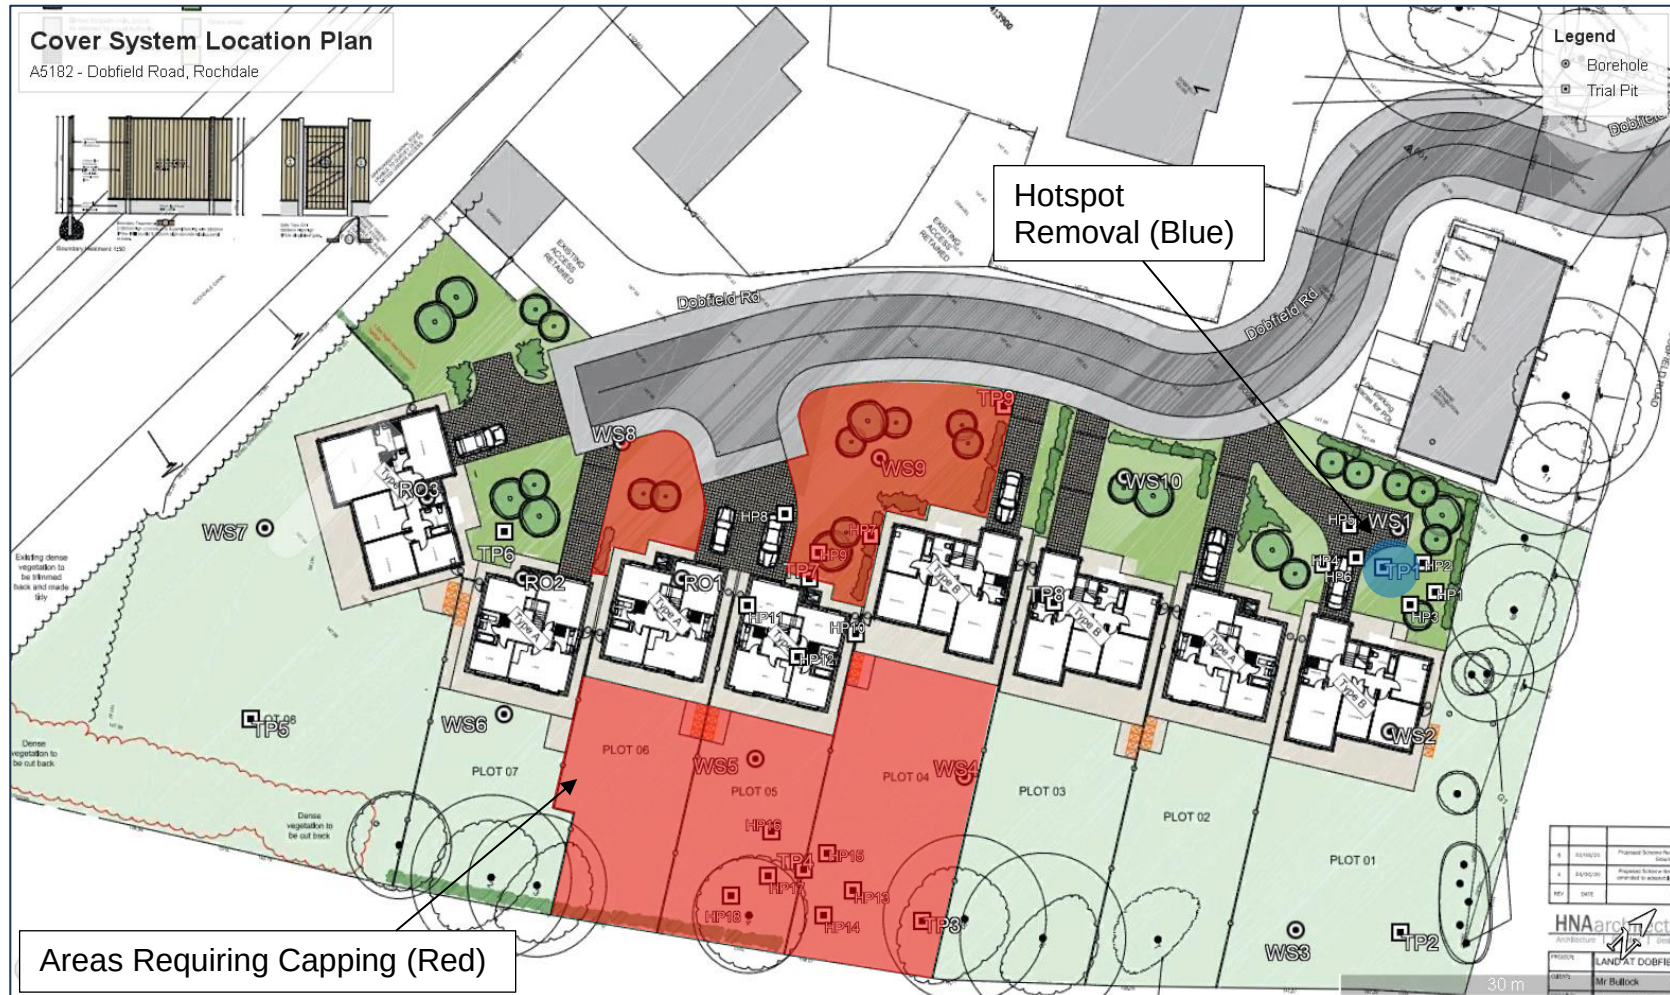
Figure 7: Cover System Location Plan

A plan showing the cover system locations (Plots 4, 5 and 6) is provided in Figure 7, overleaf.
