# Rochdale SEND PassivHaus Coal Mining Risk Assessment

*Tilbury Douglas*

Doc ref: 19522-HYD-XX-XX-RP-GE-0001

| Title | Coal Mining Risk Assessment | |

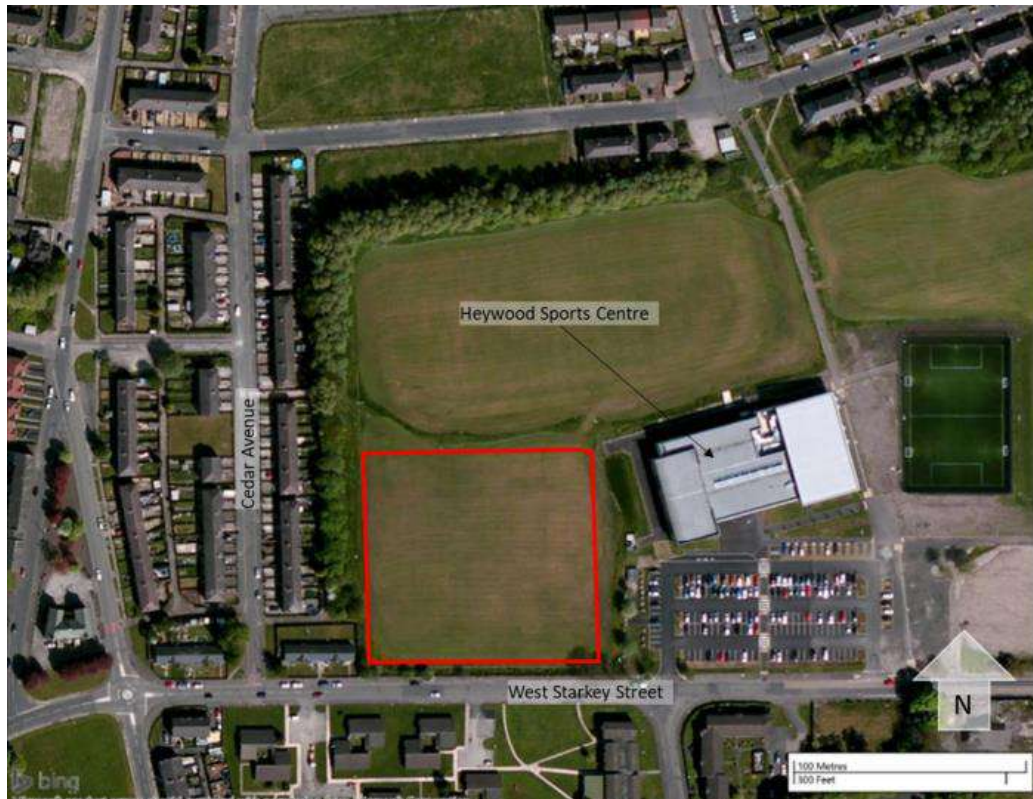
Figure 3: Aerial image of the site

A site walkover was undertaken by Mott MacDonald Limited on 8 October 2019. Mott MacDonald Noted the following based on their observations. An aerial image of the current site is shown in Figure 3.
