**Westchurch Homes**

**REMEDIATION STRATEGY**

**Brunswick Street, Heywood**

**REPORT No: 21WCH018/RS**

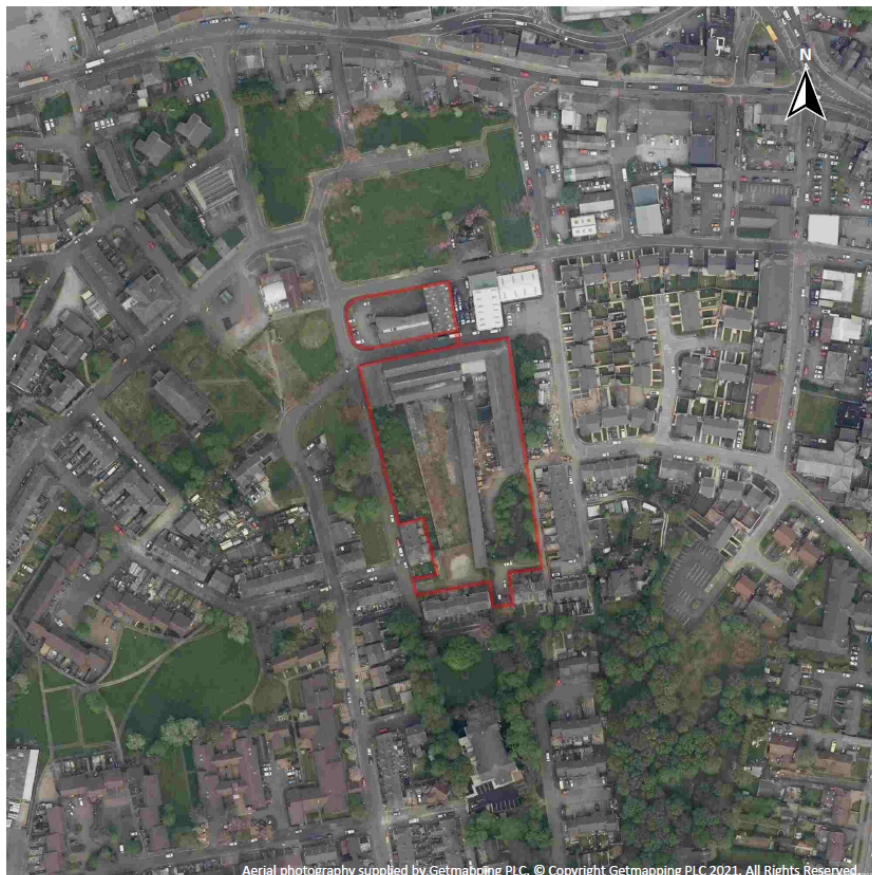
Betts Geo Environmental (Betts) has been commissioned by Westchurch Homes to prepare a Remediation Strategy for the remediation and preparatory works for the Brunswick Street, Heywood site. The plan below shows the site boundary;
