## Asbestos Refurbishment Survey

**Leopold Court  
Leopold Street  
off Bury Road  
Rochdale  
OL11 5HA**

**Triangle Architects Ltd**

| Project Number: | Survey Date: | Issue Date: |

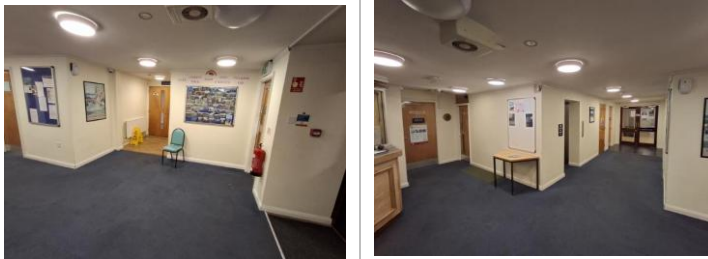
| Building: Leopold Court | | | |
|---|---|---|--|
| Ground Floor | <p><b>002 - Main Entrance Lobby</b></p> <p>Asbestos Refurbishment Survey to Leopold Court in Rochdale prior to remodelling of the building to include an increase to the bedroom capacity and the proposed layout(s) to deliver 29 standard bedrooms, including 1no. CAT 3 wheelchair accessible room per floor (2 in total), and +1 emergency bedroom.</p> <p>Plasterboard ceiling, solid brick walls with decorative wallpaper, carpet and linoleum floor covering down to concrete, electrical goods, metal door and frame, wood internal doors and frames, metal radiators and associated pipework.</p> | | |

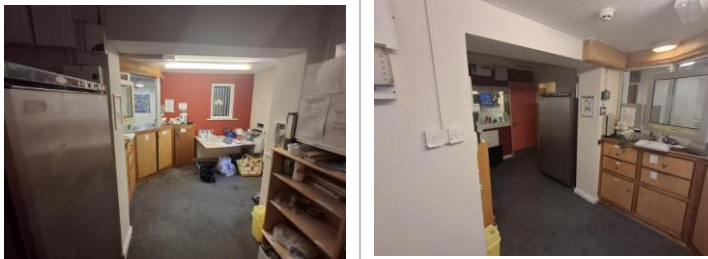
| Building: Leopold Court | | | |
|---|---|---|--|
| Ground Floor | <p><b>004 - Reception</b></p> <p>Asbestos Refurbishment Survey to Leopold Court in Rochdale prior to remodelling of the building to include an increase to the bedroom capacity and the proposed layout(s) to deliver 29 standard bedrooms, including 1no. CAT 3 wheelchair accessible room per floor (2 in total), and +1 emergency bedroom.</p> <p>Plasterboard ceiling, solid brick walls, carpet tiles down to concrete, electrical goods, wood doors and frames, metal radiator and associated pipework, UPVC window with metal internal frame.</p> | | |

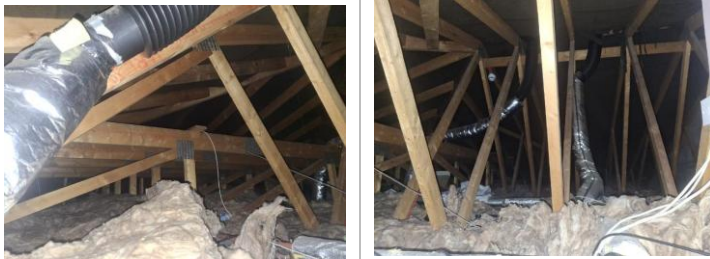
| Building: Leopold Court | | | |
|---|---|---|--|
| Ground Floor | <p>004a - Reception Roof Space</p> <p>Asbestos Refurbishment Survey to Leopold Court in Rochdale prior to remodelling of the building to include an increase to the bedroom capacity and the proposed layout(s) to deliver 29 standard bedrooms, including 1no. CAT 3 wheelchair accessible room per floor (2 in total), and +1 emergency bedroom.</p> <p>Pitched timber frame roof with felted underside, brick walls, electrical goods, MMMF insulation throughout, plastic pipework, metal pipework with MMMF insulation.</p> | | |

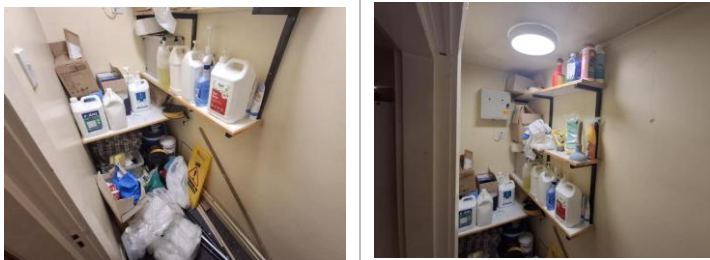
| Building: Leopold Court | | | |
|---|---|---|--|
| Ground Floor | <p>005 - Cleaners Cupboard</p> <p>Asbestos Refurbishment Survey to Leopold Court in Rochdale prior to remodelling of the building to include an increase to the bedroom capacity and the proposed layout(s) to deliver 29 standard bedrooms, including 1no. CAT 3 wheelchair accessible room per floor (2 in total), and +1 emergency bedroom.</p> <p>Plasterboard ceiling, solid brick walls, carpet tiles down to concrete, electrical goods, wood door and frame, copper pipework.</p> | | |

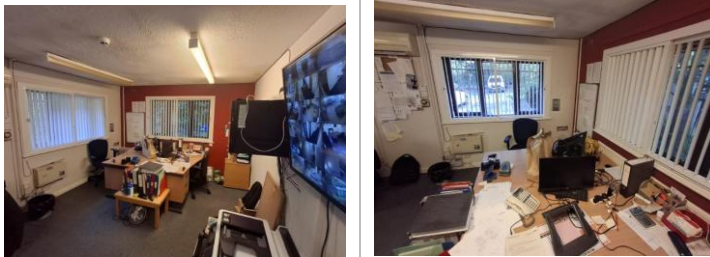
| Building: Leopold Court | | | |
|---|---|---|--|
| Ground Floor | <p>006 - Office</p> <p>Asbestos Refurbishment Survey to Leopold Court in Rochdale prior to remodelling of the building to include an increase to the bedroom capacity and the proposed layout(s) to deliver 29 standard bedrooms, including 1no. CAT 3 wheelchair accessible room per floor (2 in total), and +1 emergency bedroom.</p> <p>Plasterboard ceiling, solid brick walls, carpet tiles down to concrete, electrical goods, wood door and frame, metal radiator and associated pipework, UPVC windows with metal internal frames, server equipment.</p> | | |

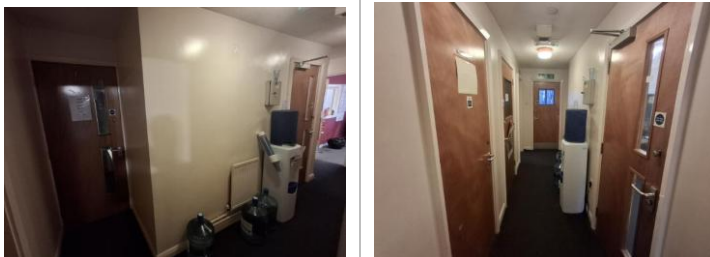
| Building: Leopold Court | | | |
|---|---|---|--|
| Ground Floor | <p>007 - Corridor</p> <p>Asbestos Refurbishment Survey to Leopold Court in Rochdale prior to remodelling of the building to include an increase to the bedroom capacity and the proposed layout(s) to deliver 29 standard bedrooms, including 1no. CAT 3 wheelchair accessible room per floor (2 in total), and +1 emergency bedroom.</p> <p>Plasterboard ceiling, solid brick walls, carpet floor covering down to concrete, electrical goods, wood doors, and frames, metal radiator and associated pipework.</p> | | |

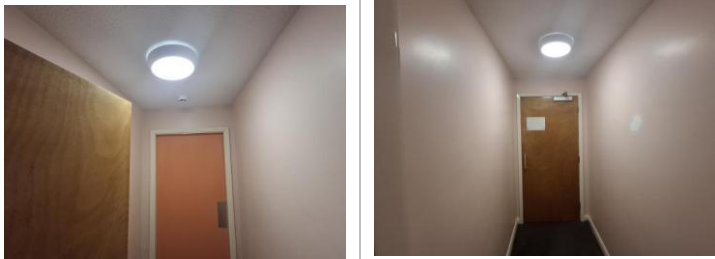
| Building: Leopold Court | | | |
|---|---|---|--|
| Ground Floor | <p>008 - Corridor to Toilet</p> <p>Asbestos Refurbishment Survey to Leopold Court in Rochdale prior to remodelling of the building to include an increase to the bedroom capacity and the proposed layout(s) to deliver 29 standard bedrooms, including 1no. CAT 3 wheelchair accessible room per floor (2 in total), and +1 emergency bedroom.</p> <p>Plasterboard ceiling, solid brick walls, carpet floor covering down to concrete, electrical goods, wood doors, and frames.</p> | | |

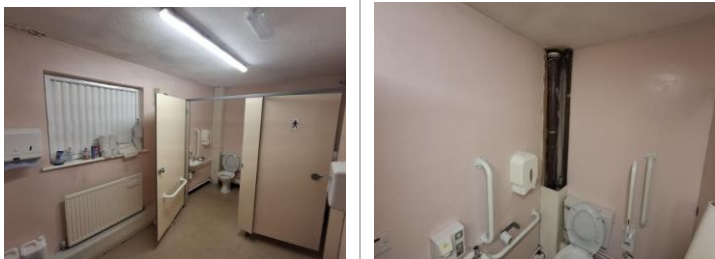
| Building: Leopold Court | | | |
|---|---|---|--|
| Ground Floor | <p>009 - Toilet</p> <p>Asbestos Refurbishment Survey to Leopold Court in Rochdale prior to remodelling of the building to include an increase to the bedroom capacity and the proposed layout(s) to deliver 29 standard bedrooms, including 1no. CAT 3 wheelchair accessible room per floor (2 in total), and +1 emergency bedroom.</p> <p>Plasterboard ceiling, solid brick walls with modern ceramic tiles to sink, linoleum floor covering down to concrete, electrical goods, wood door, and frame, modern toilet ware, copper and plastic pipework, UPVC boxing with exposed pipework, metal radiator and associated pipework, UPVC window with metal internal frame.</p> | | |

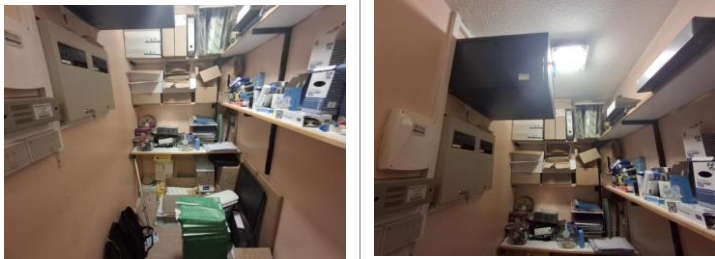
| Building: Leopold Court | | | |
|---|---|---|--|
| Ground Floor | <p>010 - Store Cupboard</p> <p>Asbestos Refurbishment Survey to Leopold Court in Rochdale prior to remodelling of the building to include an increase to the bedroom capacity and the proposed layout(s) to deliver 29 standard bedrooms, including 1no. CAT 3 wheelchair accessible room per floor (2 in total), and +1 emergency bedroom.</p> <p>Plasterboard ceiling, solid brick walls, linoleum floor covering down to concrete, electrical goods, wood door, and frame, server equipment.</p> | | |

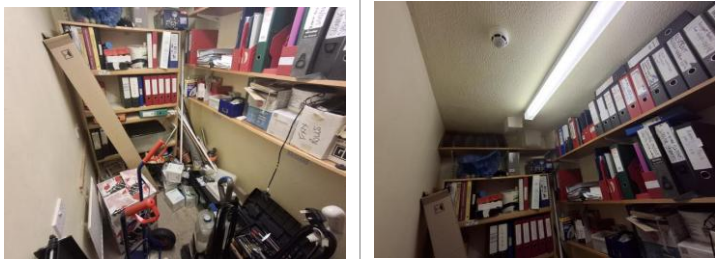
| Building: Leopold Court | | | |
|---|---|---|--|
| Ground Floor | <p>011 - Store Cupboard</p> <p>Asbestos Refurbishment Survey to Leopold Court in Rochdale prior to remodelling of the building to include an increase to the bedroom capacity and the proposed layout(s) to deliver 29 standard bedrooms, including 1no. CAT 3 wheelchair accessible room per floor (2 in total), and +1 emergency bedroom.</p> <p>Plasterboard ceiling, solid brick walls, linoleum floor covering down to concrete, electrical goods, wood door, and frame, air extraction fan, UPVC boxing.</p> | | |

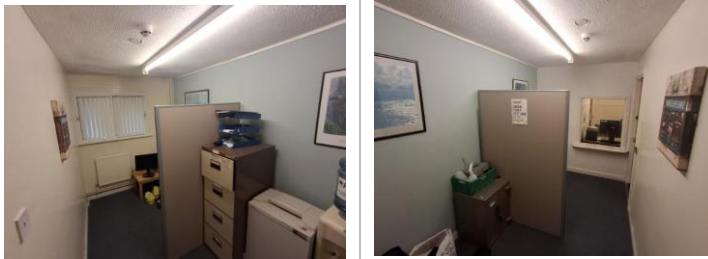
| Building: Leopold Court | | | |
|---|---|---|--|
| Ground Floor | <p><b>014 - Office</b></p> <p>Asbestos Refurbishment Survey to Leopold Court in Rochdale prior to remodelling of the building to include an increase to the bedroom capacity and the proposed layout(s) to deliver 29 standard bedrooms, including 1no. CAT 3 wheelchair accessible room per floor (2 in total), and +1 emergency bedroom.</p> <p>Plasterboard ceiling, solid brick walls, carpet floor covering down to concrete, electrical goods, wood door, and frame, metal radiator and associated pipework, UPVC window with metal internal frame.</p> | | |

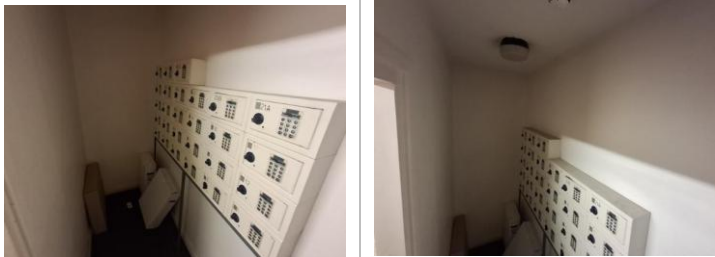
| Building: Leopold Court | | | |
|---|---|---|--|
| Ground Floor | <b>016 - Corridor</b><br><br>Asbestos Refurbishment Survey to Leopold Court in Rochdale prior to remodelling of the building to include an increase to the bedroom capacity and the proposed layout(s) to deliver 29 standard bedrooms, including 1no. CAT 3 wheelchair accessible room per floor (2 in total), and +1 emergency bedroom.<br><br>Plasterboard ceiling, solid brick walls, carpet tiles down to concrete, electrical goods, wood doors, and frames, timber boxing panels. | | |

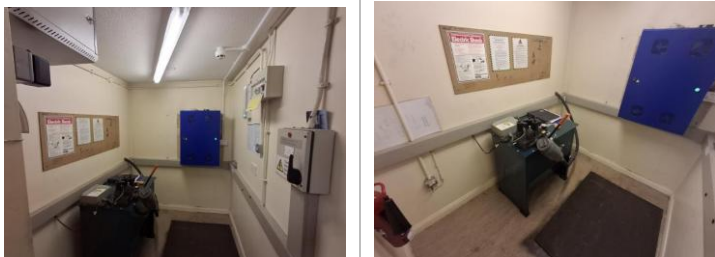
| Building: Leopold Court | | | |
|---|---|---|--|
| | <b>017 - Lift Motor Room</b><br><br>Asbestos Refurbishment Survey to Leopold Court in Rochdale prior to remodelling of the building to include an increase to the bedroom capacity and the proposed layout(s) to deliver 29 standard bedrooms, including 1no. CAT 3 wheelchair accessible room per floor (2 in total), and +1 emergency bedroom.<br><br>Plasterboard ceiling, solid brick walls, linoleum floor covering down to concrete, electrical goods, wood door, and frame, modern lift motor, motor electrical goods, cable trunking. | | |

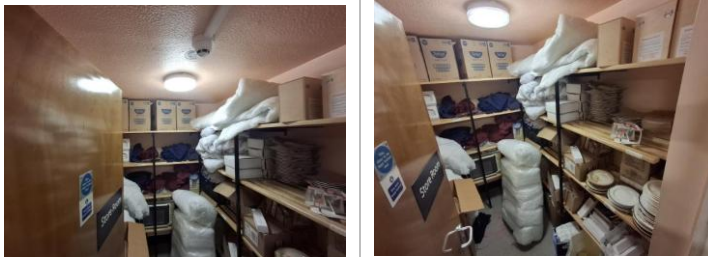
| Building: Leopold Court | | | |
|---|---|---|--|
| Ground Floor | <p><b>018 - Store Room</b></p> <p>Asbestos Refurbishment Survey to Leopold Court in Rochdale prior to remodelling of the building to include an increase to the bedroom capacity and the proposed layout(s) to deliver 29 standard bedrooms, including 1no. CAT 3 wheelchair accessible room per floor (2 in total), and +1 emergency bedroom.</p> <p>Plasterboard ceiling, solid brick walls, linoleum floor covering down to concrete, electrical goods, wood door, and frame.</p> | | |

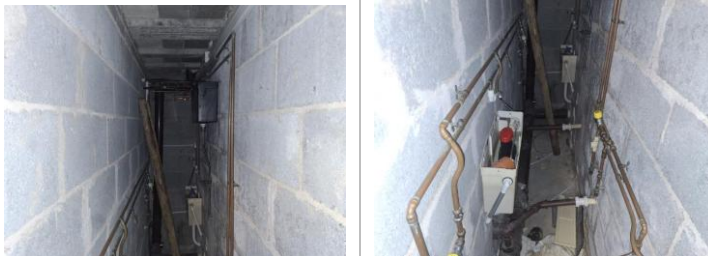
| Building: Leopold Court | | | |
|---|---|---|--|
| Ground Floor | <p><b>019 - Riser</b></p> <p>Asbestos Refurbishment Survey to Leopold Court in Rochdale prior to remodelling of the building to include an increase to the bedroom capacity and the proposed layout(s) to deliver 29 standard bedrooms, including 1no. CAT 3 wheelchair accessible room per floor (2 in total), and +1 emergency bedroom.</p> <p>Concrete ceiling, block walls, concrete floor, electrical goods, wood door, and frame, copper and plastic pipework, plastic downpipes and cisterns.</p> | | |

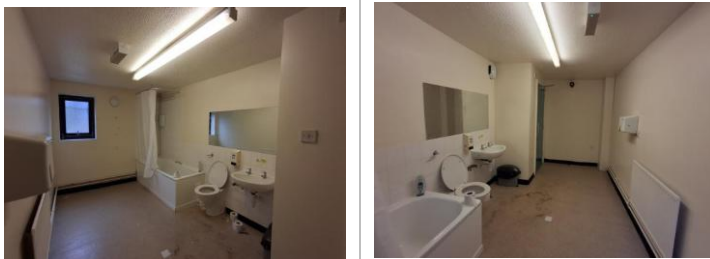
| Building: Leopold Court | | | |
|---|---|---|--|
| Ground Floor | <p>021 - Toilet/Bathroom</p> <p>Asbestos Refurbishment Survey to Leopold Court in Rochdale prior to remodelling of the building to include an increase to the bedroom capacity and the proposed layout(s) to deliver 29 standard bedrooms, including 1no. CAT 3 wheelchair accessible room per floor (2 in total), and +1 emergency bedroom.</p> <p>Plasterboard ceiling, solid brick walls with modern ceramic tiles, linoleum floor covering down to concrete, electrical goods, wood door, and frame, modern toilet ware, copper and plastic pipework, metal radiator with associated pipework, UPVC boxing with exposed pipework.</p> | | |

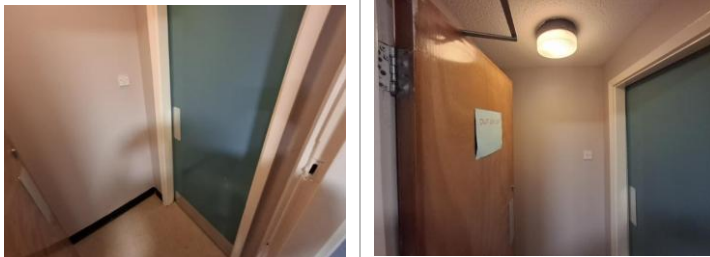
| Building: Leopold Court | | | |
|---|---|---|--|
| Ground Floor | <p>022 - Toilet Lobby</p> <p>Asbestos Refurbishment Survey to Leopold Court in Rochdale prior to remodelling of the building to include an increase to the bedroom capacity and the proposed layout(s) to deliver 29 standard bedrooms, including 1no. CAT 3 wheelchair accessible room per floor (2 in total), and +1 emergency bedroom.</p> <p>Plasterboard ceiling, solid brick walls, linoleum floor covering down to concrete, electrical goods, wood doors, and frames.</p> | | |

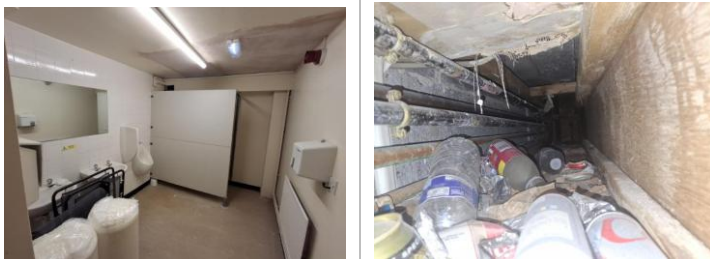
| Building: Leopold Court | | | |
|---|---|---|--|
| Ground Floor | <p>023 - Toilet</p> <p>Asbestos Refurbishment Survey to Leopold Court in Rochdale prior to remodelling of the building to include an increase to the bedroom capacity and the proposed layout(s) to deliver 29 standard bedrooms, including 1no. CAT 3 wheelchair accessible room per floor (2 in total), and +1 emergency bedroom.</p> <p>Plasterboard ceiling up to concrete, solid brick walls with modern ceramic tiles, linoleum floor covering down to concrete, electrical goods, wood door, and frame, modern toilet ware, copper and plastic pipework, metal radiator with associated pipework, UPVC boxing with exposed pipework.</p> | | |

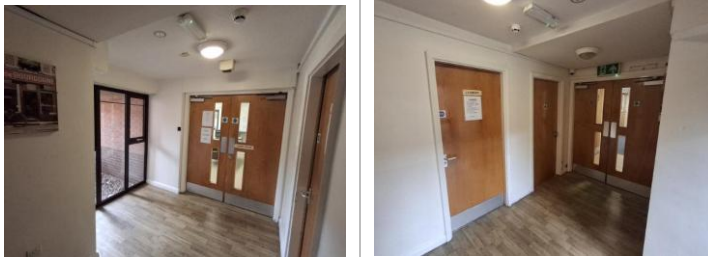
| Building: Leopold Court | | | |
|---|---|---|--|
| Ground Floor | <p>024 - Circulation</p> <p>Asbestos Refurbishment Survey to Leopold Court in Rochdale prior to remodelling of the building to include an increase to the bedroom capacity and the proposed layout(s) to deliver 29 standard bedrooms, including 1no. CAT 3 wheelchair accessible room per floor (2 in total), and +1 emergency bedroom.</p> <p>Plasterboard ceiling up to concrete, solid brick walls, linoleum floor covering down to concrete, electrical goods, wood doors, and frames.</p> | | |

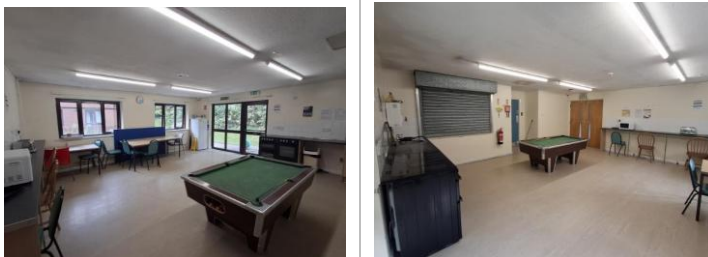
| Building: Leopold Court | | | |
|---|---|---|--|
| Ground Floor | <p>025 - Dining Room</p> <p>Asbestos Refurbishment Survey to Leopold Court in Rochdale prior to remodelling of the building to include an increase to the bedroom capacity and the proposed layout(s) to deliver 29 standard bedrooms, including 1no. CAT 3 wheelchair accessible room per floor (2 in total), and +1 emergency bedroom.</p> <p>Plasterboard ceiling up to concrete, solid brick walls with modern ceramic tiles to sink and work top areas, linoleum floor covering down to concrete, electrical goods, wood doors, and frames, copper and plastic pipework, modern hot water heater, metal radiators with associated pipework, UPVC windows and external door.</p> | | |

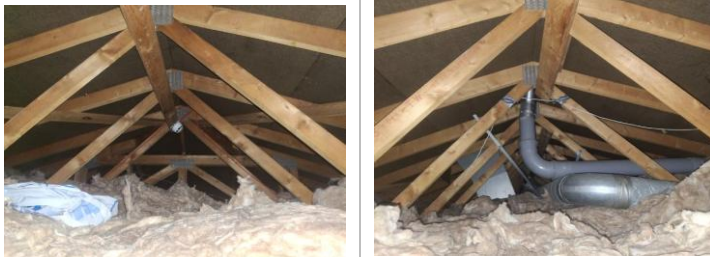
| Building: Leopold Court | | | |
|---|---|---|--|
| Ground Floor | <p>025a - Dining Room Roof Space</p> <p>Asbestos Refurbishment Survey to Leopold Court in Rochdale prior to remodelling of the building to include an increase to the bedroom capacity and the proposed layout(s) to deliver 29 standard bedrooms, including 1no. CAT 3 wheelchair accessible room per floor (2 in total), and +1 emergency bedroom.</p> <p>Pitched timber frame roof with felted underside, brick walls, electrical goods, MMMF insulation throughout, plastic pipework, metal ducting, polystyrene panel to loft hatch.</p> | | |

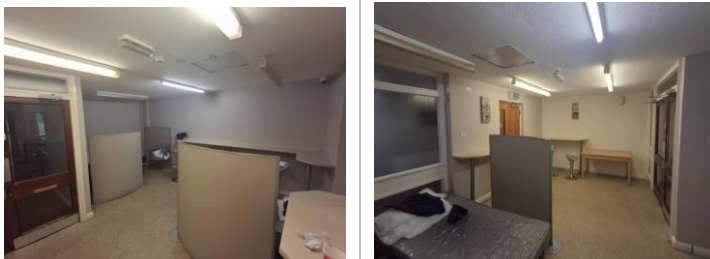
| Building: Leopold Court | | | |
|---|---|---|--|
| Ground Floor | <p>026 - Communal Space</p> <p>Asbestos Refurbishment Survey to Leopold Court in Rochdale prior to remodelling of the building to include an increase to the bedroom capacity and the proposed layout(s) to deliver 29 standard bedrooms, including 1no. CAT 3 wheelchair accessible room per floor (2 in total), and +1 emergency bedroom.</p> <p>Plasterboard ceiling, solid brick walls with decorative wallpaper, linoleum floor covering down to concrete, electrical goods, wood doors, and frames, copper pipework, metal radiator with associated pipework.</p> | | |

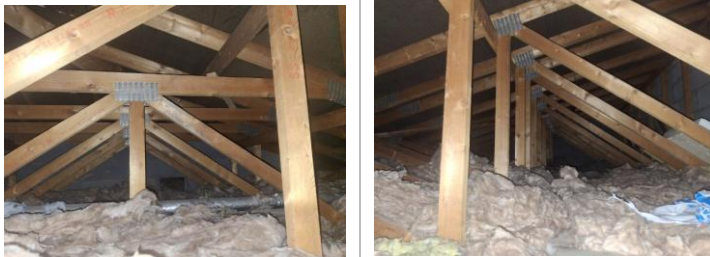
| Building: Leopold Court | | | |
|---|---|---|--|
| Ground Floor | <p>026a - Communal Space Roof Space</p> <p>Asbestos Refurbishment Survey to Leopold Court in Rochdale prior to remodelling of the building to include an increase to the bedroom capacity and the proposed layout(s) to deliver 29 standard bedrooms, including 1no. CAT 3 wheelchair accessible room per floor (2 in total), and +1 emergency bedroom.</p> <p>Pitched timber frame roof with felted underside, brick walls, electrical goods, MMMF insulation throughout, modern insulation to pipework.</p> | | |

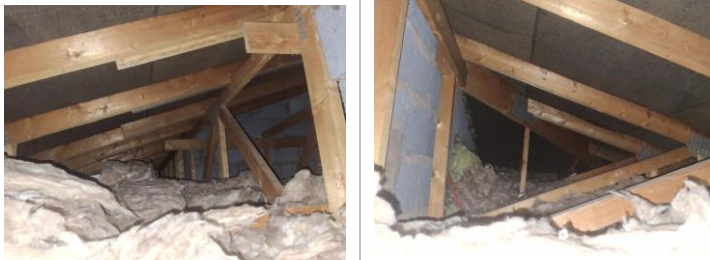
| Building: Leopold Court | | | |
|---|---|---|--|
| Ground Floor | <p>027a - Bedroom 11 Roof Space</p> <p>Asbestos Refurbishment Survey to Leopold Court in Rochdale prior to remodelling of the building to include an increase to the bedroom capacity and the proposed layout(s) to deliver 29 standard bedrooms, including 1no. CAT 3 wheelchair accessible room per floor (2 in total), and +1 emergency bedroom.</p> <p>Pitched timber frame roof with felted underside, brick walls, electrical goods, MMMF insulation throughout, modern insulation to pipework.</p> | | |

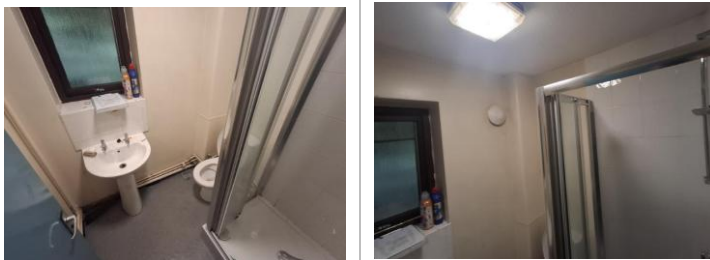
| Building: Leopold Court | | | |
|---|---|---|--|
| Ground Floor | <p>028 - Bedroom 11 Bathroom</p> <p>Asbestos Refurbishment Survey to Leopold Court in Rochdale prior to remodelling of the building to include an increase to the bedroom capacity and the proposed layout(s) to deliver 29 standard bedrooms, including 1no. CAT 3 wheelchair accessible room per floor (2 in total), and +1 emergency bedroom.</p> <p>Plasterboard ceiling, solid brick walls with modern ceramic tiles, linoleum floor covering down to concrete, electrical goods, wood door, and frame, metal radiator with associated pipework, UPVC window, modern toilet ware, copper and plastic pipework, UPVC boxing with exposed pipework.</p> | | |

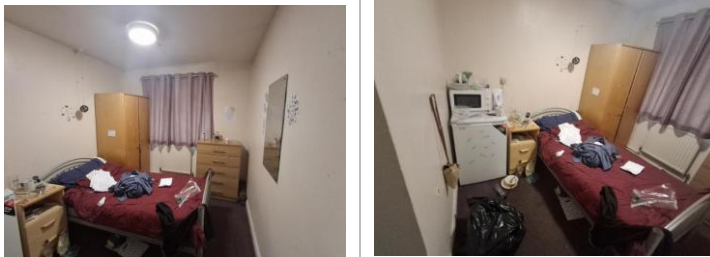
| Building: Leopold Court | | | |
|---|---|---|--|
| Ground Floor | <p>029 - Bedroom 10</p> <p>Asbestos Refurbishment Survey to Leopold Court in Rochdale prior to remodelling of the building to include an increase to the bedroom capacity and the proposed layout(s) to deliver 29 standard bedrooms, including 1no. CAT 3 wheelchair accessible room per floor (2 in total), and +1 emergency bedroom.</p> <p>Plasterboard ceiling, solid brick walls, carpet floor covering down to concrete, electrical goods, wood doors, and frames, metal radiator with associated pipework, UPVC window.</p> | | |

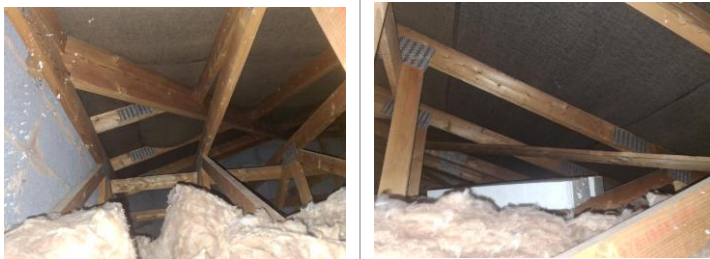
| Building: Leopold Court | | | |
|---|---|---|--|
| Ground Floor | <p>029a - Bedroom 10 Roof Space</p> <p>Asbestos Refurbishment Survey to Leopold Court in Rochdale prior to remodelling of the building to include an increase to the bedroom capacity and the proposed layout(s) to deliver 29 standard bedrooms, including 1no. CAT 3 wheelchair accessible room per floor (2 in total), and +1 emergency bedroom.</p> <p>Pitched timber frame roof with felted underside, brick walls, electrical goods, MMMF insulation throughout, modern insulation to pipework.</p> | | |

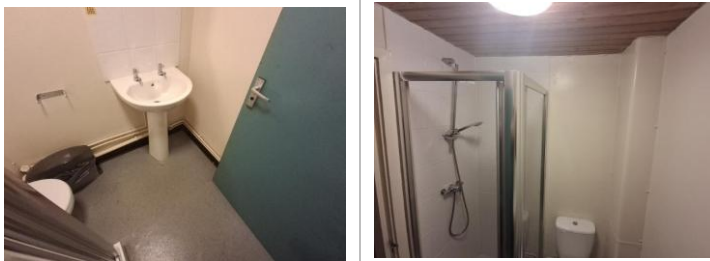
| Building: Leopold Court | | | |
|---|---|---|--|
| Ground Floor | <p>032 - Bedroom 5 Bathroom</p> <p>Asbestos Refurbishment Survey to Leopold Court in Rochdale prior to remodelling of the building to include an increase to the bedroom capacity and the proposed layout(s) to deliver 29 standard bedrooms, including 1no. CAT 3 wheelchair accessible room per floor (2 in total), and +1 emergency bedroom.</p> <p>Timber ceiling, solid brick walls with modern ceramic tiles, linoleum floor covering down to concrete, electrical goods, wood door, and frame, metal radiator with associated pipework, modern toilet ware, copper and plastic pipework, UPVC boxing with exposed pipework.</p> | | |

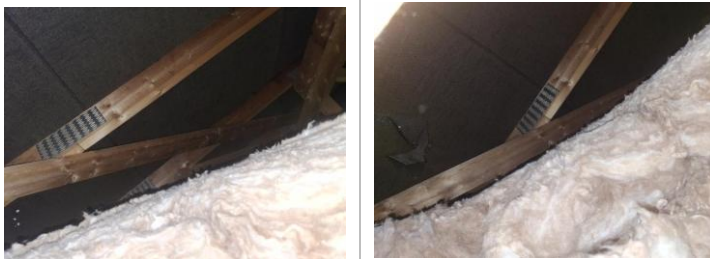
| Building: Leopold Court | | | |
|---|---|---|--|
| Ground Floor | <p>034a - Bedroom 7 Roof Space</p> <p>Asbestos Refurbishment Survey to Leopold Court in Rochdale prior to remodelling of the building to include an increase to the bedroom capacity and the proposed layout(s) to delivery standard bedrooms, including 1no. CAT 3 wheelchair accessible room per floor (2 in total), and +1 emergency bedroom.</p> <p>Pitched timber frame roof with felted underside, brick walls, electrical goods, MMMF insulation throughout.</p> | | |

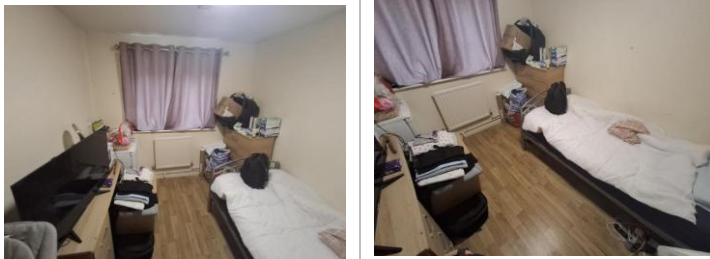
| Building: Leopold Court | | | |
|---|---|---|--|
| Ground Floor | <p><b>035 - Bedroom 4</b></p> <p>Asbestos Refurbishment Survey to Leopold Court in Rochdale prior to remodelling of the building to include an increase to the bedroom capacity and the proposed layout(s) to deliver 29 standard bedrooms, including 1no. CAT 3 wheelchair accessible room per floor (2 in total), and +1 emergency bedroom.</p> <p>Plasterboard ceiling, solid brick walls, linoleum floor covering down to concrete, electrical goods, wood doors, and frames, metal radiator with associated pipework, UPVC window.</p> | | |

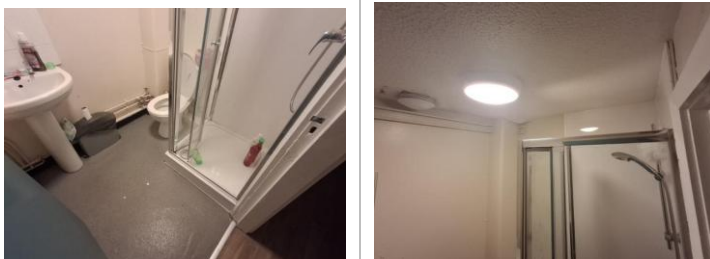
| Building: Leopold Court | | | |
|---|---|---|--|
| Ground Floor | <p><b>036 - Bedroom 4 Bathroom</b></p> <p>Asbestos Refurbishment Survey to Leopold Court in Rochdale prior to remodelling of the building to include an increase to the bedroom capacity and the proposed layout(s) to deliver 29 standard bedrooms, including 1no. CAT 3 wheelchair accessible room per floor (2 in total), and +1 emergency bedroom.</p> <p>Plasterboard ceiling, solid brick walls with modern ceramic tiles, linoleum floor covering down to concrete, electrical goods, wood door, and frame, metal radiator with associated pipework, modern toilet ware, copper and plastic pipework, UPVC boxing with exposed pipework.</p> | | |

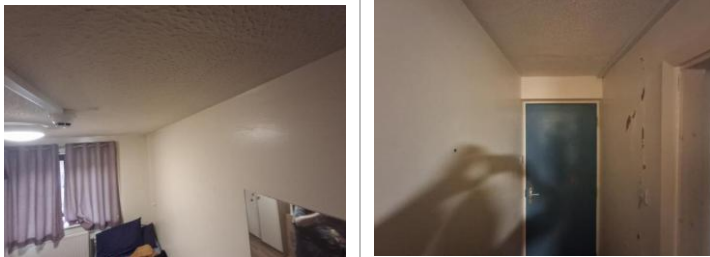
| Building: Leopold Court | | | |
|---|---|---|--|
| Ground Floor | <p><b>037 - Bedroom 3</b></p> <p>Asbestos Refurbishment Survey to Leopold Court in Rochdale prior to remodelling of the building to include an increase to the bedroom capacity and the proposed layout(s) to deliver 29 standard bedrooms, including 1no. CAT 3 wheelchair accessible room per floor (2 in total), and +1 emergency bedroom.</p> <p>Plasterboard ceiling, solid brick walls, linoleum floor covering down to concrete, electrical goods, wood doors, and frames, metal radiator with associated pipework, UPVC window.</p> | | |

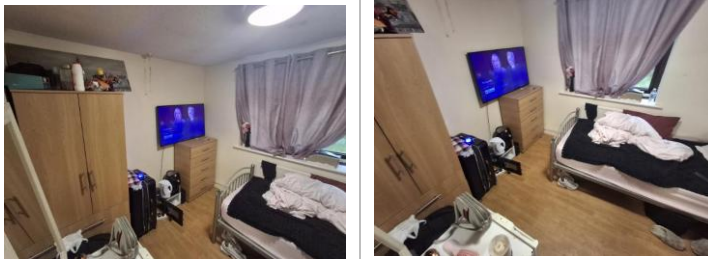
| Building: Leopold Court | | | |
|---|---|---|--|
| Ground Floor | <p><b>039 - Bedroom 2</b></p> <p>Asbestos Refurbishment Survey to Leopold Court in Rochdale prior to remodelling of the building to include an increase to the bedroom capacity and the proposed layout(s) to deliver 29 standard bedrooms, including 1no. CAT 3 wheelchair accessible room per floor (2 in total), and +1 emergency bedroom.</p> <p>Plasterboard ceiling, solid brick walls, linoleum floor covering down to concrete, electrical goods, wood doors, and frames, metal radiator with associated pipework, UPVC window.</p> | | |

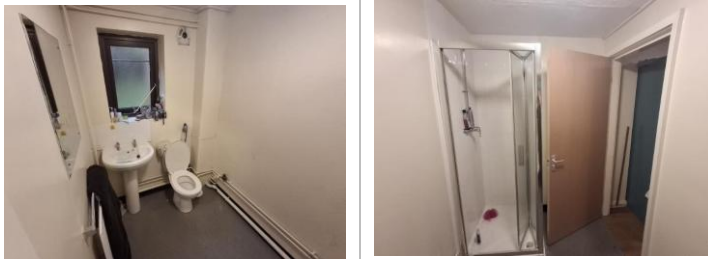
| Building: Leopold Court | | | |
|---|---|---|--|
| Ground Floor | <p><b>040 - Bedroom 2 Bathroom</b></p> <p>Asbestos Refurbishment Survey to Leopold Court in Rochdale prior to remodelling of the building to include an increase to the bedroom capacity and the proposed layout(s) to deliver 29 standard bedrooms, including 1no. CAT 3 wheelchair accessible room per floor (2 in total), and +1 emergency bedroom.</p> <p>Plasterboard ceiling, solid brick walls with modern ceramic tiles, linoleum floor covering down to concrete, electrical goods, wood door, and frame, metal radiator with associated pipework, modern toilet ware, copper and plastic pipework, UPVC boxing with exposed pipework, UPVC window.</p> | | |

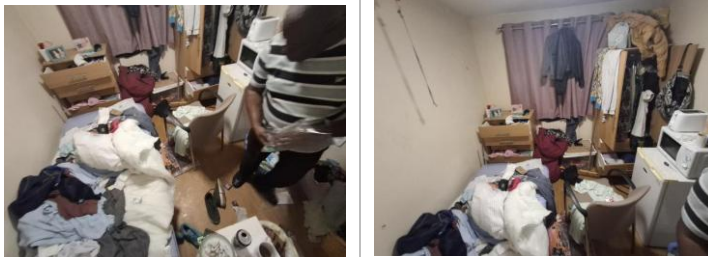
| Building: Leopold Court | | | |
|---|---|---|--|
| Ground Floor | <p><b>041 - Bedroom 1</b></p> <p>Asbestos Refurbishment Survey to Leopold Court in Rochdale prior to remodelling of the building to include an increase to the bedroom capacity and the proposed layout(s) to deliver 29 standard bedrooms, including 1no. CAT 3 wheelchair accessible room per floor (2 in total), and +1 emergency bedroom.</p> <p>Plasterboard ceiling, solid brick walls, linoleum floor covering down to concrete, electrical goods, wood doors, and frames, metal radiator with associated pipework, UPVC window.</p> | | |

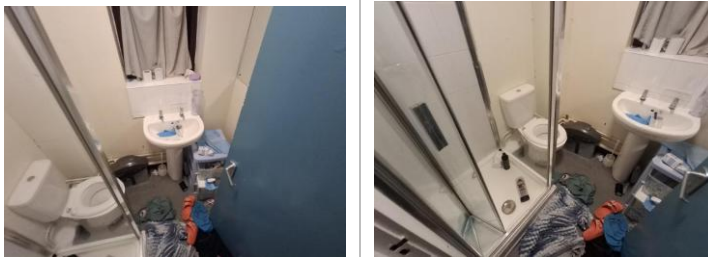
| Building: Leopold Court | | | |
|---|---|---|--|
| Ground Floor | <p><b>042 - Bedroom 1 Bathroom</b></p> <p>Asbestos Refurbishment Survey to Leopold Court in Rochdale prior to remodelling of the building to include an increase to the bedroom capacity and the proposed layout(s) to deliver 29 standard bedrooms, including 1no. CAT 3 wheelchair accessible room per floor (2 in total), and +1 emergency bedroom.</p> <p>Plasterboard ceiling, solid brick walls with modern ceramic tiles, linoleum floor covering down to concrete, electrical goods, wood door, and frame, metal radiator with associated pipework, modern toilet ware, copper and plastic pipework, UPVC boxing with exposed pipework, UPVC window.</p> | | |

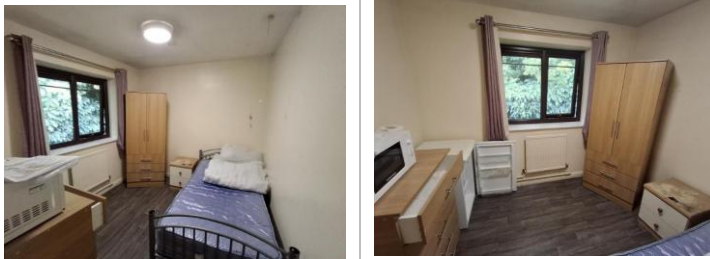
| Building: Leopold Court | | | |
|---|---|---|--|
| Ground Floor | <p><b>063 - Bedroom 8</b></p> <p>Asbestos Refurbishment Survey to Leopold Court in Rochdale prior to remodelling of the building to include an increase to the bedroom capacity and the proposed layout(s) to deliver 29 standard bedrooms, including 1no. CAT 3 wheelchair accessible room per floor (2 in total), and +1 emergency bedroom.</p> <p>Plasterboard ceiling, solid brick walls, linoleum floor covering down to concrete, electrical goods, wood doors, and frames, metal radiator with associated pipework, UPVC window.</p> | | |

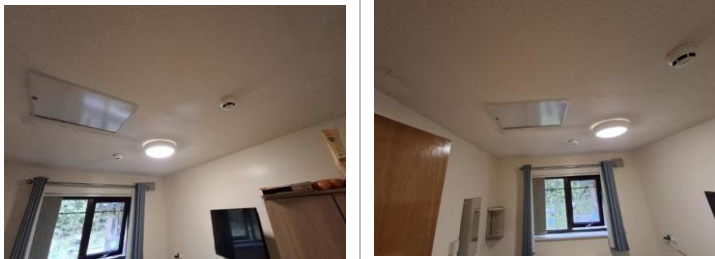
| Building: Leopold Court | | | |
|---|---|---|--|
| Ground Floor | <p><b>067 - Bedroom 23</b></p> <p>Asbestos Refurbishment Survey to Leopold Court in Rochdale prior to remodelling of the building to include an increase to the bedroom capacity and the proposed layout(s) to deliver 29 standard bedrooms, including 1no. CAT 3 wheelchair accessible room per floor (2 in total), and +1 emergency bedroom.</p> <p>Plasterboard ceiling, solid brick walls, linoleum floor covering down to concrete, electrical goods, wood door, and frame, metal radiator with associated pipework, UPVC window.</p> | | |

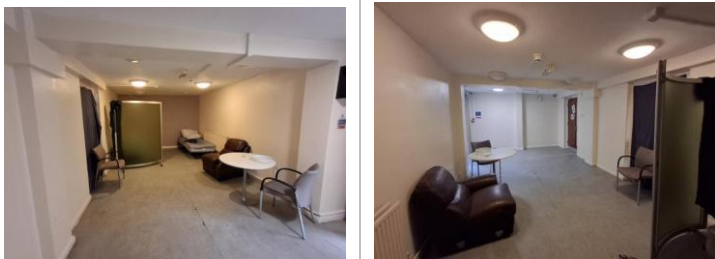
| Building: Leopold Court | | | |
|---|---|---|--|
| Ground Floor | <p><b>068 - Emergency Bedroom</b></p> <p>Asbestos Refurbishment Survey to Leopold Court in Rochdale prior to remodelling of the building to include an increase to the bedroom capacity and the proposed layout(s) to deliver 29 standard bedrooms, including 1no. CAT 3 wheelchair accessible room per floor (2 in total), and +1 emergency bedroom.</p> <p>Plasterboard ceiling, solid brick walls, linoleum floor covering down to concrete, electrical goods, wood door, and frame, metal radiator with associated pipework, UPVC door and window.</p> | | |

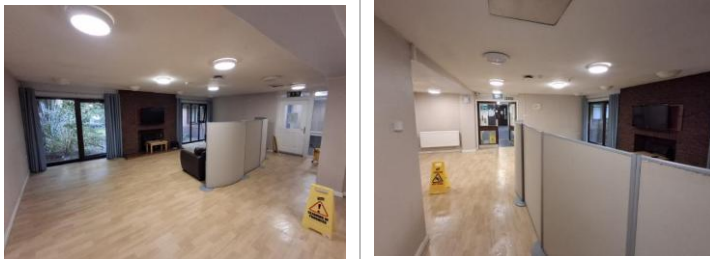
| Building: Leopold Court | | | |
|---|---|---|--|
| Ground Floor | <p>069 - Residents Lounge</p> <p>Asbestos Refurbishment Survey to Leopold Court in Rochdale prior to remodelling of the building to include an increase to the bedroom capacity and the proposed layout(s) to deliver 29 standard bedrooms, including 1no. CAT 3 wheelchair accessible room per floor (2 in total), and +1 emergency bedroom.</p> <p>Plasterboard ceiling, solid brick walls with decorative wallpaper, linoleum floor covering down to concrete, electrical goods, wood doors, and frames, UPVC door and frame, metal radiator with associated pipework, UPVC window.</p> | | |

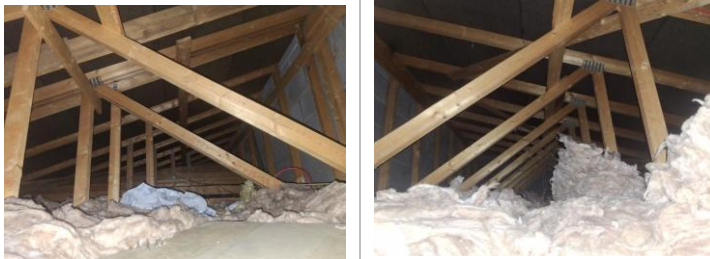
| Building: Leopold Court | | | |
|---|---|---|--|
| Ground Floor | <p>069a - Residents Lounge Roof Space</p> <p>Asbestos Refurbishment Survey to Leopold Court in Rochdale prior to remodelling of the building to include an increase to the bedroom capacity and the proposed layout(s) to deliver 29 standard bedrooms, including 1no. CAT 3 wheelchair accessible room per floor (2 in total), and +1 emergency bedroom.</p> <p>Pitched timber frame roof with felted underside, brick walls, electrical goods, MMMF insulation throughout.</p> | | |

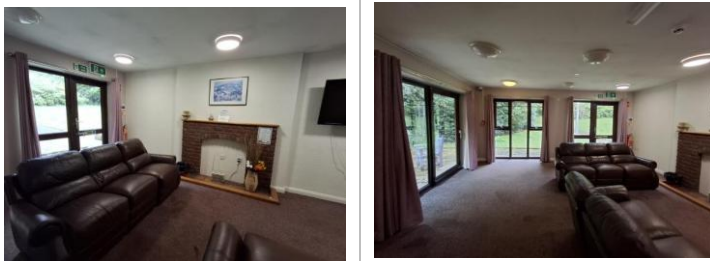
| Building: Leopold Court | | | |
|---|---|---|--|
| Ground Floor | <p>070 - Communal Space</p> <p>Asbestos Refurbishment Survey to Leopold Court in Rochdale prior to remodelling of the building to include an increase to the bedroom capacity and the proposed layout(s) to deliver 29 standard bedrooms, including 1no. CAT 3 wheelchair accessible room per floor (2 in total), and +1 emergency bedroom.</p> <p>Plasterboard ceiling, solid brick walls with decorative wallpaper, carpet floor covering down to concrete, electrical goods, wood door, and frame, UPVC door and frame, metal radiators with associated pipework, UPVC windows.</p> | | |

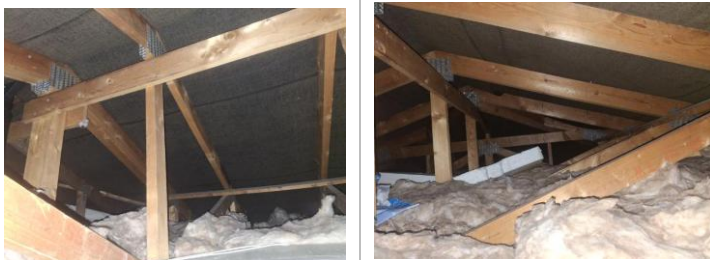
| Building: Leopold Court | | | |
|---|---|---|--|
| Ground Floor | <p>070a - Communal Space Roof Space</p> <p>Asbestos Refurbishment Survey to Leopold Court in Rochdale prior to remodelling of the building to include an increase to the bedroom capacity and the proposed layout(s) to deliver 29 standard bedrooms, including 1no. CAT 3 wheelchair accessible room per floor (2 in total), and +1 emergency bedroom.</p> <p>Pitched timber frame roof with felted underside, brick walls, electrical goods, MMMF insulation throughout.</p> | | |

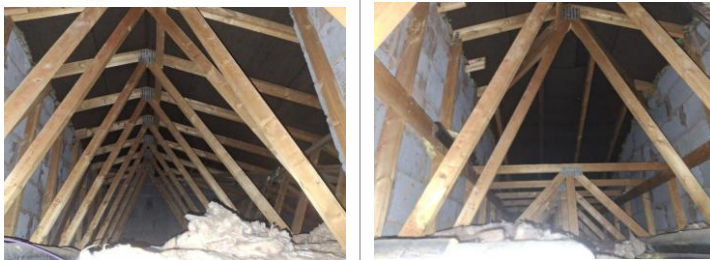
| Building: Leopold Court | | | |
|---|---|---|--|
| Ground Floor | <p>071a - Corridor Roof Space</p> <p>Asbestos Refurbishment Survey to Leopold Court in Rochdale prior to remodelling of the building to include an increase to the bedroom capacity and the proposed layout(s) to deliver 29 standard bedrooms, including 1no. CAT 3 wheelchair accessible room per floor (2 in total), and +1 emergency bedroom.</p> <p>Pitched timber frame roof with felted underside, brick walls, electrical goods, MMMF insulation throughout, MMMF insulation to metal pipework.</p> | | |

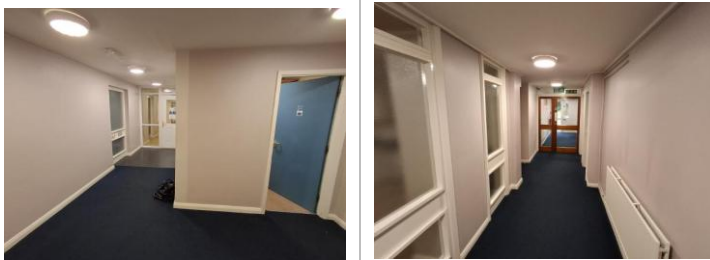
| Building: Leopold Court | | | |
|---|---|---|--|
| Ground Floor | <p>072 - Corridor</p> <p>Asbestos Refurbishment Survey to Leopold Court in Rochdale prior to remodelling of the building to include an increase to the bedroom capacity and the proposed layout(s) to deliver 29 standard bedrooms, including 1no. CAT 3 wheelchair accessible room per floor (2 in total), and +1 emergency bedroom.</p> <p>Plasterboard ceiling, solid brick walls, linoleum floor covering down to concrete, electrical goods, wood doors, and frames, metal radiator with associated pipework.</p> | | |

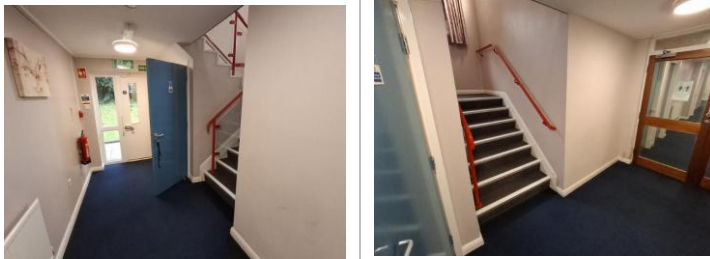
| Building: Leopold Court | | | |
|---|---|---|--|
| Ground Floor | <p><b>074 - Stairs Lobby</b></p> <p>Asbestos Refurbishment Survey to Leopold Court in Rochdale prior to remodelling of the building to include an increase to the bedroom capacity and the proposed layout(s) to deliver 29 standard bedrooms, including 1no. CAT 3 wheelchair accessible room per floor (2 in total), and +1 emergency bedroom.</p> <p>Plasterboard ceiling, solid brick walls, carpet floor covering down to concrete, electrical goods, wood door, and frame, UPVC external door, metal radiator with associated pipework, rubber nosing strips.</p> | | |

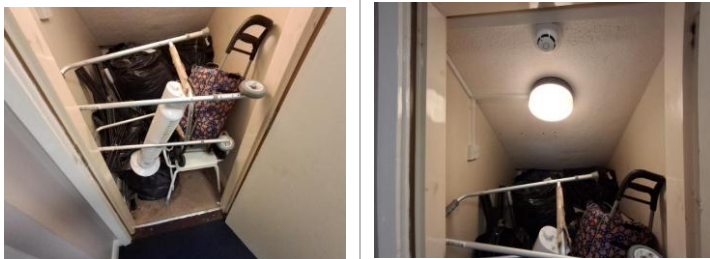
| Building: Leopold Court | | | |
|---|---|---|--|
| Ground Floor | <p><b>075 - Understairs Cupboard</b></p> <p>Asbestos Refurbishment Survey to Leopold Court in Rochdale prior to remodelling of the building to include an increase to the bedroom capacity and the proposed layout(s) to deliver 29 standard bedrooms, including 1no. CAT 3 wheelchair accessible room per floor (2 in total), and +1 emergency bedroom.</p> <p>Concrete ceiling, solid brick walls, linoleum floor covering down to concrete, electrical goods, wood door, and frame.</p> | | |

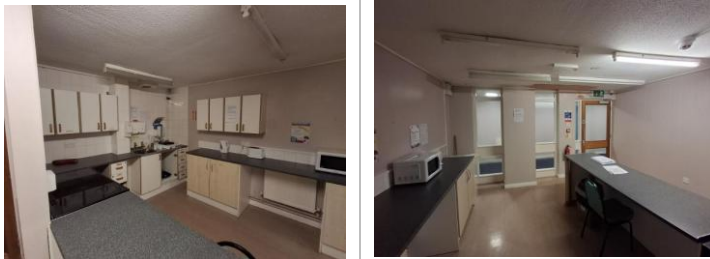
| Building: Leopold Court | | | |
|---|---|---|--|
| Ground Floor | <p>076 - Training Kitchen</p> <p>Asbestos Refurbishment Survey to Leopold Court in Rochdale prior to remodelling of the building to include an increase to the bedroom capacity and the proposed layout(s) to deliver 29 standard bedrooms, including 1no. CAT 3 wheelchair accessible room per floor (2 in total), and +1 emergency bedroom.</p> <p>Plasterboard ceiling, solid brick walls with decorative wallpaper and modern ceramic tiles, linoleum floor covering down to concrete, electrical goods, wood doors, and frames, copper pipework, metal radiator with associated pipework, modern kitchen ware, copper and plastic pipework.</p> | | |

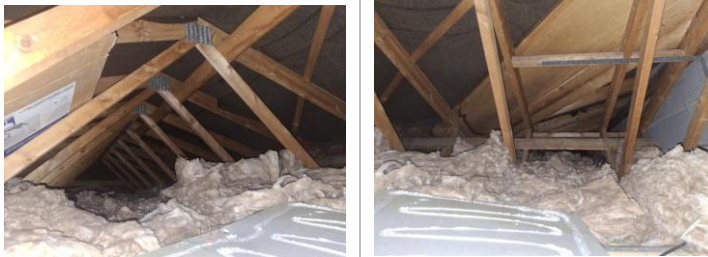
| Building: Leopold Court | | | |
|---|---|---|--|
| Ground Floor | <p>077a - Training Room Roof Space</p> <p>Asbestos Refurbishment Survey to Leopold Court in Rochdale prior to remodelling of the building to include an increase to the bedroom capacity and the proposed layout(s) to deliver 29 standard bedrooms, including 1no. CAT 3 wheelchair accessible room per floor (2 in total), and +1 emergency bedroom.</p> <p>Pitched timber frame roof with felted underside, brick walls, electrical goods, MMMF insulation throughout.</p> | | |

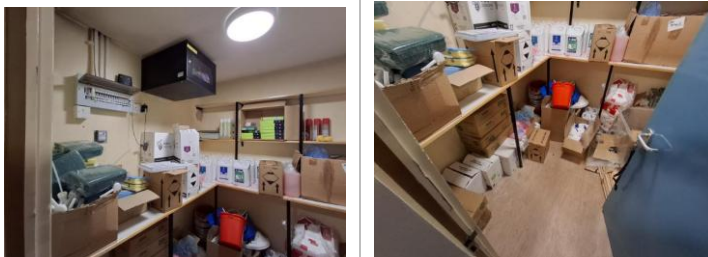
| Building: Leopold Court | | | |
|---|---|---|--|
| Ground Floor | <p>078 - Store</p> <p>Asbestos Refurbishment Survey to Leopold Court in Rochdale prior to remodelling of the building to include an increase to the bedroom capacity and the proposed layout(s) to deliver 29 standard bedrooms, including 1no. CAT 3 wheelchair accessible room per floor (2 in total), and +1 emergency bedroom.</p> <p>Plasterboard ceiling, solid brick walls, linoleum floor covering down to concrete, electrical goods, wood door, and frame, server equipment, modern switch board.</p> | | |

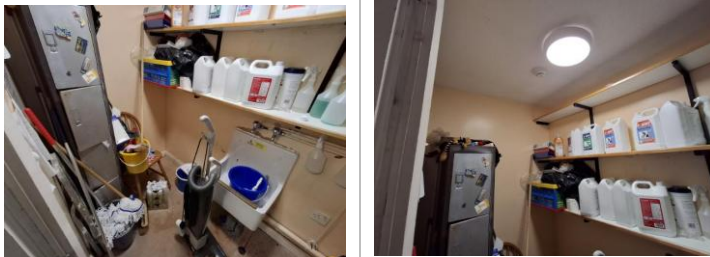
| Building: Leopold Court | | | |
|---|---|---|--|
| Ground Floor | <p>079 - Store</p> <p>Asbestos Refurbishment Survey to Leopold Court in Rochdale prior to remodelling of the building to include an increase to the bedroom capacity and the proposed layout(s) to deliver 29 standard bedrooms, including 1no. CAT 3 wheelchair accessible room per floor (2 in total), and +1 emergency bedroom.</p> <p>Plasterboard ceiling, solid brick walls, linoleum floor covering down to concrete, electrical goods, wood door, and frame, copper and plastic pipework.</p> | | |

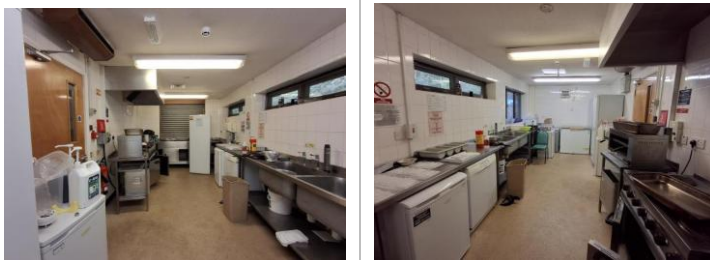
| Building: Leopold Court | | | |
|---|---|---|--|
| Ground Floor | <p>081 - Kitchen</p> <p>Asbestos Refurbishment Survey to Leopold Court in Rochdale prior to remodelling of the building to include an increase to the bedroom capacity and the proposed layout(s) to deliver 29 standard bedrooms, including 1no. CAT 3 wheelchair accessible room per floor (2 in total), and +1 emergency bedroom.</p> <p>Plasterboard ceiling, solid brick walls with ceramic tiles, linoleum floor covering down to concrete, electrical goods, wood door, and frame, copper and plastic pipework, kitchen equipment, modern switch board, UPVC boxing with exposed pipework, metal roller shutter, UPVC windows.</p> | | |

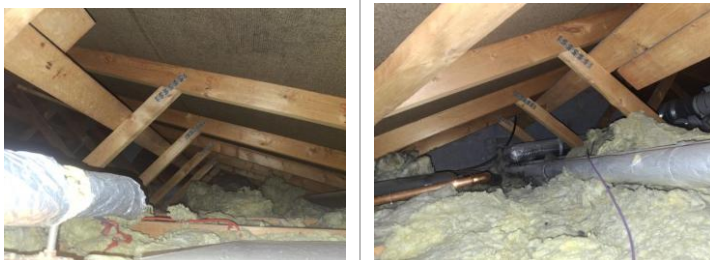
| Building: Leopold Court | | | |
|---|---|---|--|
| Ground Floor | <p>081a - Kitchen Roof Space</p> <p>Asbestos Refurbishment Survey to Leopold Court in Rochdale prior to remodelling of the building to include an increase to the bedroom capacity and the proposed layout(s) to deliver 29 standard bedrooms, including 1no. CAT 3 wheelchair accessible room per floor (2 in total), and +1 emergency bedroom.</p> <p>Pitched timber frame roof with felted underside, brick walls, electrical goods, MMMF insulation throughout, copper pipework with MMMF and foam insulation, metal ducting.</p> | | |

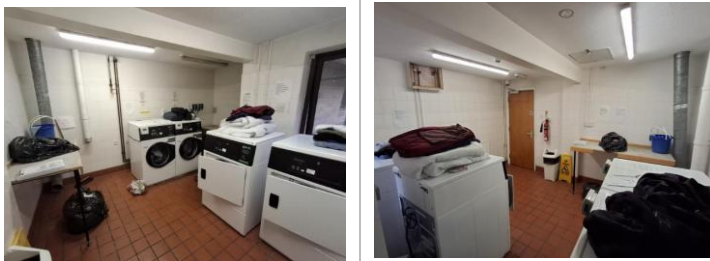
| Building: Leopold Court | | | |
|---|---|---|--|
| Ground Floor | <p>084 - Laundry Room</p> <p>Asbestos Refurbishment Survey to Leopold Court in Rochdale prior to remodelling of the building to include an increase to the bedroom capacity and the proposed layout(s) to deliver 29 standard bedrooms, including 1no. CAT 3 wheelchair accessible room per floor (2 in total), and +1 emergency bedroom.</p> <p>Plasterboard ceiling, solid brick walls with ceramic tiles, ceramic/concrete floor, electrical goods, wood doors, and frames, metal radiator with associated pipework, copper and plastic pipework, metal redundant duct pipe, plastic downpipe.</p> | | |

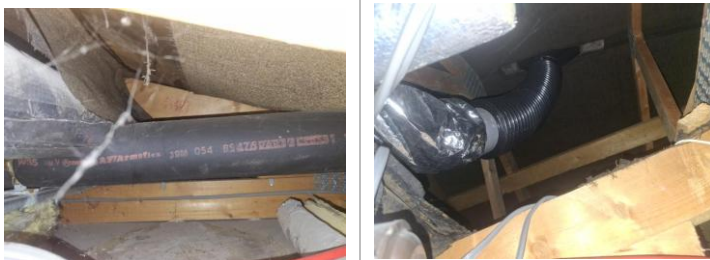
| Building: Leopold Court | | | |
|---|---|---|--|
| Ground Floor | <p>084a - Laundry Room Roof Space</p> <p>Asbestos Refurbishment Survey to Leopold Court in Rochdale prior to remodelling of the building to include an increase to the bedroom capacity and the proposed layout(s) to deliver 29 standard bedrooms, including 1no. CAT 3 wheelchair accessible room per floor (2 in total), and +1 emergency bedroom.</p> <p>Pitched timber frame roof with felted underside, brick walls, electrical goods, MMMF insulation throughout, copper pipework with MMMF and foam insulation, metal and plastic ducting.</p> | | |

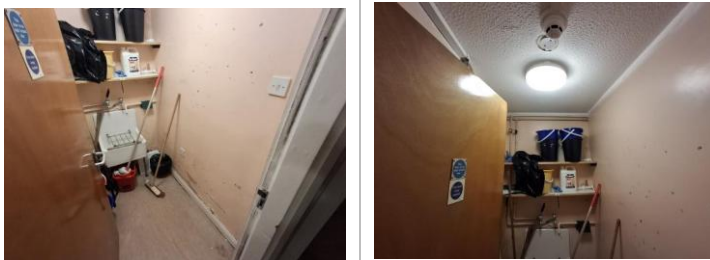
| Building: Leopold Court | | | |
|---|---|---|--|
| Ground Floor | <p>085 - Cleaners Cupboard</p> <p>Asbestos Refurbishment Survey to Leopold Court in Rochdale prior to remodelling of the building to include an increase to the bedroom capacity and the proposed layout(s) to deliver 29 standard bedrooms, including 1no. CAT 3 wheelchair accessible room per floor (2 in total), and +1 emergency bedroom.</p> <p>Plasterboard ceiling, solid brick walls, linoleum floor covering down to concrete, electrical goods, wood door, and frame, copper, and plastic pipework.</p> | | |

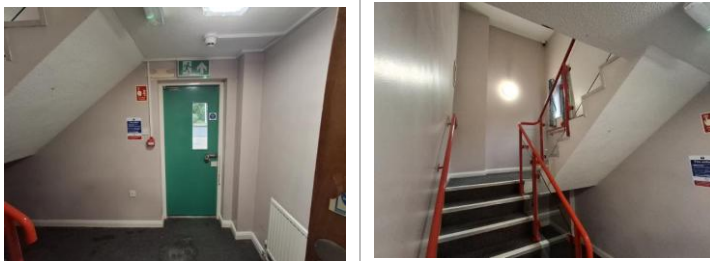
| Building: Leopold Court | | | |
|---|---|---|--|
| Ground Floor | <p><b>087 - Stairs</b></p> <p>Asbestos Refurbishment Survey to Leopold Court in Rochdale prior to remodelling of the building to include an increase to the bedroom capacity and the proposed layout(s) to deliver 29 standard bedrooms, including 1no. CAT 3 wheelchair accessible room per floor (2 in total), and +1 emergency bedroom.</p> <p>Plasterboard and concrete ceiling, solid brick walls, carpet floor covering down to concrete, electrical goods, wood doors, and frames, metal radiator with associated pipework, copper pipework, timber boxing, rubber stair nosings.</p> | | |

| Building | Floor | Room | Description |
|---|---|---|---|
| Leopold Court | Ground Floor | 087 - Stairs | No access within sealed boxing due to damage limitations and the area still in occupation. Integrity would be compromised once access was gained. |

| Building | Floor | Room | Description | Location Photo |
|---|---|---|---|---|
| Leopold Court | Ground Floor | 087 - Stairs | No access within sealed boxing due to damage limitations and the area still in occupation.<br>Integrity would be compromised once access was gained. | |

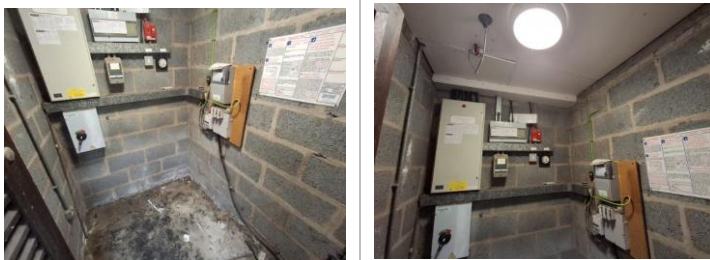
| Building: Leopold Court | | | |
|---|---|---|--|
| Ground Floor | <p><b>088 - Electric Room</b></p> <p>Asbestos Refurbishment Survey to Leopold Court in Rochdale prior to remodelling of the building to include an increase to the bedroom capacity and the proposed layout(s) to deliver 29 standard bedrooms, including 1no. CAT 3 wheelchair accessible room per floor (2 in total), and +1 emergency bedroom.</p> <p>Insulating board ceiling panels, brick block walls, concrete floor, electrical goods, wood door, and frame, timber back board to electric metre, cable trunking.</p> | | |

| Building | Floor | Room | Description | Product Type | Material Risk Score | Action / Recommendation |
|---|---|---|---|---|---|---|
| Leopold Court | Ground Floor | 088 - Electric Room | Busbar Wedged Between Cable Trunking & Fuse Box | Resin | 3 | Manage |

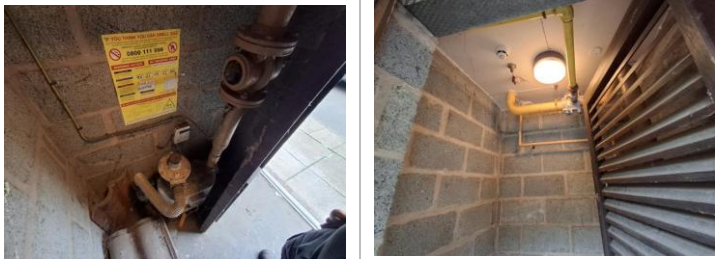
| Building: Leopold Court | | | |
|---|---|---|--|
| Ground Floor | <p>089 - Gas Meter Room</p> <p>Asbestos Refurbishment Survey to Leopold Court in Rochdale prior to remodelling of the building to include an increase to the bedroom capacity and the proposed layout(s) to deliver 29 standard bedrooms, including 1no. CAT 3 wheelchair accessible room per floor (2 in total), and +1 emergency bedroom.</p> <p>Insulating board ceiling panels, brick block walls, concrete floor, electrical goods, wood door, and frame, gas mains, metal pipework.</p> | | |

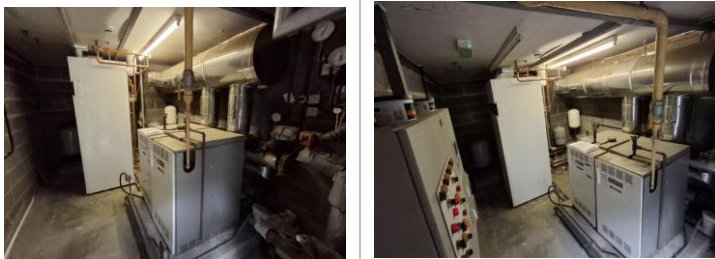
| Building: Leopold Court | | | |
|---|---|---|--|
| Ground Floor | <p>090 - Boiler Room</p> <p>Asbestos Refurbishment Survey to Leopold Court in Rochdale prior to remodelling of the building to include an increase to the bedroom capacity and the proposed layout(s) to deliver 29 standard bedrooms, including 1no. CAT 3 wheelchair accessible room per floor (2 in total), and +1 emergency bedroom.</p> <p>Insulating board ceiling panels, brick block walls, concrete floor, wood doors, and frame, electrical goods, metal ducting, metal pipework with modern insulation, cable trunking.</p> | | |

| Building | Floor | Room | Description | Product Type | Material Risk Score | Action / Recommendation |
|---|---|---|---|---|---|---|
| Leopold Court | Ground Floor | 090 - Boiler Room | Gaskets to Pipework | Gaskets | 4 | Manage |

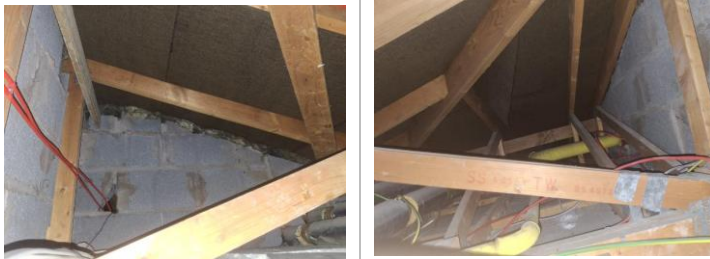
| Building: Leopold Court | | | |
|---|---|---|--|
| Ground Floor | <p>090a - Boiler Room Roof Space</p> <p>Asbestos Refurbishment Survey to Leopold Court in Rochdale prior to remodelling of the building to include an increase to the bedroom capacity and the proposed layout(s) to deliver 29 standard bedrooms, including 1no. CAT 3 wheelchair accessible room per floor (2 in total), and +1 emergency bedroom.</p> <p>Pitched timber frame roof with felted underside, brick walls, electrical goods, MMMF insulation throughout, copper pipework with MMMF insulation.</p> | | |
