## Asbestos Refurbishment Survey

**Leopold Court  
Leopold Street  
off Bury Road  
Rochdale  
OL11 5HA**

**Triangle Architects Ltd**

| Project Number: | Survey Date: | Issue Date: |

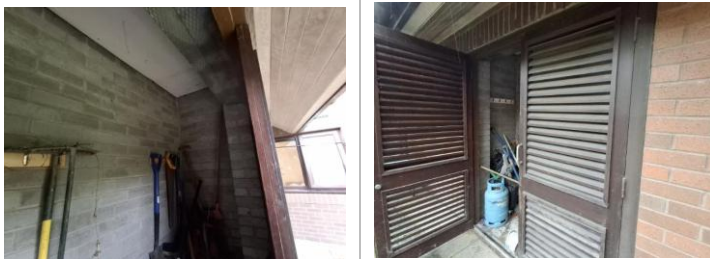
| Building: Leopold Court | | | |
|---|---|---|--|
| Ground Floor | <p>100 - Tool Cupboard</p> <p>Asbestos Refurbishment Survey to Leopold Court in Rochdale prior to remodelling of the building to include an increase to the bedroom capacity and the proposed layout(s) to deliver 29 standard bedrooms, including 1no. CAT 3 wheelchair accessible room per floor (2 in total), and +1 emergency bedroom.</p> <p>Insulating board ceiling panels, brick walls, concrete floor, electrical goods, wood doors, and frame.</p> | | |

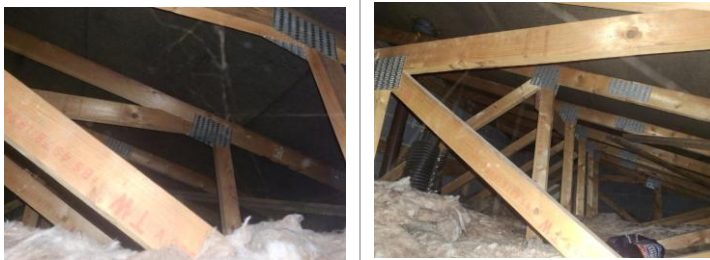
| Building: Leopold Court | | | |
|---|---|---|--|
| 1st Floor | <p>043a - Bedroom 13 Roof Space</p> <p>Asbestos Refurbishment Survey to Leopold Court in Rochdale prior to remodelling of the building to include an increase to the bedroom capacity and the proposed layout(s) to delivery standard bedrooms, including 1no. CAT 3 wheelchair accessible room per floor (2 in total), and +1 emergency bedroom.</p> <p>Pitched timber frame roof with felted underside, brick walls, electrical goods, MMMF insulation throughout.</p> | | |

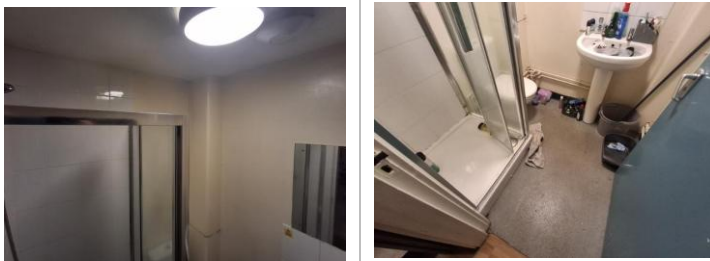
| Building: Leopold Court | | | |
|---|---|---|--|
| 1st Floor | <p>044 - Bedroom 13 Bathroom</p> <p>Asbestos Refurbishment Survey to Leopold Court in Rochdale prior to remodelling of the building to include an increase to the bedroom capacity and the proposed layout(s) to deliver 29 standard bedrooms, including 1no. CAT 3 wheelchair accessible room per floor (2 in total), and +1 emergency bedroom.</p> <p>Plasterboard ceiling, solid brick walls with modern ceramic tiles, linoleum floor covering down to concrete, electrical goods, wood door, and frame, metal radiator with associated pipework, modern toilet ware, copper and plastic pipework, UPVC boxing with exposed pipework.</p> | | |

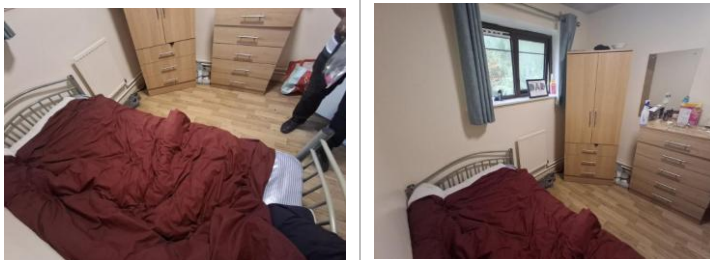
| Building: Leopold Court | | | |
|---|---|---|--|
| 1st Floor | <p>045 - Bedroom 12</p> <p>Asbestos Refurbishment Survey to Leopold Court in Rochdale prior to remodelling of the building to include an increase to the bedroom capacity and the proposed layout(s) to draw 29 standard bedrooms, including 1no. CAT 3 wheelchair accessible room per floor (2 in total), and +1 emergency bedroom.</p> <p>Plasterboard ceiling, solid brick walls, linoleum floor covering down to concrete, electrical goods, wood doors, and frames, metal radiator with associated pipework, UPVC window.</p> | | |

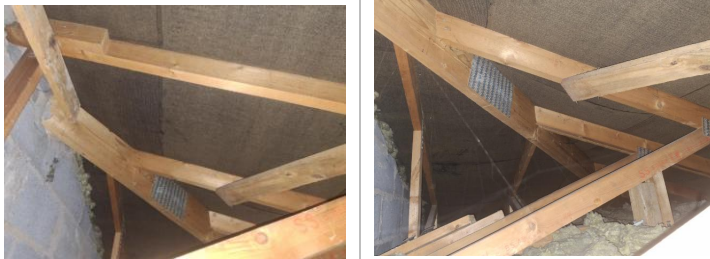
| Building: Leopold Court | | | |
|---|---|---|--|
| 1st Floor | <p>045a - Bedroom 12 Roof Space</p> <p>Asbestos Refurbishment Survey to Leopold Court in Rochdale prior to remodelling of the building to include an increase to the bedroom capacity and the proposed layout(s) to delivery standard bedrooms, including 1no. CAT 3 wheelchair accessible room per floor (2 in total), and +1 emergency bedroom.</p> <p>Pitched timber frame roof with felted underside, brick walls, electrical goods, MMMF insulation throughout.</p> | | |

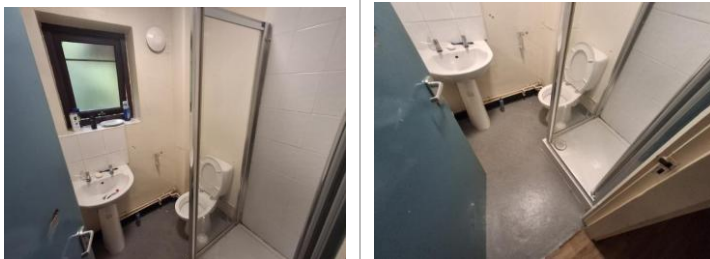
| Building: Leopold Court | | | |
|---|---|---|--|
| 1st Floor | <p>046 - Bedroom 12 Bathroom</p> <p>Asbestos Refurbishment Survey to Leopold Court in Rochdale prior to remodelling of the building to include an increase to the bedroom capacity and the proposed layout(s) to deliver 29 standard bedrooms, including 1no. CAT 3 wheelchair accessible room per floor (2 in total), and +1 emergency bedroom.</p> <p>Plasterboard ceiling, solid brick walls with modern ceramic tiles, linoleum floor covering down to concrete, electrical goods, wood door, and frame, metal radiator with associated pipework, modern toilet ware, copper and plastic pipework, UPVC boxing with exposed pipework, UPVC window.</p> | | |

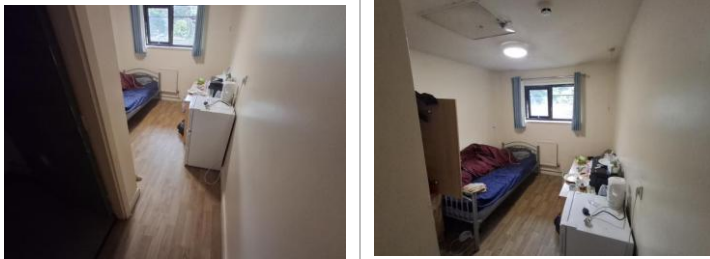
| Building: Leopold Court | | | |
|---|---|---|--|
| 1st Floor | <p>047 - Bedroom 18</p> <p>Asbestos Refurbishment Survey to Leopold Court in Rochdale prior to remodelling of the building to include an increase to the bedroom capacity and the proposed layout(s) to deliver 29 standard bedrooms, including 1no. CAT 3 wheelchair accessible room per floor (2 in total), and +1 emergency bedroom.</p> <p>Plasterboard ceiling, solid brick walls, linoleum floor covering down to concrete, electrical goods, wood doors, and frames, metal radiator with associated pipework, UPVC window.</p> | | |

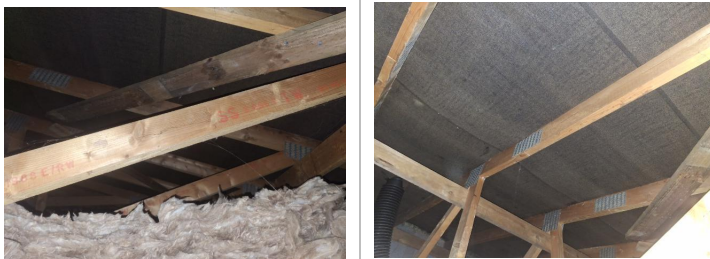
| Building: Leopold Court | | | |
|---|---|---|--|
| 1st Floor | <p>047a - Bedroom 18 Roof Space</p> <p>Asbestos Refurbishment Survey to Leopold Court in Rochdale prior to remodelling of the building to include an increase to the bedroom capacity and the proposed layout(s) to delivery standard bedrooms, including 1no. CAT 3 wheelchair accessible room per floor (2 in total), and +1 emergency bedroom.</p> <p>Pitched timber frame roof with felted underside, brick walls, electrical goods, MMMF insulation throughout.</p> | | |

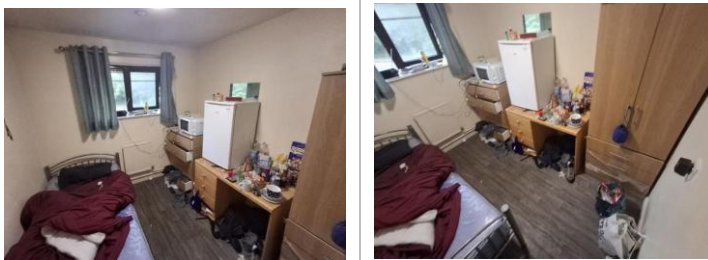
| Building: Leopold Court | | | |
|---|---|---|--|
| 1st Floor | <p>049 - Bedroom 14</p> <p>Asbestos Refurbishment Survey to Leopold Court in Rochdale prior to remodelling of the building to include an increase to the bedroom capacity and the proposed layout(s) to deliver 29 standard bedrooms, including 1no. CAT 3 wheelchair accessible room per floor (2 in total), and +1 emergency bedroom.</p> <p>Plasterboard ceiling, solid brick walls, linoleum floor covering down to concrete, electrical goods, wood doors, and frames, metal radiator with associated pipework, UPVC window.</p> | | |

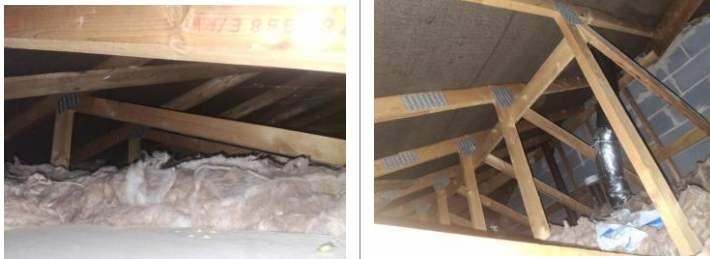
| Building: Leopold Court | | | |
|---|---|---|--|
| 1st Floor | <p>049a - Bedroom 14 Roof Space</p> <p>Asbestos Refurbishment Survey to Leopold Court in Rochdale prior to remodelling of the building to include an increase to the bedroom capacity and the proposed layout(s) to delivery standard bedrooms, including 1no. CAT 3 wheelchair accessible room per floor (2 in total), and +1 emergency bedroom.</p> <p>Pitched timber frame roof with felted underside, brick walls, electrical goods, MMMF insulation throughout.</p> | | |

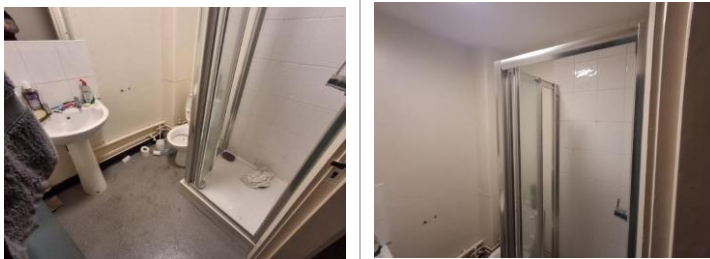
| Building: Leopold Court | | | |
|---|---|---|--|
| 1st Floor | <p>050 - Bedroom 14 Bathroom</p> <p>Asbestos Refurbishment Survey to Leopold Court in Rochdale prior to remodelling of the building to include an increase to the bedroom capacity and the proposed layout(s) to deliver 29 standard bedrooms, including 1no. CAT 3 wheelchair accessible room per floor (2 in total), and +1 emergency bedroom.</p> <p>Plasterboard ceiling, solid brick walls with modern ceramic tiles, linoleum floor covering down to concrete, electrical goods, wood door, and frame, metal radiator with associated pipework, modern toilet ware, copper and plastic pipework, UPVC boxing with exposed pipework.</p> | | |

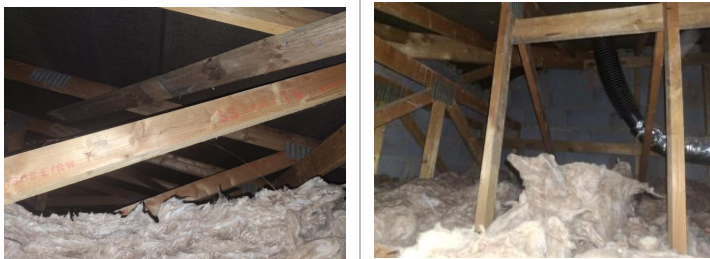
| Building: Leopold Court | | | |
|---|---|---|--|
| 1st Floor | <p>051a - Bedroom 15 Roof Space</p> <p>Asbestos Refurbishment Survey to Leopold Court in Rochdale prior to remodelling of the building to include an increase to the bedroom capacity and the proposed layout(s) to delivery standard bedrooms, including 1no. CAT 3 wheelchair accessible room per floor (2 in total), and +1 emergency bedroom.</p> <p>Pitched timber frame roof with felted underside, brick walls, electrical goods, MMMF insulation throughout.</p> | | |

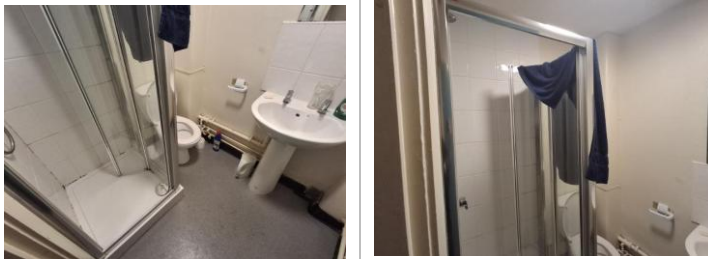
| Building: Leopold Court | | | |
|---|---|---|--|
| 1st Floor | <p>052 - Bedroom 15 Bathroom</p> <p>Asbestos Refurbishment Survey to Leopold Court in Rochdale prior to remodelling of the building to include an increase to the bedroom capacity and the proposed layout(s) to deliver 29 standard bedrooms, including 1no. CAT 3 wheelchair accessible room per floor (2 in total), and +1 emergency bedroom.</p> <p>Plasterboard ceiling, solid brick walls with modern ceramic tiles, linoleum floor covering down to concrete, electrical goods, wood door, and frame, metal radiator with associated pipework, modern toilet ware, copper and plastic pipework, UPVC boxing with exposed pipework.</p> | | |

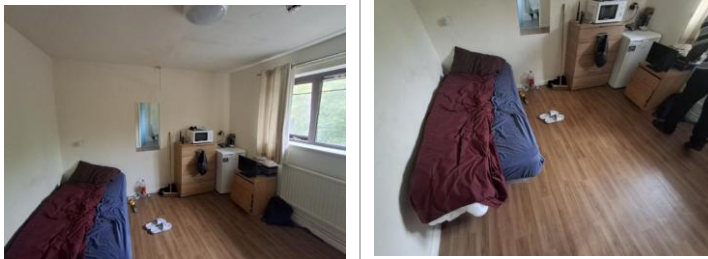
| Building: Leopold Court | | | |
|---|---|---|--|
| 1st Floor | <p>053 - Bedroom 19</p> <p>Asbestos Refurbishment Survey to Leopold Court in Rochdale prior to remodelling of the building to include an increase to the bedroom capacity and the proposed layout(s) to deliver 29 standard bedrooms, including 1no. CAT 3 wheelchair accessible room per floor (2 in total), and +1 emergency bedroom.</p> <p>Plasterboard ceiling, solid brick walls, linoleum floor covering down to concrete, electrical goods, wood doors, and frames, metal radiator with associated pipework, UPVC window.</p> | | |

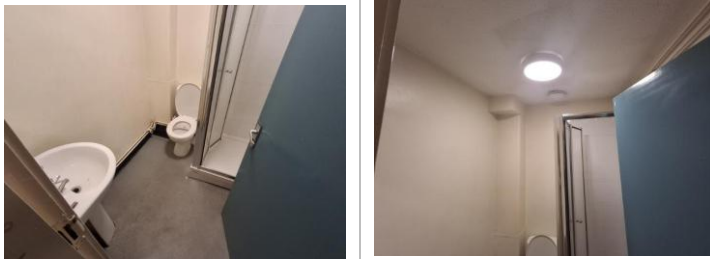
| Building: Leopold Court | | | |
|---|---|---|--|
| 1st Floor | <p>056 - Bedroom 20 Bathroom</p> <p>Asbestos Refurbishment Survey to Leopold Court in Rochdale prior to remodelling of the building to include an increase to the bedroom capacity and the proposed layout(s) to deliver 29 standard bedrooms, including 1no. CAT 3 wheelchair accessible room per floor (2 in total), and +1 emergency bedroom.</p> <p>Plasterboard ceiling, solid brick walls with modern ceramic tiles, linoleum floor covering down to concrete, electrical goods, wood door, and frame, metal radiator with associated pipework, modern toilet ware, copper and plastic pipework, UPVC boxing with exposed pipework.</p> | | |

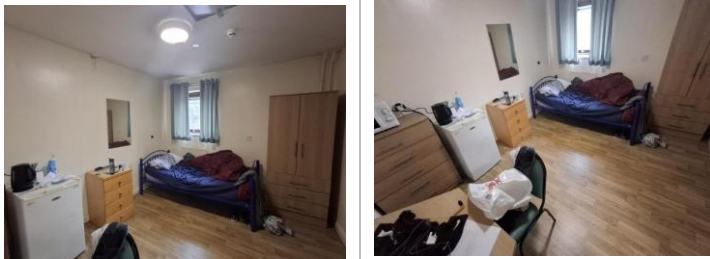
| Building: Leopold Court | | | |
|---|---|---|--|
| 1st Floor | <p>057 - Bedroom 22</p> <p>Asbestos Refurbishment Survey to Leopold Court in Rochdale prior to remodelling of the building to include an increase to the bedroom capacity and the proposed layout(s) to deliver 29 standard bedrooms, including 1no. CAT 3 wheelchair accessible room per floor (2 in total), and +1 emergency bedroom.</p> <p>Plasterboard ceiling, solid brick walls, linoleum floor covering down to concrete, electrical goods, wood doors, and frames, metal radiator with associated pipework, UPVC window.</p> | | |

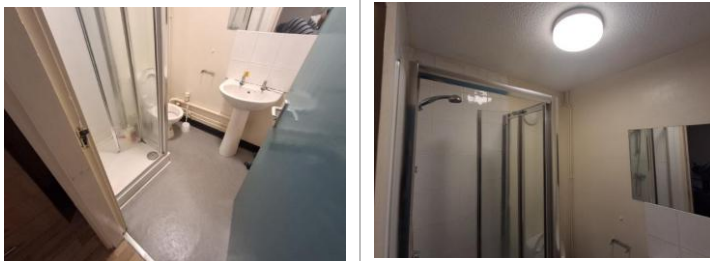
| Building: Leopold Court | | | |
|---|---|---|--|
| 1st Floor | <p>058 - Bedroom 22 Bathroom</p> <p>Asbestos Refurbishment Survey to Leopold Court in Rochdale prior to remodelling of the building to include an increase to the bedroom capacity and the proposed layout(s) to deliver 29 standard bedrooms, including 1no. CAT 3 wheelchair accessible room per floor (2 in total), and +1 emergency bedroom.</p> <p>Plasterboard ceiling, solid brick walls with modern ceramic tiles, linoleum floor covering down to concrete, electrical goods, wood door, and frame, metal radiator with associated pipework, modern toilet ware, copper and plastic pipework.</p> | | |

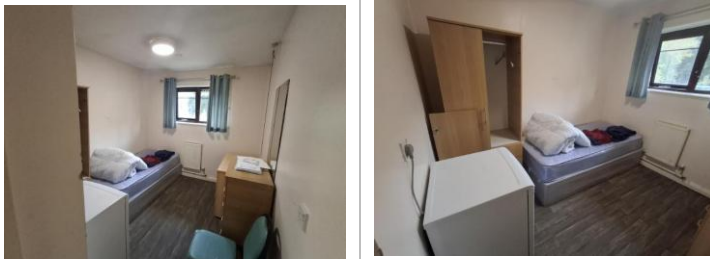
| Building: Leopold Court | | | |
|---|---|---|--|
| 1st Floor | <p>061 - Bedroom 16</p> <p>Asbestos Refurbishment Survey to Leopold Court in Rochdale prior to remodelling of the building to include an increase to the bedroom capacity and the proposed layout(s) to deliver 29 standard bedrooms, including 1no. CAT 3 wheelchair accessible room per floor (2 in total), and +1 emergency bedroom.</p> <p>Plasterboard ceiling, solid brick walls, linoleum floor covering down to concrete, electrical goods, wood doors, and frames, metal radiator with associated pipework, UPVC window.</p> | | |

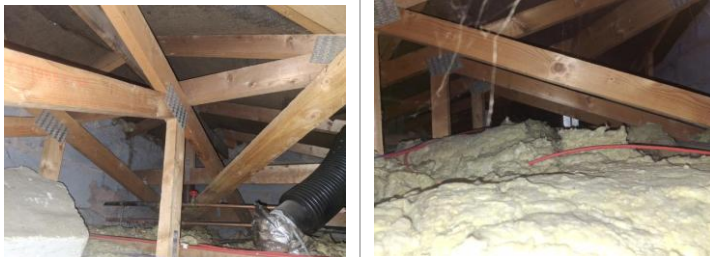
| Building: Leopold Court | | | |
|---|---|---|--|
| 1st Floor | <p>061a - Bedroom 16 Roof Space</p> <p>Asbestos Refurbishment Survey to Leopold Court in Rochdale prior to remodelling of the building to include an increase to the bedroom capacity and the proposed layout(s) to delivery standard bedrooms, including 1no. CAT 3 wheelchair accessible room per floor (2 in total), and +1 emergency bedroom.</p> <p>Pitched timber frame roof with felted underside, brick walls, electrical goods, MMMF insulation throughout, plastic pipework.</p> | | |

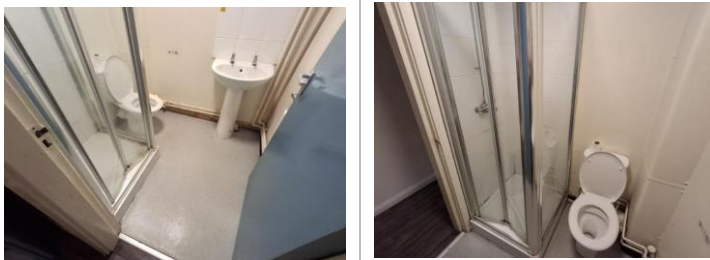
| Building: Leopold Court | | | |
|---|---|---|--|
| 1st Floor | <p>062 - Bedroom 16 Bathroom</p> <p>Asbestos Refurbishment Survey to Leopold Court in Rochdale prior to remodelling of the building to include an increase to the bedroom capacity and the proposed layout(s) to deliver 29 standard bedrooms, including 1no. CAT 3 wheelchair accessible room per floor (2 in total), and +1 emergency bedroom.</p> <p>Plasterboard ceiling, solid brick walls with modern ceramic tiles, linoleum floor covering down to concrete, electrical goods, wood door, and frame, metal radiator with associated pipework, modern toilet ware, copper and plastic pipework, UPVC boxing with exposed pipework.</p> | | |

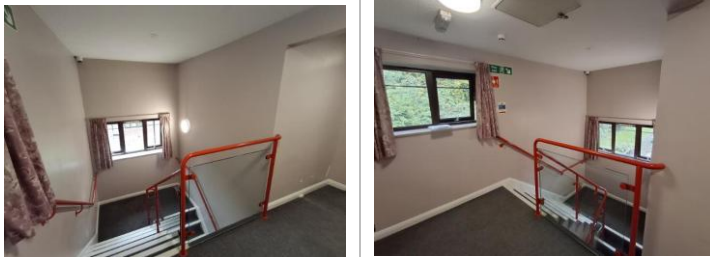
| Building: Leopold Court | | | |
|---|---|---|--|
| 1st Floor | <p>091 - Stairs</p> <p>Asbestos Refurbishment Survey to Leopold Court in Rochdale prior to remodelling of the building to include an increase to the bedroom capacity and the proposed layout(s) to deliver 29 standard bedrooms, including 1no. CAT 3 wheelchair accessible room per floor (2 in total), and +1 emergency bedroom.</p> <p>Plasterboard ceiling, solid brick walls, carpet floor covering down to concrete, electrical goods, wood doors, and frame, rubber nosing strips.</p> | | |

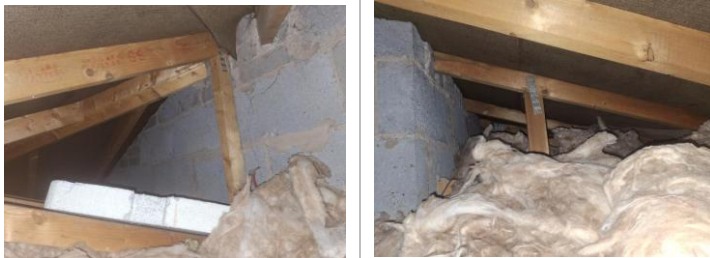
| Building: Leopold Court | | | |
|---|---|---|--|
| 1st Floor | <p>091a - Stairs Roof Space</p> <p>Asbestos Refurbishment Survey to Leopold Court in Rochdale prior to remodelling of the building to include an increase to the bedroom capacity and the proposed layout(s) to deliver 29 standard bedrooms, including 1no. CAT 3 wheelchair accessible room per floor (2 in total), and +1 emergency bedroom.</p> <p>Pitched timber frame roof with felted underside, brick walls, electrical goods, MMMF insulation throughout.</p> | | |

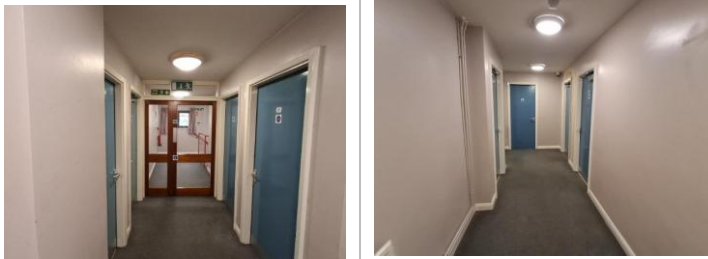
| Building: Leopold Court | | | |
|---|---|---|--|
| 1st Floor | <p>092 - Corridor</p> <p>Asbestos Refurbishment Survey to Leopold Court in Rochdale prior to remodelling of the building to include an increase to the bedroom capacity and the proposed layout(s) to deliver 29 standard bedrooms, including 1no. CAT 3 wheelchair accessible room per floor (2 in total), and +1 emergency bedroom.</p> <p>Plasterboard ceiling, solid brick walls, carpet floor covering down to concrete, electrical goods, wood doors, and frames, metal radiator, and associated pipework</p> | | |

| Building | Floor | Room | Description |
|---|---|---|---|
| Leopold Court | 1st Floor | 092 - Corridor | No access within sealed boxing due to damage limitations and the area still in occupation.<br>Integrity would be compromised once access was gained. |

| Building | Floor | Room | Description | Location Photo |
|---|---|---|---|---|
| Leopold Court | 1st Floor | 092 - Corridor | No access within sealed boxing due to damage limitations and the area still in occupation.<br>Integrity would be compromised once access was gained. | |

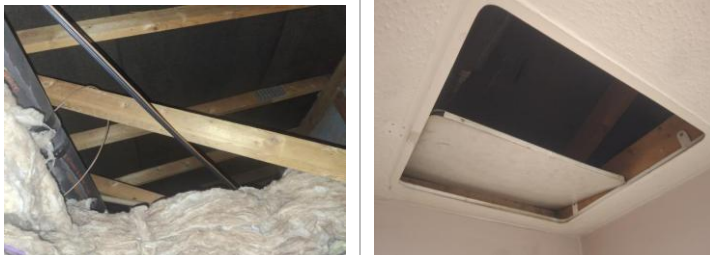
| Building: Leopold Court | | | |
|---|---|---|--|
| 1st Floor | <p>093a - Corridor Roof Space</p> <p>Asbestos Refurbishment Survey to Leopold Court in Rochdale prior to remodelling of the building to include an increase to the bedroom capacity and the proposed layout(s) to deliver 29 standard bedrooms, including 1no. CAT 3 wheelchair accessible room per floor (2 in total), and +1 emergency bedroom.</p> <p>Pitched timber frame roof with felted underside, brick walls, electrical goods, MMMF insulation throughout, copper pipework with MMMF and foam insulation.</p> | | |

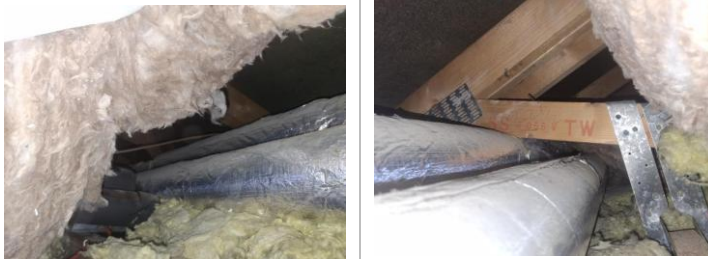
| Building: Leopold Court | | | |
|---|---|---|--|
| 1st Floor | <p>094a - Store Room Roof Space</p> <p>Asbestos Refurbishment Survey to Leopold Court in Rochdale prior to remodelling of the building to include an increase to the bedroom capacity and the proposed layout(s) to deliver 29 standard bedrooms, including 1no. CAT 3 wheelchair accessible room per floor (2 in total), and +1 emergency bedroom.</p> <p>Pitched timber frame roof with felted underside, brick walls, electrical goods, MMMF insulation throughout, copper pipework with MMMF and foam insulation.</p> | | |

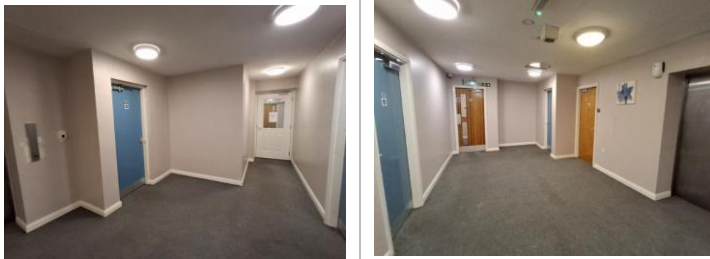
| Building: Leopold Court | | | |
|---|---|---|--|
| 1st Floor | <p>096 - Circulation</p> <p>Asbestos Refurbishment Survey to Leopold Court in Rochdale prior to remodelling of the building to include an increase to the bedroom capacity and the proposed layout(s) to deliver 29 standard bedrooms, including 1no. CAT 3 wheelchair accessible room per floor (2 in total), and +1 emergency bedroom.</p> <p>Plasterboard ceiling, solid brick walls, carpet floor covering down to concrete, electrical goods, wood doors, and frames, UPVC door and frame, metal radiator, and associated pipework.</p> | | |

| Building | Floor | Room | Description | Location Photo |
|---|---|---|---|---|
| Leopold Court | 1st Floor | 096 - Circulation | No access within sealed boxing due to damage limitations and the area still in occupation.<br><br>Integrity would be compromised once access was gained. | |

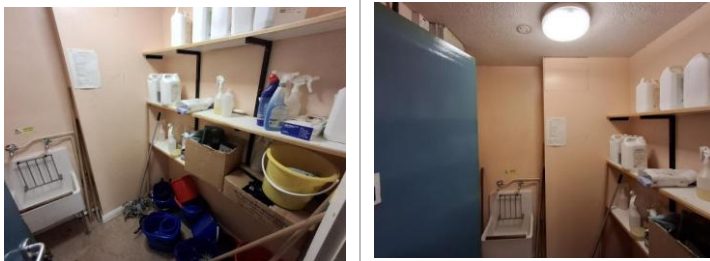
| Building: Leopold Court | | | |
|---|---|---|--|
| 1st Floor | <p>099 - Cleaners Cupboard</p> <p>Asbestos Refurbishment Survey to Leopold Court in Rochdale prior to remodelling of the building to include an increase to the bedroom capacity and the proposed layout(s) to deliver 29 standard bedrooms, including 1no. CAT 3 wheelchair accessible room per floor (2 in total), and +1 emergency bedroom.</p> <p>Plasterboard ceiling, solid brick walls, linoleum floor covering down to concrete, electrical goods, wood door, and frame, copper and plastic pipework, timber boxing with exposed pipework with modern MMMF and foam insulation.</p> | | |

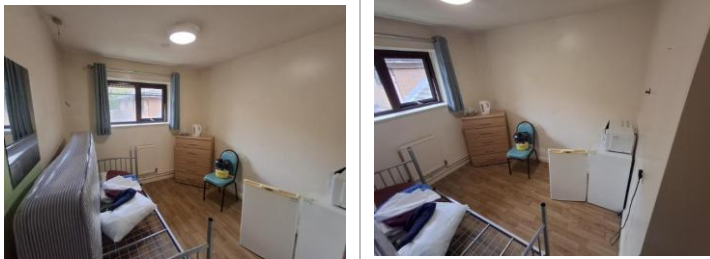
| Building: Leopold Court | | | |
|---|---|---|--|
| 1st Floor | <p>101 - Bedroom 17</p> <p>Asbestos Refurbishment Survey to Leopold Court in Rochdale prior to remodelling of the building to include an increase to the bedroom capacity and the proposed layout(s) to deliver 29 standard bedrooms, including 1no. CAT 3 wheelchair accessible room per floor (2 in total), and +1 emergency bedroom.</p> <p>Plasterboard ceiling, solid brick walls, linoleum floor covering down to concrete, electrical goods, wood doors, and frames, metal radiator with associated pipework, UPVC window.</p> | | |

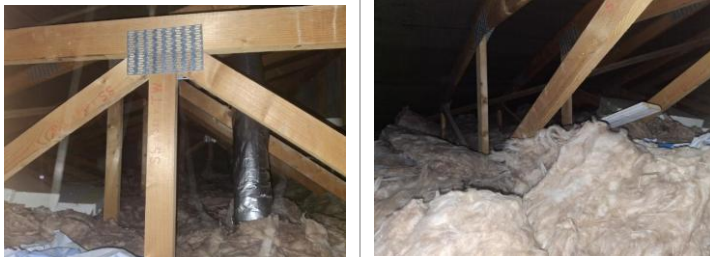
| Building: Leopold Court | | | |
|---|---|---|--|
| 1st Floor | <p>101a - Bedroom 17 Roof Space</p> <p>Asbestos Refurbishment Survey to Leopold Court in Rochdale prior to remodelling of the building to include an increase to the bedroom capacity and the proposed layout(s) to delivery standard bedrooms, including 1no. CAT 3 wheelchair accessible room per floor (2 in total), and +1 emergency bedroom.</p> <p>Pitched timber frame roof with felted underside, brick walls, electrical goods, MMMF insulation throughout.</p> | | |

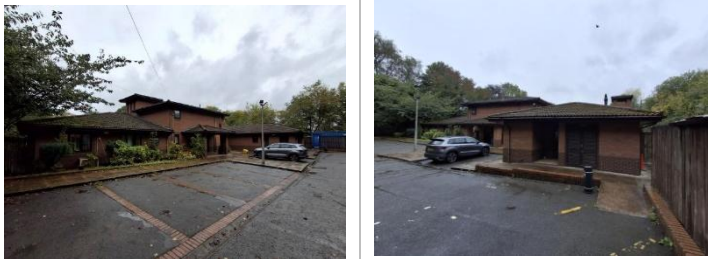
| Building: Leopold Court | | | |
|---|---|---|--|
| 1st Floor | <p>99 - Externals</p> <p>Asbestos Refurbishment Survey to Leopold Court in Rochdale prior to remodelling of the building to include an increase to the bedroom capacity and the proposed layout(s) to deliver 29 standard bedrooms, including 1no. CAT 3 wheelchair accessible room per floor (2 in total), and +1 emergency bedroom.</p> <p>Modern roof tiles, brick chimney breasts, brick walls, concrete floor, electrical goods, UPVC windows with rubber mastics, plastic rainwater goods, timber soffits and fascias, wood, metal and UPVC doors.</p> | | |

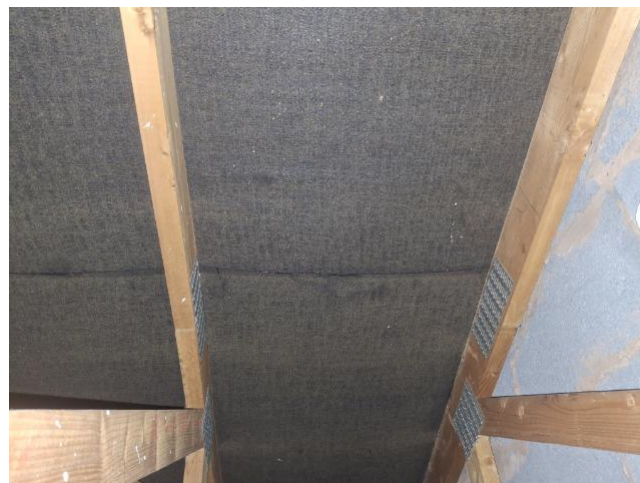
| <b>Sample Reference</b> | Ref S012 |

| <b>Quantity</b> | <100 m <sup>2</sup> |

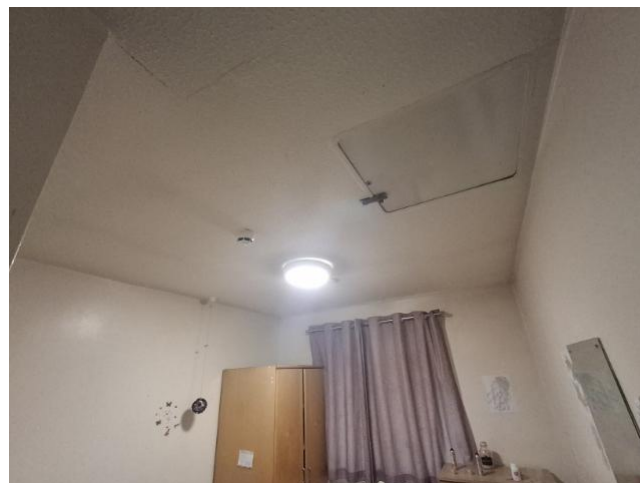
| <b>Sample Reference</b> | Ref S013 |

| <b>Quantity</b> | 15 m <sup>2</sup> |

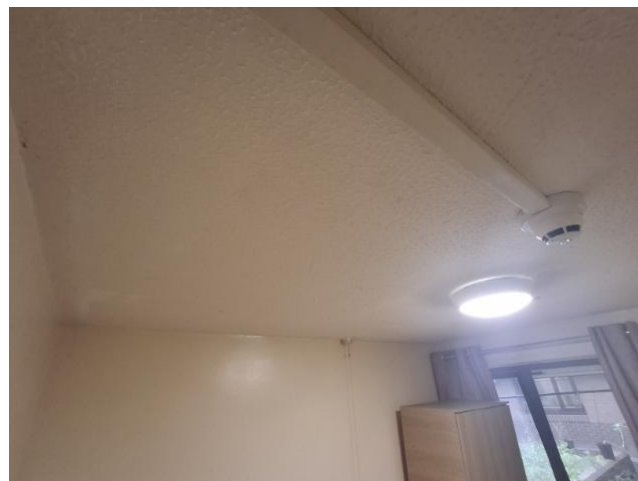
| Sample Reference | S014 |

| Quantity | 15 m <sup>2</sup> |

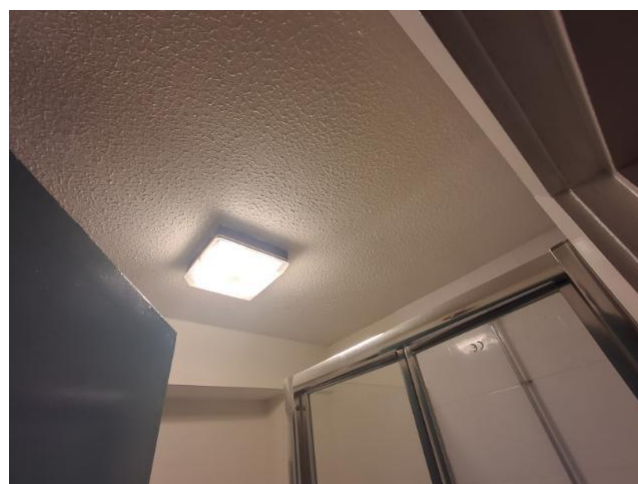
| Sample Reference | Ref S014 |

| Quantity | 4 m <sup>2</sup> |

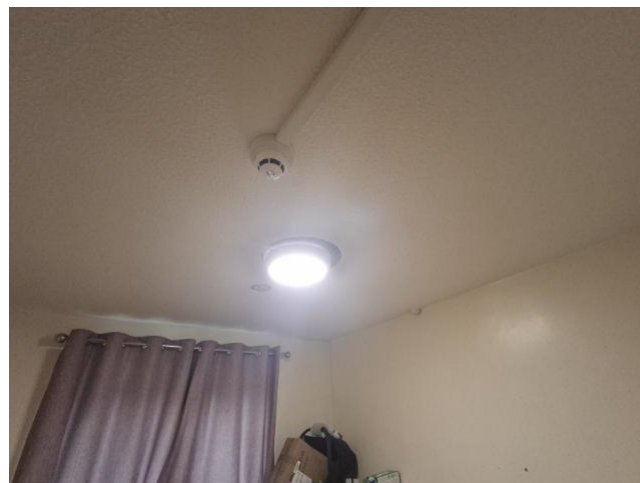
| <b>Sample Reference</b> | S015 |

| <b>Quantity</b> | 15 m <sup>2</sup> |
