| PROJECT | SMP - St Mary's CE Primary School |
| TITLE | Elevation BB - Demolition & Repairs |
| NUMBER | SMP-SEV-XX-XX-DR-A-03011 |

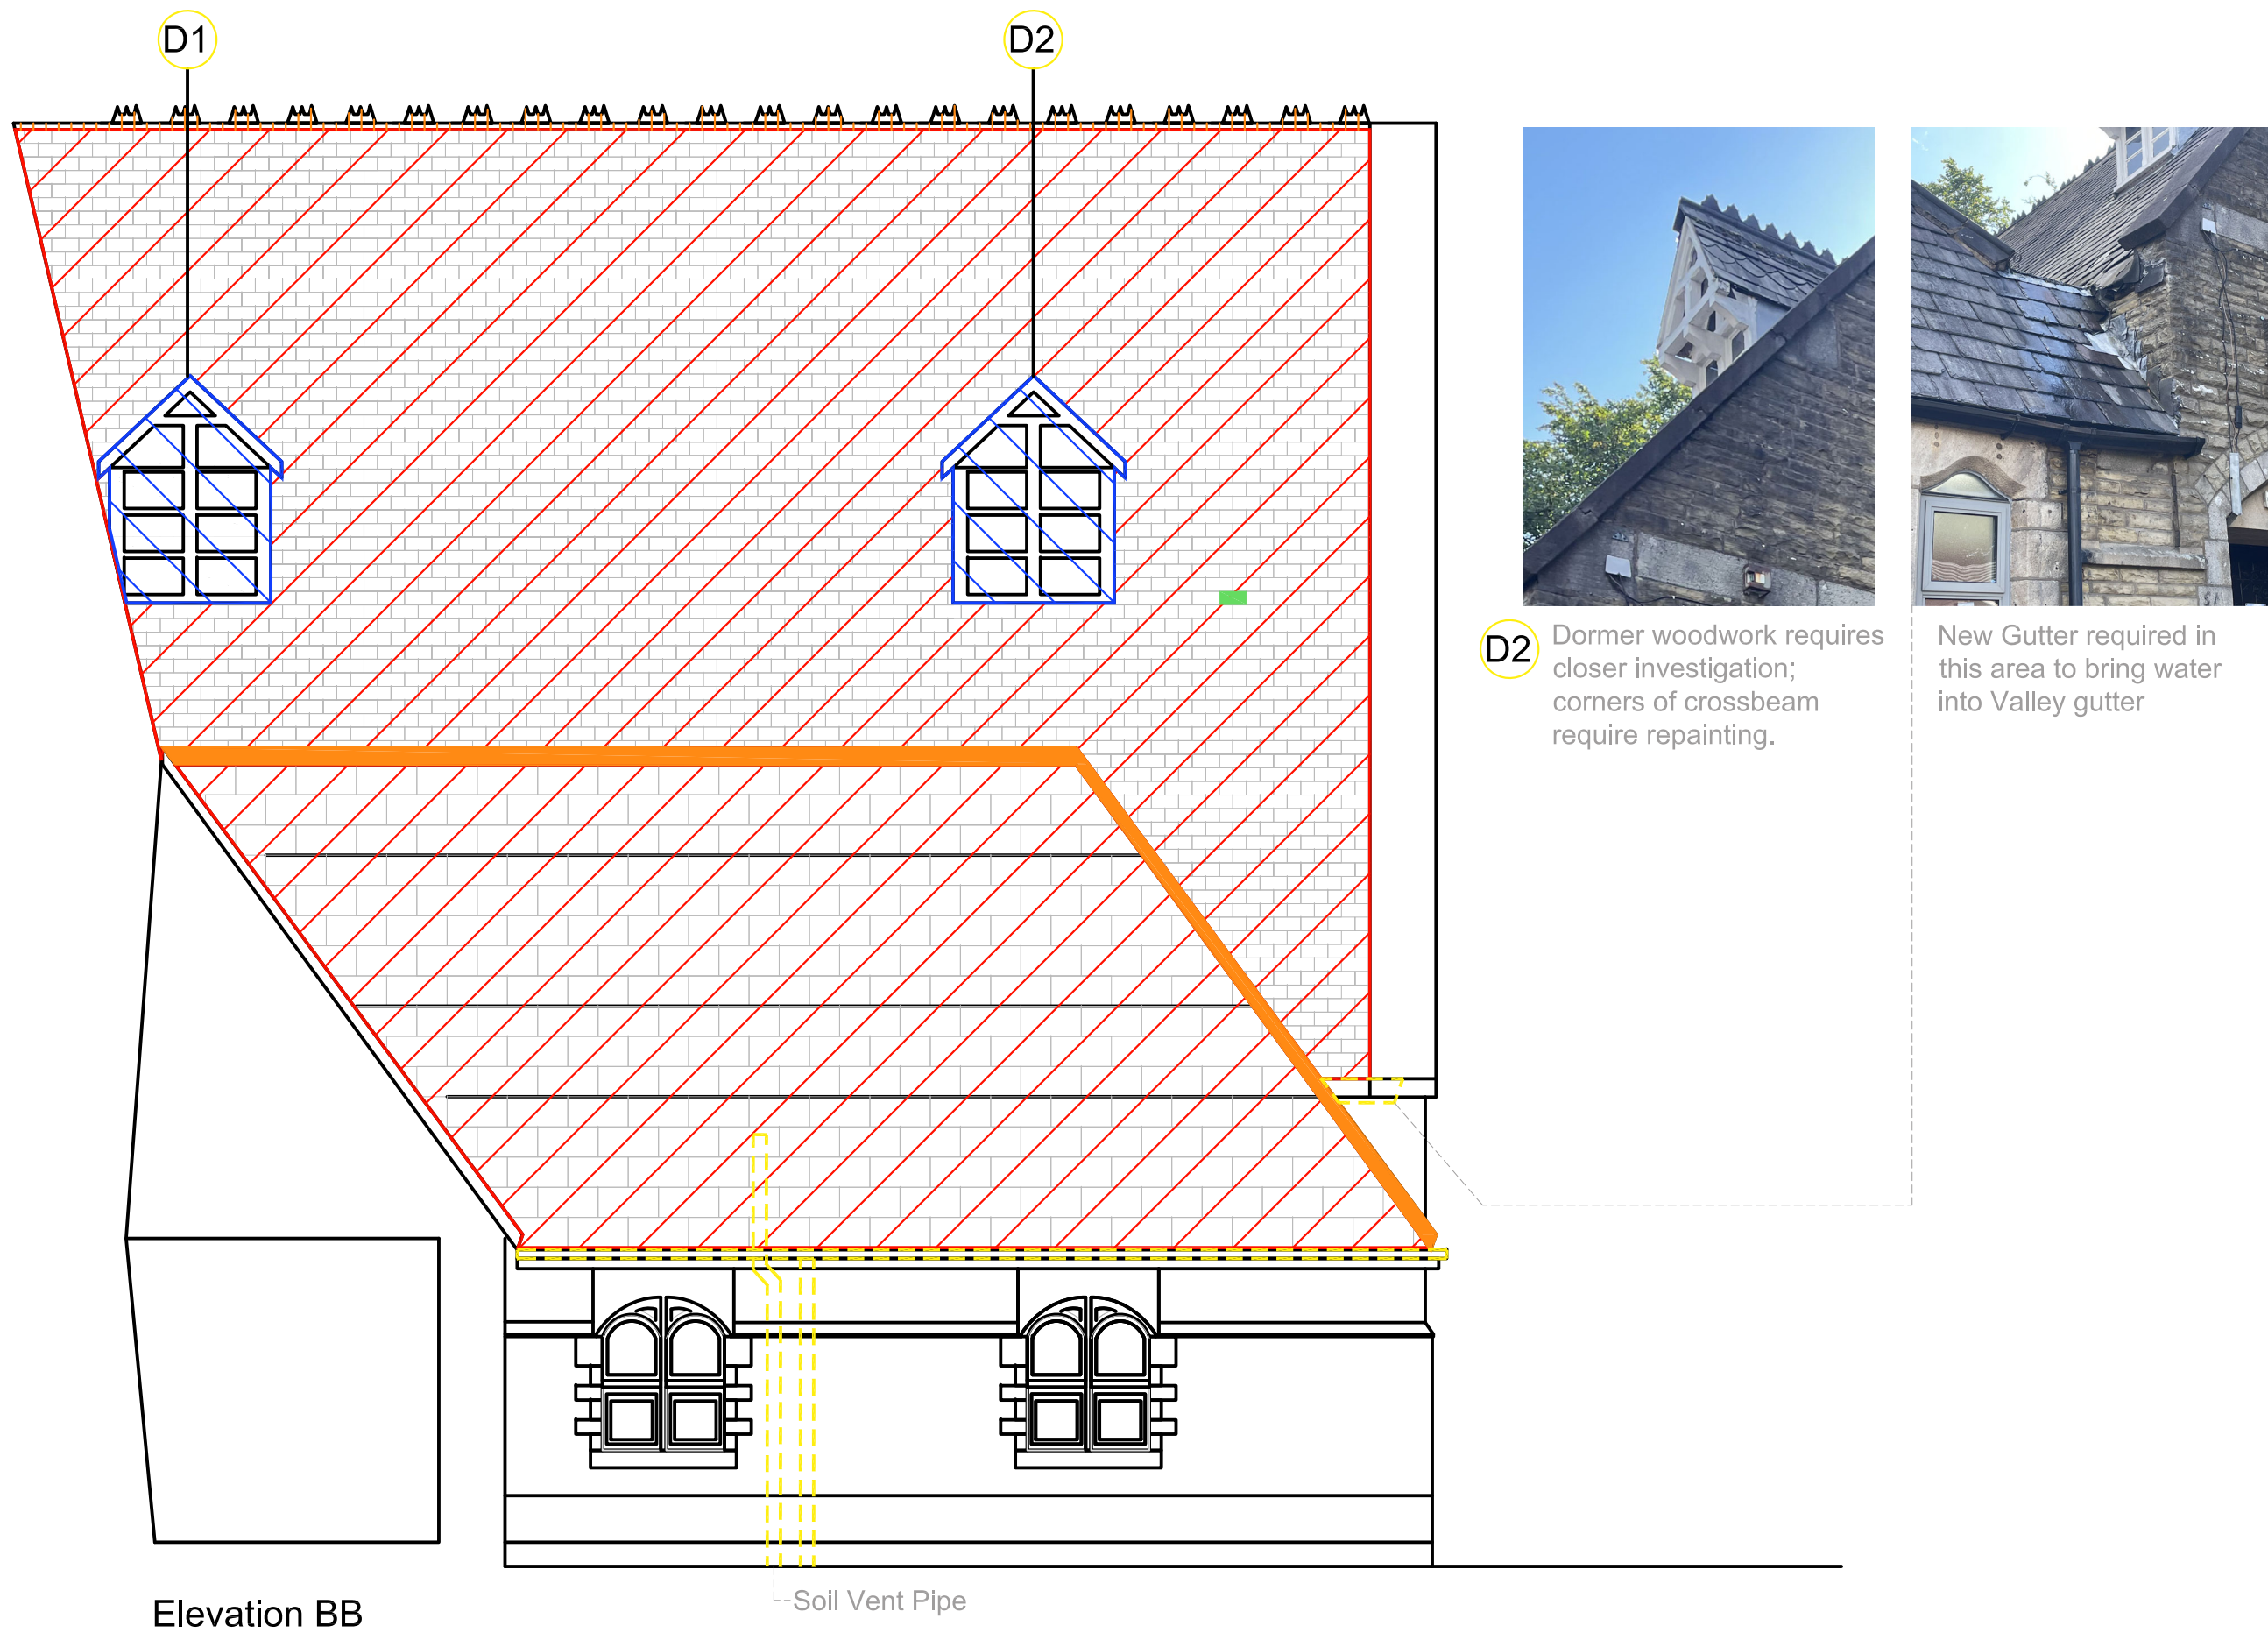
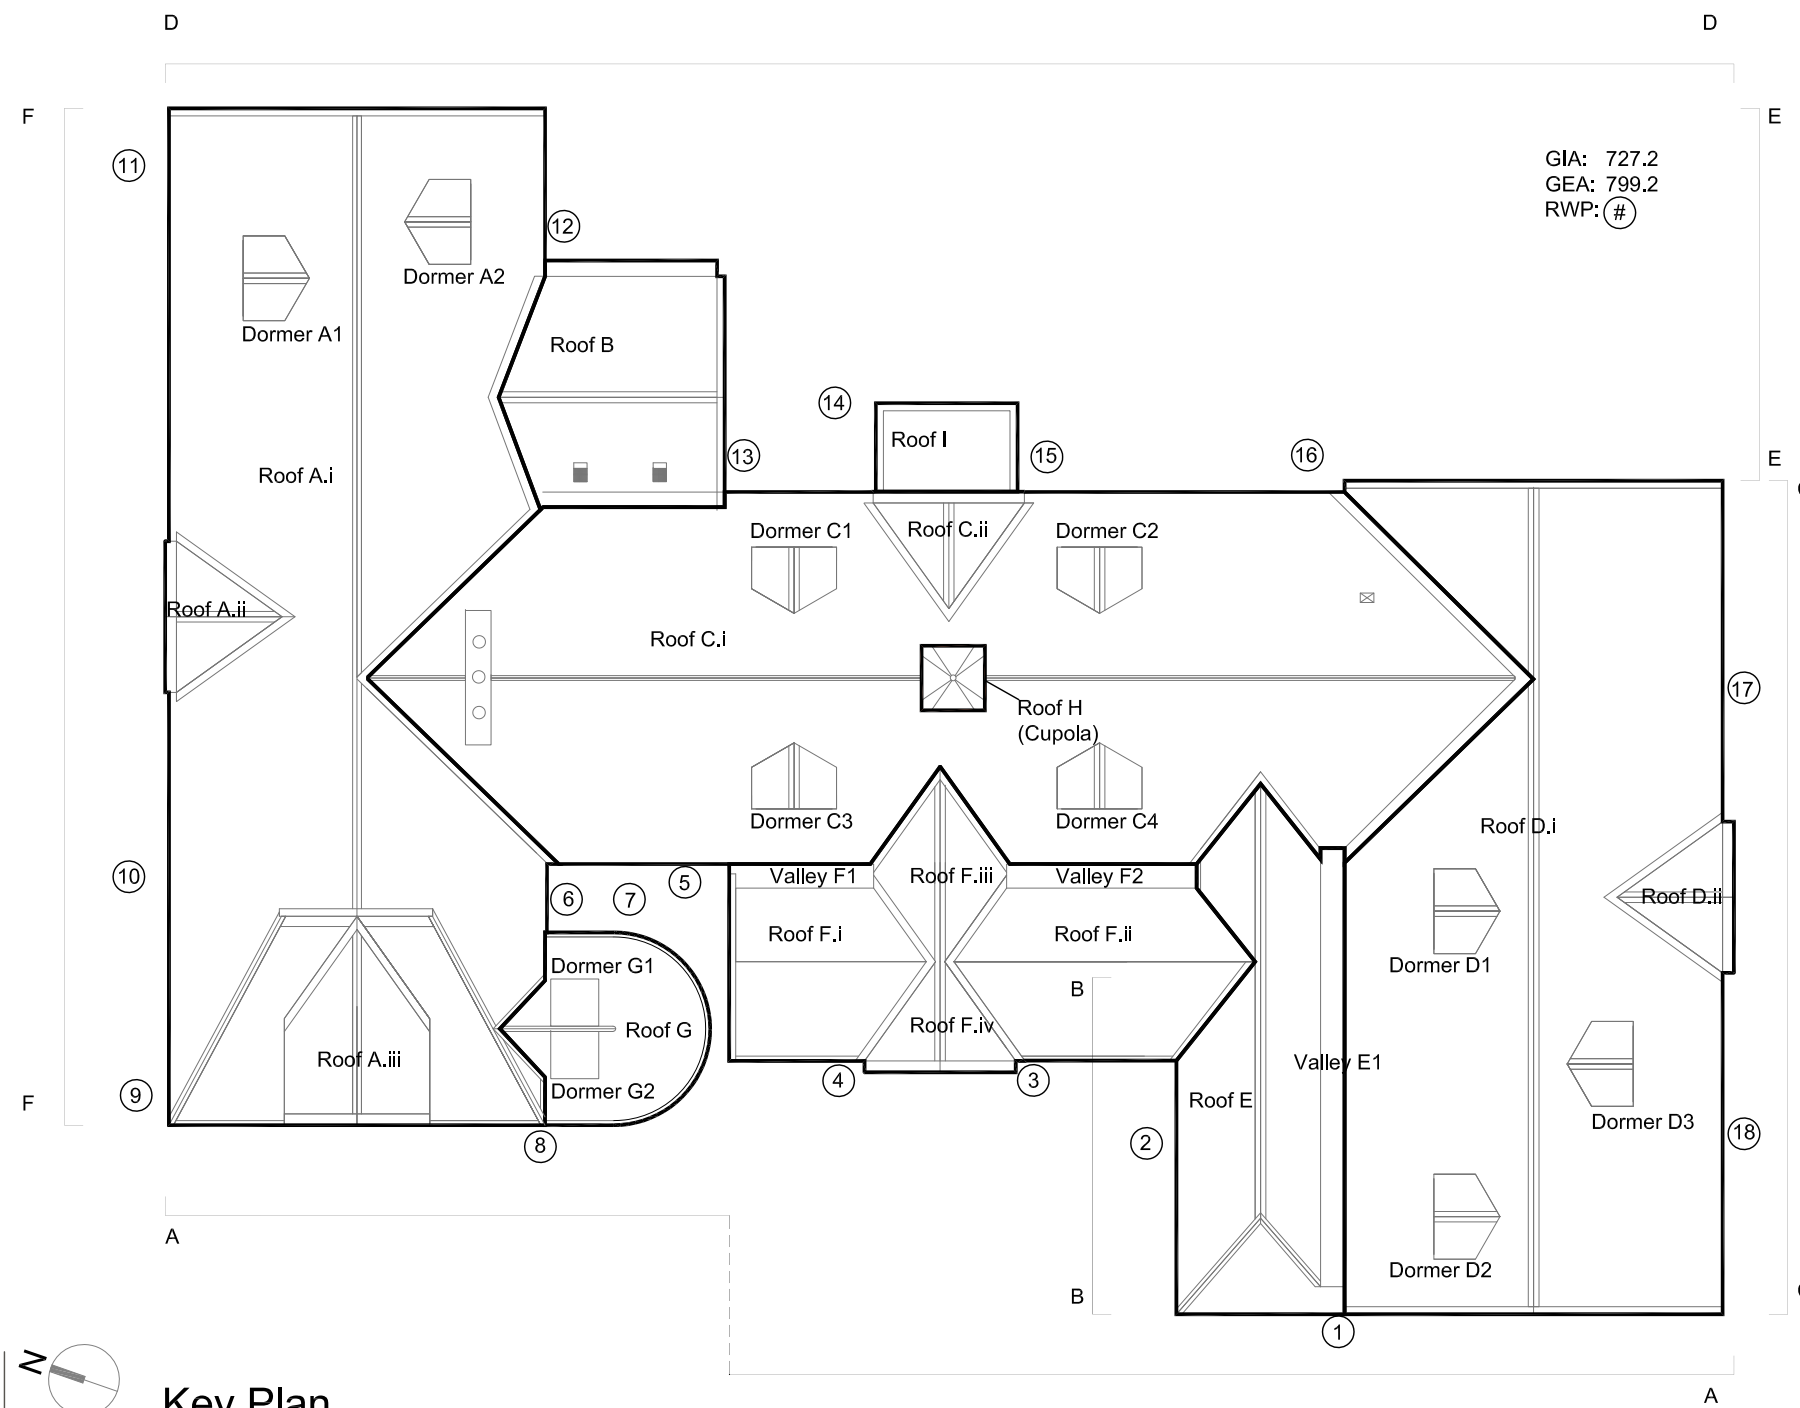
- Roof Slate Restoration: 762sqm / 8220sqft  
Strip existing slate roof coverings and set aside salvaged slates for re-use. Strip existing battens, felt, lead-lined gutters and gutter structure then safely dispose of any defective material. Re-felt & batten existing roof slope. As per detail A-A in drawing SMP-SEV-XX-XX-DR-A-03100 (Typical Roof Build-Up)

- Dormer Window: 09 no.  
Splice in new timbers where appropriate. Access to be provided for detailed inspection and methodology agreed. Carefully sand down and repaint in appropriate materials as per the specification. Roofing section per detail F-F in drawing SMP-SEV-XX-XX-DR-A-03105 (Typical Dormer Window)

- Cupola: 01 no.  
Splice in new timbers where appropriate. Access to be provided for detailed inspection and methodology agreed. Carefully sand down and repaint in appropriate materials as per the specification. Cupola roofing is as per the building's other slate roof eaves, but is at a steeper gradient (assume larger area than in plan).

- Rainwater Goods: 18 no.  
Down-pipe to be removed and replaced with cast-iron rainwater goods allowing for increased diameter (8 inch) to mitigate increased rainfall. Existing cast-iron hoppers to be retained & refurbished where possible. Guttering per detail B-B in drawing SMP-SEV-XX-XX-DR-A-03100 (Typical External Gutter)

- Lead Flashing: 75 Lm  
Replace with new Terne-coated stainless steel (TCSS) flashing where appropriate, taking note of Historic England guidance (<https://tinyurl.com/3taekx9n>). This also applies to damaged or visually-unfortunate soakers. Access to be provided for detailed inspection and methodology agreed.

- Decorative Ridge Tiles: 105 Lm  
Ridge tiles to be removed and set aside with salvaged tiles for re-use. Replace damaged tiles as per the existing style. Ridge ventilation provided with new linear vent. Ridge venting per detail F-F in drawing SMP-SEV-XX-XX-DR-A-03105 (Typical Dormer Window)

- Valley Gutter: 10sqm  
Replace damaged lead & structure (where necessary) with terne-coated stainless steel (TCSS) as the preference for necessary replacement works. Access to be provided for detailed inspection & methodology agreed. Valley Gutter per detail C-C in drawing SMP-SEV-XX-XX-DR-A-03100 (Typical Valley Gutter)

- Non-Gabled Dormer Windows:  
"Shed Dormer" windows with flat felt topping. Splice in new timbers where appropriate. Access to be provided for detailed inspection and methodology agreed. Carefully sand down and repaint in appropriate materials as per the specification. Remove felt and re-top with terne-coated stainless steel (TCSS) with a round-batten seam to match Historic England (HE) Guidelines.

- Bat Slate: [Dashed Hatch Approx. Location, Solid Hatch Exact Location]  
Integrated Bat access slate: metal vent to allow access for bats into roof void, with sufficient gap cut into roof structure underneath. Fitted within a hole cut to slate which is placed over the vent to reduce visual impact. 1no. Bat Slate located in area of observed bat emergence (west wing of the building, facing north, adjacent to Dormer D2) and then 3no. supplementary 'enhancement slates' along remaining wings (north, east, south).
