## **Littleborough Family Hub Desk-Based Coal Mining Risk Assessment**

**Job Number  
LKC261170**

**Client  
Rochdale Borough Council**

| <b>Report Title</b> | Desk Based Coal Mining Risk Assessment |

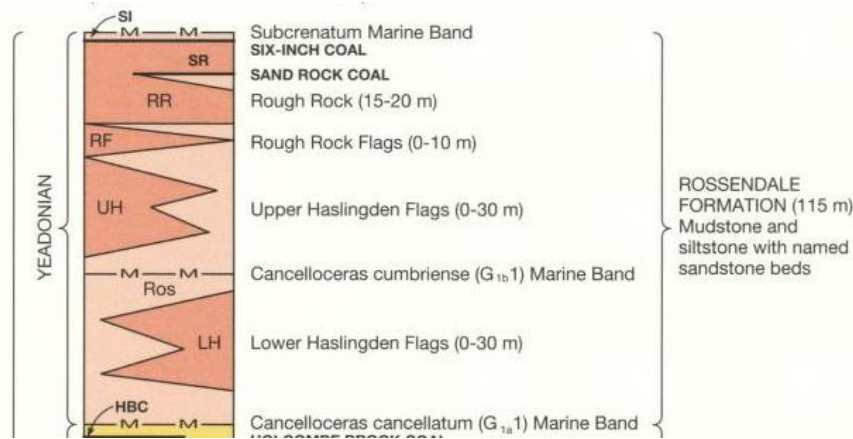
Plate 2-2 shows an extract of the generalized vertical section from Sheet 76 showing the section of strata expected on and below the site.

Plate 2-2: Extract of the generalized vertical section from Sheet 76 (dated 2008). Not to scale.

The Rough Rock subcrops on site, therefore based on the vertical section, it is possible that the Sand Rock coal is present below site. However, it is not persistent across the area on the vertical section and may not be present. Given the faulting on or close to the site boundary, possible depth of the seam below site if present is unknown. The Six Inch coal is mapped to the south of site and is likely dipping away from site.
