# HERITAGE STATEMENT

Client: Watergrove Trust  
Reference: 21074  
Date: May | 2026  
Document Ref: SMS-SEV-ZZ-ZZ-RP-A-09100

This Statement has been prepared by Seven Architecture on behalf of the Watergrove Trust to support a listed building application for the refurbishment of the KS1 Reception Classroom and part of the adjacent corridor at St Mary’s C of E Primary School in Rochdale. The school is currently open to the public and used as a primary school however deterioration of the floor in the Reception Classroom has prompted remedial works to repair defective building fabric. The project will protect the replacement floor by improving ventilation of the sub-floor void and providing a french drain to the perimeter of the building, where ground levels have been raised over time, covering ventilation openings under the floor. While the opportunity to undertake works to the floor arose, it seemed prudent to address fire safety concerns to the classroom wall construction and improve secondary escape to the adjacent classroom introducing a connecting door. The replacement floor and fire protection works have been identified as key to the continued use of the building.

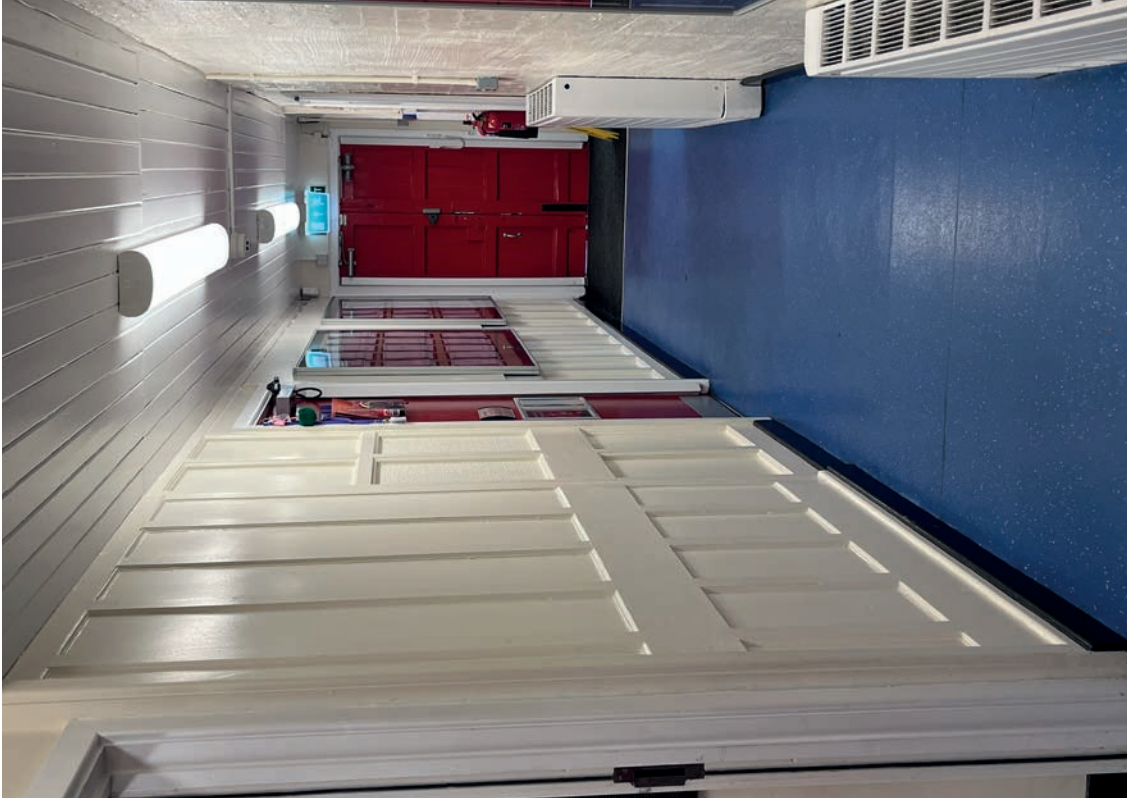
1 View of timber panelling in the corridor
