Phase I Geoenvironmental Site Assessment  
Bamford, Norden

Reference: 14-785-R1  
Date: June 2021

## PHASE I GEOENVIRONMENTAL SITE ASSESSMENT

Bamford, Norden  
Rochdale  
OL11 5PW

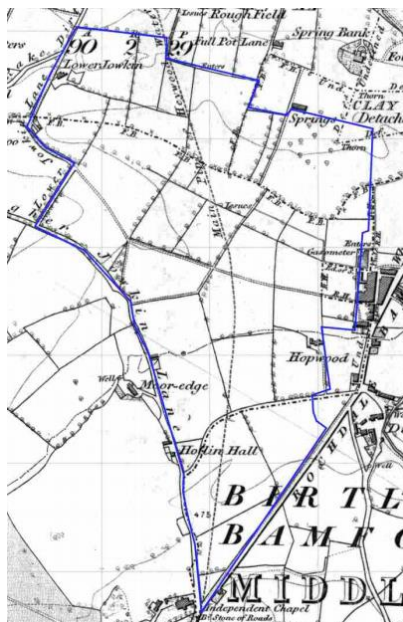
| MAP EDITION | HISTORICAL LAND USE | HISTORICAL MAP EXCERPT |
|---|---|---|
| <p><b>1851</b><br/><b>1:10,560</b></p> | <p>The site is predominantly agricultural land with clear field boundaries. Mature trees and minor roads follow field boundaries. There are limited structures with three buildings located north west of the site following Jowkin Lane, as well as one building on the south east boundary and along the western boundary.</p> <p>A county and civil boundary intersects the northern section of the site from east to west with multiple foot bridges crossing the pathway.</p> <p>The main pipes of Heywood Water Works run directly through the middle of the site from north to south.</p> <p>A gasometer is located on the central eastern boundary.</p> <p>Contour lines indicate changes in topography.</p> | |

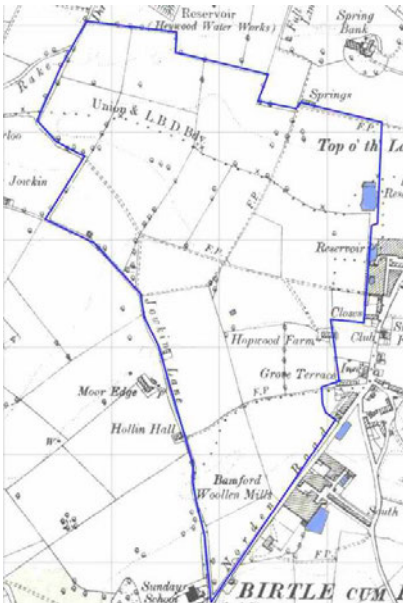
| MAP EDITION | HISTORICAL LAND USE | HISTORICAL MAP EXCERPT |
|---|---|---|
| <p><b>1890</b><br/><b>1:10,560</b></p> | <p>The civil boundary is now recognised as the Union &amp; L.B.D Boundary. The water works pipe is no longer present on the map.</p> <p>Field boundaries have increased in size with footpaths following boundaries. Only one building is located on site along the western boundary at Hopwood Farm.</p> <p>A reservoir is located onsite next to the eastern boundary. Other reservoirs are in close proximity to the eastern boundary.</p> <p>The southern section of the site is part of the Bamford Woollen Mills. The Pitfield Mills borders the eastern boundary.</p> | |

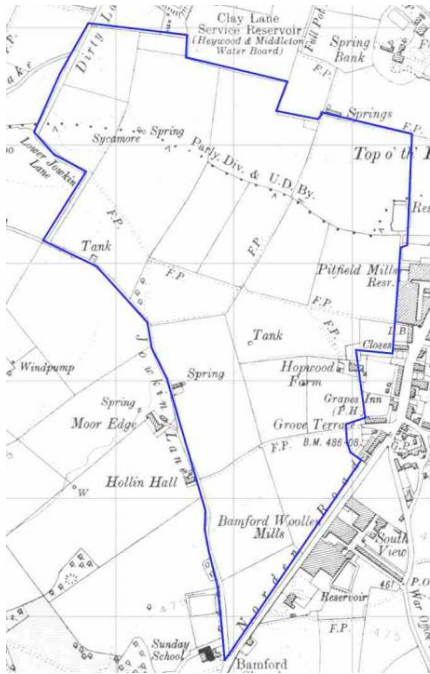
| <p><b>1928</b><br/><b>1:10,560</b></p> | <p>Two tanks and two springs are recorded onsite. A tank and a spring are located on the western boundary. The second tank is located within the middle of the site. The second spring is located along the civil boundary, now recorded as the Parly Div. &amp; U.D. Boundary.</p> <p>Mature tree coverage is sparce with one Sycamore recorded north west of the site.</p> | |

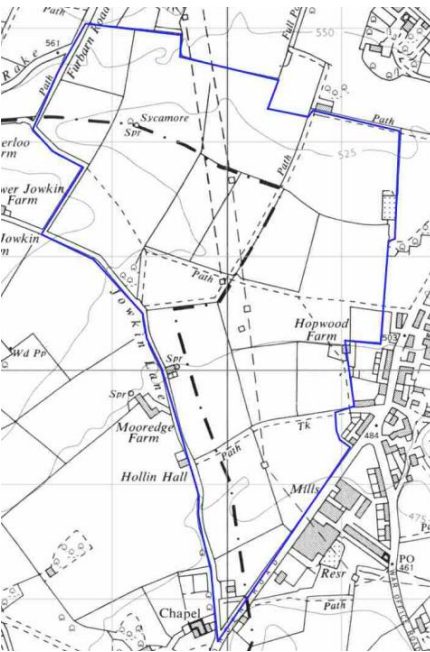
| <p><b>1967 – 1968</b><br/><b>1:1,250</b></p> | <p>The Boro. Const. Boundary (North) and Co. Const. Boundary (South) has relocated. The boundary enters the site along the western border and exits at the south.</p> <p>Two electrical cables intersect the site from north to south feeding from a 'Works' located north of the site boundary. Pylons are located onsite, supporting the cables.</p> | |

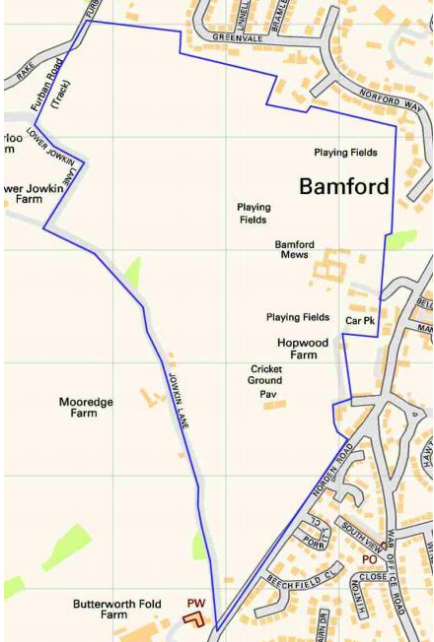
| <p><b>2010</b><br/><b>1:10,000</b></p> | <p>There are more buildings present on site, particularly in the east surrounding the school. The surrounding land is used as playing fields.</p> <p>The springs and tanks are no longer recorded on site.</p> | |

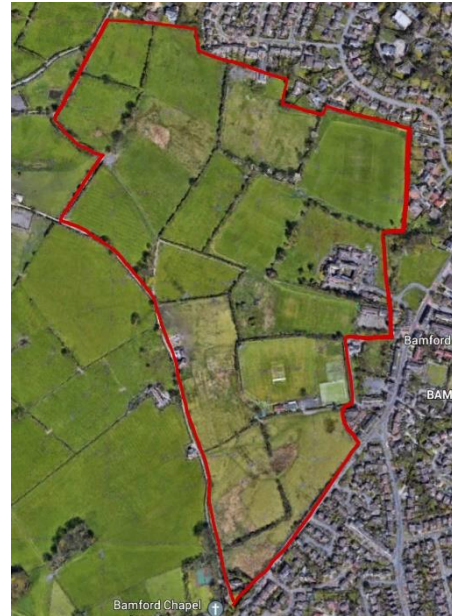
**2021**  
**1:10,000**

One building is located along the western boundary of the site, following Jowkin Lane.

Six pylons are located onsite with associated overhead electrical cables.

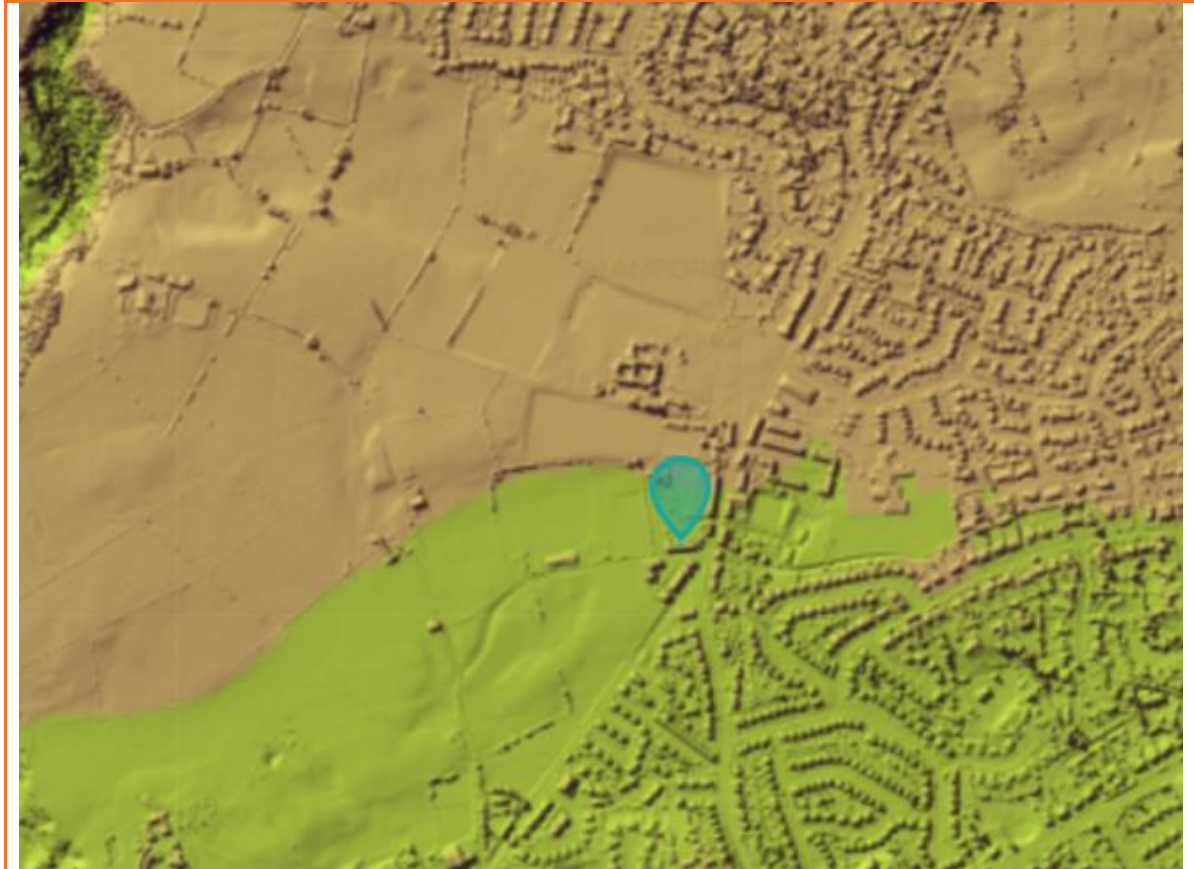
FIGURE 4.3 SURFACE LIDAR DATA (GROUNDSURE IO)
