RTH - DIA - 77- 77 - DR- A - 3594 C01

Rochdale Town Hall  
for Rochdale Development Agency

Clocktower Repairs  
Internal Elevation DD

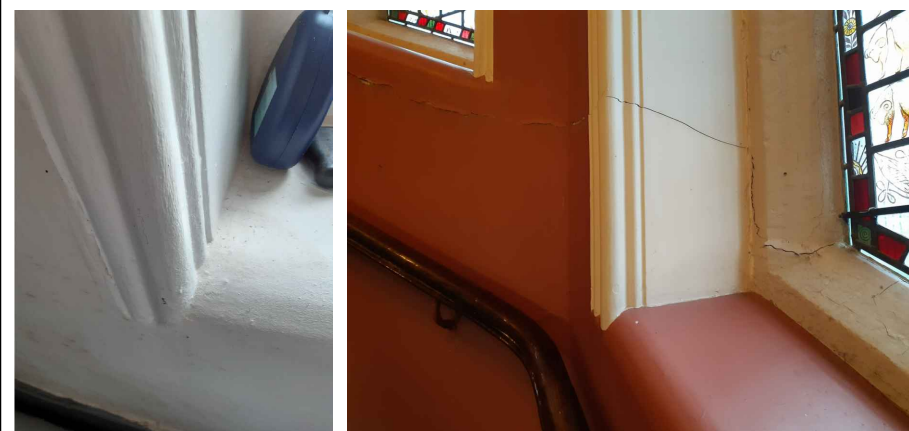
Where new filleted plaster cill is to be formed, replicate detailing of F3b/Stair  
5 windows, as indicated in the images above.  
(NBS M20/685A - 4.5)
