Proposed WC Block \* Lobby Extension

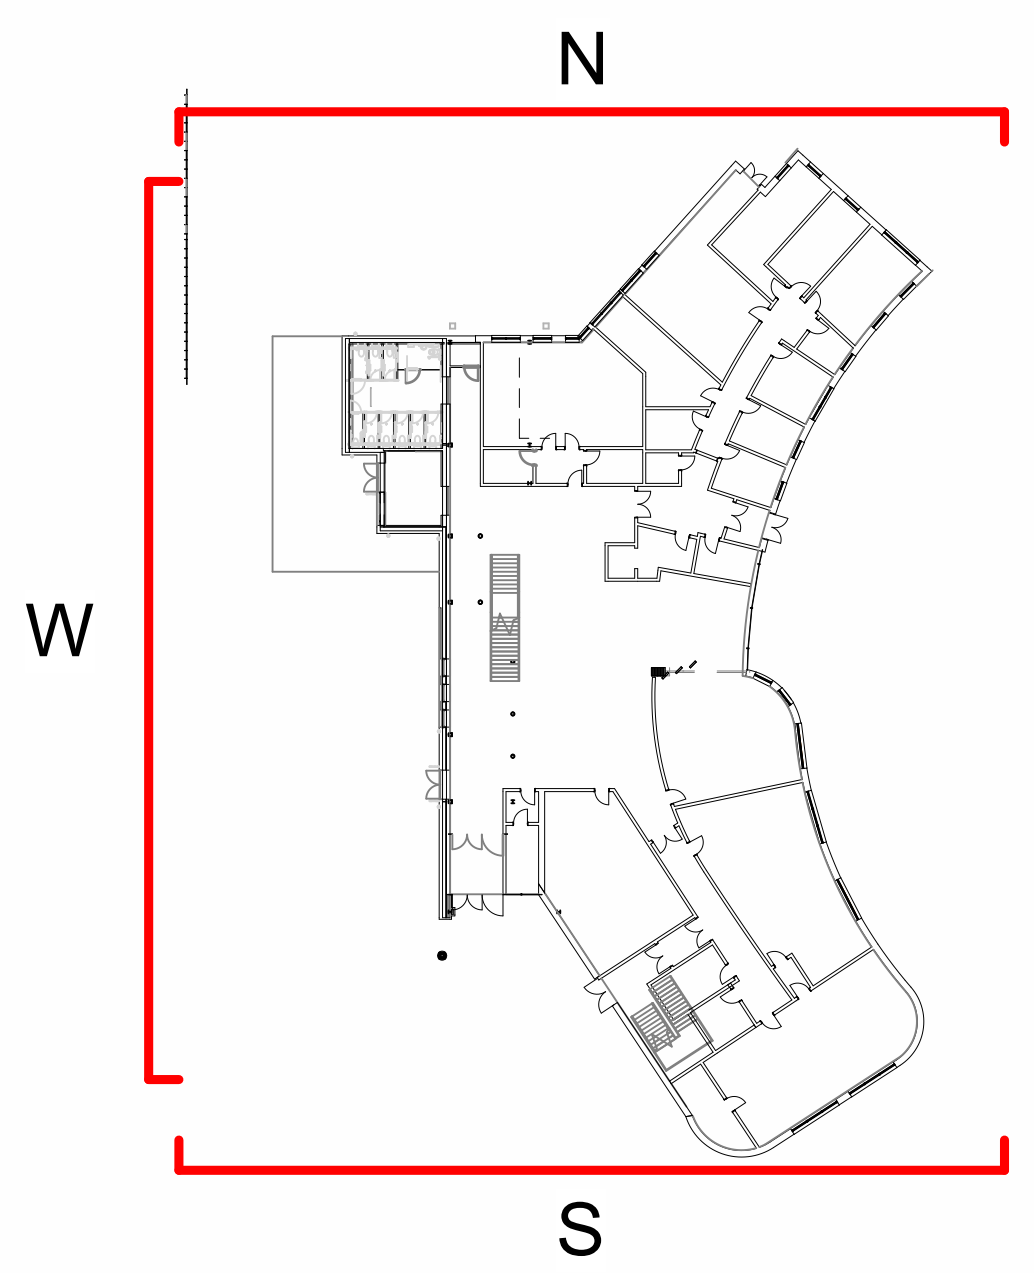
1 North Elevation  
1:50

Caping to match with New Build

Facade has moved further out due to existing slab edge cantilevering further out.

Return of Equitone cladding

Existing single glazed door replaced with fixed glazing

WC block has moved further out due to existing slab edge.

New WC Block

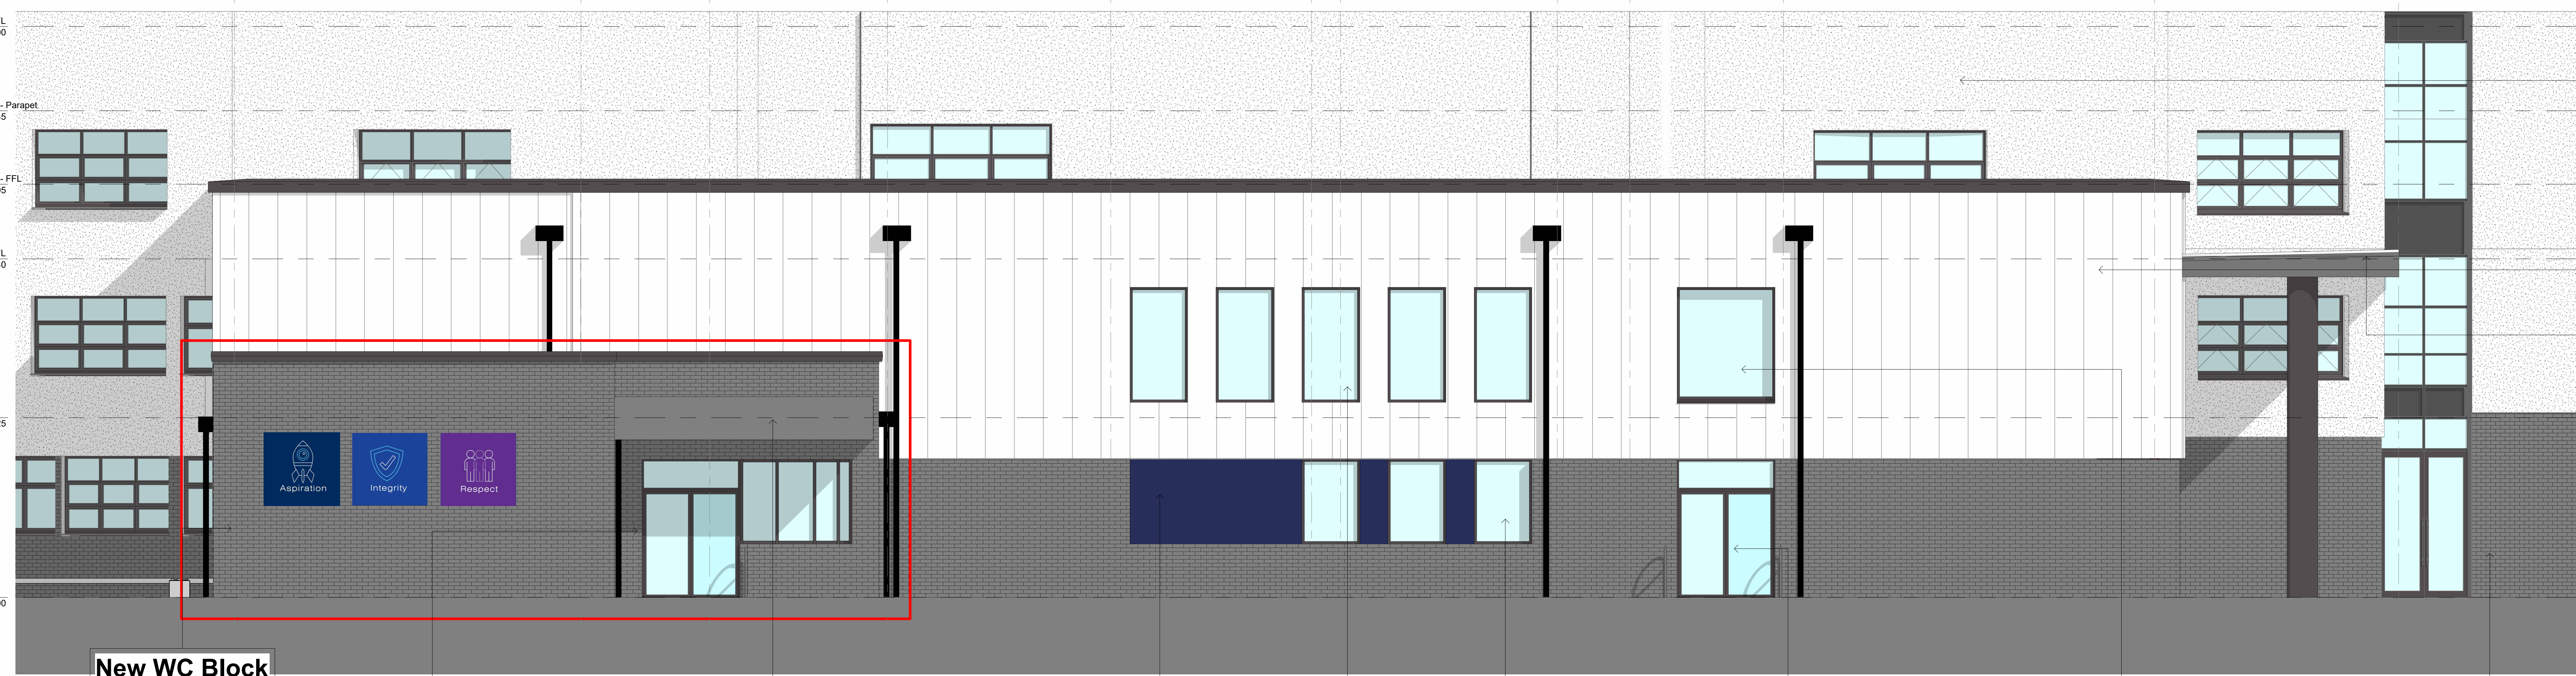
2 West Elevation  
1:50

Existing level 2 Render retained

New Equitone cladding

Structure Retained Canopy behind

New WC Block

New lobby entrance

canopy fascia added to hide structure of canopy.

New Windows placed within Existing Openings

New Door in existing opening

New window within existing door opening

Existing Brick

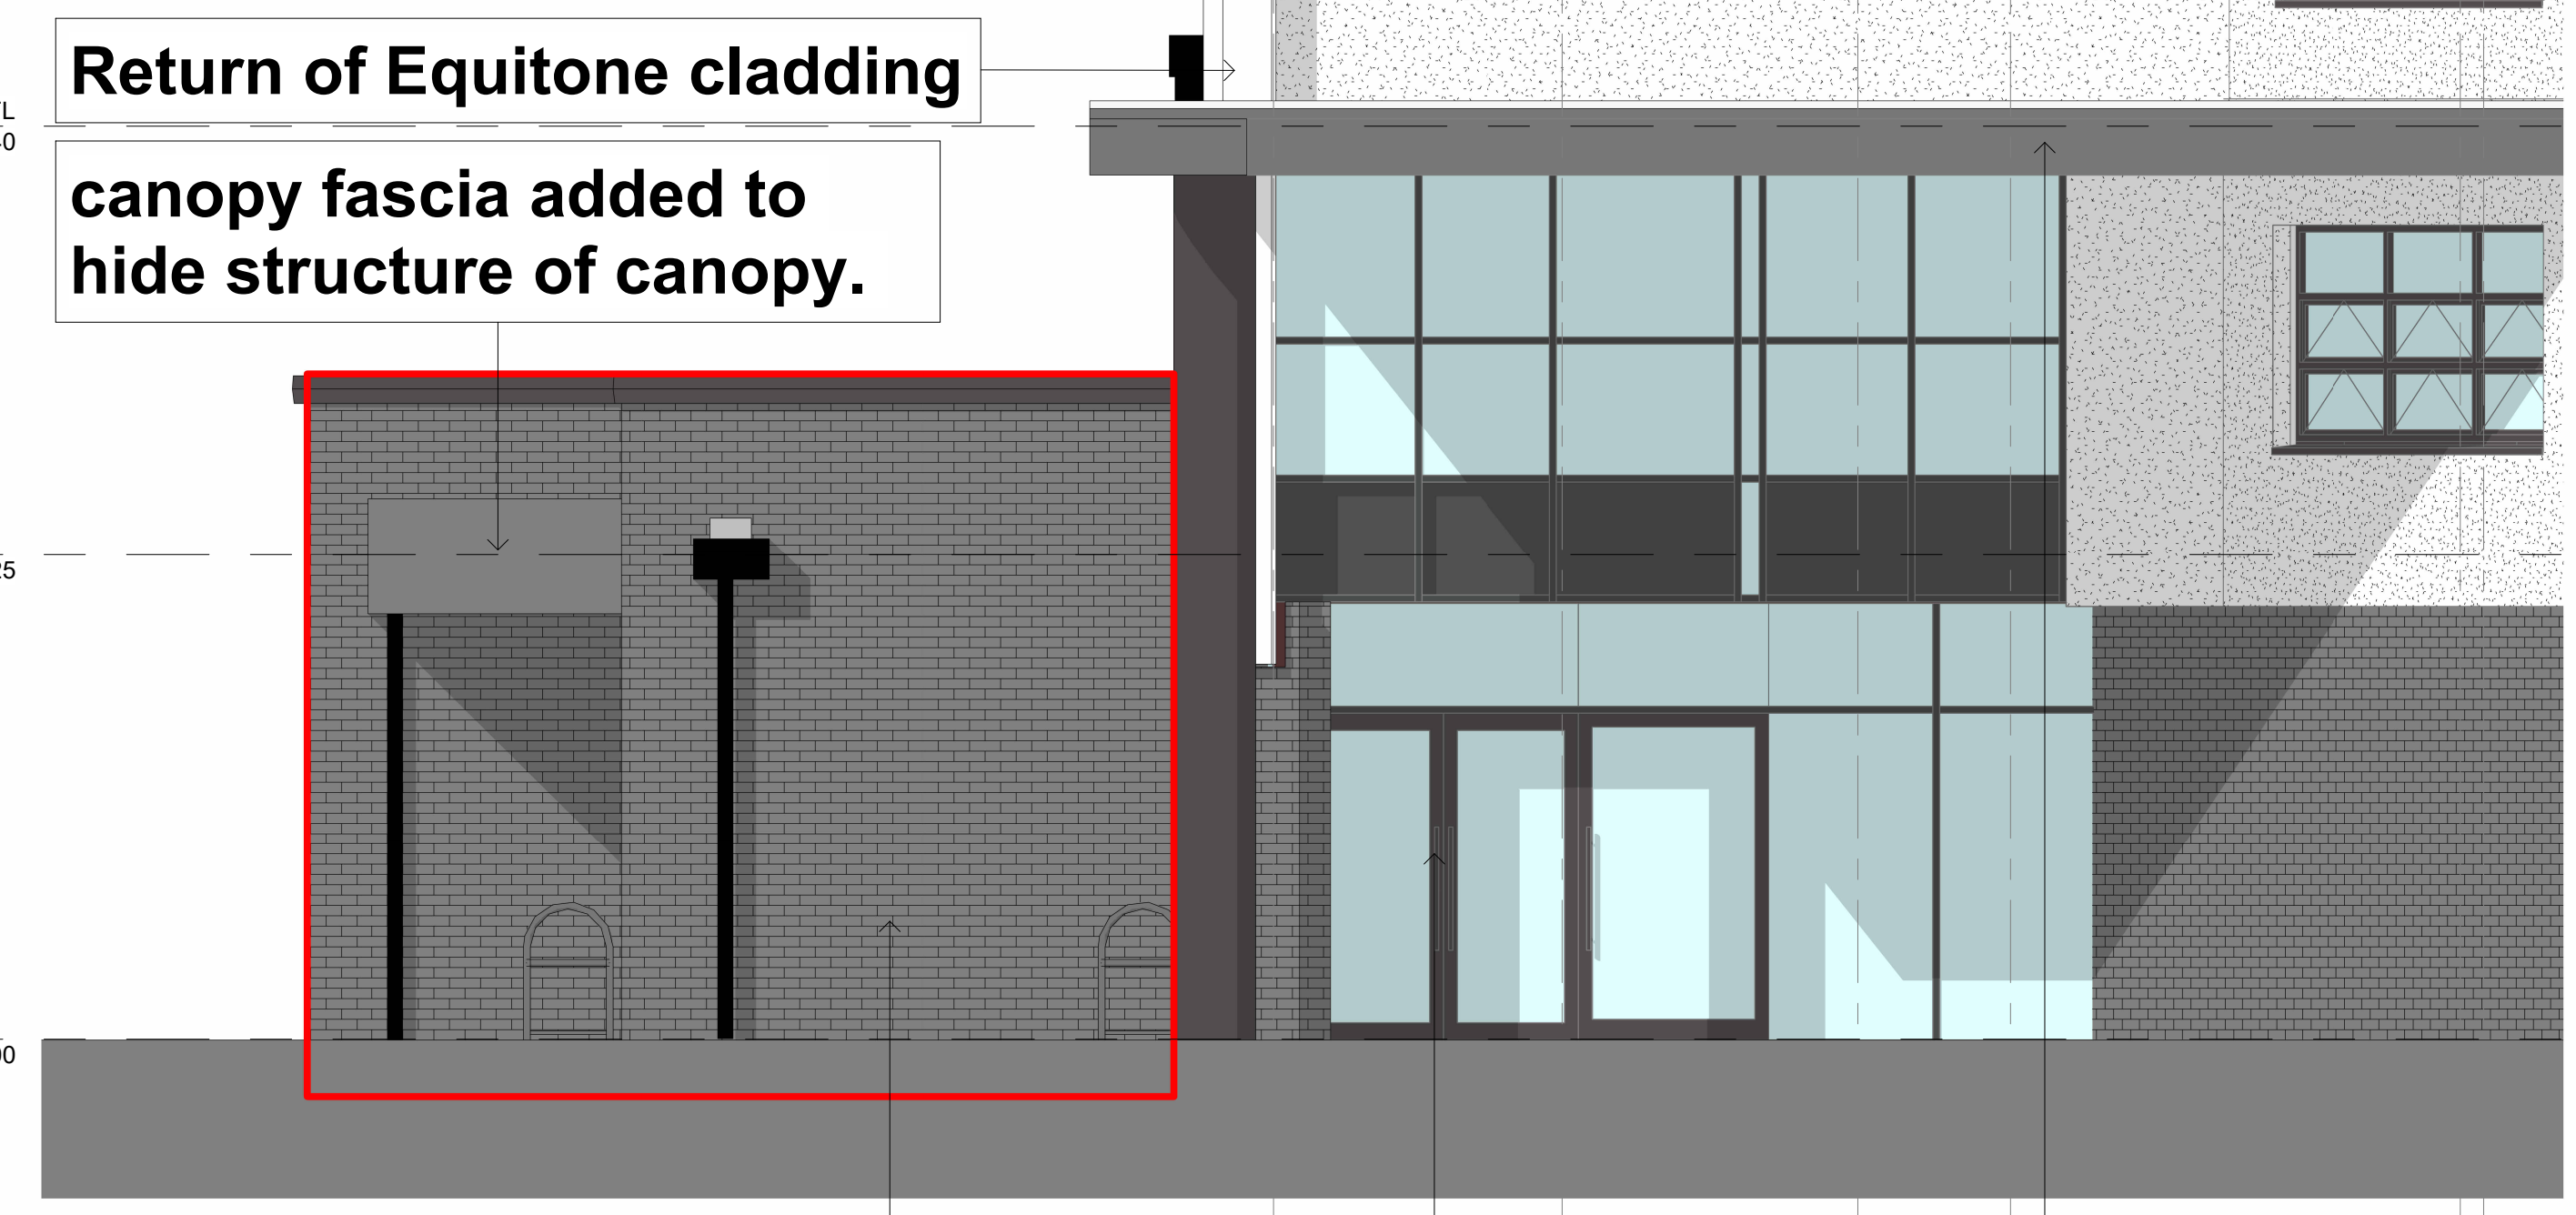
3 South Elevation  
1:50

Return of Equitone cladding

canopy fascia added to hide structure of canopy.

Colour cladding cassette to match with New build

New Ground Floor Windows

New Lobby

Existing Entrance

Existing Canopy
