367 Don Street

Dewatering Sketch

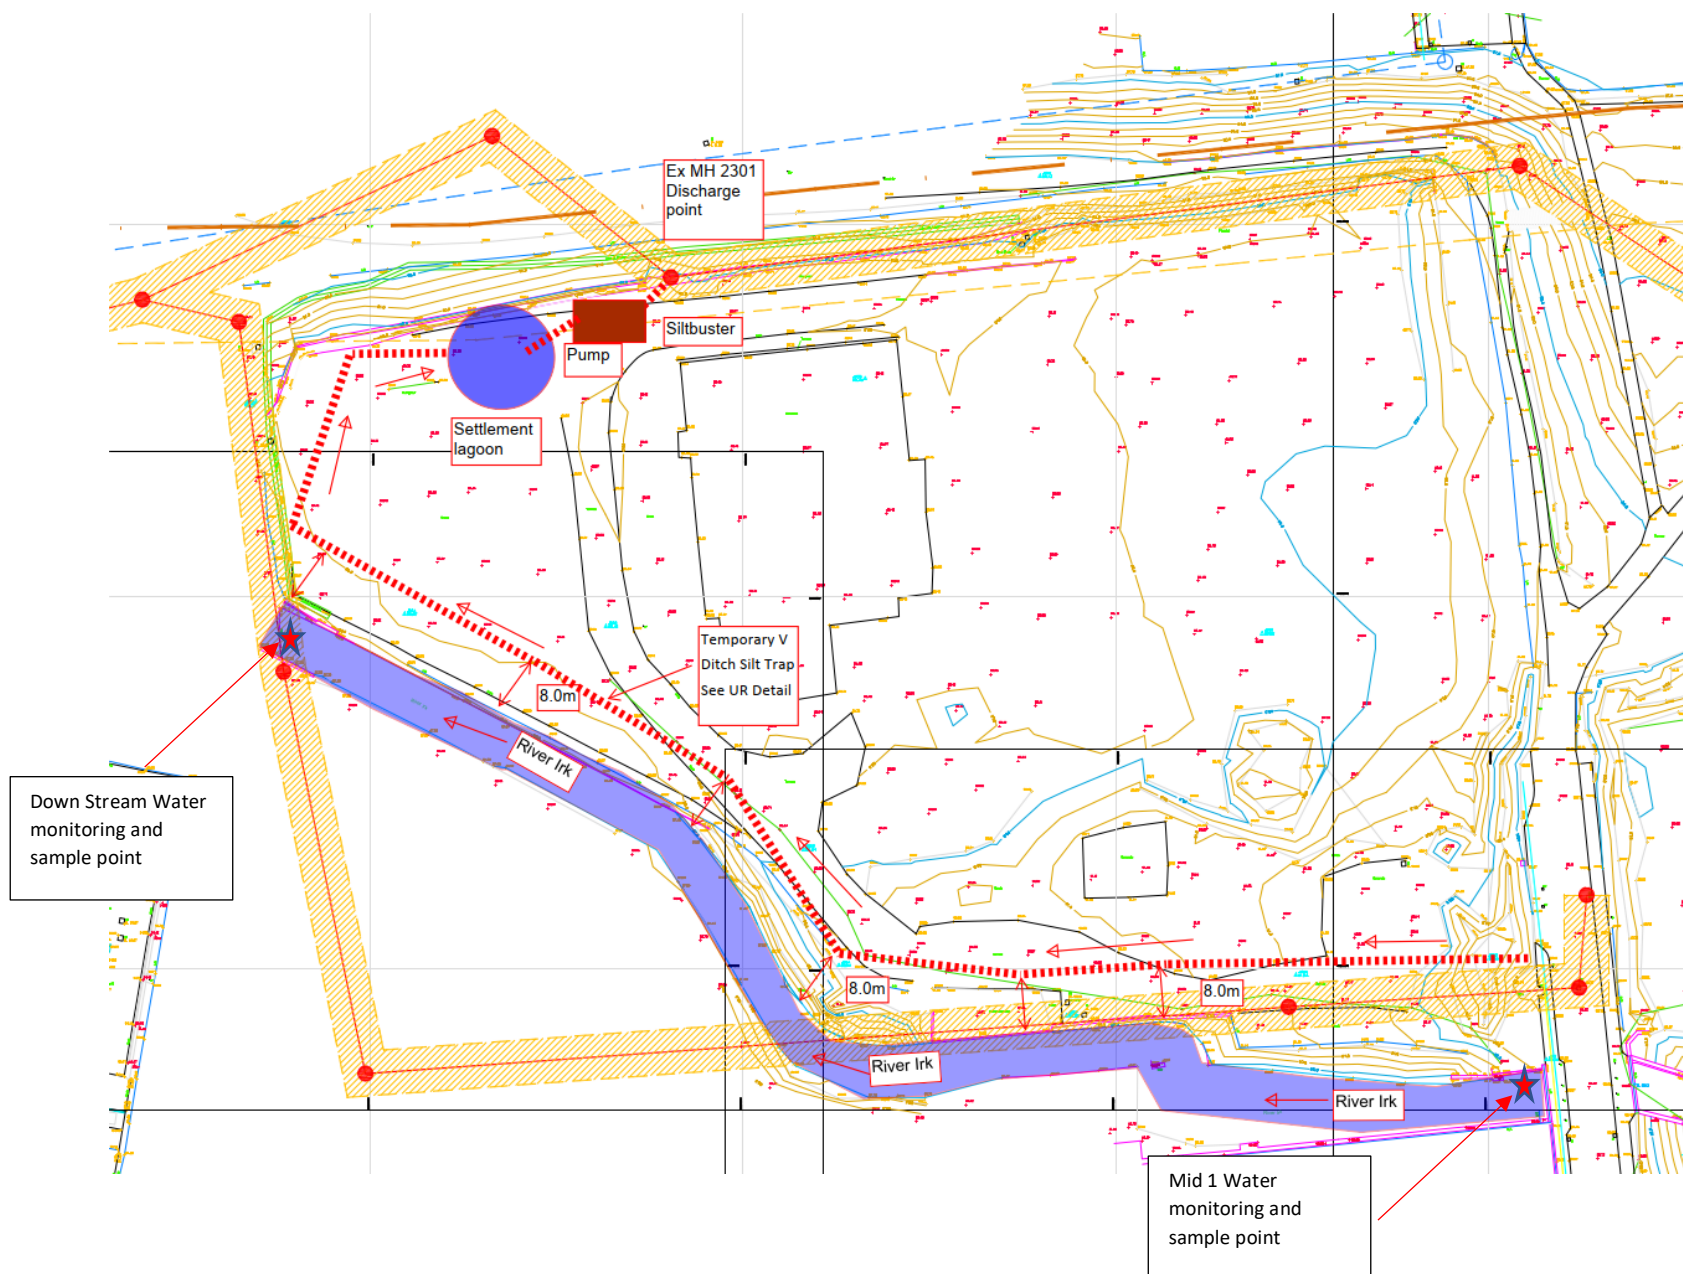
Area 1

Any redundant outfalls identified during V ditch excavation shall be stoppered up to prevent discharge to River Irk.

Discharge points subject to UU formal discharge consent

River Irk watercourse will be subject to daily visual inspection recorded on record sheet ENV-08-UR Watercourse Inspection sheet, supplemented with record photos, for retention on site for inspection. sampling known outfalls tbc by E3P / Kellen Homes

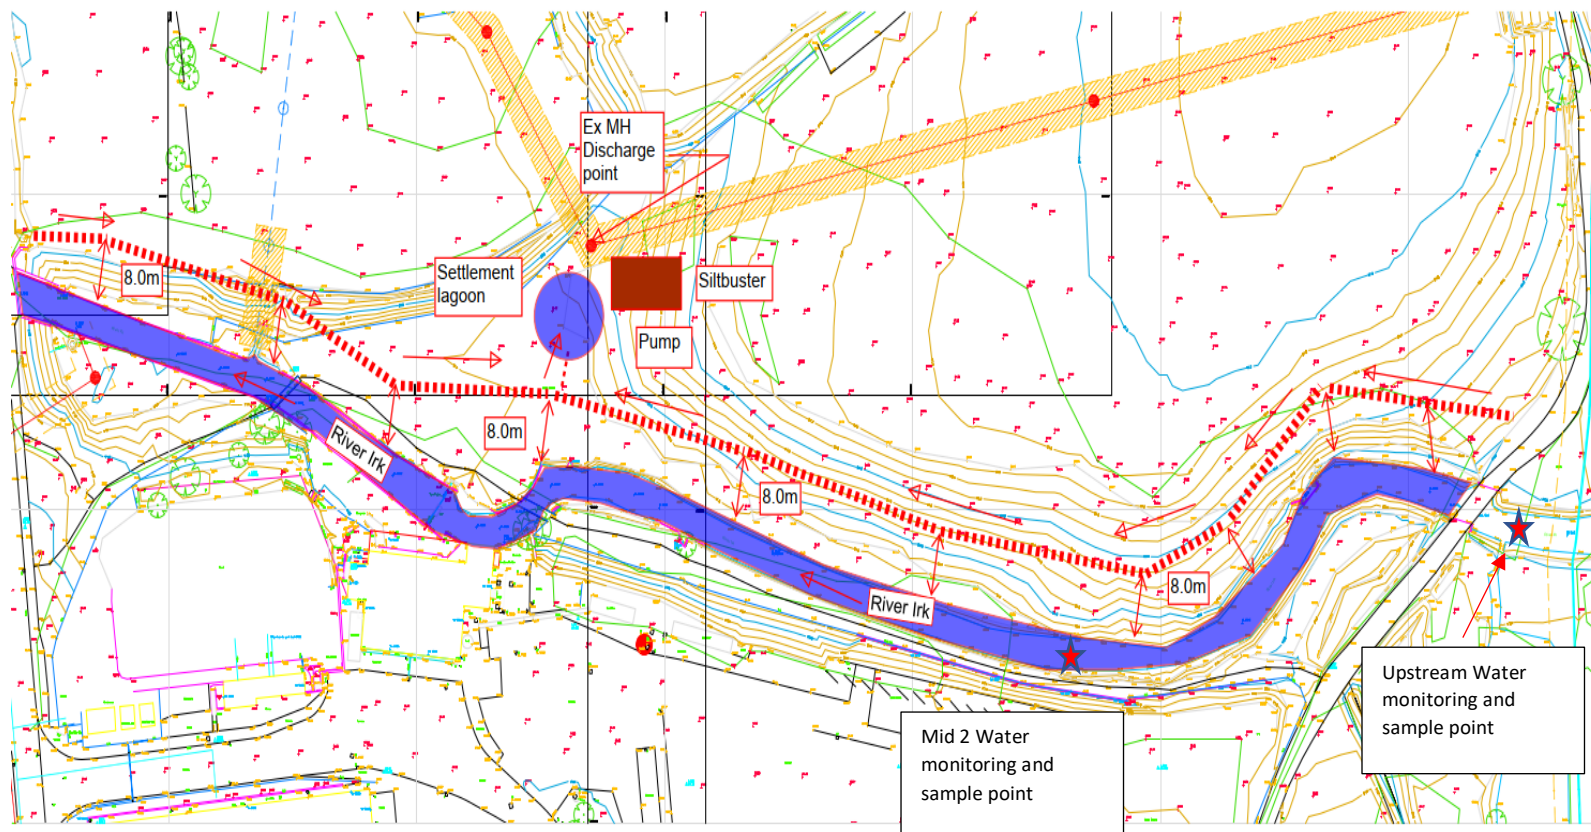
Area 2/4

Any redundant outfalls identified during V ditch excavation shall be stoppered up to prevent discharge to River Irk

Discharge points subject to UU formal discharge consent

River Irk watercourse will be subject to daily visual inspection recorded on record sheet ENV-08-UR Watercourse Inspection sheet, supplemented with record photos, for retention on site for inspection. sampling known outfalls tbc by E3P / Kellen Homes

Dewatering Sketch

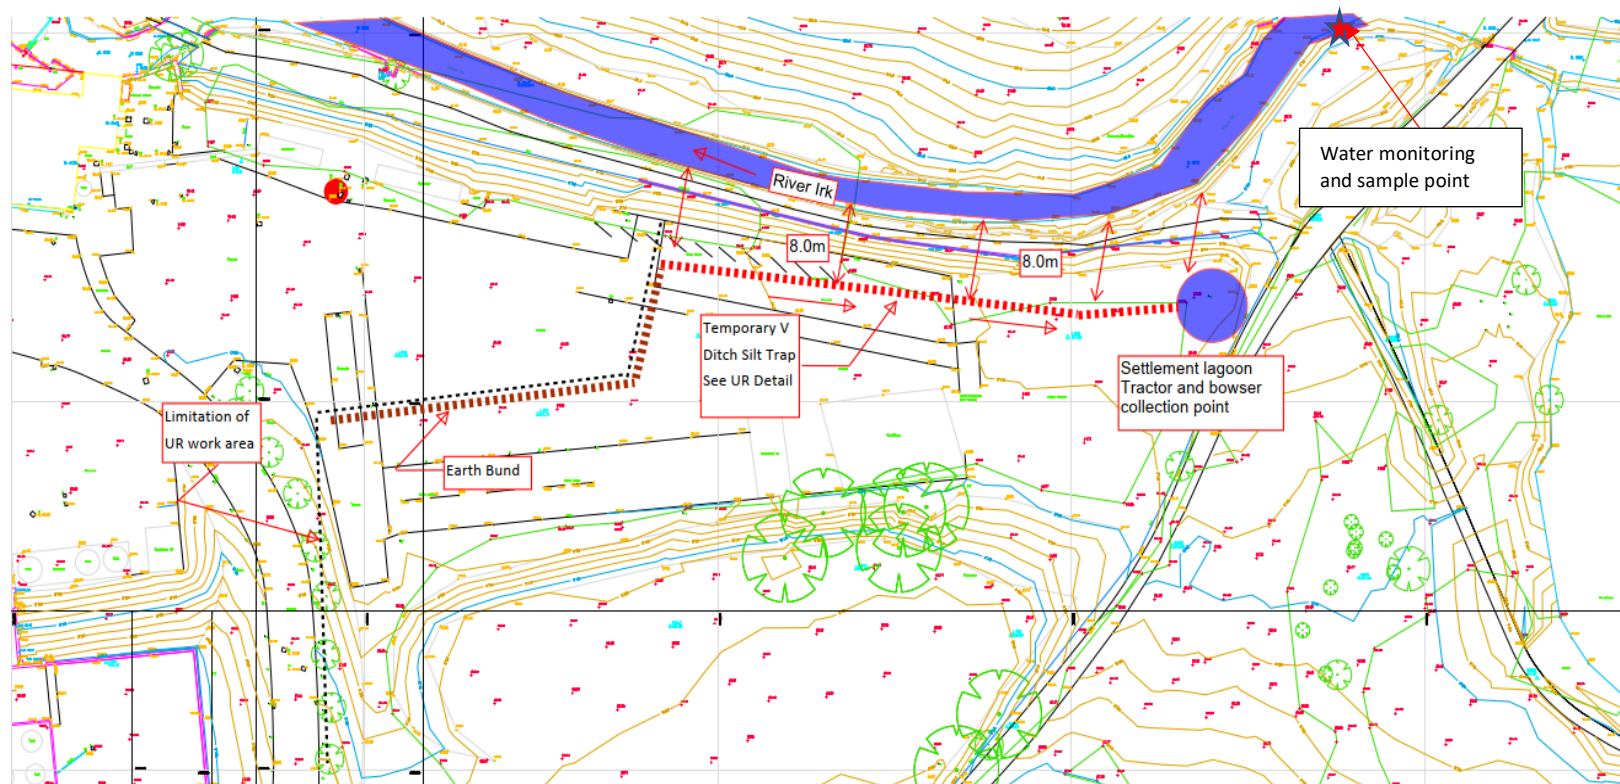
Area 5

Any redundant outfalls identified during V ditch excavation shall be stoppered up to prevent discharge to River Irk

River Irk watercourse will be subject to daily visual inspection recorded on record sheet ENV-08-UR Watercourse Inspection sheet, supplemented with record photos, for retention on site for inspection. sampling known outfalls tbc by E3P / Kellen Homes

Dewatering Sketch

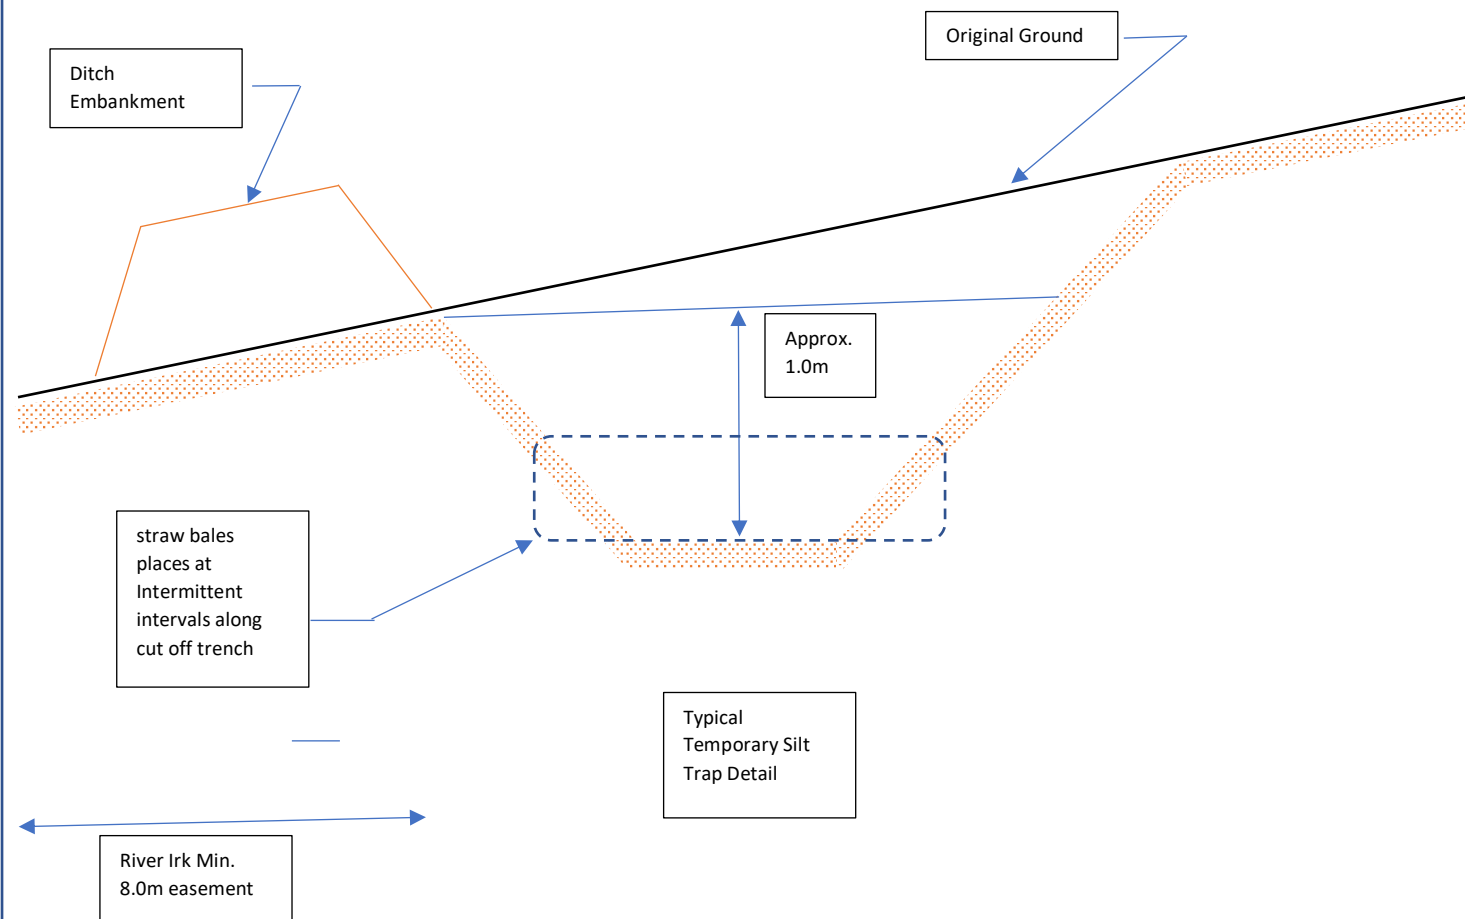
Any redundant outfalls identified during V ditch excavation shall be stoppered up to prevent discharge to River Irk

Typical Temporary V  
Ditch Silt Trap Detail
