**RTH.06**  
**Decoration Schedule**  
Rochdale Town Hall - Phase 3

| File Name | | | | | |
|---|---|---|---|---|---|
| RTH-DIA-XX-XX-SH-A-6500-DecorationsSchedule | | | | | |

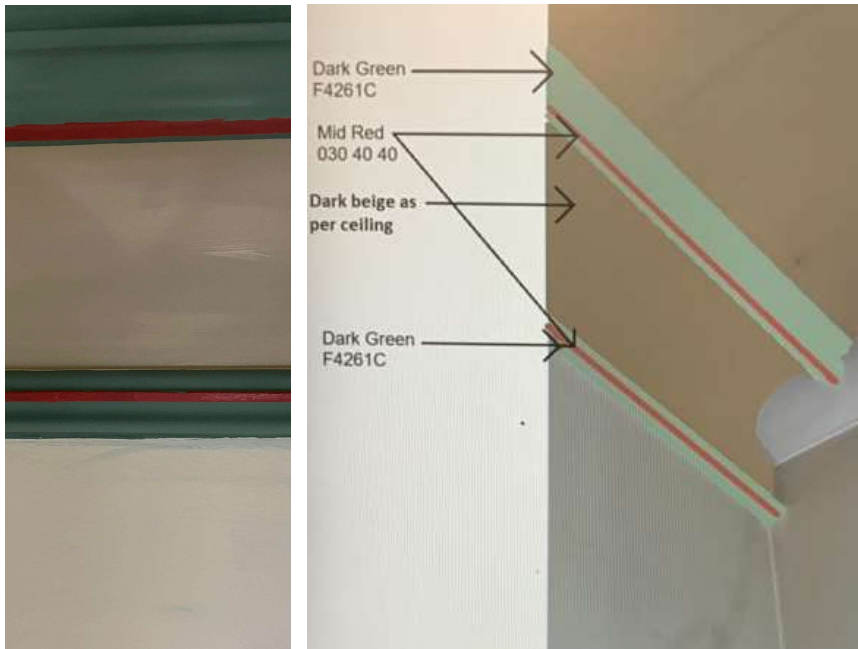
Ornate cornice in dark green, mid red, & dark beige

| Surface | | | Masonry | | | | Building Control - For Information | | Plaster | | | | Clear Finish Joinery | | | | Painted joinery | | | Painted Metalwork | | |
|---|---|---|---|---|---|---|---|---|---|---|---|---|---|---|---|---|---|---|---|---|---|---|
| S13a | Corridor | Walls - Light Beige: B57600<br>Ceiling - Dark Beige: 1510 – Y20R<br>Cornice - Dark Green (F4261C) upper and lower profiles with single line Mid Red (030 40 40) highlight to each. Dark Beige (1510-Y20R) to central section of cornice. Refer to images in Appendix.<br>Dry Riser: RAL 7022 | NA | NA | NA | NA | Patch repaired plaster | Escape Route / Circulation | NA | M60/151 - Paint System 1 (To Existing Walls above panelling)<br>M60/151 - Paint System 3(To New Walls above panelling) | M60/151 - Paint System 3 ceiling<br>M60/151 - Paint System 1 to cornice | NA | Existing M60/131 Repairs M60/132 | NA | Panelling: Existing M16/131 Repairs M60/132 | Panelling: Existing M16/131 Repairs M60/132 | NA | NA | NA | NA | NA | Dry Riser: M60/1126 RAL 7022 |

| Room Ref | Room Name | Colour Notes: | Masonry | | | | Building Control - For Information | | Plaster | | | Features | Clear Finish Joinery | | | | Painted joinery | | | Painted Metalwork | | | |
|---|---|---|---|---|---|---|---|---|---|---|---|---|---|---|---|---|---|---|---|---|---|---|---|
| F11a | Corridor | Walls - Light Beige: B57600<br>Ceiling - Dark Beige: 1510 – Y20R<br>Cornice - Dark Green (F4261C) upper and lower profiles with single line Mid Red (030 40 40) highlight to each. Dark Beige (1510-Y20R) to central section of cornice. Refer to images in Appendix. | NA | NA | NA | NA | Patch repaired plaster | Escape Route / Circulation | NA | M60/151 - Paint System 1 | M60/151 - Paint System 1 -Including Cornice | NA | Existing M60/131 Repairs M60/132 | NA | NA | Existing M16/131 Repairs M60/132 | Benches:<br>Existing M16/131 Repairs M60/132<br>Panelling:<br>Existing M16/131 Repairs M60/132 | NA | NA | NA | NA | NA | |

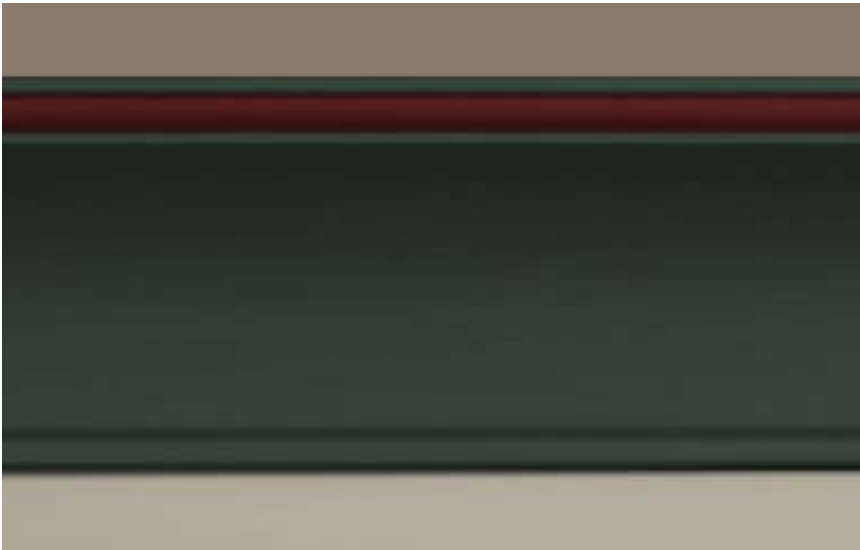
Simplified cornice in dark green & mid red.

| Room Ref | Room Name | Colour Notes: | Masonry | | | | Building Control - For Information | | Plaster | | | Features | Clear Finish Joinery | | | | Painted joinery | | | Painted Metalwork | | | |
|---|---|---|---|---|---|---|---|---|---|---|---|---|---|---|---|---|---|---|---|---|---|---|---|
| F14c.1 | Lift & WC Lobby | Walls - Light Beige: B57600<br>Ceiling - Dark Beige: 1510 – Y20R<br>Cornice - Dark Green (F4261C) with single line Mid Red (030 40 40) highlight to upper moulding. Refer to images in Appendix Simplified cornice in dark green & mid red. | NA | NA | M60/172 | NA | Patch repaired plaster & some new walls | escape route/circulation | NA | M60/151 - Paint System 1 (To Existing Walls)<br>M60/151 - Paint System 3(To New Walls) | M60/151 - Paint System 1 to existing repaired ceilings and cornice, M60/151 - Paint System 3 to new suspended ceiling and new cornice | NA | DF14b.2:<br>Existing M60/131 Repairs M60/132 | NA | NA | Existing M16/131 Repairs M60/132 | Panelling:<br>Existing M16/131 Repairs M60/132<br>New: M60/125 | NA | NA | NA | NA | NA | NA |

| Surface | | Colour Notes: | Masonry | | | | Building Control - For Information | | Plaster | | | | Clear Finish Joinery | | | | Painted joinery | | | Painted Metalwork | | |
|---|---|---|---|---|---|---|---|---|---|---|---|---|---|---|---|---|---|---|---|---|---|---|
| F14c.3 | Lift & WC Lobby | Walls - Light Beige: B57600<br>Ceiling - Dark Beige: 1510 – Y20R<br>Cornice - Dark Green (F4261C) with single line Mid Red (030 40 40) highlight to upper moulding. Refer to images in Appendix Simplified cornice in dark green & mid red.<br><br>WC Cubicles:<br>Walls - Light Green: F3680P<br>Ceiling - Mid Green: F4460V<br>IPS: Dark Green: F4261C<br>Cornice: NA | NA | NA | M60/172 | NA | Patch repaired plaster & some new walls | escape route/circulation | NA | M60/151 - Paint System 1 (To Existing Walls)<br>M60/151 - Paint System 3(To New Walls) | M60/151 - Paint System 1 to existing repaired ceilings and cornice, M60/151 - Paint System 3 to new suspended ceiling and new cornice | NA | New HW doors: M60/125 | NA | Existing M16/131 Repairs M60/132 | NA | NA | IPS: M60/150 Dark Green (F4261C) | M60/631 | NA | NA | |
