| PROJECT | SMP - St Mary's CE Primary School |
| TITLE | Roof - Fabric Repair Plan |
| NUMBER | SMP-SEV-XX-R1-DR-A-02012 |

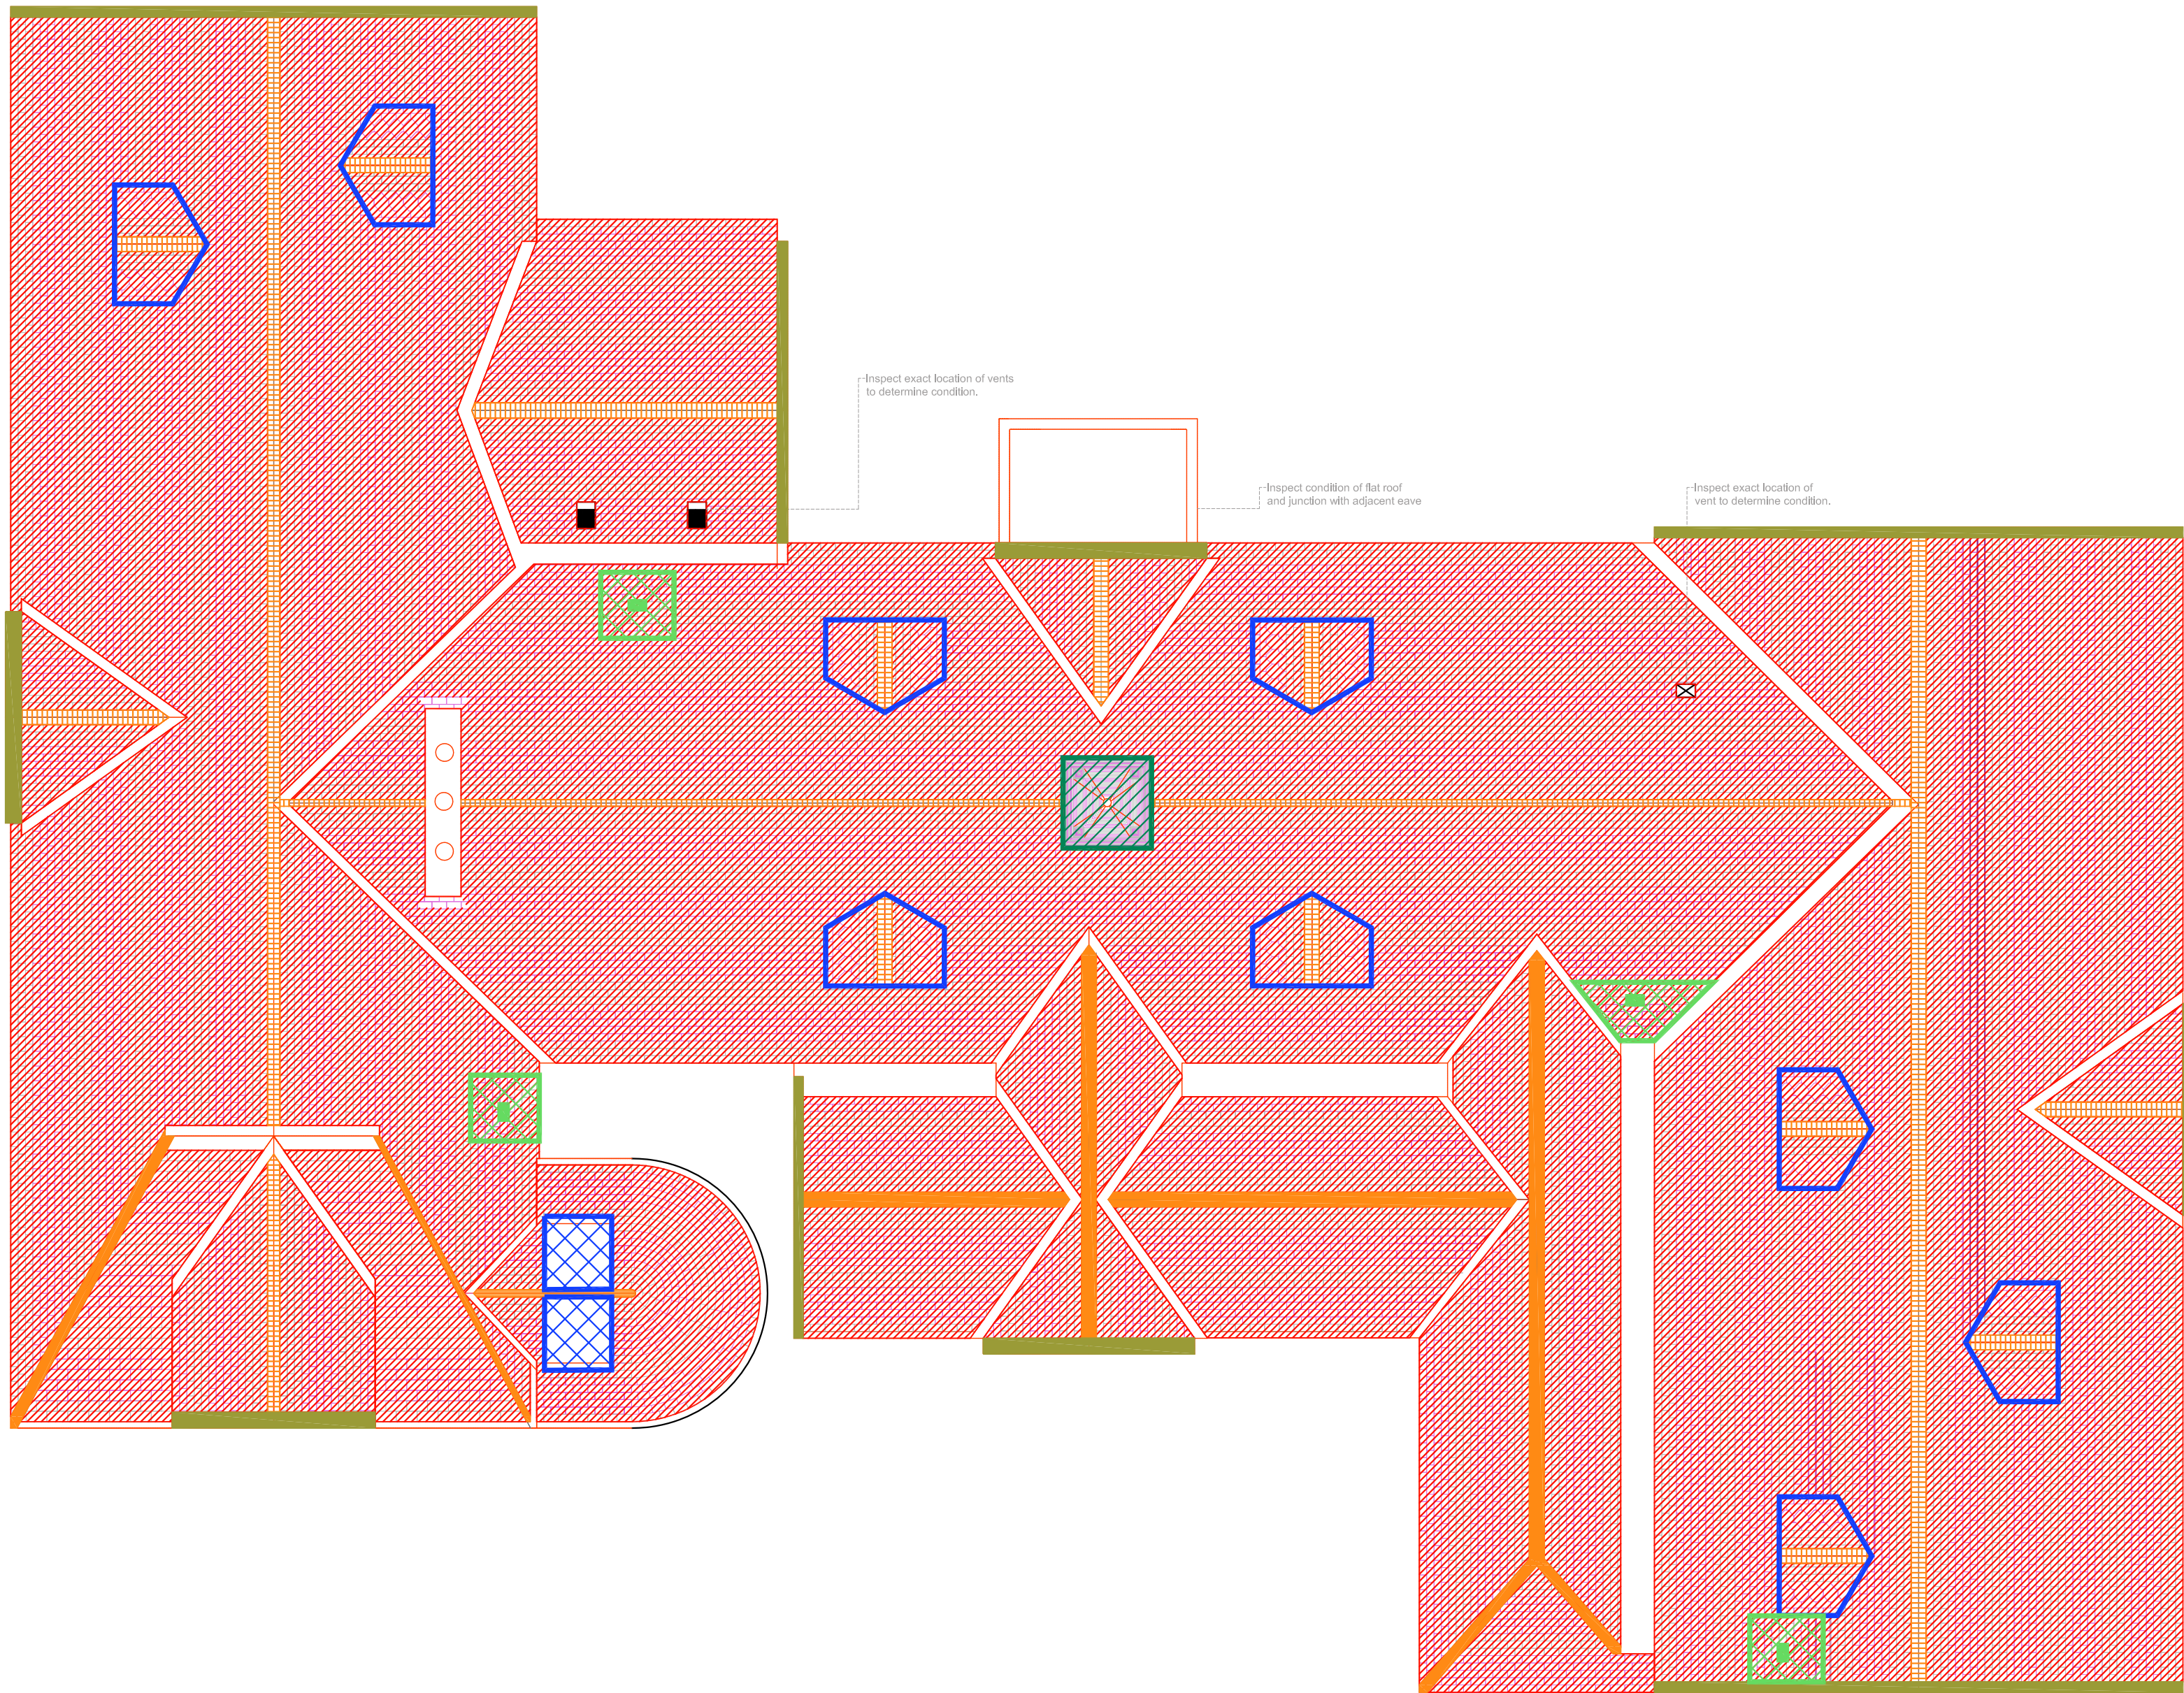
- Roof Slate Restoration: 762sqm / 8220sqft  
Strip existing slate roof coverings and set aside salvaged slates for re-use. Strip existing battens, felt, lead-lined gutters and gutter structure then safely dispose of any defective material. Re-felt & batten existing roof slope. As per detail A-A in drawing SMP-SEV-XX-XX-DR-A-03100 (Typical Roof Build-Up)

- Dormer Window: 09 no.  
Splice in new timbers where appropriate. Access to be provided for detailed inspection and methodology agreed. Carefully sand down and repaint in appropriate materials as per the specification. Roofing section per detail F-F in drawing SMP-SEV-XX-XX-DR-A-03105 (Typical Dormer Window)

- Cupola: 01 no.  
Splice in new timbers where appropriate. Access to be provided for detailed inspection and methodology agreed. Carefully sand down and repaint in appropriate materials as per the specification. Cupola roofing is as per the building's other slate roof eaves, but is at a steeper gradient (assume larger area than in plan).

- Decorative Ridge Tiles: 105 Lm  
Ridge tiles to be removed and set aside with salvaged tiles for re-use. Replace damaged tiles as per the existing style. Ridge ventilation provided with new linear vent. Ridge venting per detail F-F in drawing SMP-SEV-XX-XX-DR-A-03105 (Typical Dormer Window)

- Flat Ridge Tiles: 50 Lm  
Ridge tiles to be removed and set aside with salvaged tiles for re-use. Replace damaged tiles like-for-like.
- Stone Capping:  
Take up and re-bed existing stone capping pieces and re-point. Ensure appropriate stiff mortar (NHL 3.5 Lime Mortar) applied to capping sections. Sample cappings to be provided to ensure secure structure.

- Non-Gabled Dormer Windows:  
'Shed Dormer' windows with flat felt topping. Splice in new timbers where appropriate. Access to be provided for detailed inspection and methodology agreed. Carefully sand down and repaint in appropriate materials as per the specification. Remove felt and re-top with terne-coated stainless steel (TCSS) with a round-batten seam to match HE Guidelines.

- Slate Tiles:  
Grey and Grey-Purple slate tiles.  
To be relocated in the same location/pattern as existing.
- Bat Slate: [Dashed Hatch Approx. Location, Solid Hatch Exact Location]  
Integrated Bat access slate; metal vent to allow access for bats into roof void, with sufficient gap cut into roof structure underneath. Fitted within a hole cut to slate which is placed over the vent to reduce visual impact. 1no. Bat Slate located in area of observed bat emergence (west wing of the building, facing north, adjacent to Dormer D2) and then 3no. supplementary 'enhancement slates' along remaining wings (north, east, south).
