| PROJECT | SMP - St Mary's CE Primary School |
| TITLE | Elevation CC - Demolition & Repairs |
| NUMBER | SMP-SEV-XX-XX-DR-A-03012 |

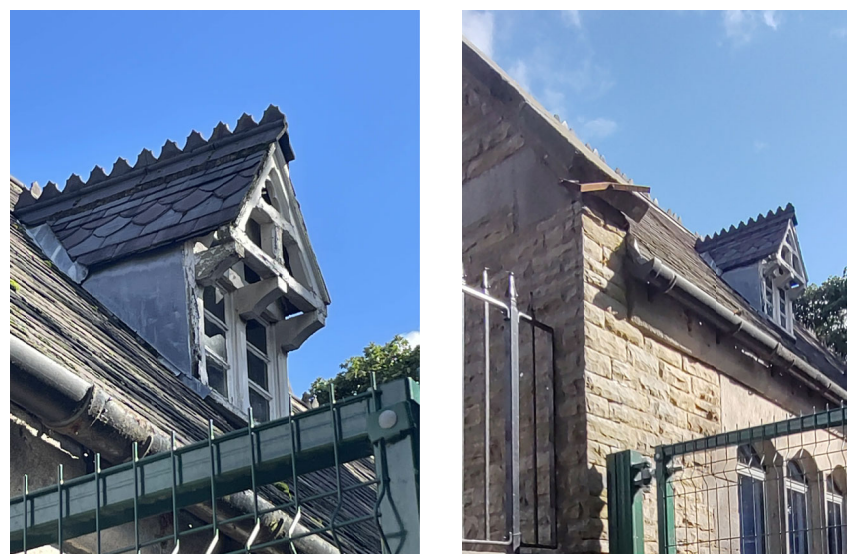
**D3** Dormer damaged; requires replacement sections spliced into remaining framework

Rusted metal clamping at base of stone capping

- Dormer Window: 09 no.  
Splice in new timbers where appropriate. Access to be provided for detailed inspection and methodology agreed. Carefully sand down and repaint in appropriate materials as per the specification. Roofing section per detail F-F in drawing SMP-SEV-XX-XX-DR-A-03105 (Typical Dormer Window)

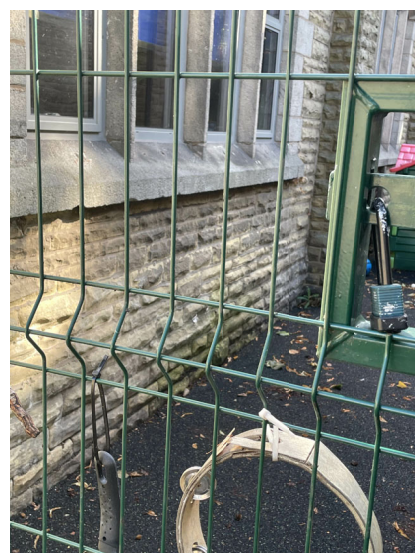
Mould at ground level - investigate if moisture trapped by adjacent Nursery rubberised hard-standing
