Typical Cedar Avenue Porch  
Arrangement - Existing

| Client | Rochdale Boroughwide Housing |
| Job | Cedar Avenue Porch Renewal<br>Heywood |
| Title | Existing and Proposed Elevations<br>Porch Details |

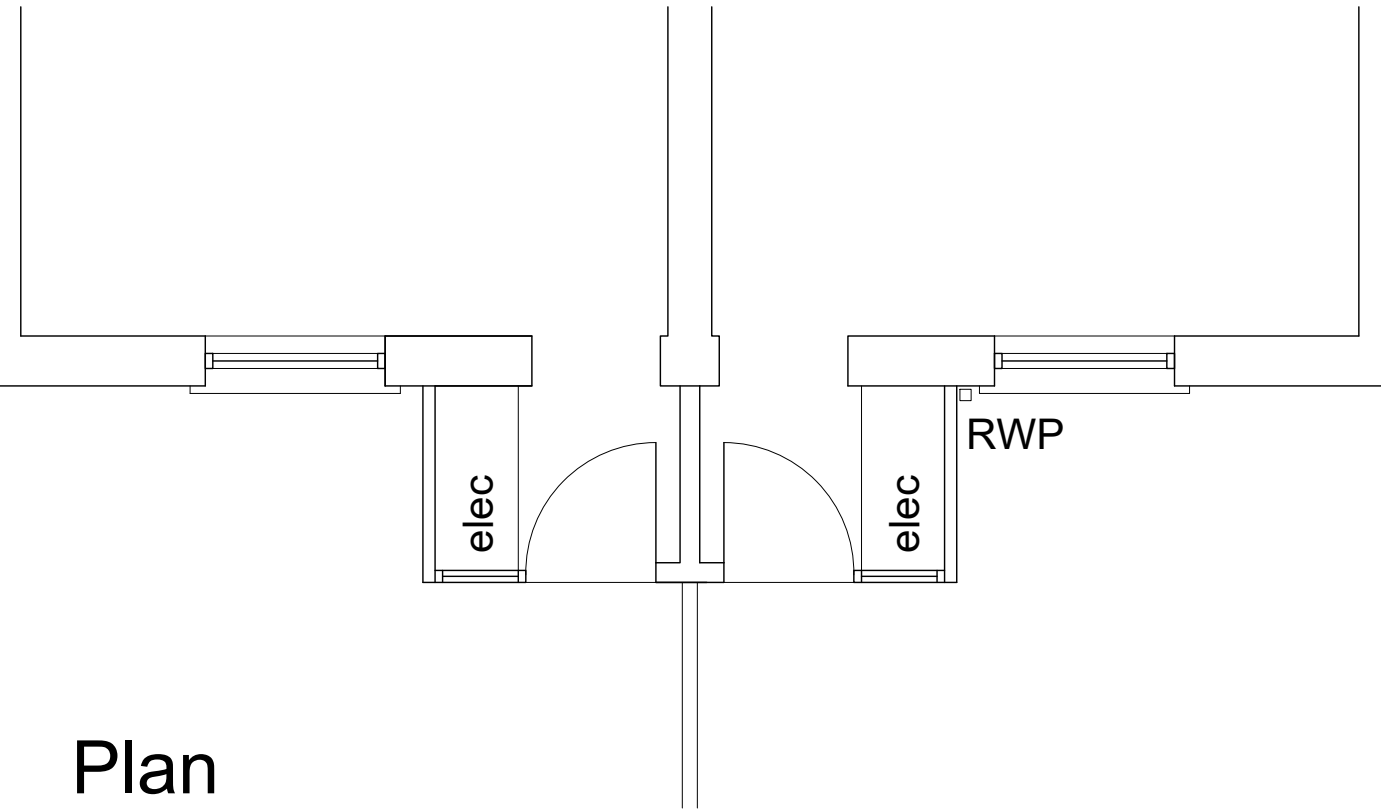
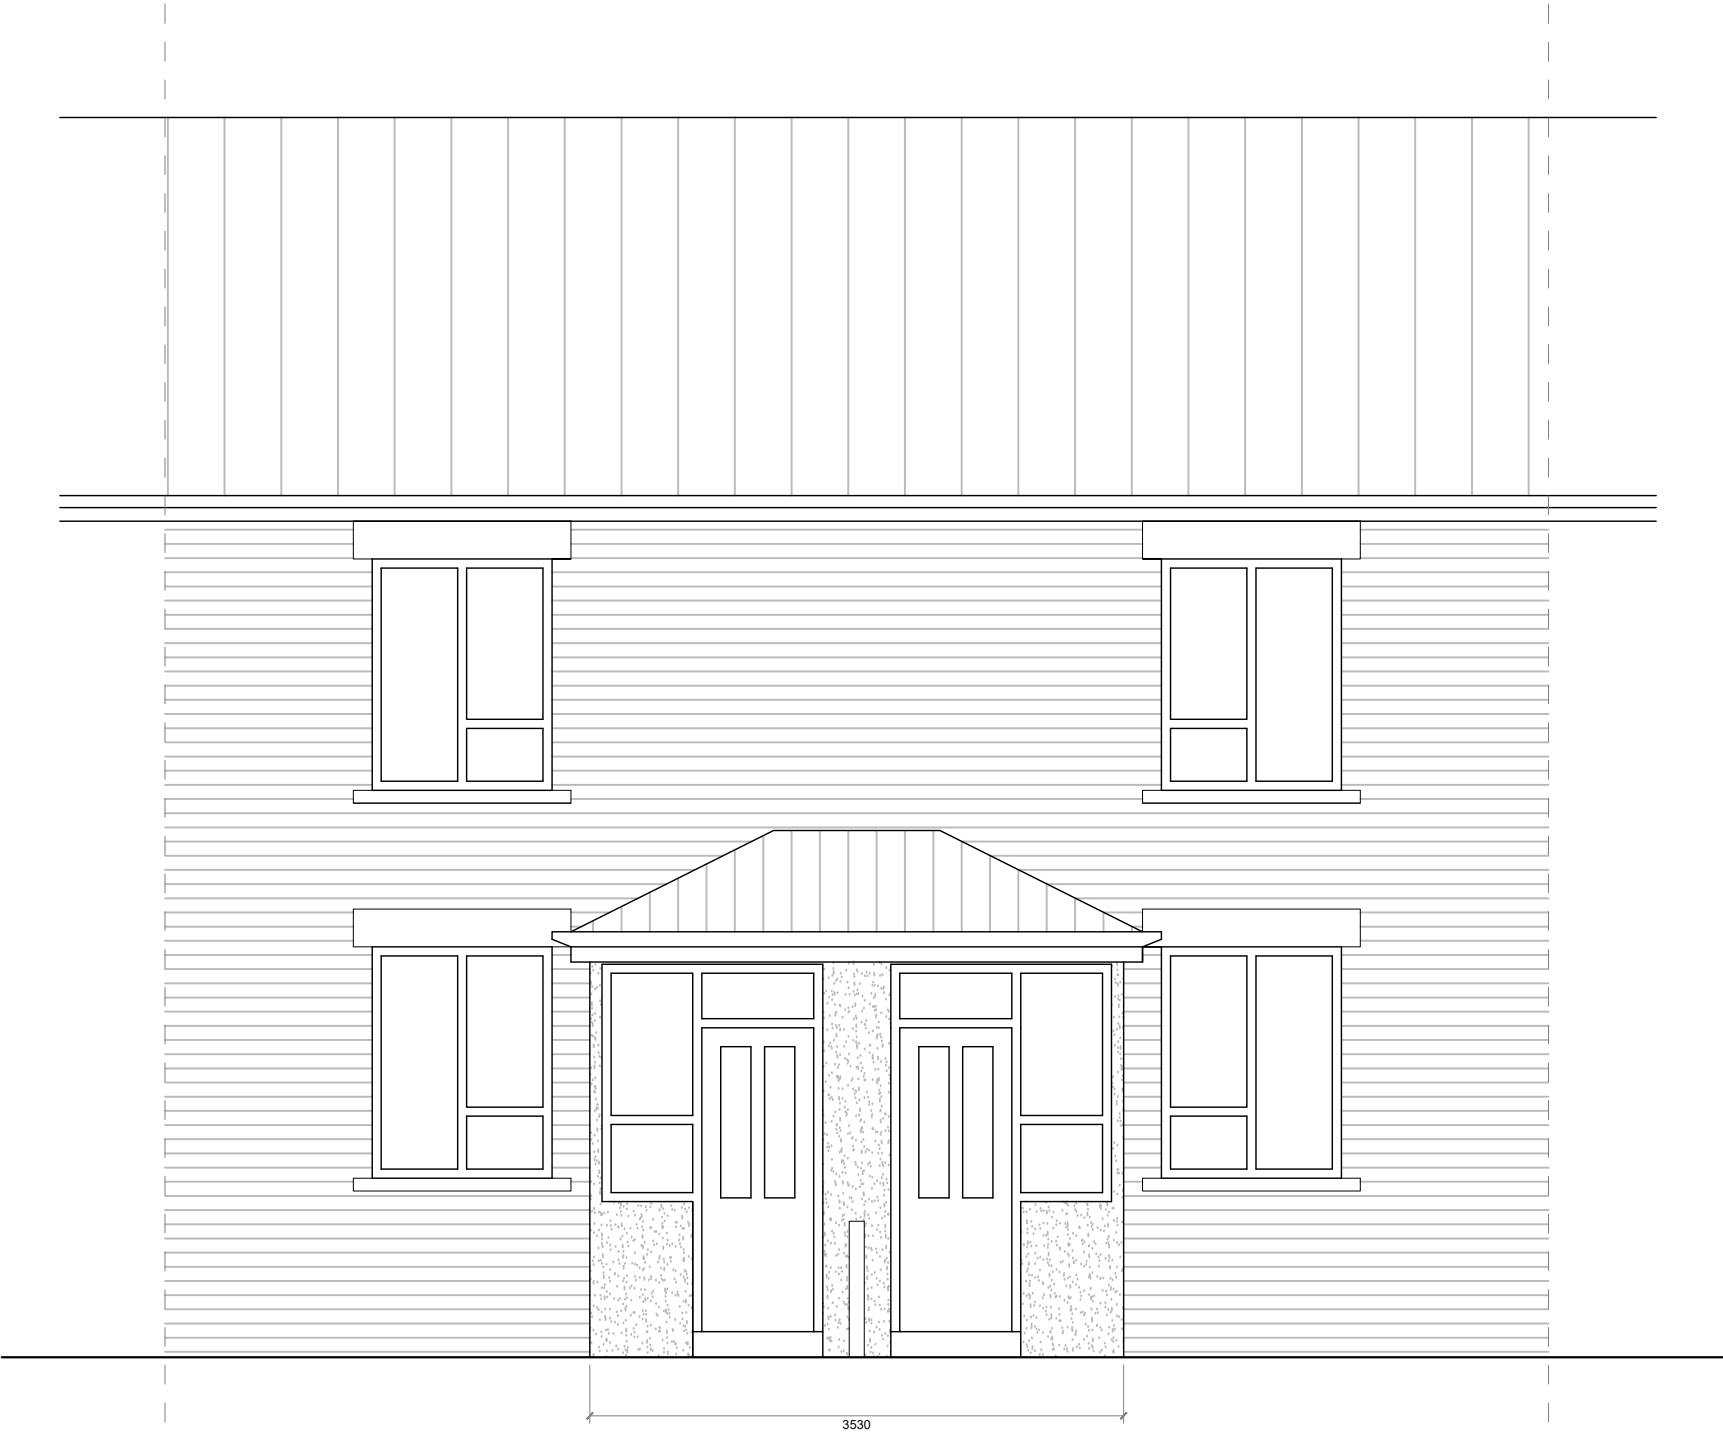
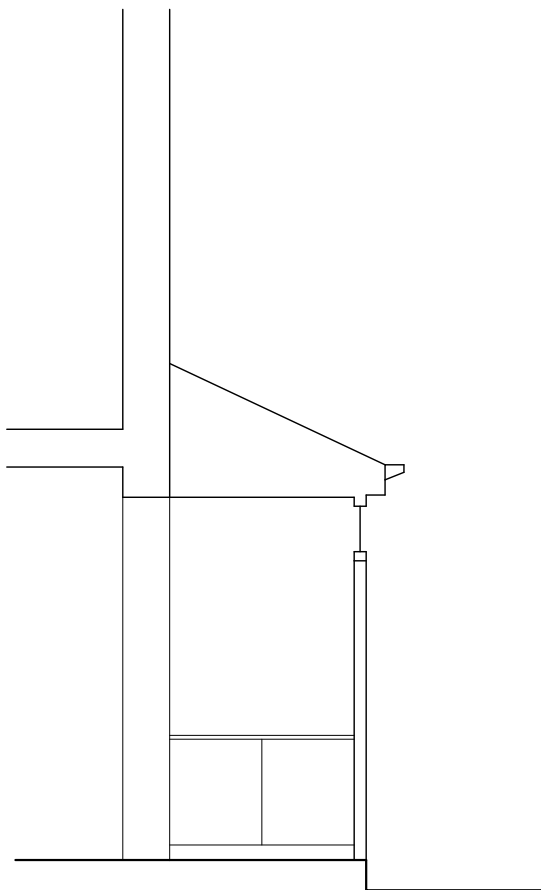
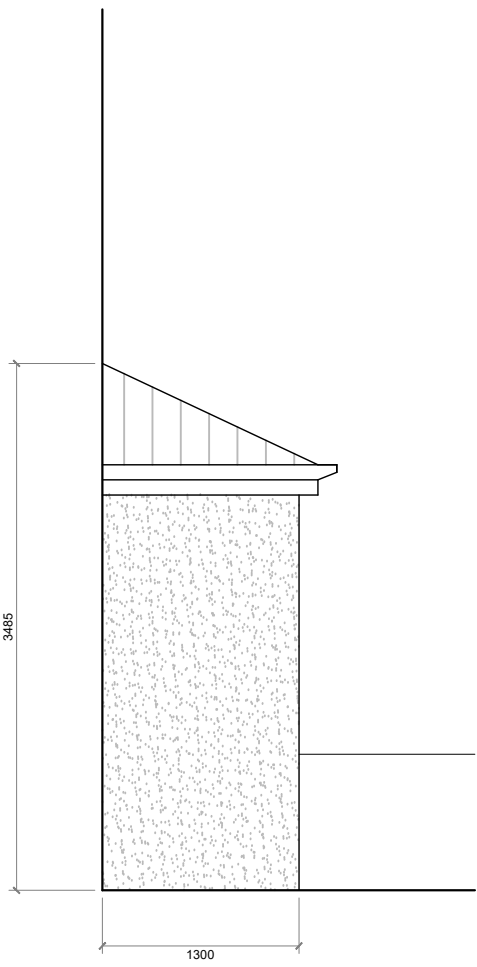
| 01 | Existing Porch Details |

Porch materials - render, upvc, concrete tile  
House materials - brick, concrete tile

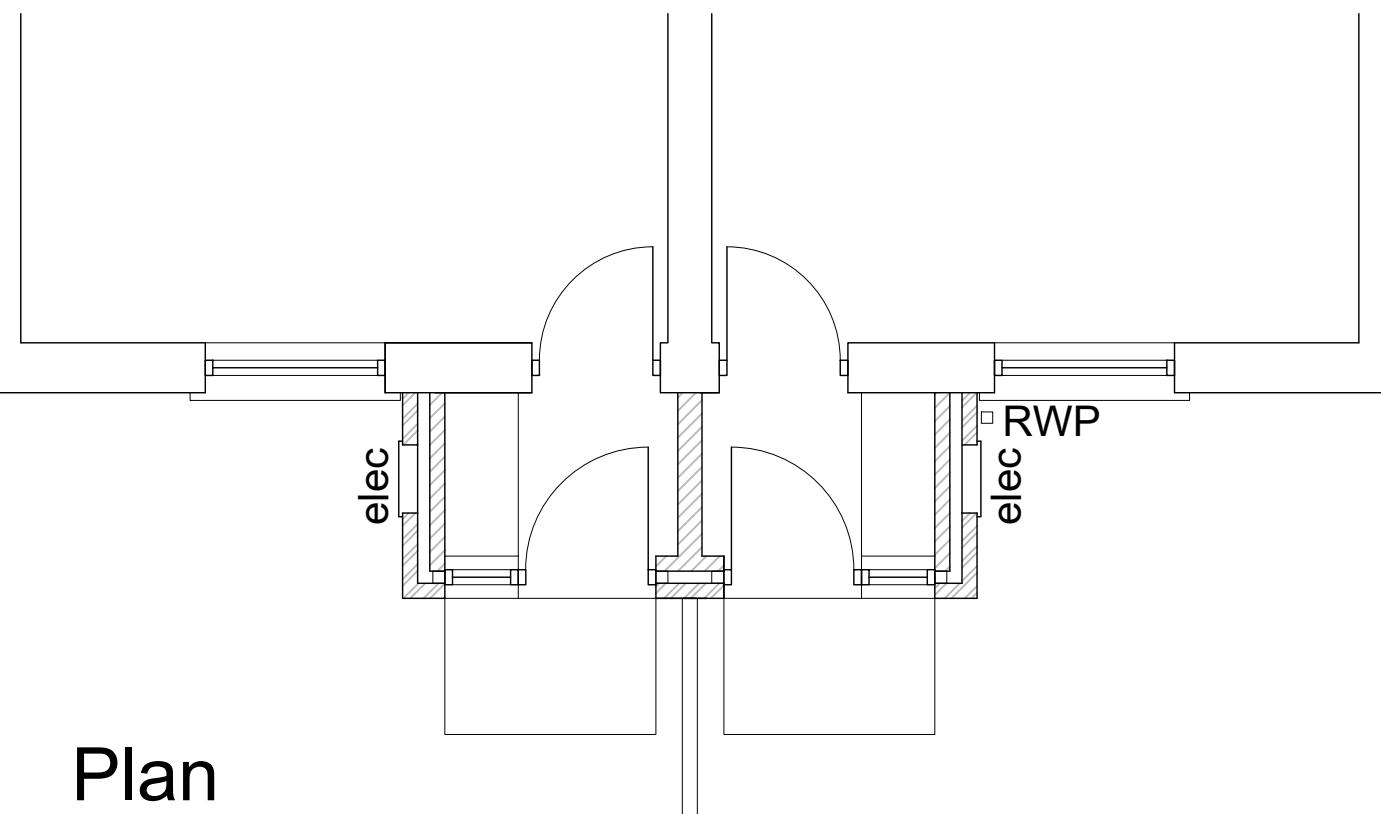
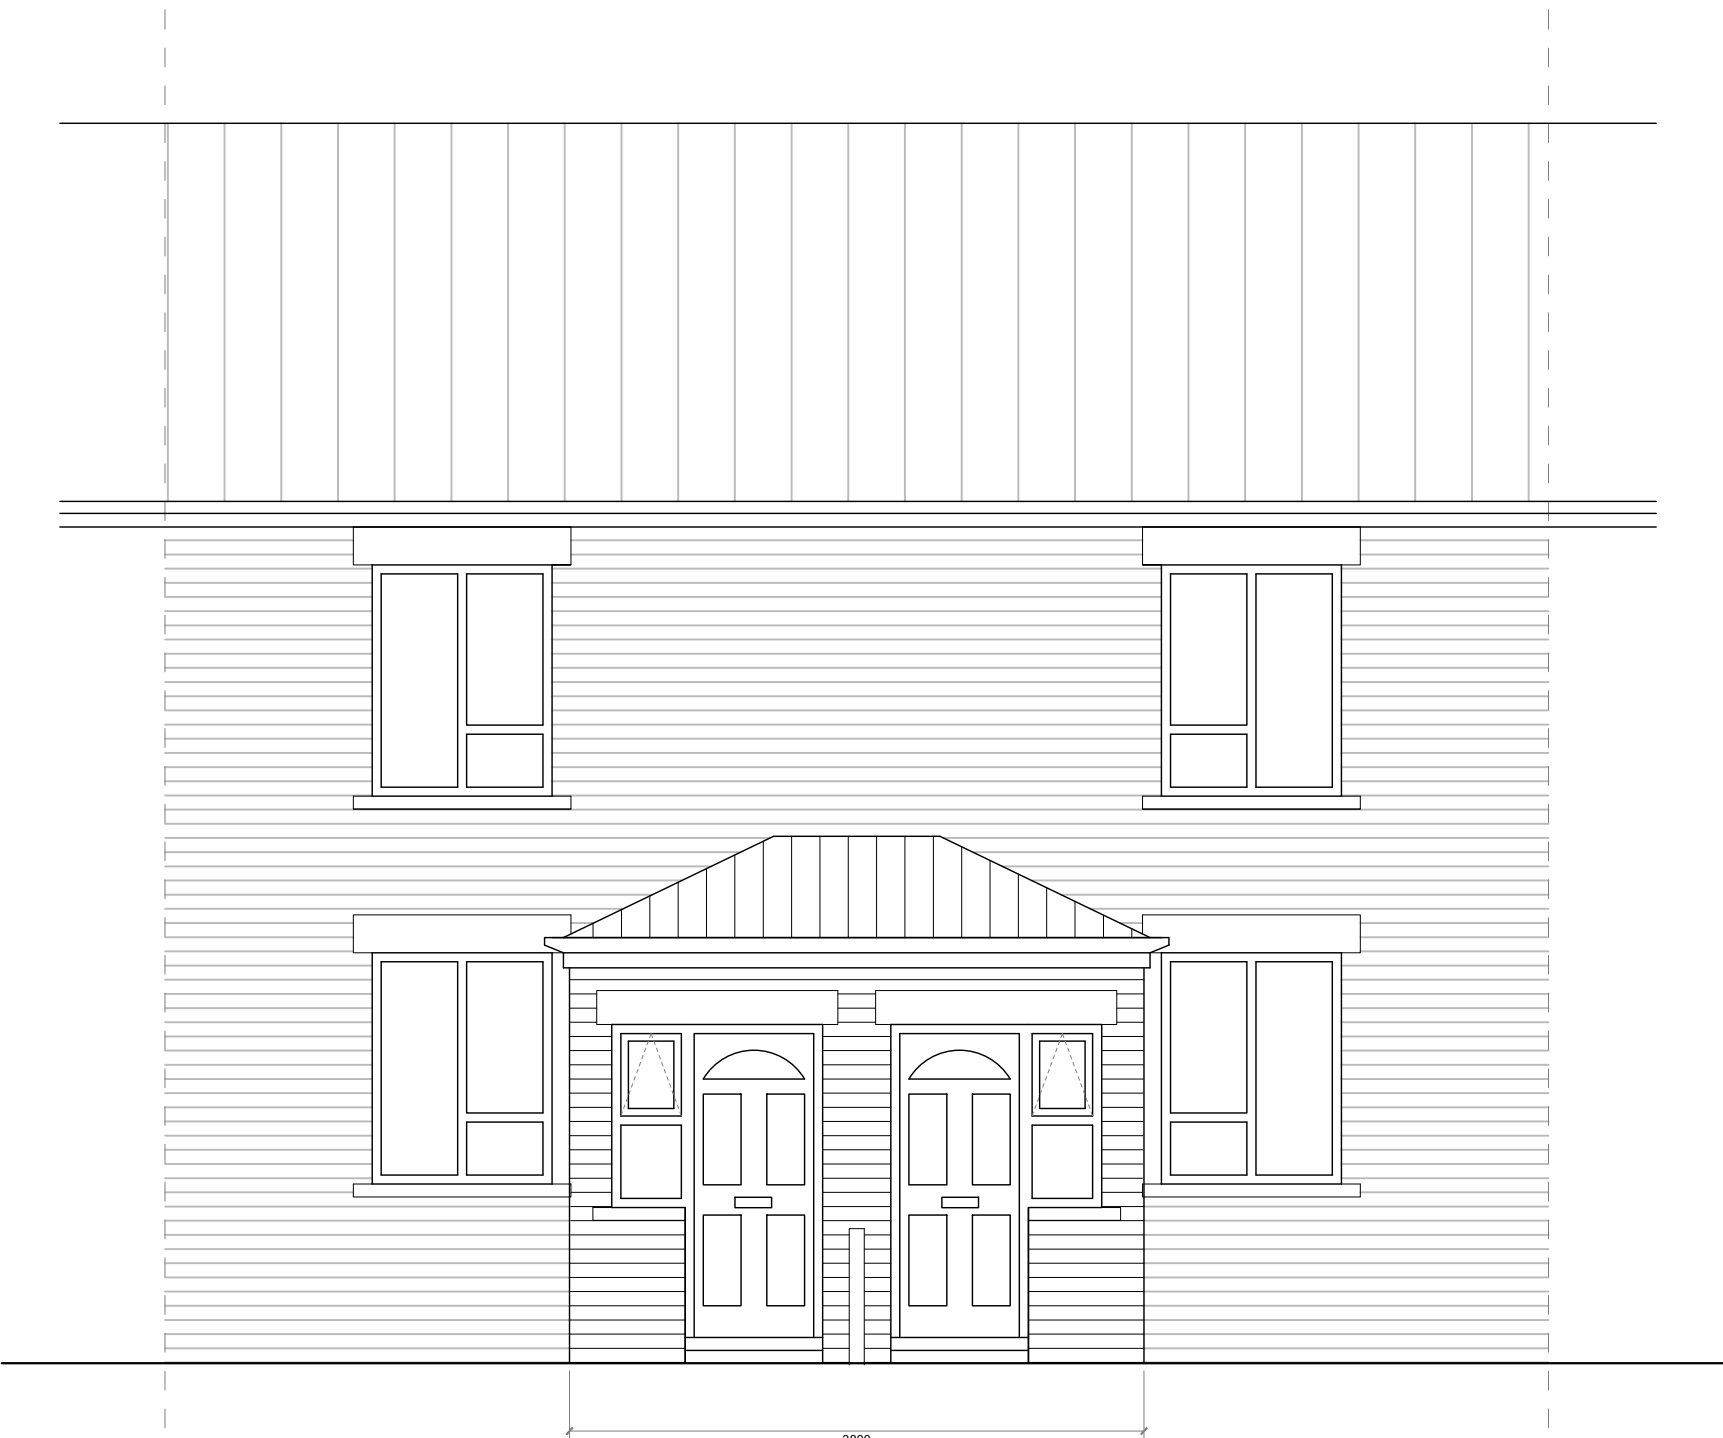
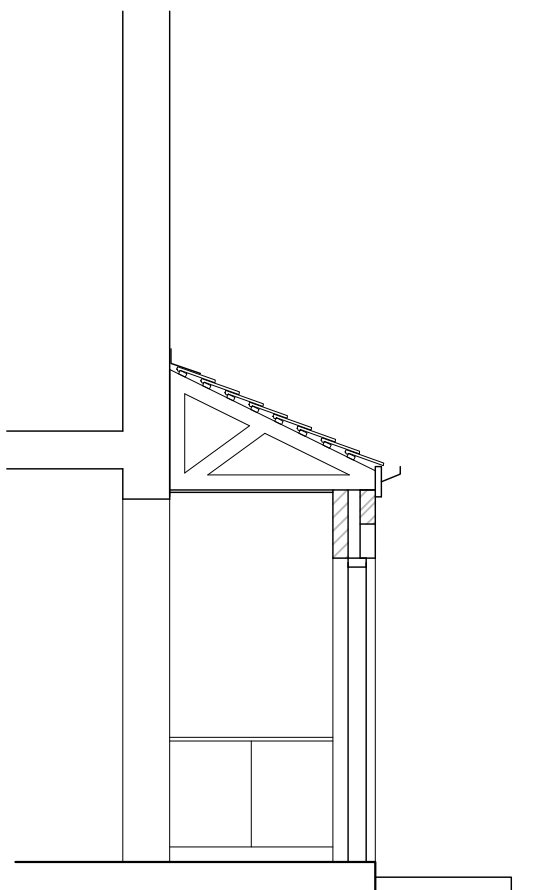
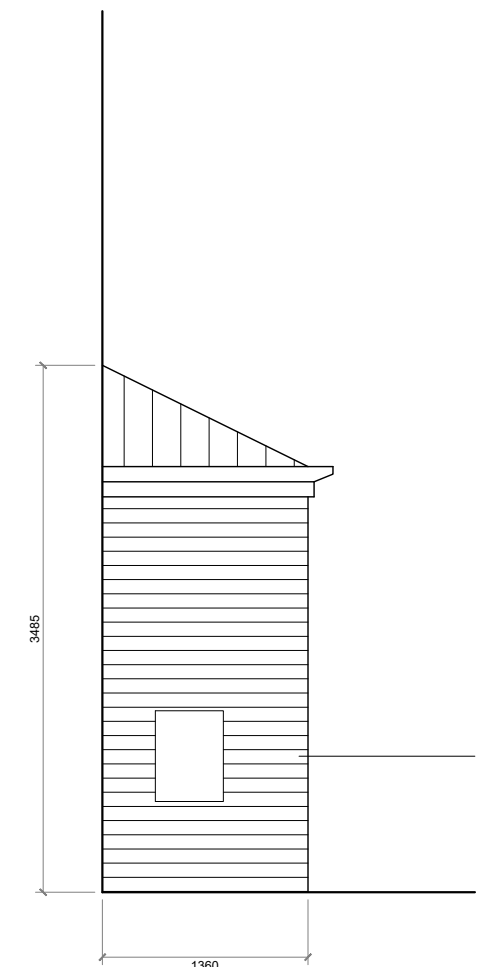
| 02 | Proposed Porch Details |

Typical Cedar Avenue Porch  
Arrangement - Proposed

Porch materials - brick and block, insulated  
cavity, upvc, concrete tile
