| PROJECT | SMP - St Mary's CE Primary School |
| TITLE | Elevation EE - Demolition & Repairs |
| NUMBER | SMP-SEV-XX-XX-DR-A-03014 |

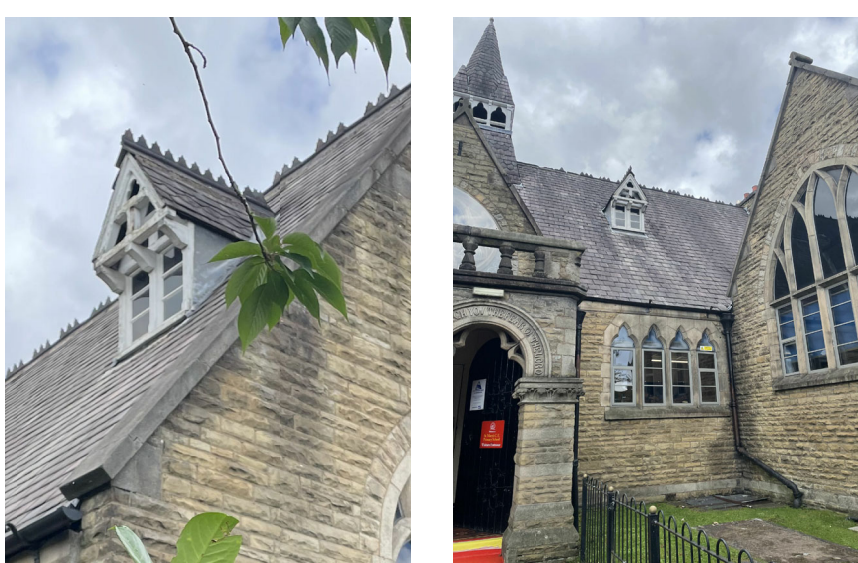
A2 Dormer wood paintwork worn; requires further inspection

- Dormer Window: 09 no.  
Splice in new timbers where appropriate. Access to be provided for detailed inspection and methodology agreed. Carefully sand down and repaint in appropriate materials as per the specification. Roofing section per detail F-F in drawing SMP-SEV-XX-XX-DR-A-03105 (Typical Dormer Window)

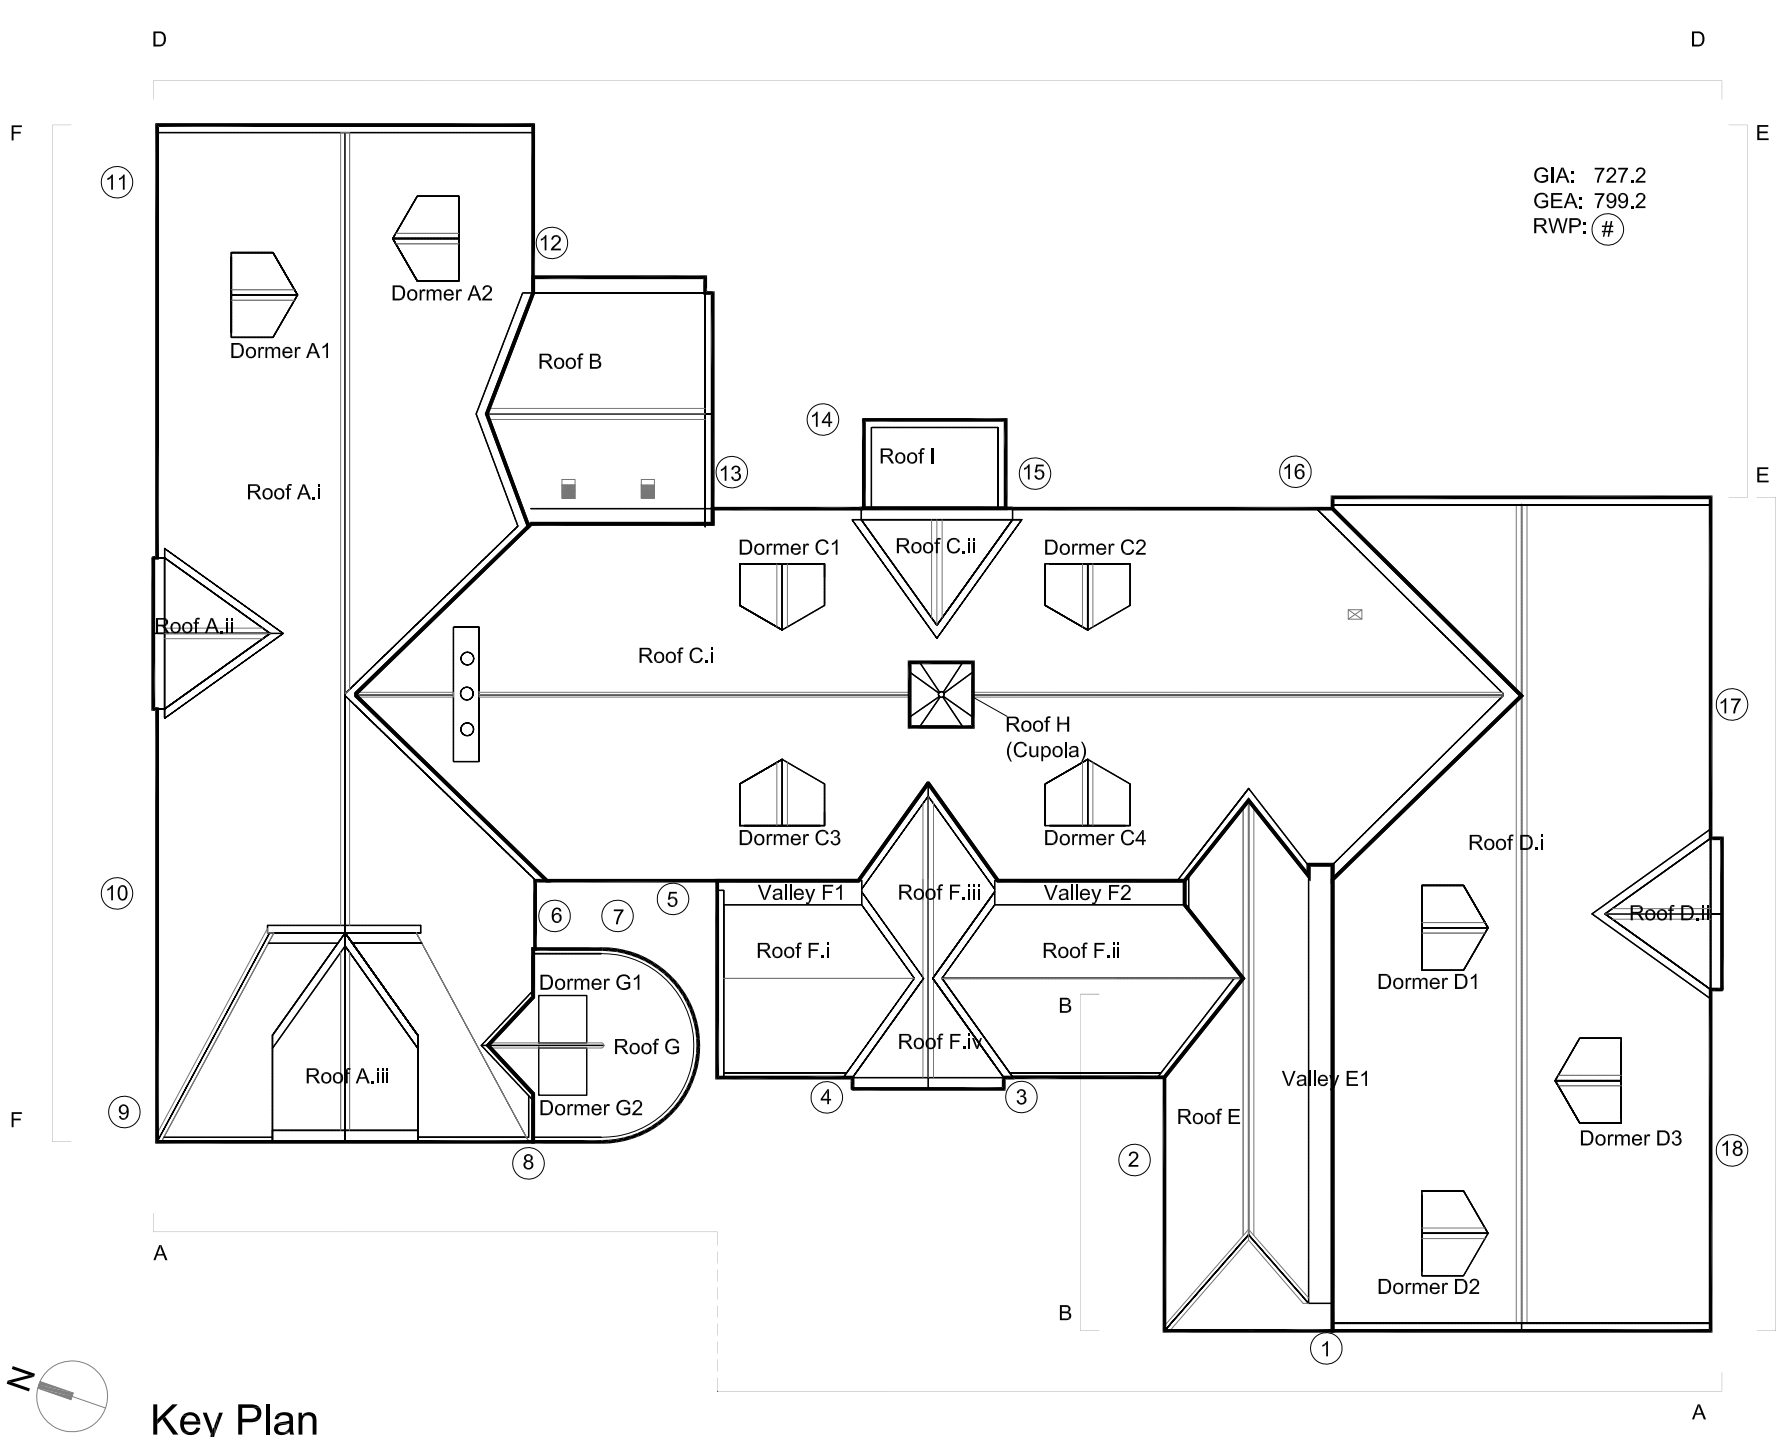
Downpipe rusted; requires sanding down & repainting

- Rainwater Goods: 18 no.  
Down-pipe to be removed and replaced with cast-iron rainwater goods allowing for increased diameter (6 inch) to mitigate increased rainfall.  
Guttering per detail B-B in drawing SMP-SEV-XX-XX-DR-A-03100 (Typical External Gutter)
