## GARDEN VALIDATION – ROYLE ROAD

| <b>Project Name:</b> | Royle Road |
| <b>Plots:</b> | 20 and 176 |

## Garden Cover System Validation

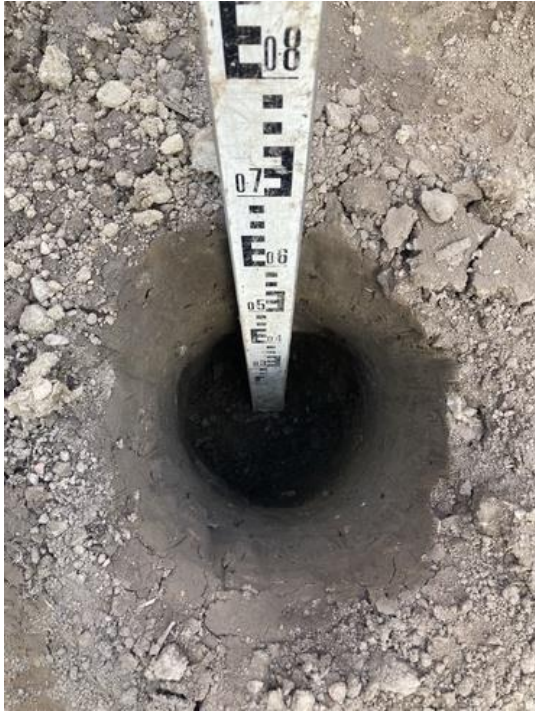
Photo 1

| Depth of Cover System Materials (record the depth and support with Photo down the hole) | 600 |
| Depth of Topsoil (mm) | 150 |
| Depth of Subsoil (mm) | 450 |

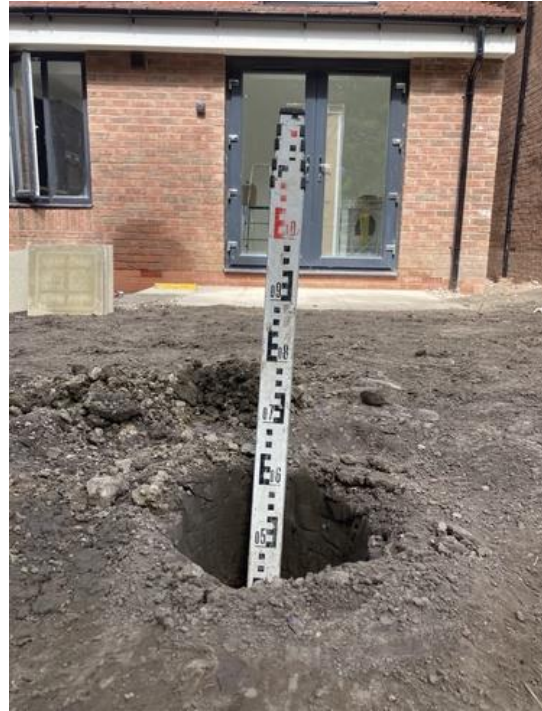
Photo 2

| Depth of Cover System at Ground Level (Photo) | |

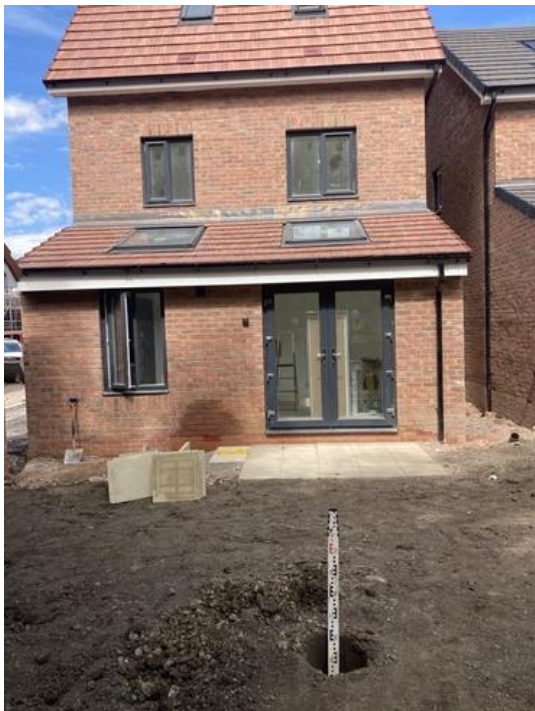
Photo 3

| Depth of Cover System in Relation to Plot (Ensure the whole plot can be seen in the photo) | |

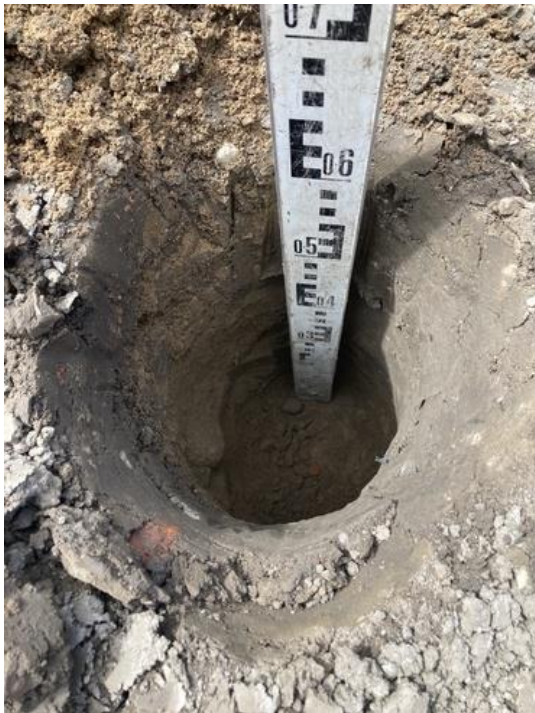
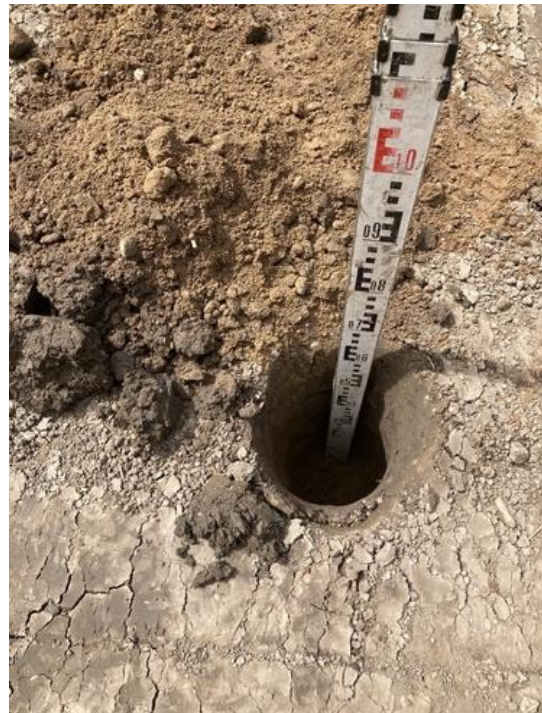
Photo 15

| Depth of Cover System Materials (record the depth and support with Photo down the hole) | | 600 |
| Depth of Topsoil (mm) | | 150 |
| Depth of Subsoil (mm) | | 450 |

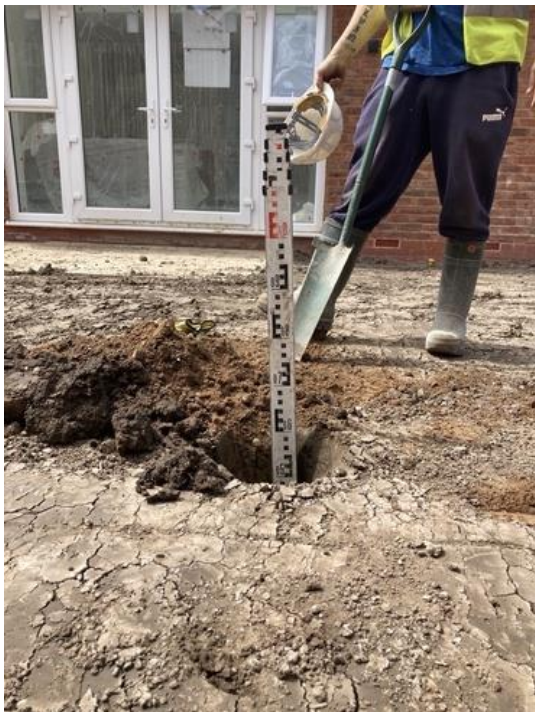
Photo 17

| Depth of Cover System at Ground Level (Photo) | | <div>✕</div> |

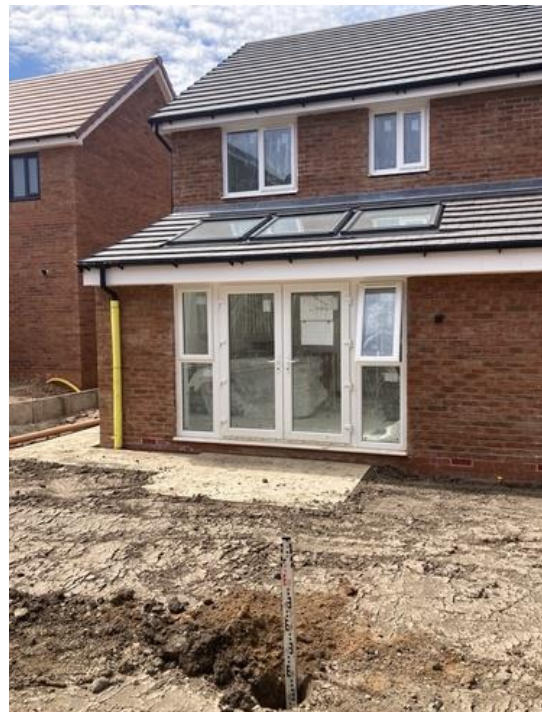
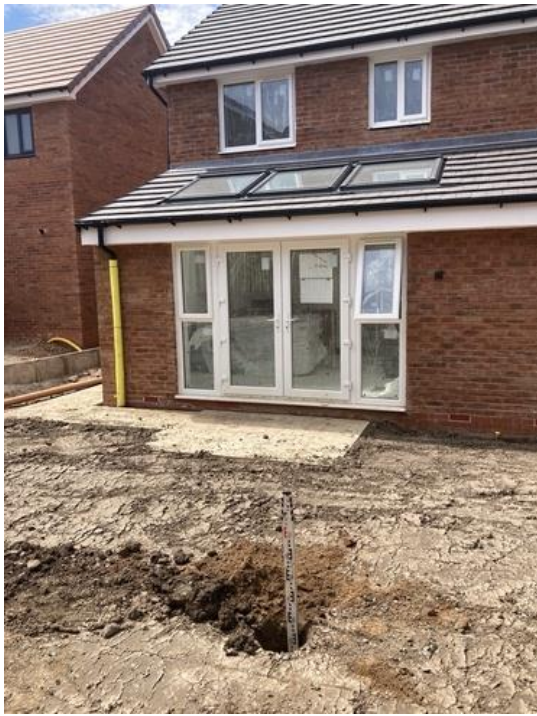
Photo 18

| Depth of Cover System in Relation to Plot (Ensure the whole plot can be seen in the photo) | | <div>✕</div> |
