## Phase II Interpretative Ground Assessment

Oldham Road Woodbine Street,  
Rochdale

Reference: 31163-SUT-ZZ-00-RP-G-702-0002

Date: September 2022

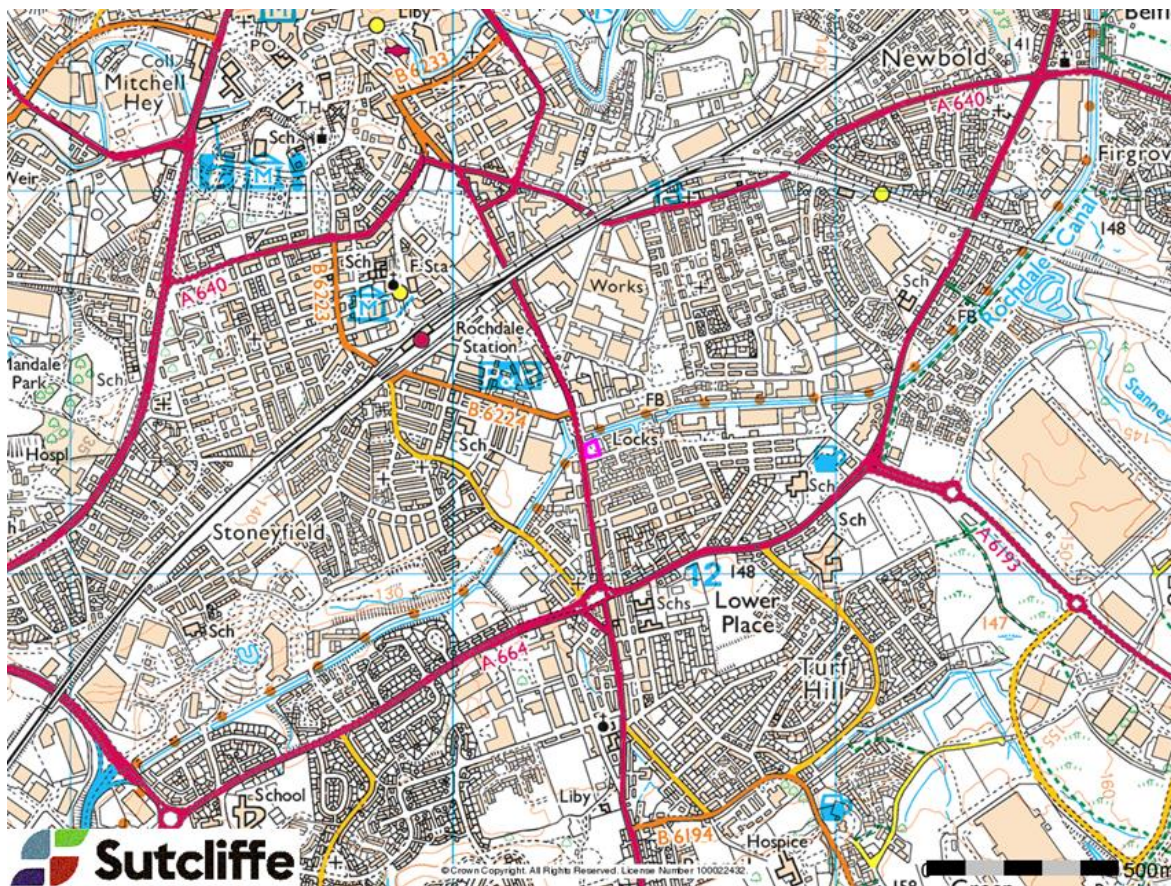
Figure 1: General Location of Site

The site is located at Oldham Road and Woodbine Street, Rochdale, OL16 5JB at National Grid Reference (NGR) 390370, 412330, with Rochdale Canal to the north west and commercial properties to the north and south.

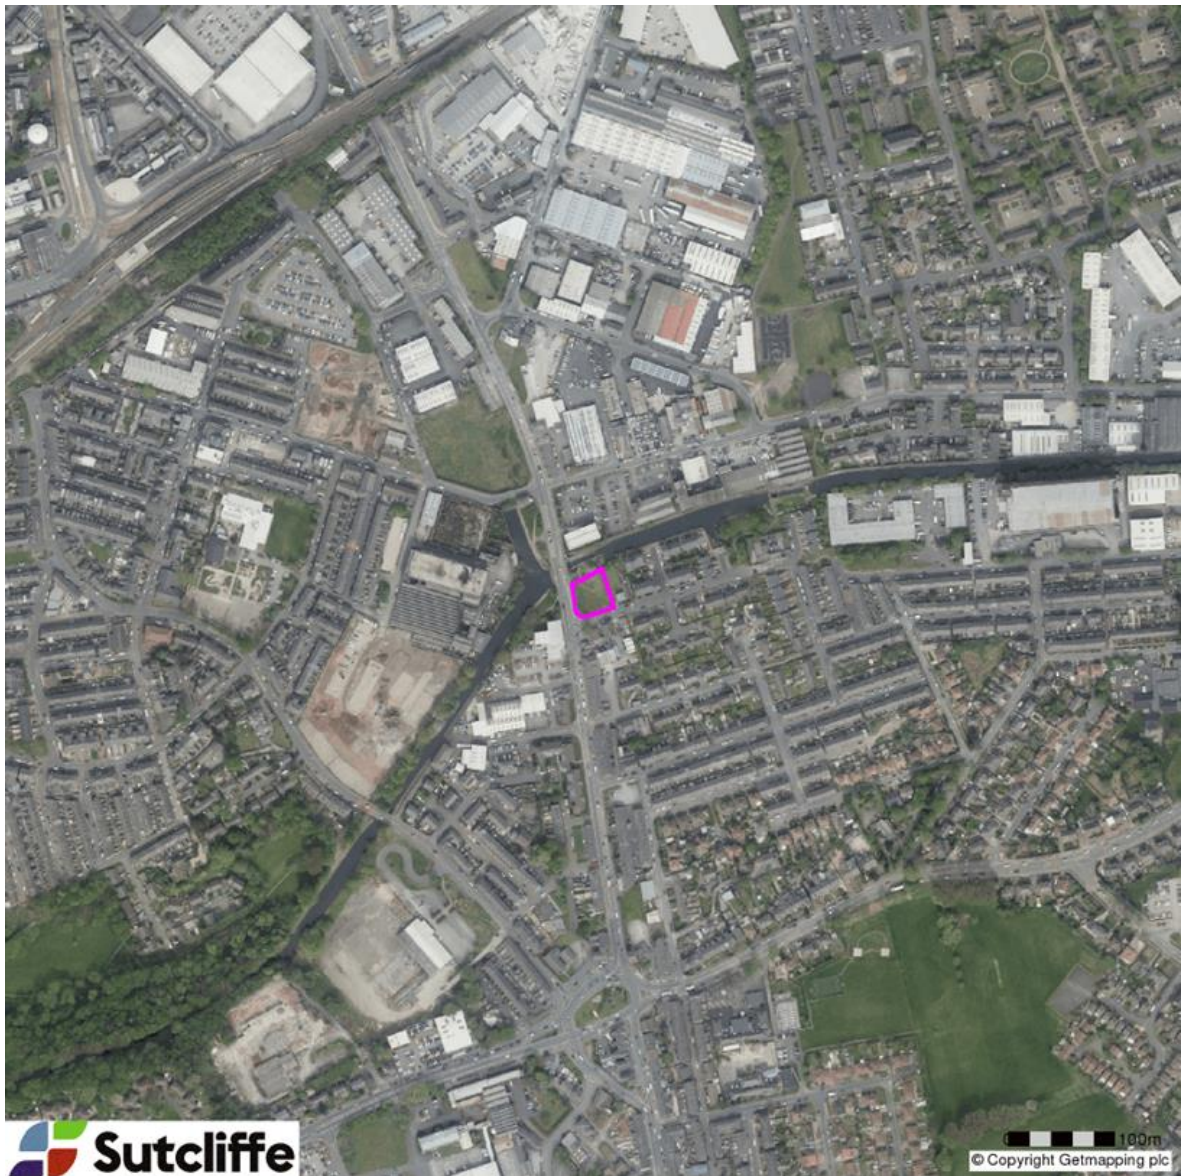
Figure 2: Aerial Photograph of the Site

The site is square in shape and can be accessed via Oldham Road to the west of the site and Woodbine Street to the south of the site. The site is a relatively flat grass area with a low wooden fence that marks the site's western and southern boundaries. Also of note is an electricity pole located in the south western corner of the site. The site is currently undeveloped.

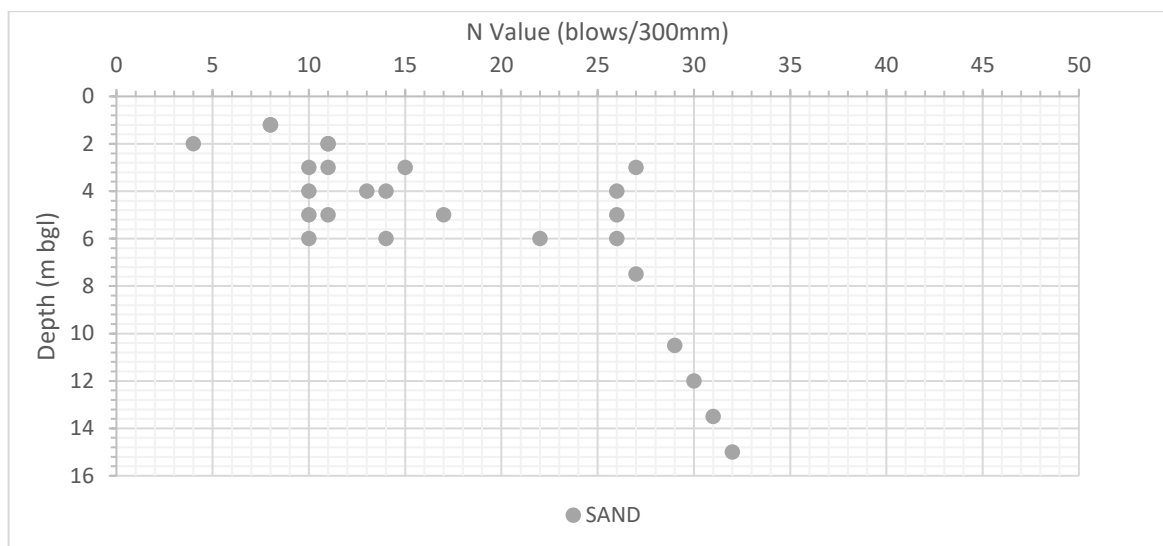
Figure 4: SPT Results

The standard penetration test (SPT) is used to provide geotechnical engineering properties for foundation design purposes. The results can be used to determine the relative density, bearing capacity, and settlement of granular soil. The results can also be used to correlate the approximate strength of cohesive soil.

| Strata | No. of Tests | Range | Average |
| SAND | 26 | 4 – 32 | 17.4 |

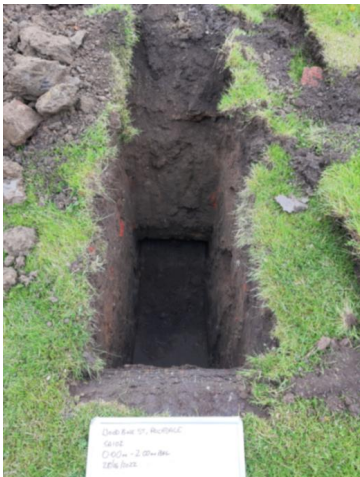
| | | | | | <div>0.90</div> <div>(1.10)</div> | <div>Brown very sandy slightly gravelly CLAY with some clayey silt pockets. Sand is fine to medium Gravel is fine subangular and of sandstone</div> | <div></div> | | | | |
| | | | | | <div>2.00</div> | <div>Complete at 2.00m</div> | | | | | |

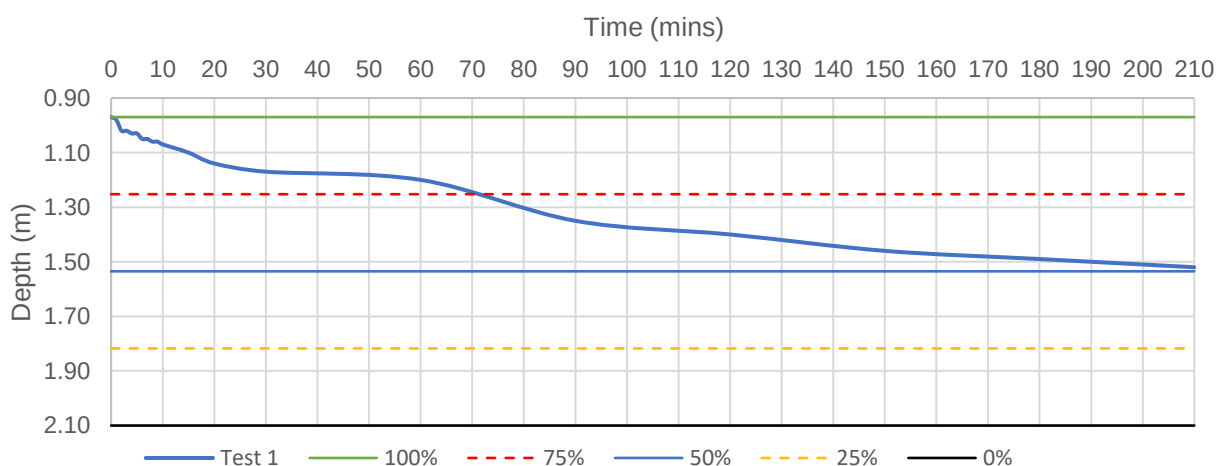
| <b>Soil Infiltration Rate</b> | = | $V_{p75-25} / (a_{p50} * t_{p75-25} * 60)$ | | | | |

2No. infiltration tests (SA101 & SA102) were carried out on site.

The test results did not provide an infiltration rate due to the inefficiencies of the ground to infiltrate. Infiltration testing has been undertaken and failed; therefore, alternative drainage solutions will be required.

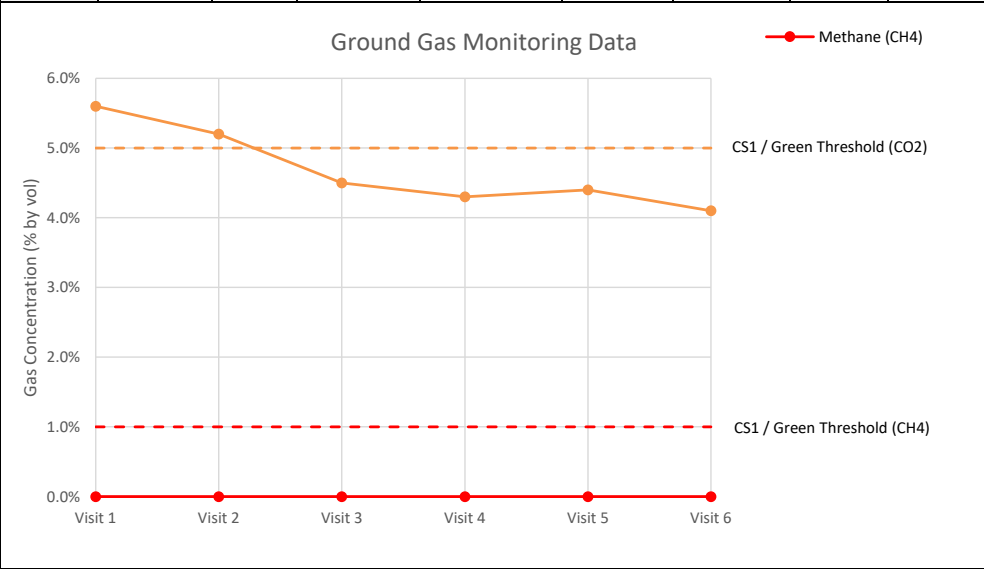
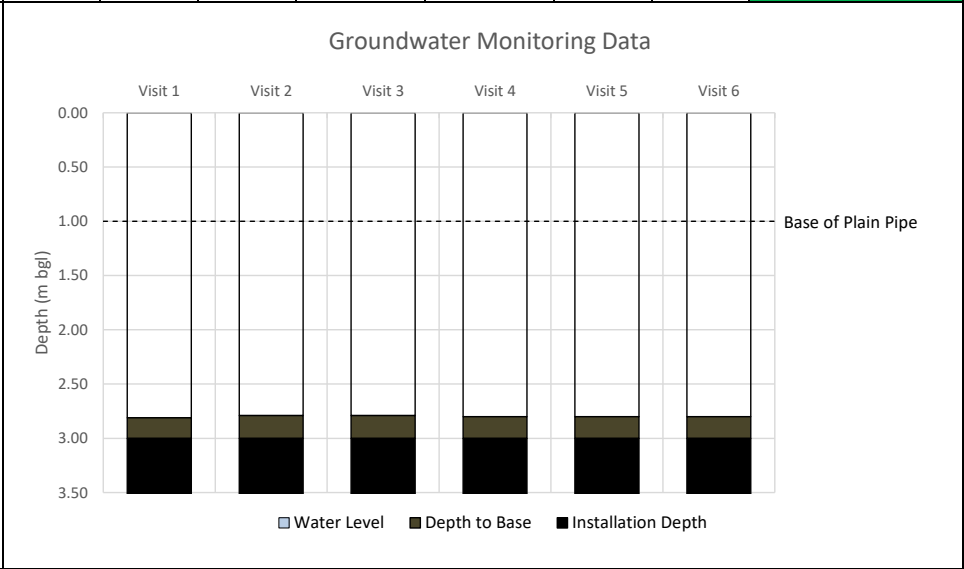
<sup>1</sup> Hazardous Gas Flow Rate Assessment Methodology (HGFR).

<sup>2</sup> Where maximum recorded flow is <0.1l/h, 0.1l/h has been used to calculate HGFR as recommended in CIRIA C665.

<sup>3</sup> Where maximum recorded concentration is <0.1%, 0.1% has been used as recommended in BS8485.

\* Peak flow recorded is likely to be due to a build-up of hydrolic pressure caused by rising water trapping the gas within the solid section of pipe; the initial peak flow is not representative of the rate of gas generation within the ground and can be discounted from the

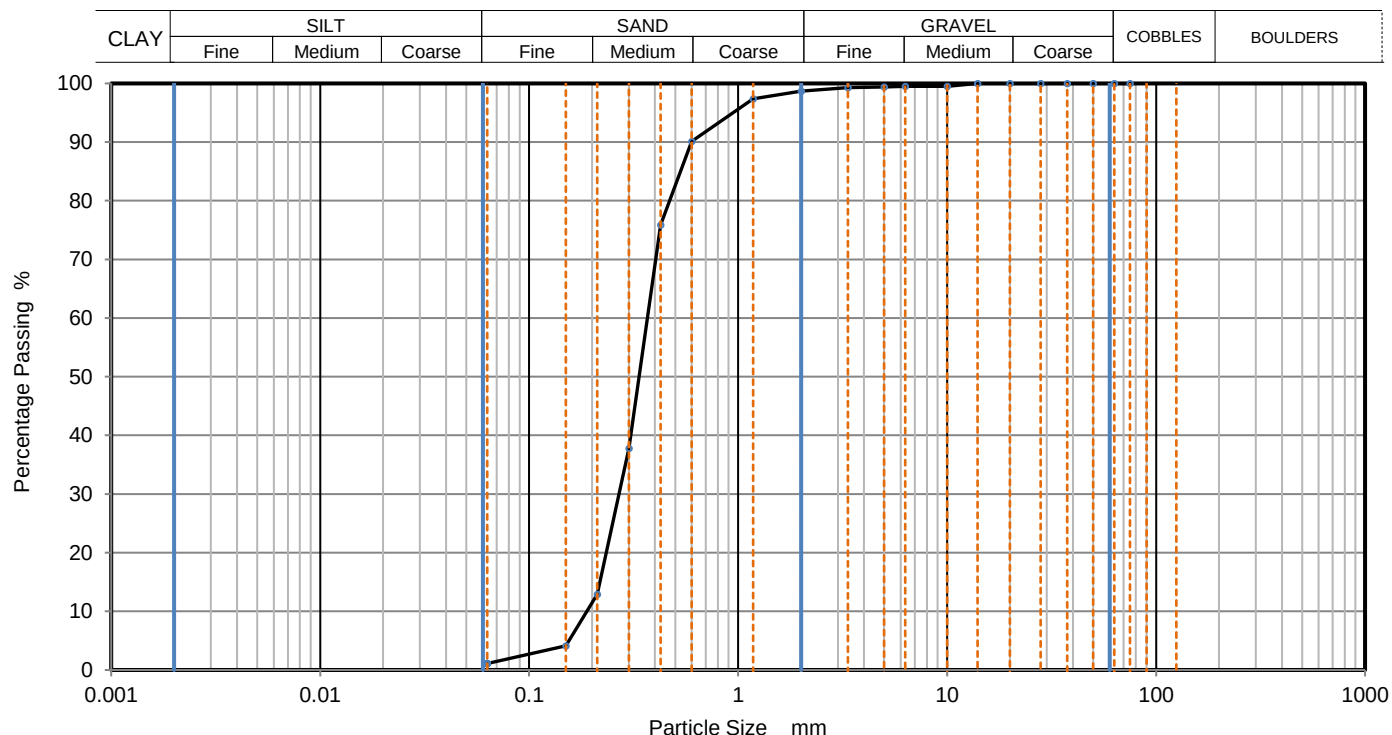
| Sieving | | Sedimentation | |
| Particle Size mm | % Passing | Particle Size mm | % Passing |

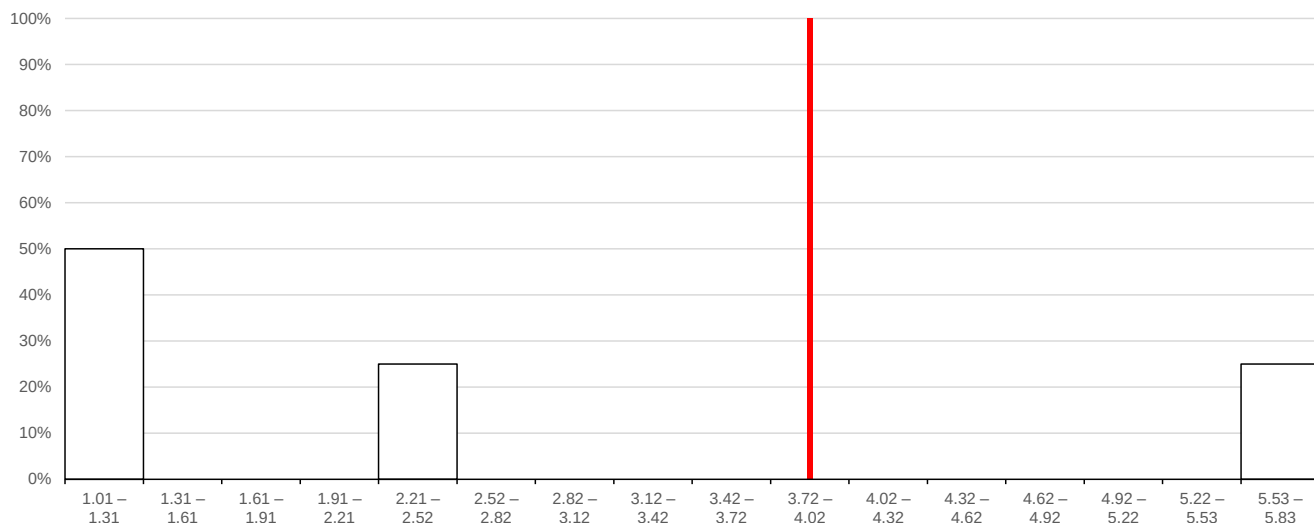
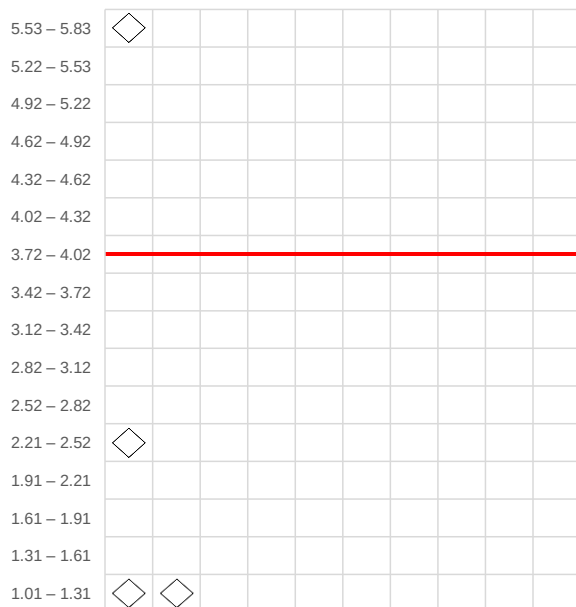
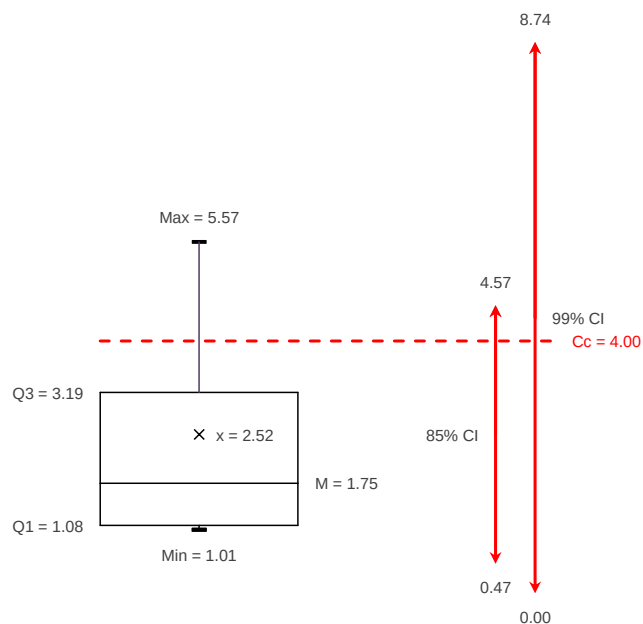
| <b>Maximum (Max):</b> | 5.57 | <b>Critical Concentration (Cc):</b> | 4.00 |
| <b>Upper Quartile (Q3):</b> | 3.19 | <b>Mean (x):</b> | 2.52 |

Sutcliffe are 85% confident that the true mean concentration ( $\mu$ ) for benzo(b)fluoranthene lies between 0.47mg/kg and 4.57mg/kg.  
 Sutcliffe are 99% confident that the true mean concentration ( $\mu$ ) for benzo(b)fluoranthene does not lie outside of 0.00mg/kg and 8.74mg/kg.  
 The Critical Concentration (Cc) for benzo(b)fluoranthene under a 6.0% S.O.M. Residential Without Plant Uptake end use is 4.00mg/kg.

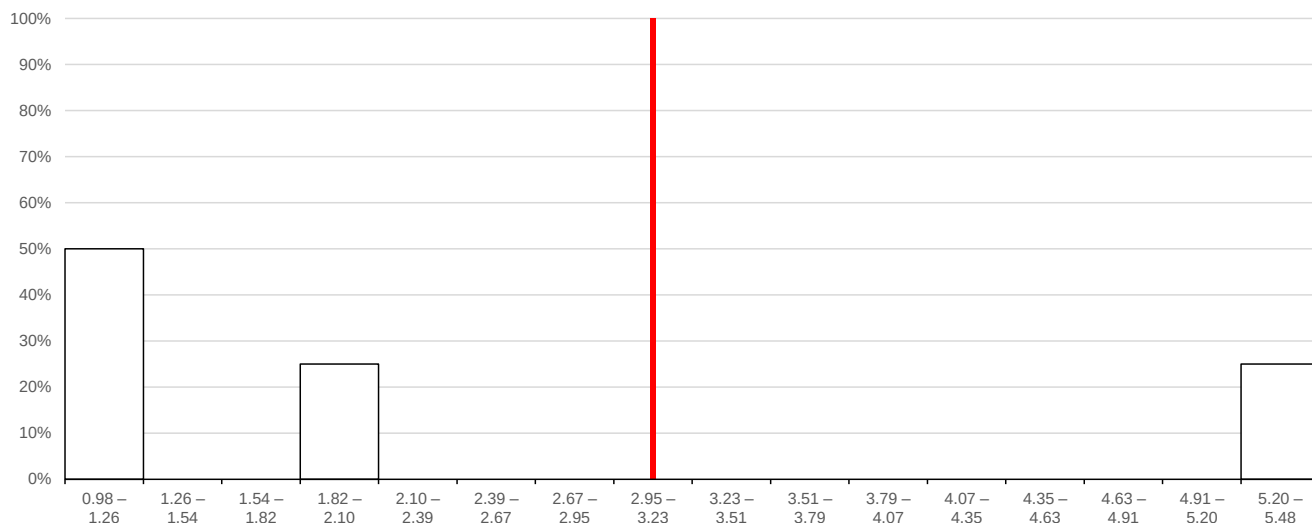
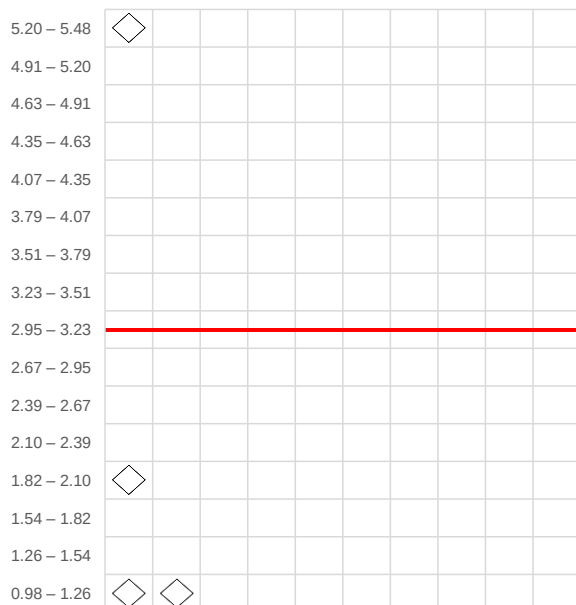
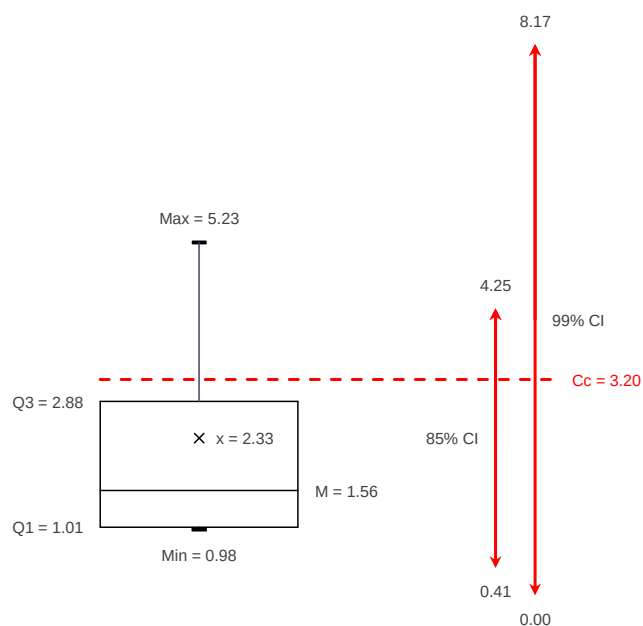
| <b>Maximum (Max):</b> | 5.23 | <b>Critical Concentration (Cc):</b> | 3.20 |
| <b>Upper Quartile (Q3):</b> | 2.88 | <b>Mean (x):</b> | 2.33 |

Sutcliffe are 85% confident that the true mean concentration ( $\mu$ ) for benzo(a)pyrene lies between 0.41mg/kg and 4.25mg/kg.  
 Sutcliffe are 99% confident that the true mean concentration ( $\mu$ ) for benzo(a)pyrene does not lie outside of 0.00mg/kg and 8.17mg/kg.  
 The Critical Concentration (Cc) for benzo(a)pyrene under a 6.0% S.O.M. Residential Without Plant Uptake end use is 3.20mg/kg.

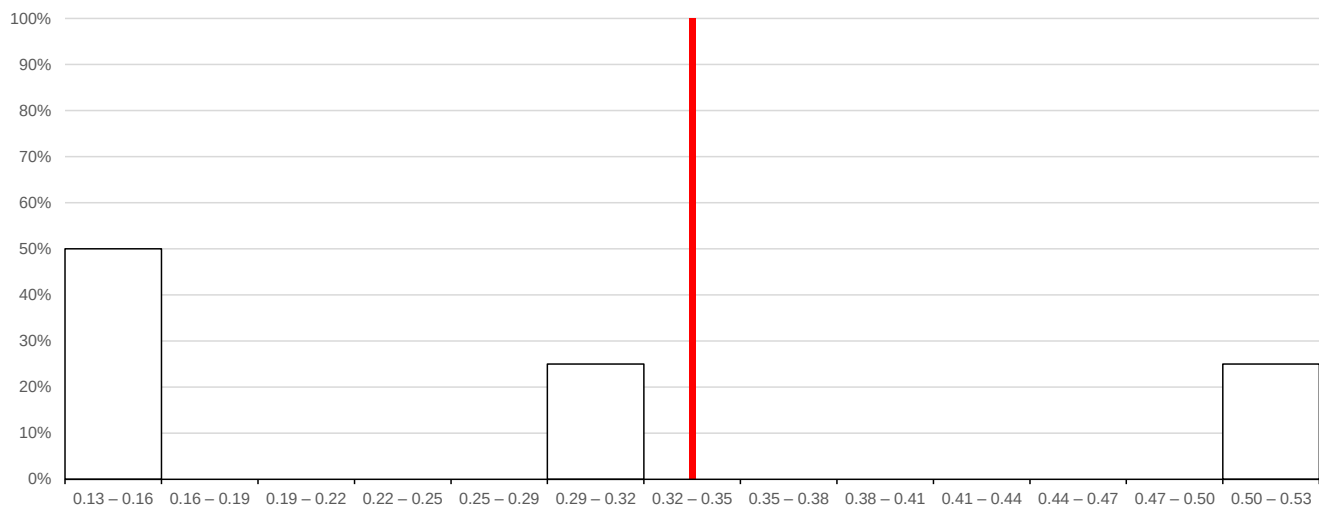
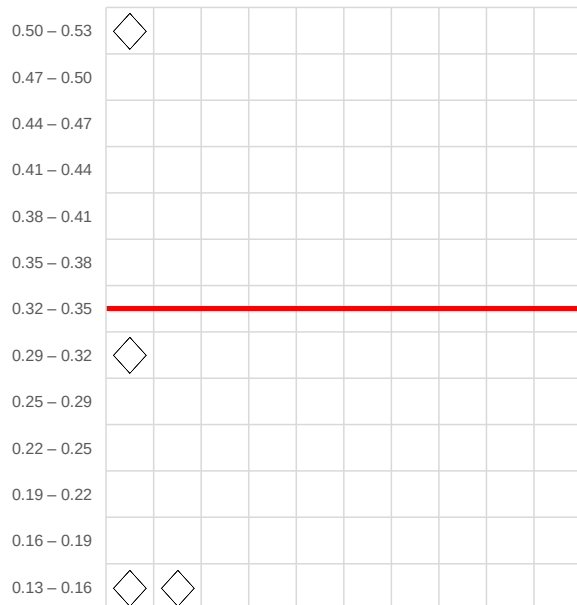
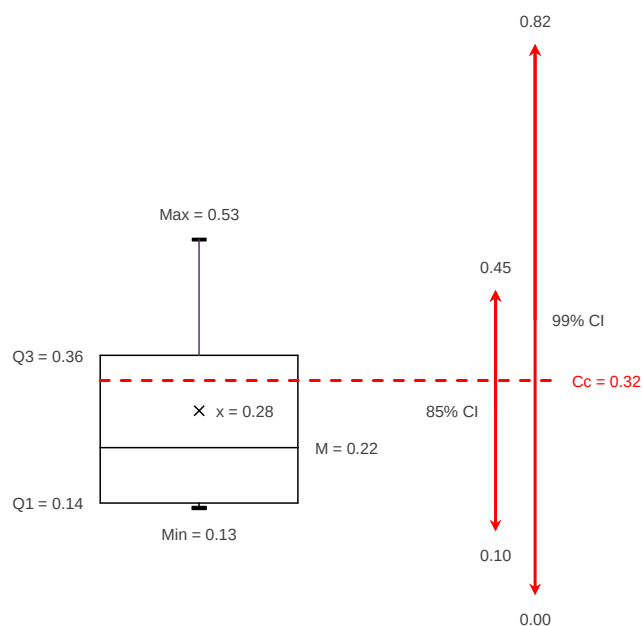
| Maximum (Max): | 0.53 | Critical Concentration (Cc): | 0.32 |
| Upper Quartile (Q3): | 0.36 | Mean (x): | 0.28 |

Sutcliffe are 85% confident that the true mean concentration ( $\mu$ ) for dibenzo(ah)anthracene lies between 0.10mg/kg and 0.45mg/kg.

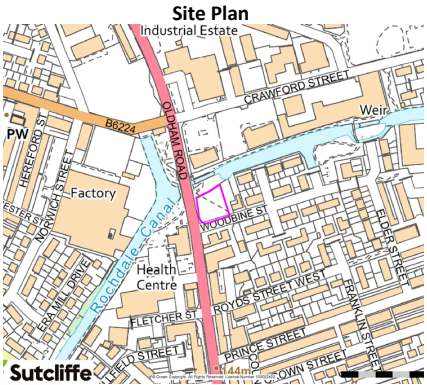
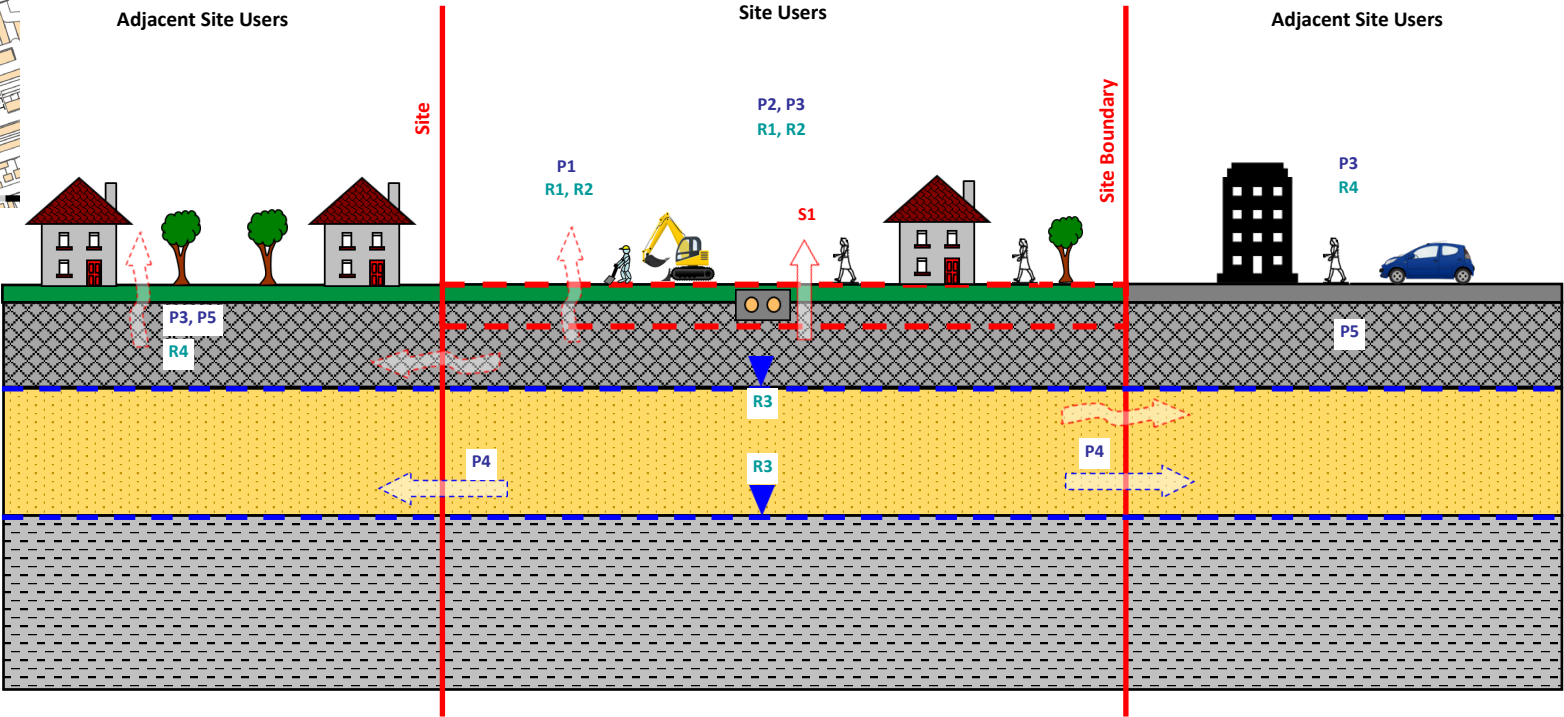
## Figure 3 – Preliminary Conceptual Site Model

Preliminary Conceptual Site Model (CSM)

| Stratum | Aquifer |
| MADE GROUND | N/A |
| GLACIOFLUVIAL DEPOSITS, DEVENSIAN | SECONDARY A |
| OLD LAWRENCE ROCK / PENNINE LOWER COAL MEASURES | SECONDARY A |

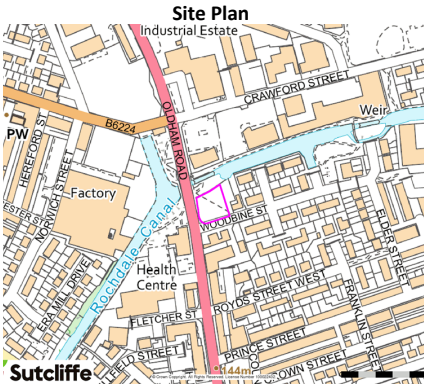
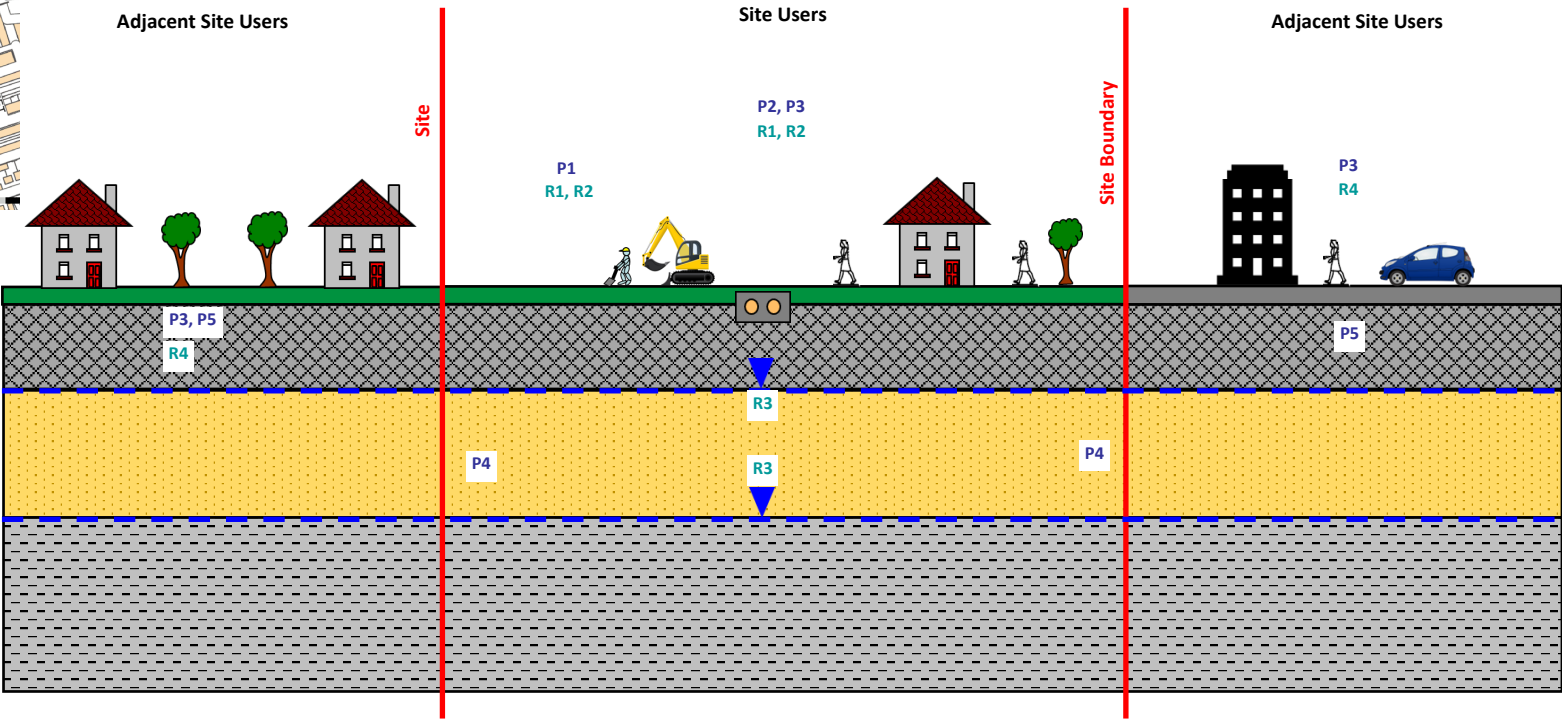
## Figure 7 – Revised Conceptual Site Model

Revised Conceptual Site Model (CSM)

| Stratum | Aquifer |
| MADE GROUND | N/A |
| GLACIOFLUVIAL DEPOSITS, DEVENSIAN | SECONDARY A |
| OLD LAWRENCE ROCK / PENNINE LOWER COAL MEASURES | SECONDARY A |

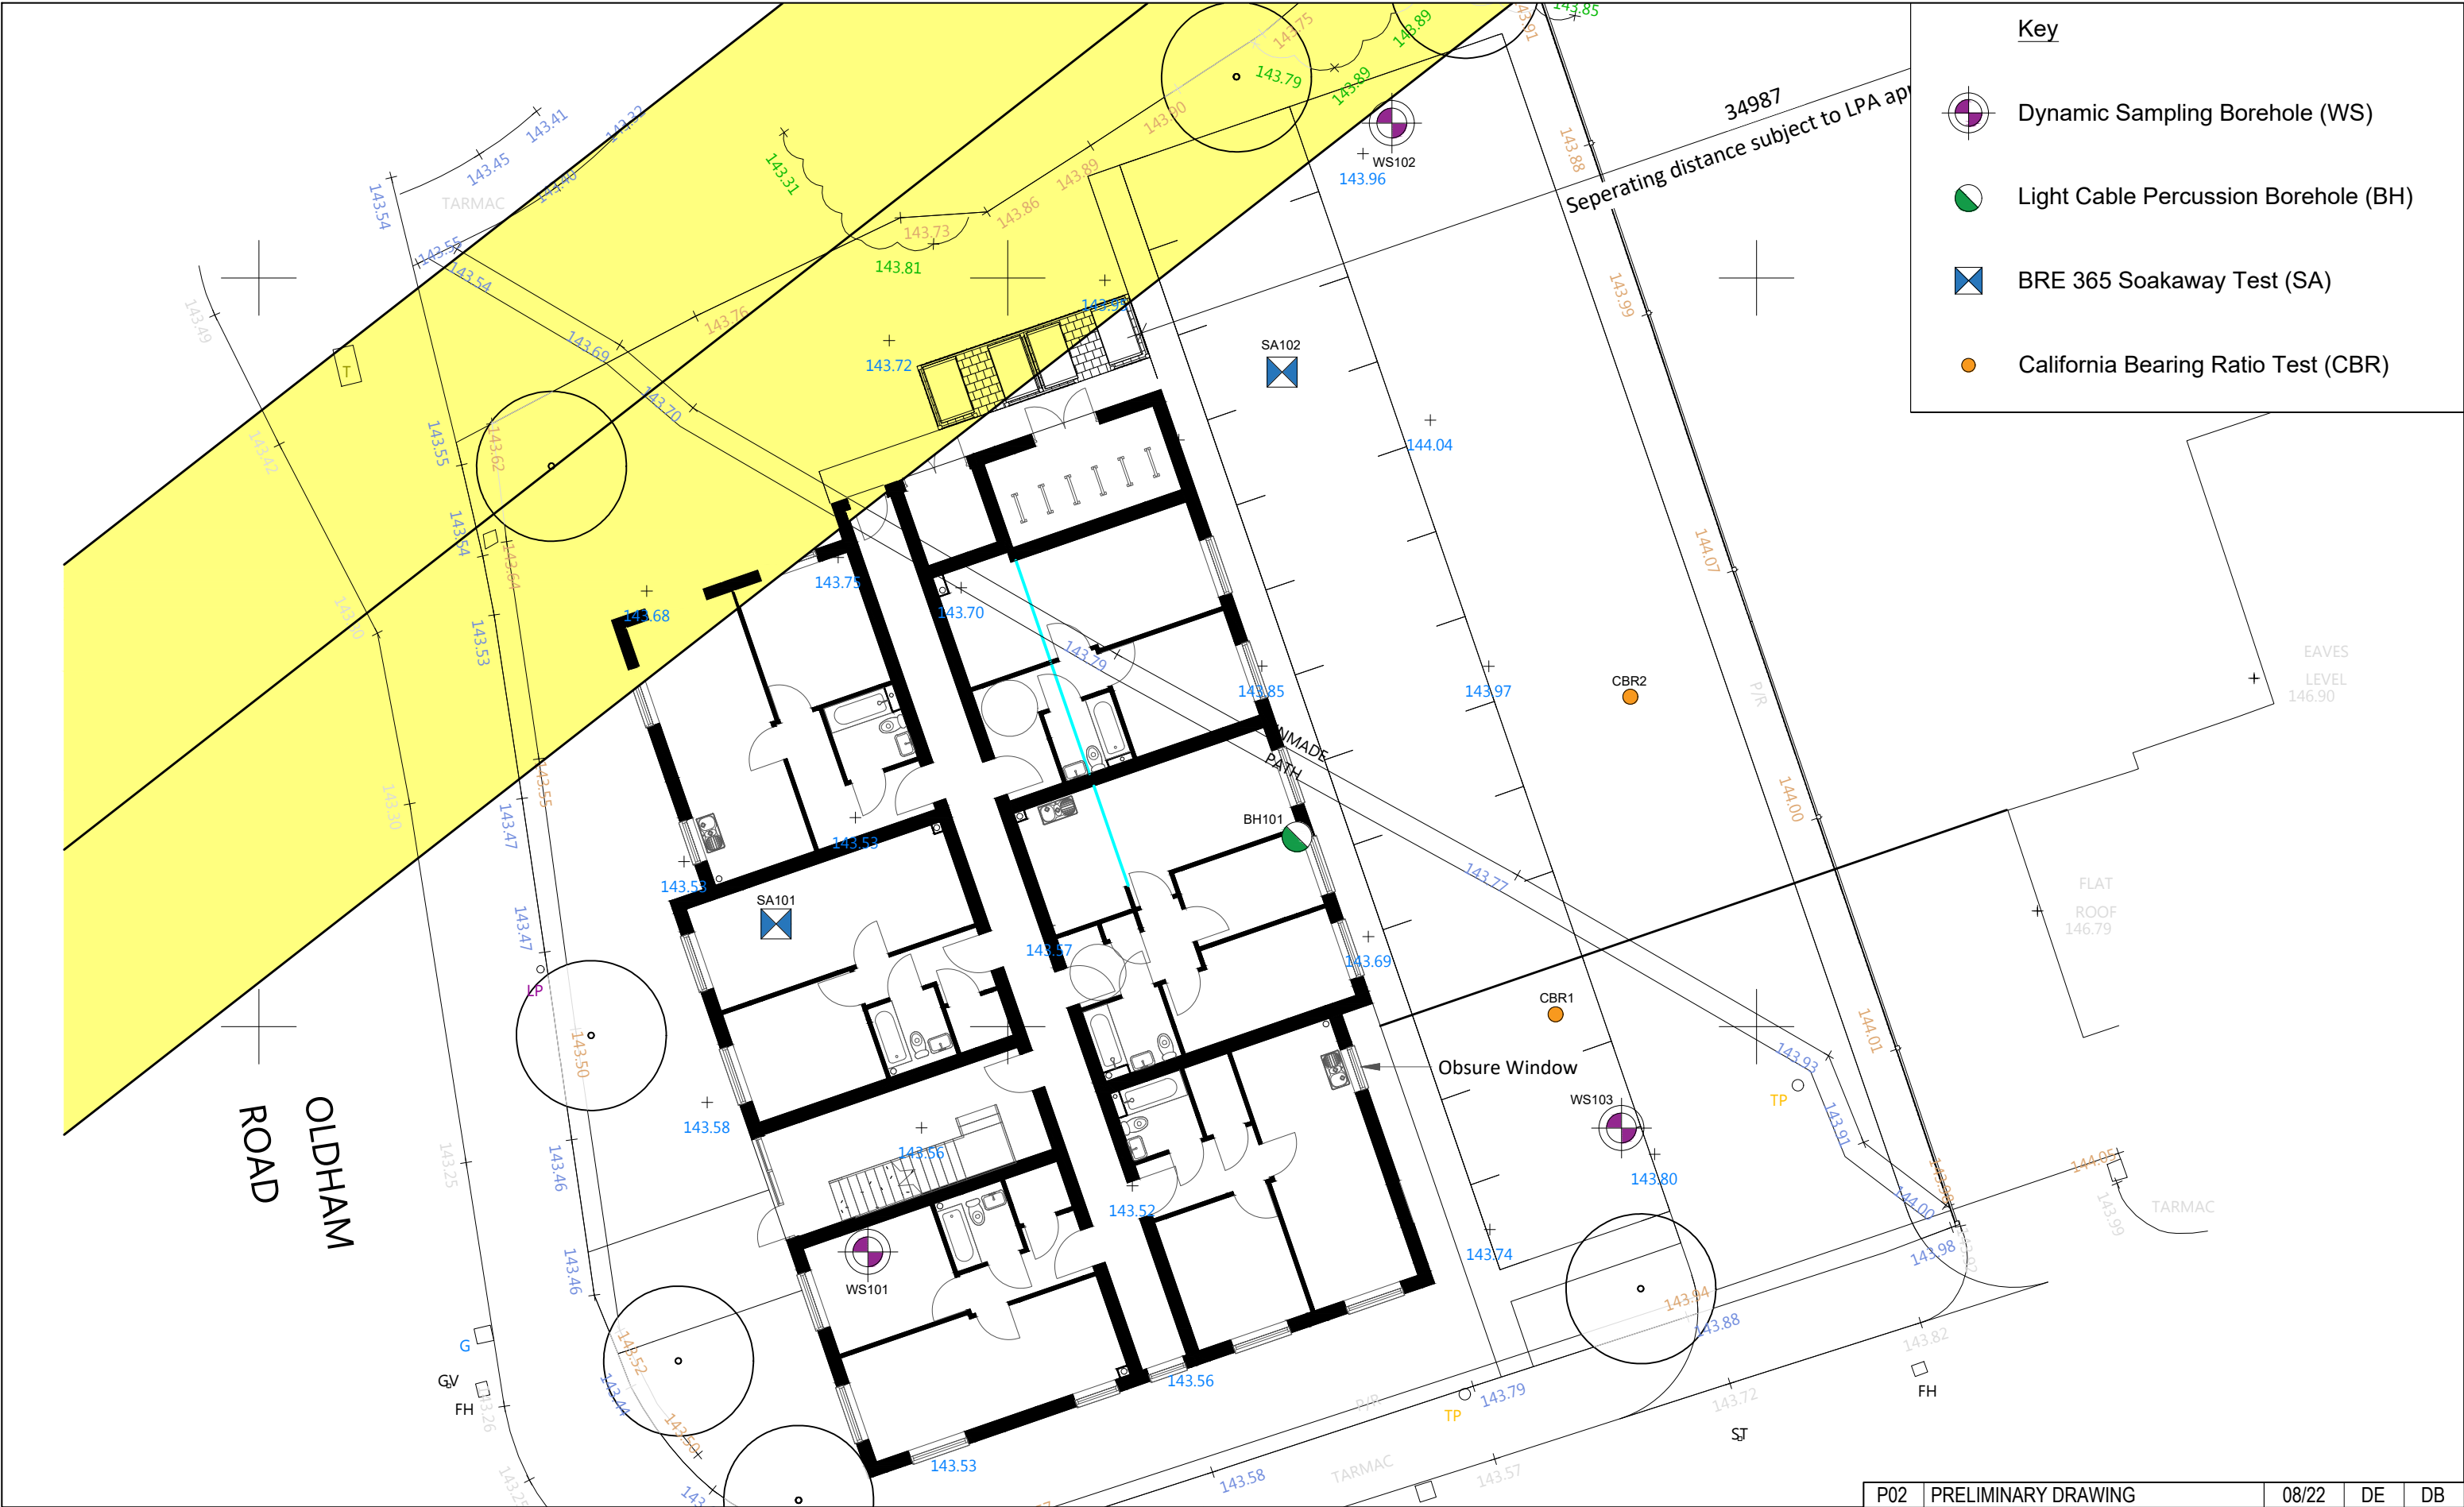
**Drawing Ref: 31163-SUT-ZZ-00-DR-G-720-0002 (Site Investigation on Proposed Layout)**

Dynamic Sampling Borehole (WS)
