**Rochdale Town Hall  
Restoration and Transformation**

**Mammal Excavation  
Precautionary Working  
Method Statement**

**October 2022**

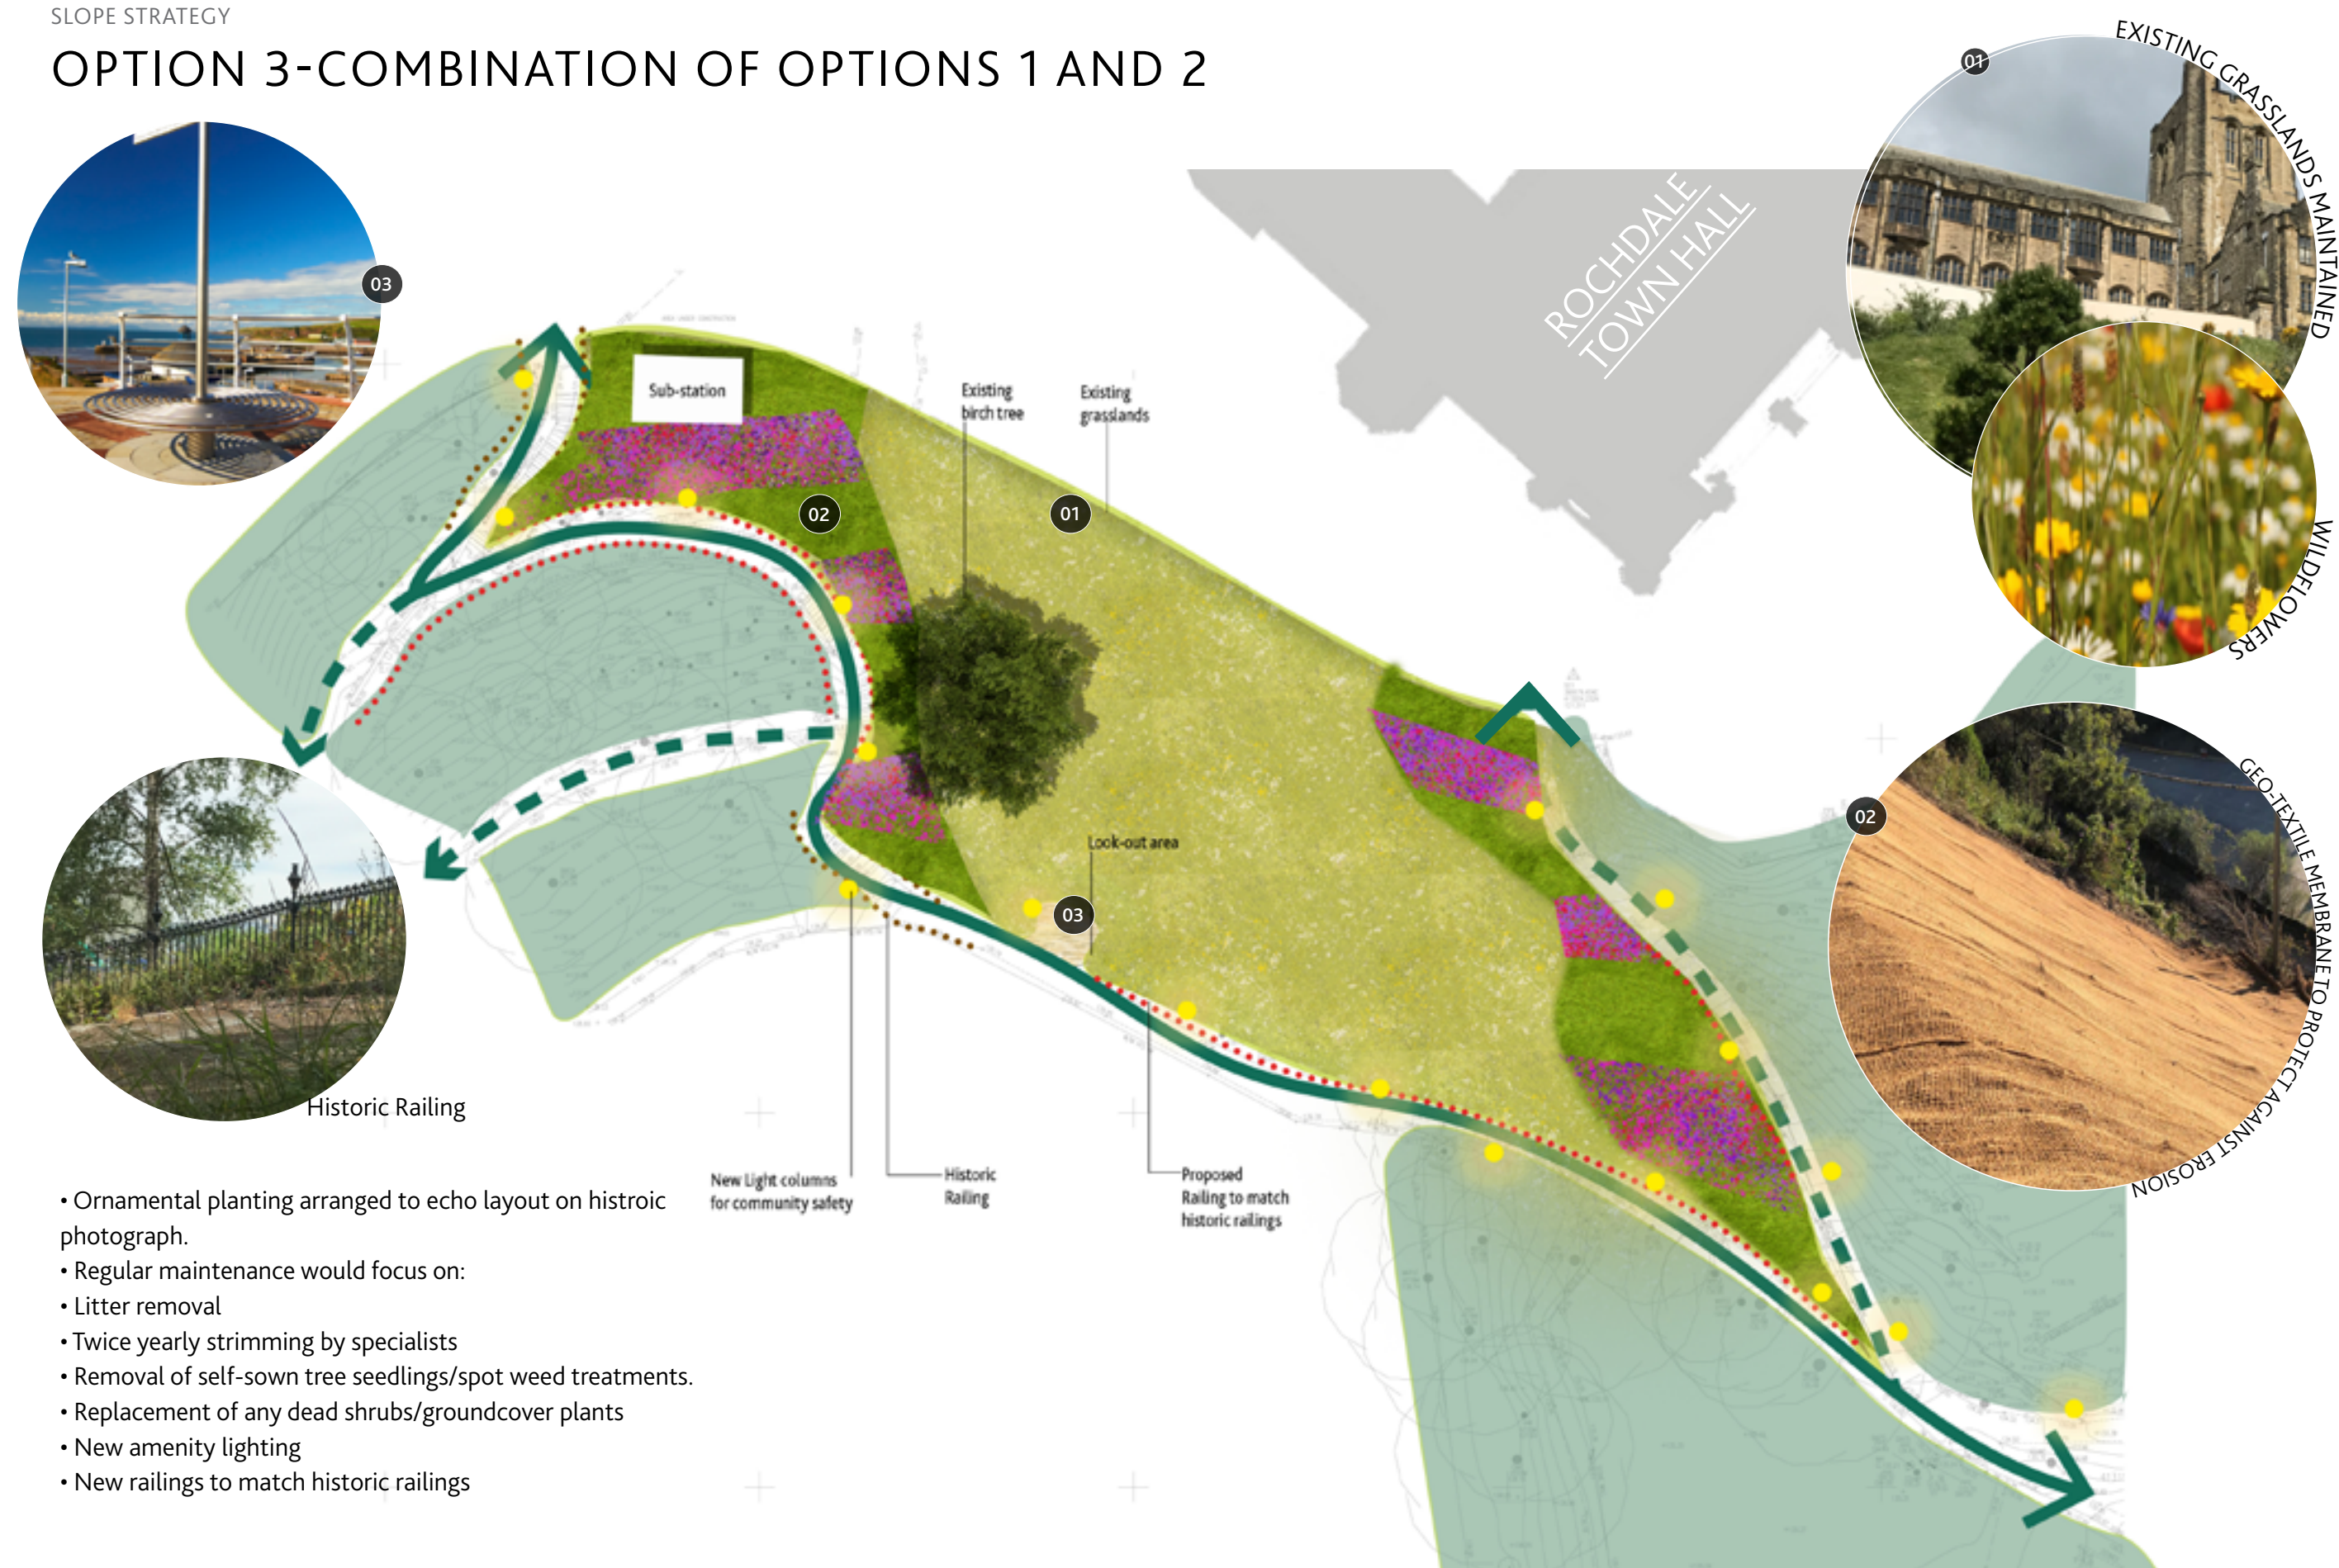
OPTION 3-COMBINATION OF OPTIONS 1 AND 2

- Ornamental planting arranged to echo layout on historic photograph.
- Regular maintenance would focus on:
  - Litter removal
  - Twice yearly strimming by specialists
  - Removal of self-sown tree seedlings/spot weed treatments.
  - Replacement of any dead shrubs/groundcover plants
- New amenity lighting
- New railings to match historic railings

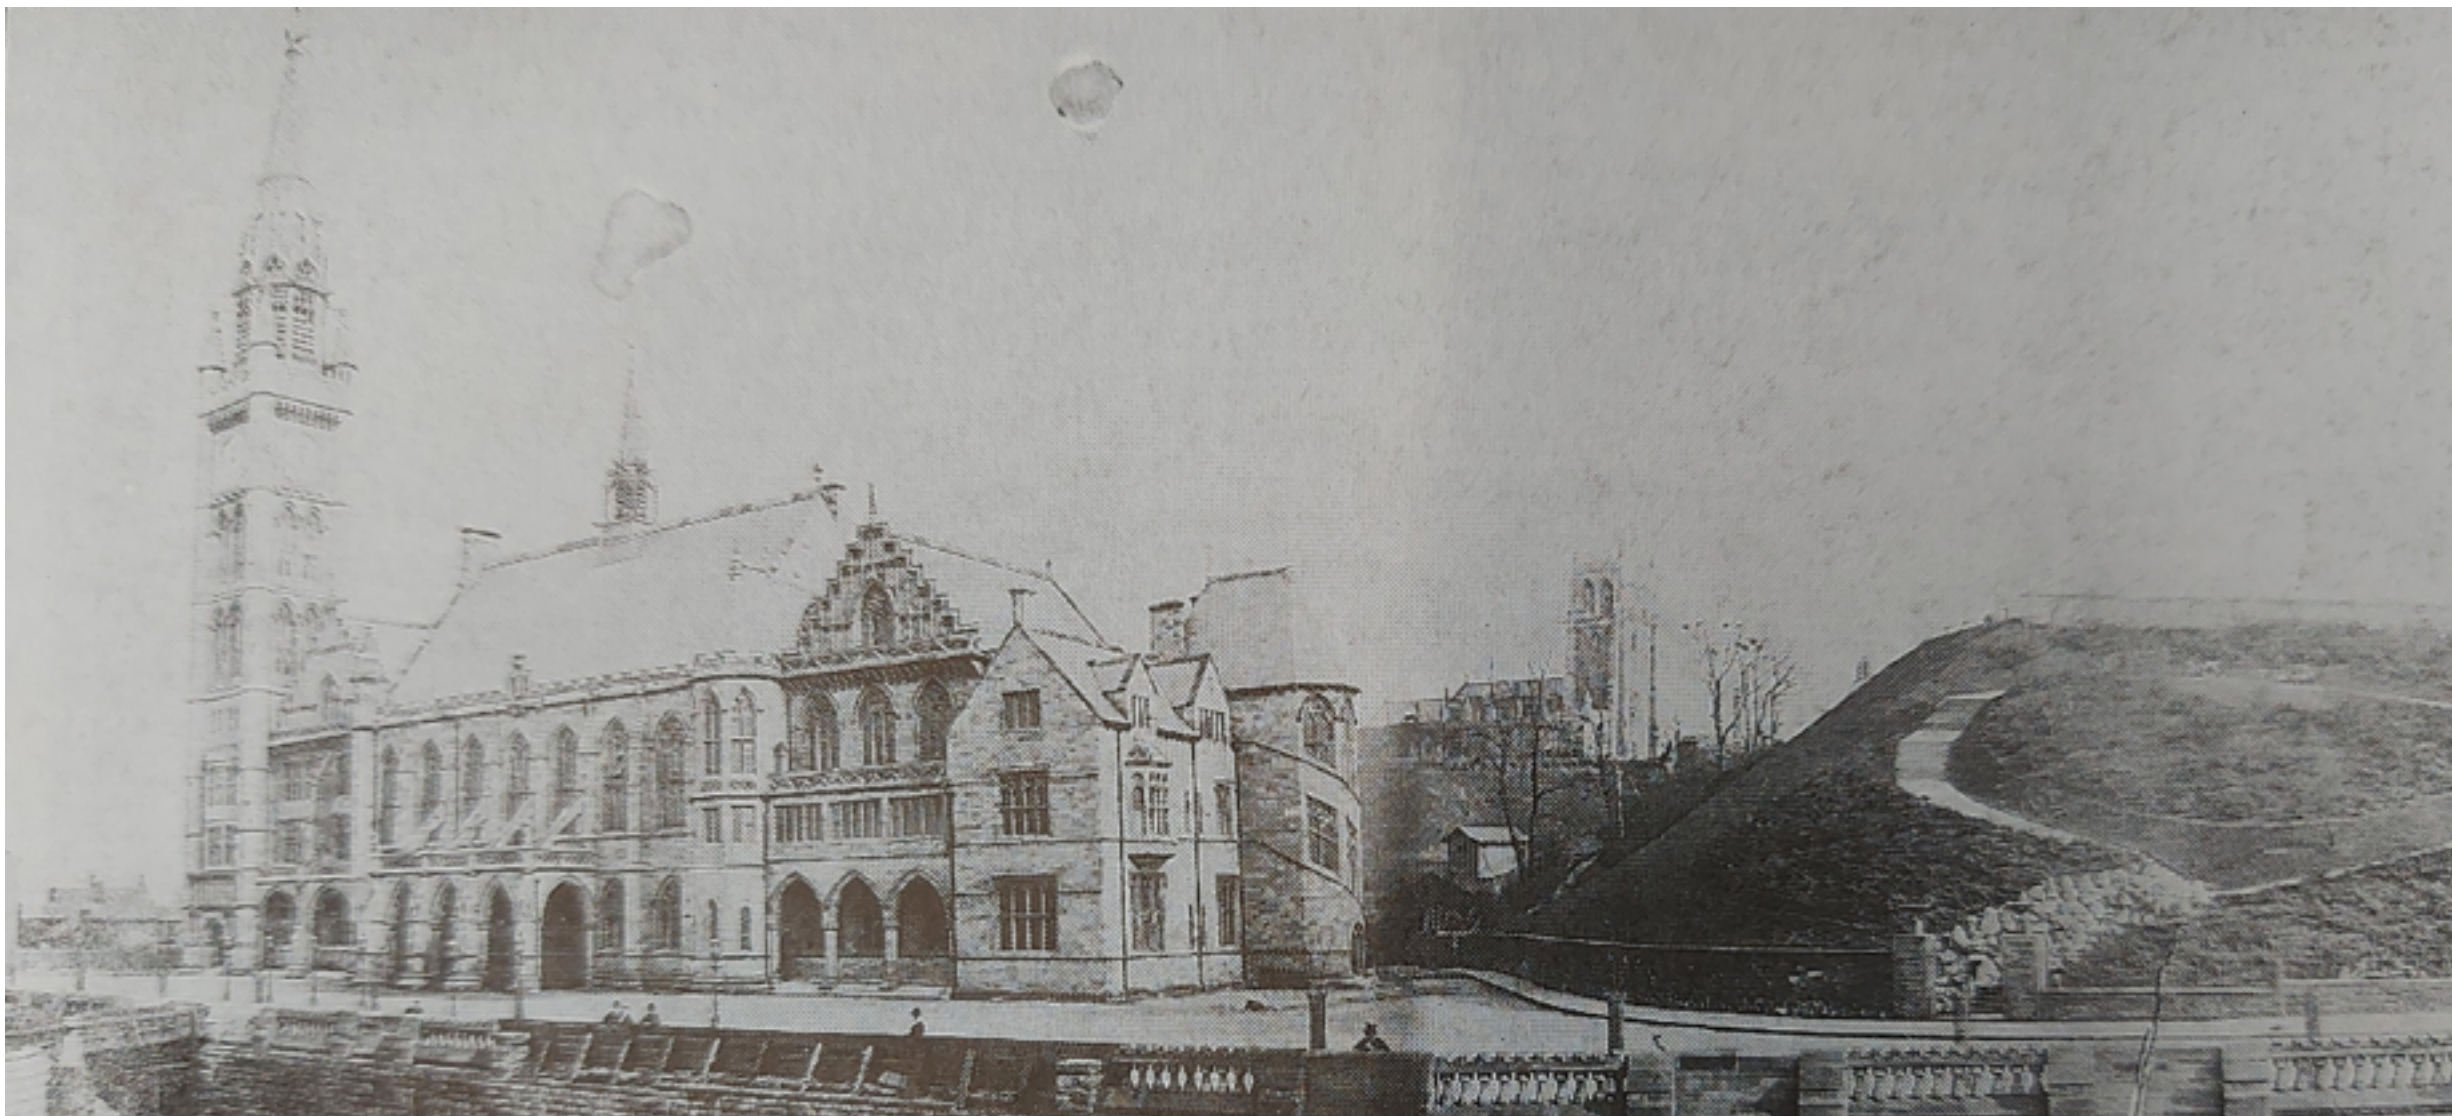
HISTORIC IMAGE SHOWING VIEW OF PLANTING ON SLOPES

- 1.2 As part of the Rochdale Town Hall Restoration and Transformation project the slopes are being restored. The self-seeded trees and scrub obscure the key view to the parish church of St Chads, provide a screen for antisocial behaviour and damage the historic drainage system below.
- 1.3 An application was granted by Rochdale Council for the removal of 56 trees within Rochdale Town Centre Conservation Area. The trees and scrub was cleared. The next stage is for the existing grassland to be maintained and enhanced and new ornamental planting to reflect the layouts on historic photographs. Refer to Appendix A for slope strategy.
