# ARBORICULTURAL IMPLICATIONS ASSESSMENT

PROPOSED DEVELOPMENT

LAND AT WEST STREET  
ROCHDALE

Author: C. Salisbury  
Date: 31 July 2022  
Ref: TRE/WSR

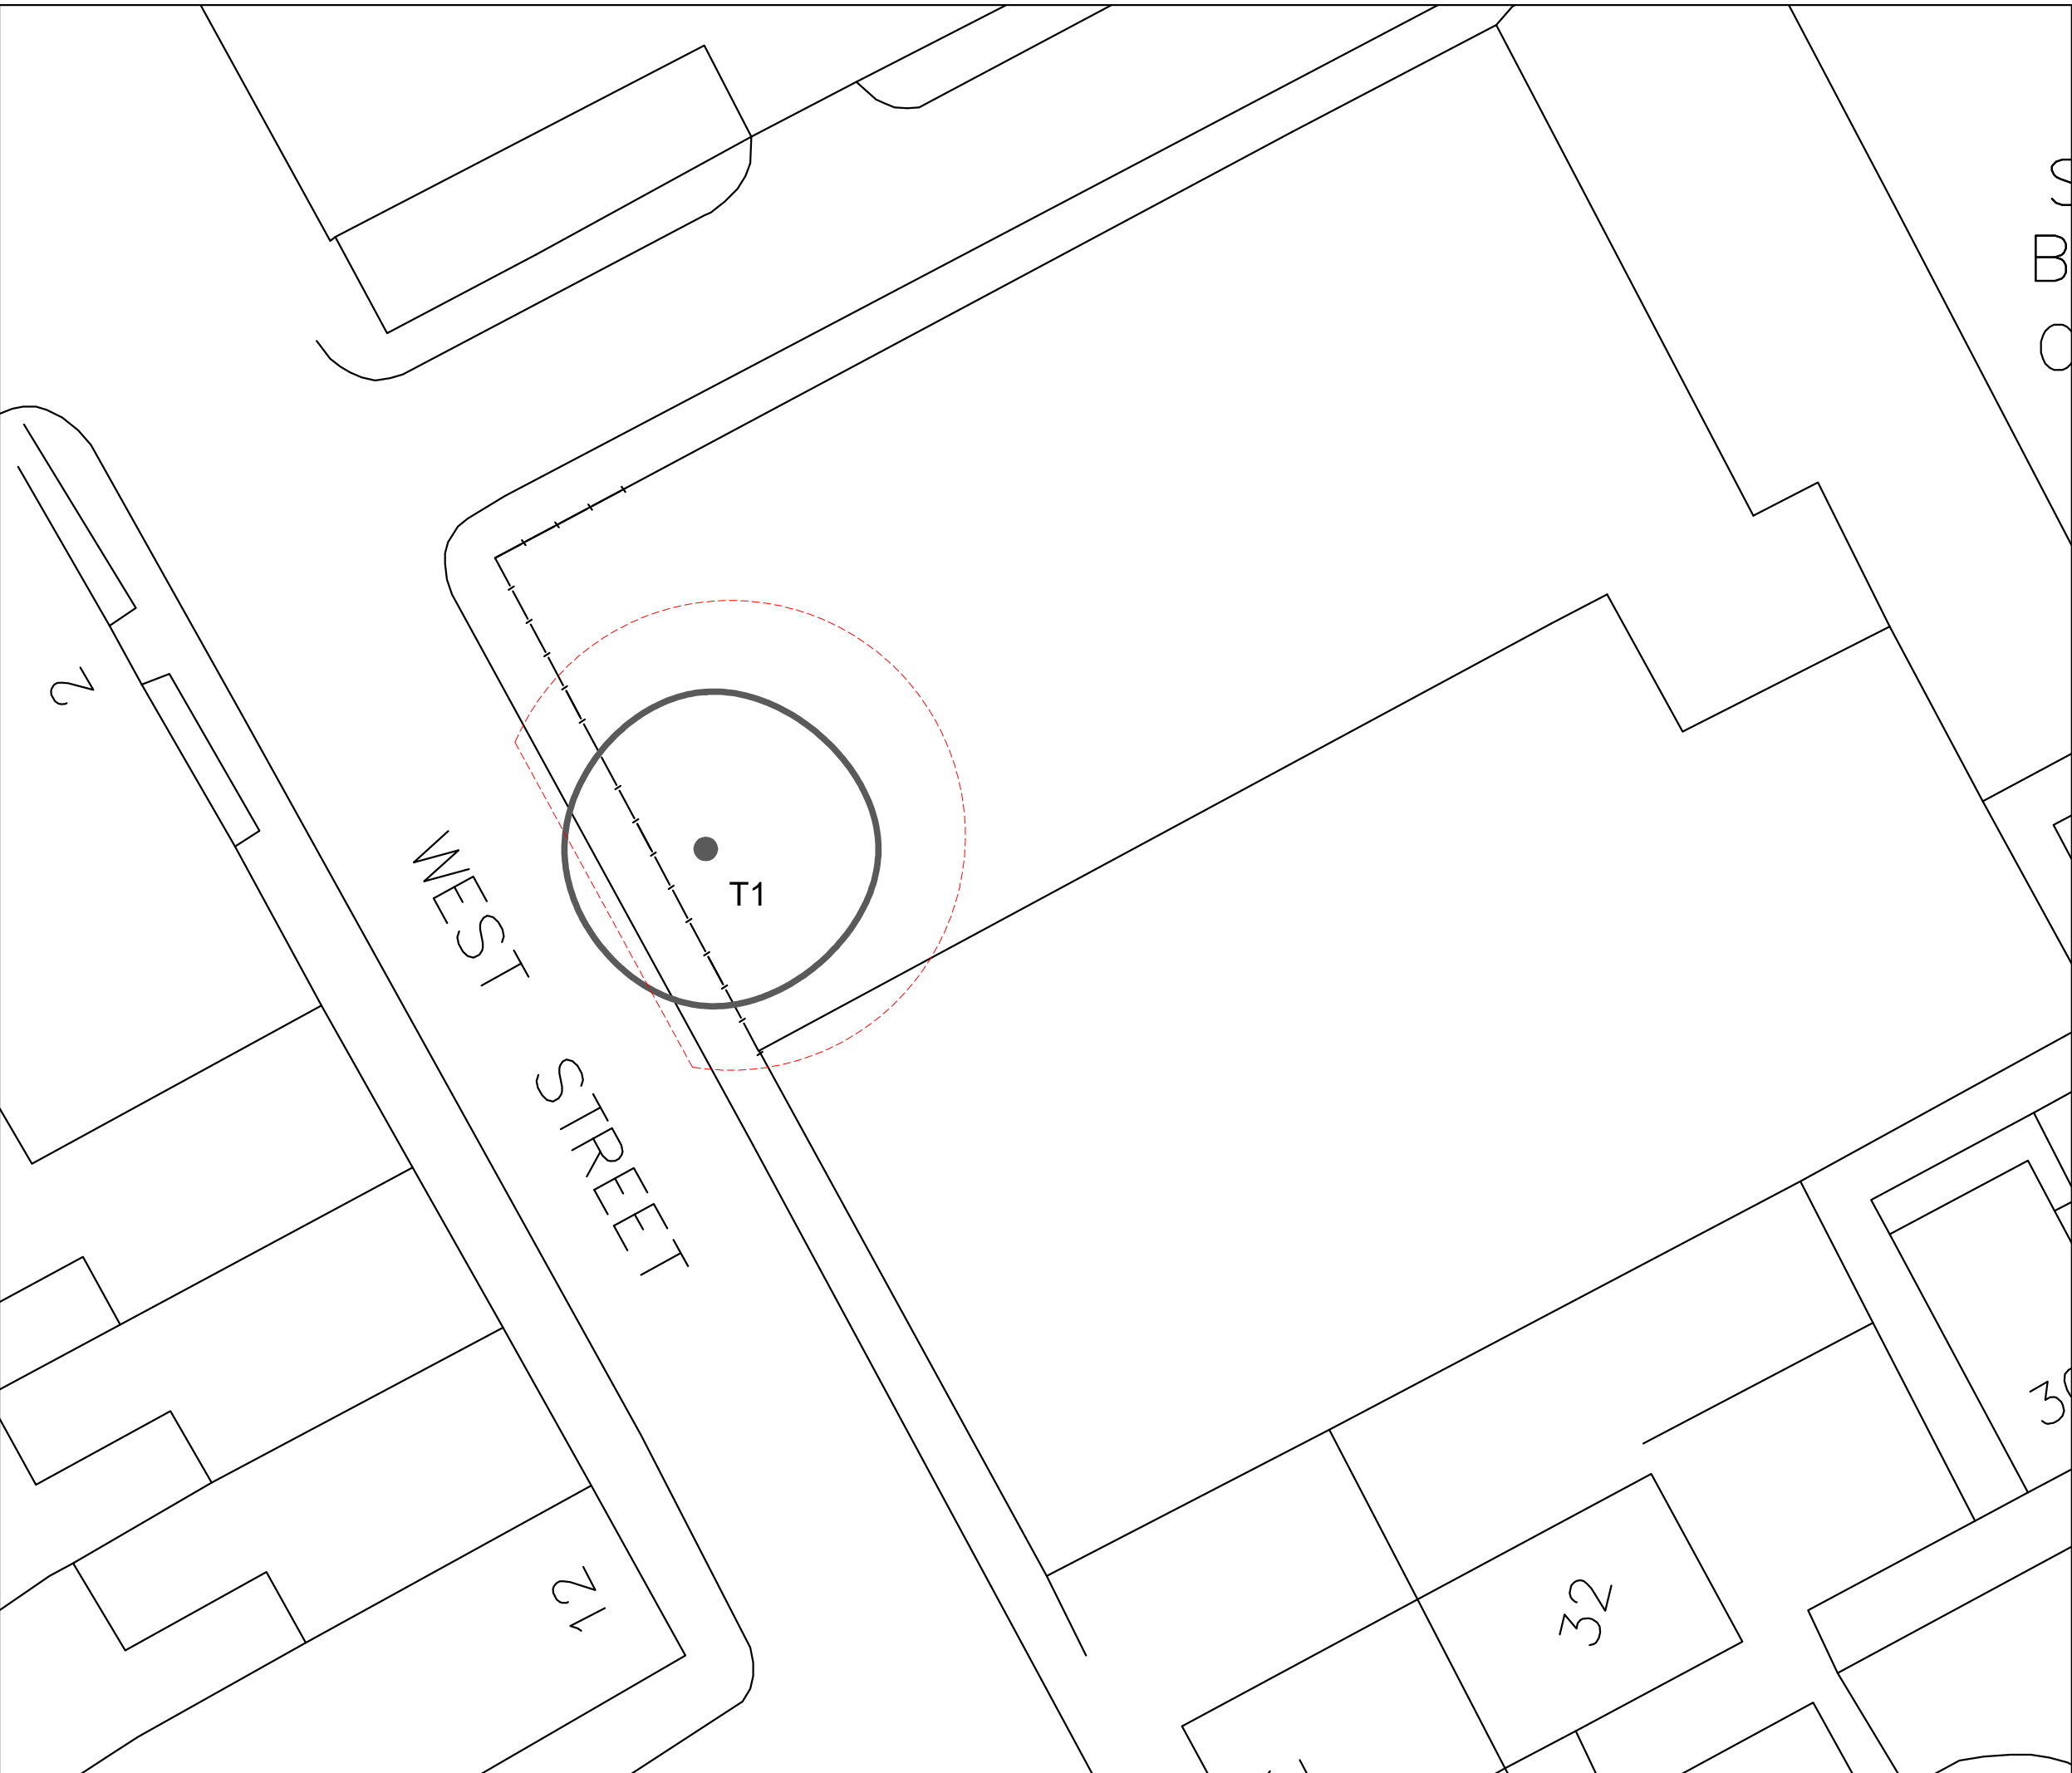
Drawing No:  
WSR/BS/01

Drawing Title:  
BS5837 Plan

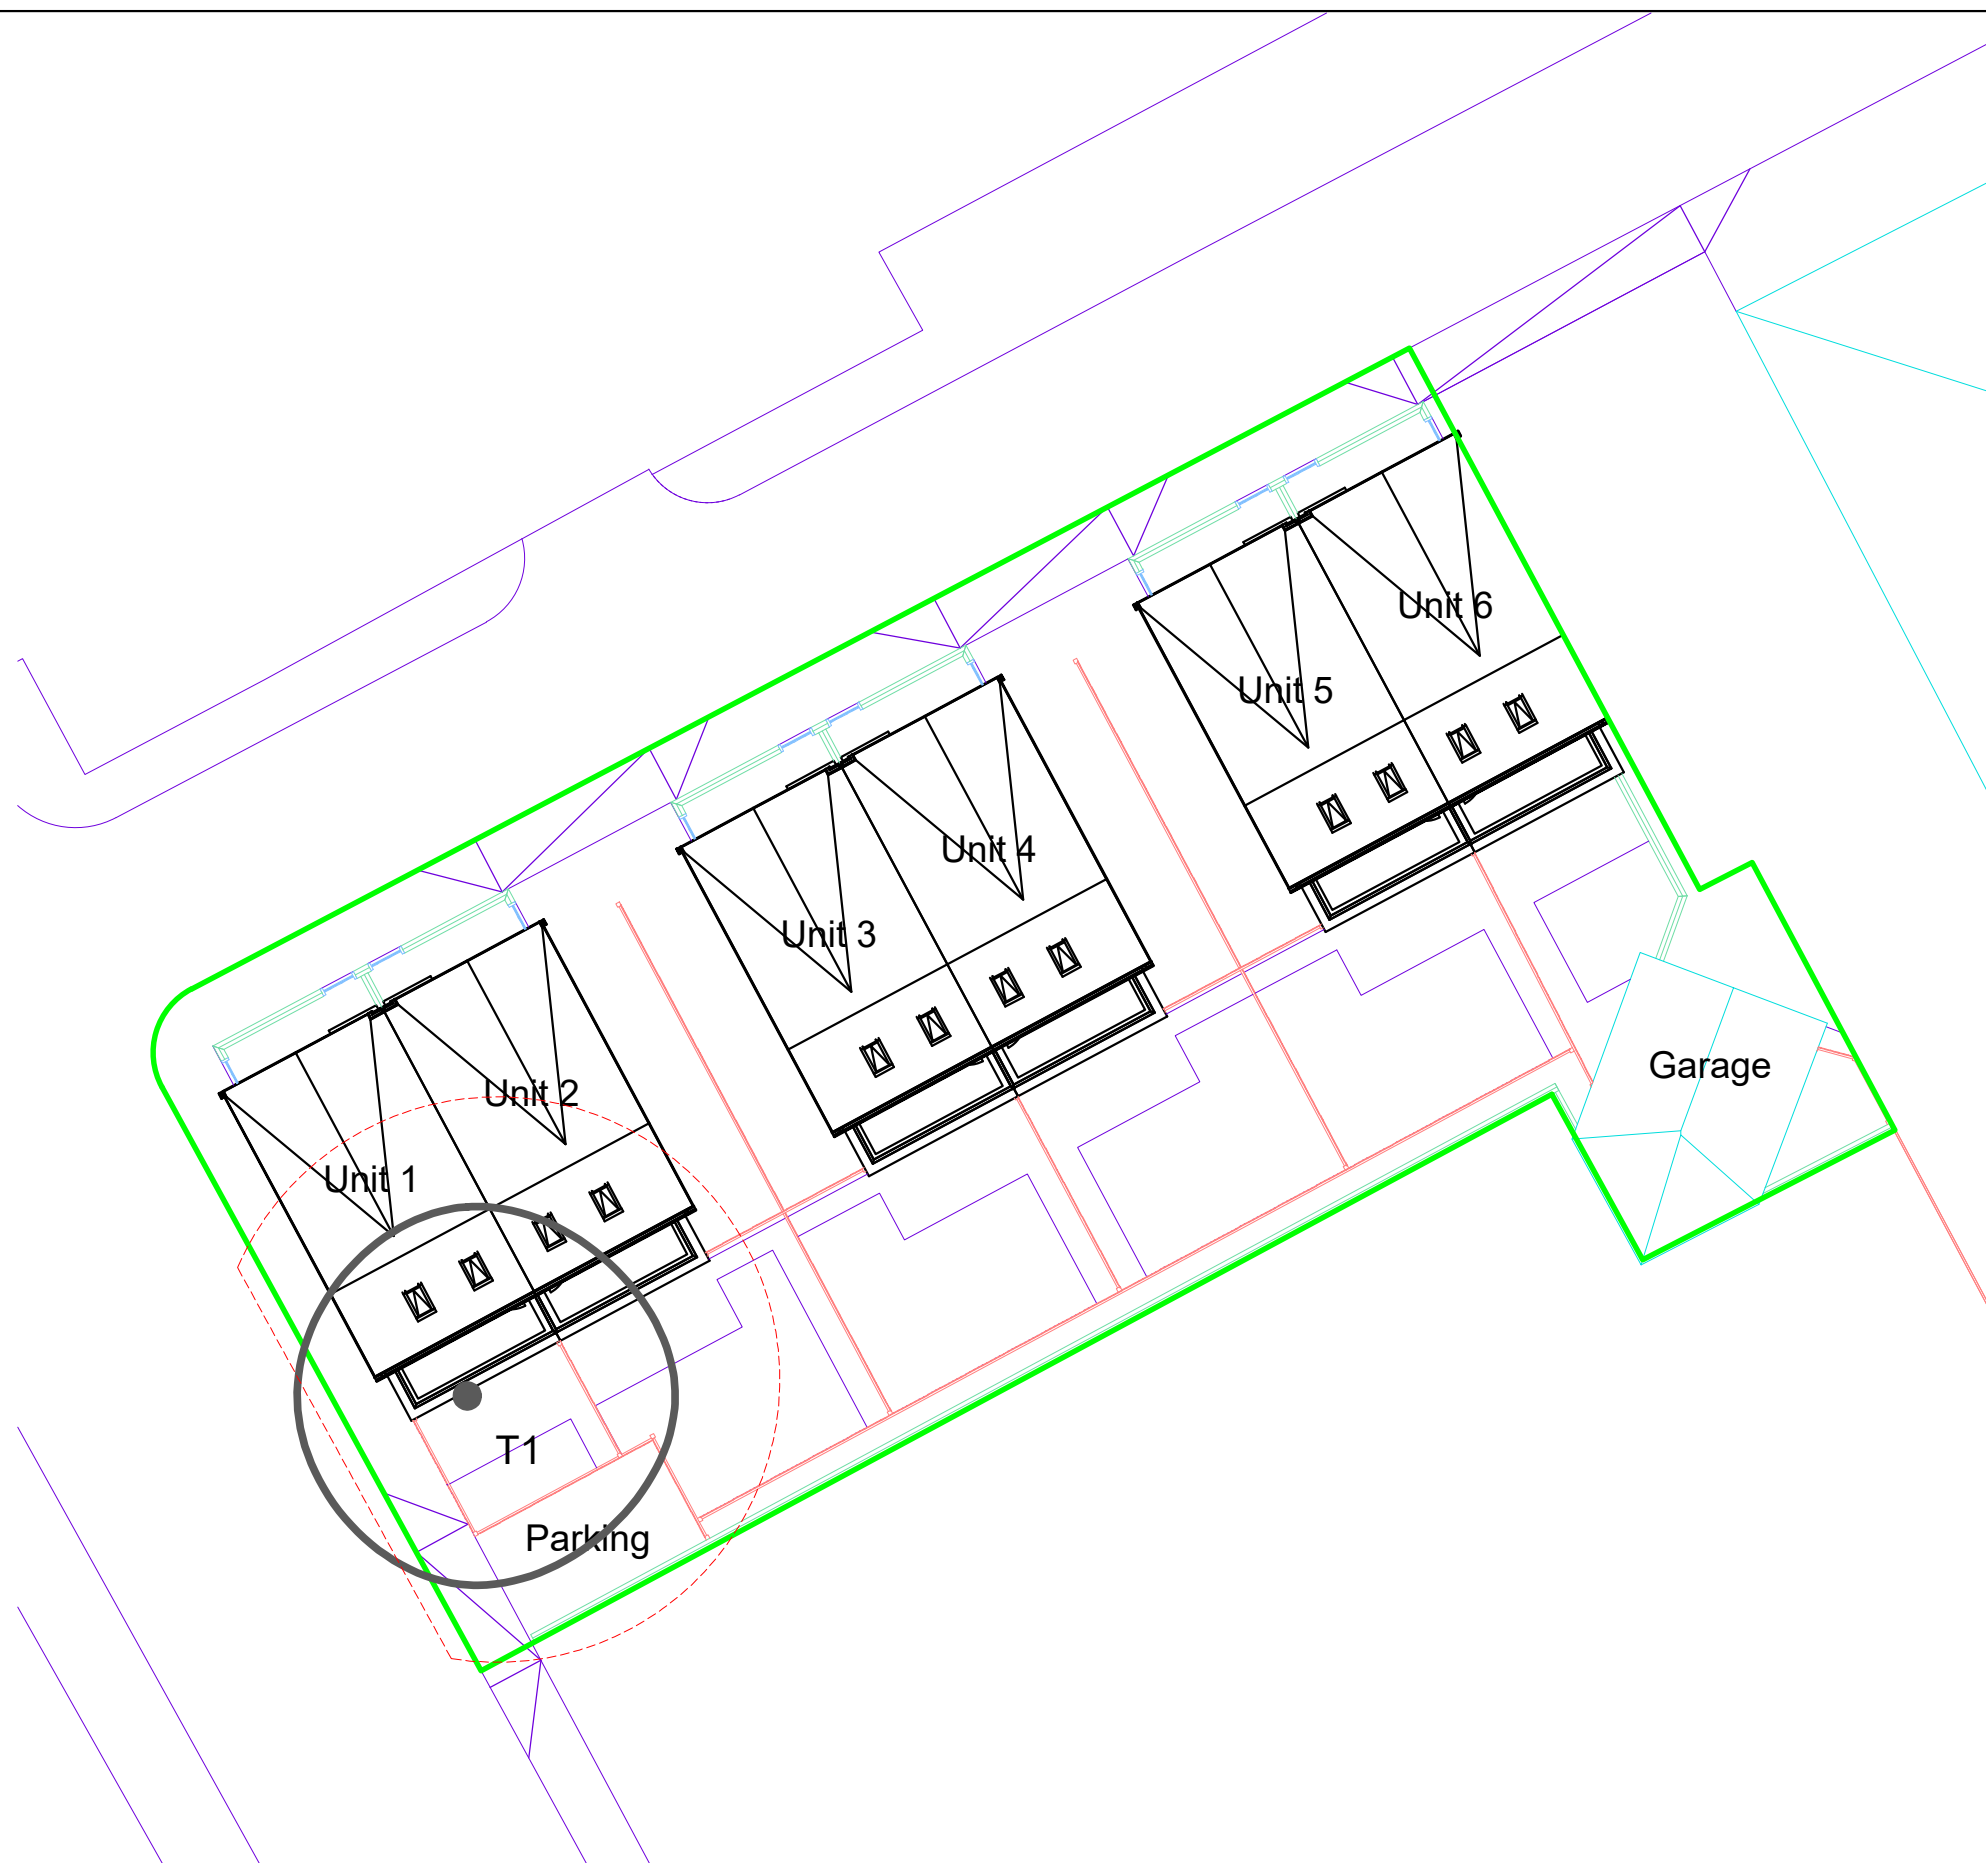
Drawing No:  
WSR/AIS/01

- 3.1 Due to the proposed development and its associated infrastructure there are a number of locations where the proposals are in close proximity to the trees surveyed. The Site Layout Plan within appendix three identifies the trees in relation to the proposed development.
- 3.2 In order to fully assess the impact of the proposals an Impact Table has been created detailing each tree, which shows the proximity of the associated works to the tree.
- 3.3 This can then be assessed in accordance with BS 5837:2012 to determine whether the development will have a detrimental impact on the health of each tree. Once this has been determined remedial measures can be detailed to reduce the impact the proposals will have on the treescape.

Drawing Title:  
AIS Plan
