**Bat Survey Report (preliminary day-time survey):**  
**Tithe Barn,**  
**212 Lower Lane,**  
**Rochdale,**  
**OL16 4PT**

OS grid reference:  
SD 9115 11384

**Survey Date: 9/5/23**

**Report Date: 16/5/23**

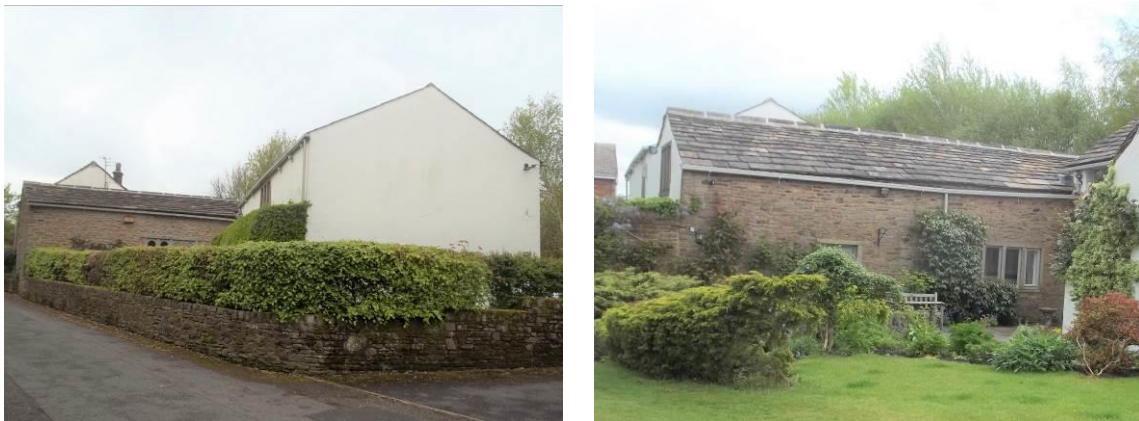
This is an L-shaped barn/stables block which has already been largely converted for residential use in the past, forming part of the living accommodation associated with the adjoining house. It is now to be separated from the house and redeveloped as a new dwelling. Both elements of the building are shown below:

Building as seen from north-east and south-west respectively

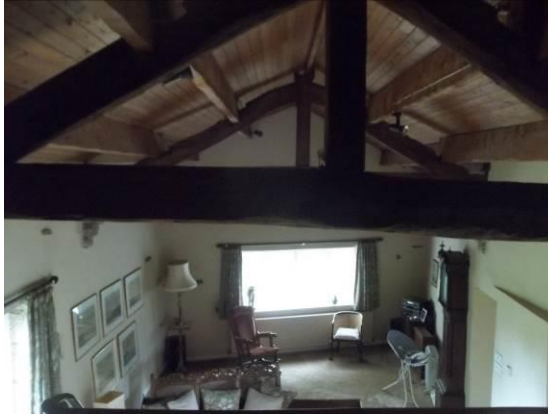
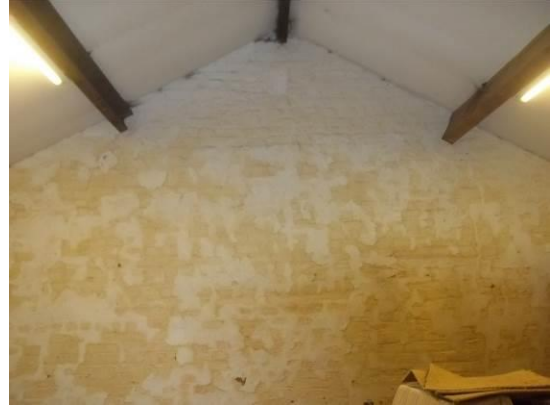
Buildings 1 and 2 respectively (see Fig. 1)

The more northerly - building 2 - is essentially still a barn on two levels.

There was no obvious bat access available to the interior of either element.

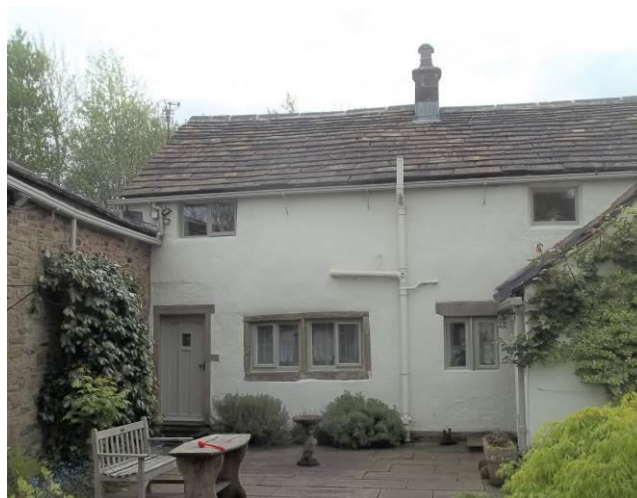
It appears that a loft suitable for use by a typical loft-dwelling species of bat, such as the brown long-eared, exists in the house:

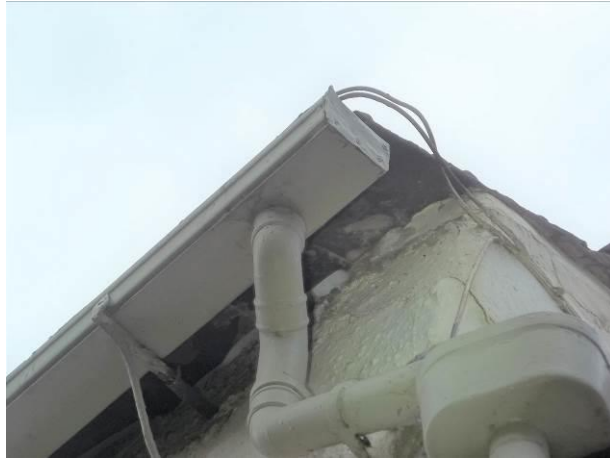
Bat access was apparently available at the east-facing wall-head of the house:

It was evident the roof has been lined with breathable membrane.

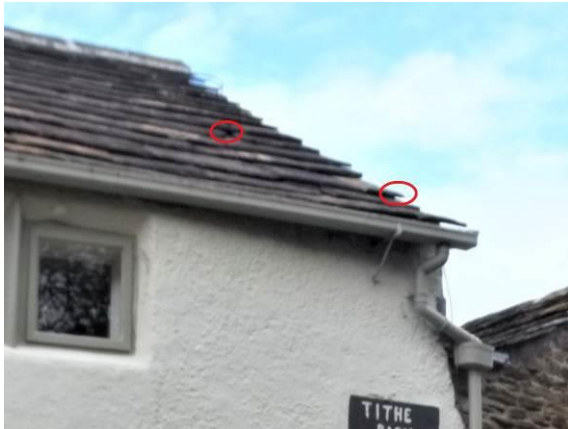
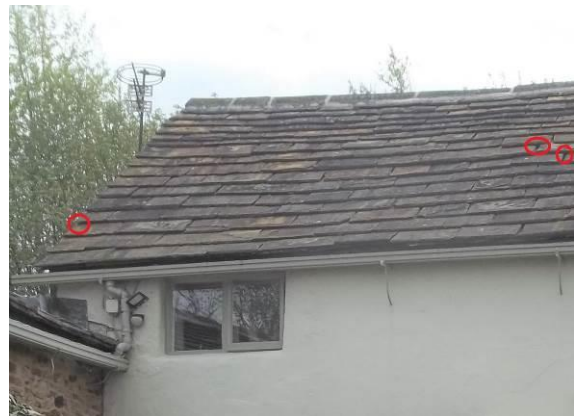
At/close-to the gable end overlooking building 1, there are a few uneven roof-stones present:

Examples of gaps large enough for bats illustrated in red (house)

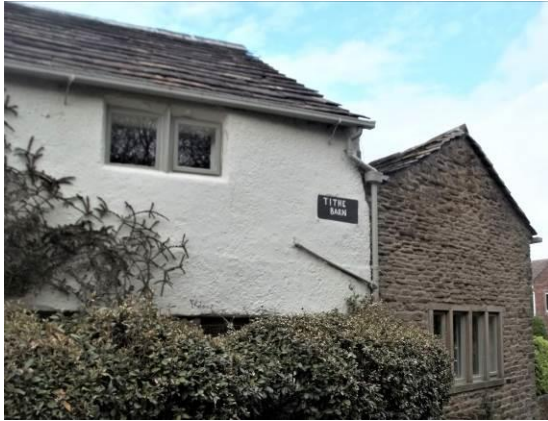
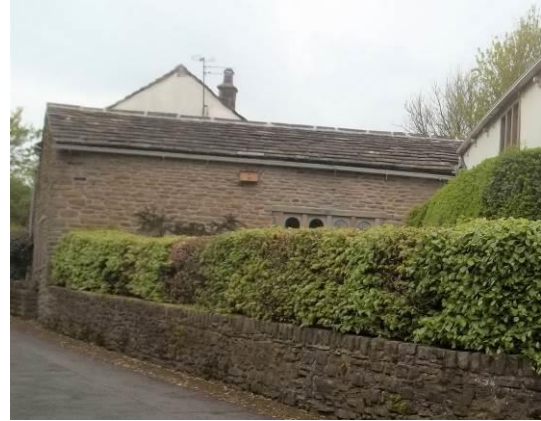
The proximity of this gable end to building 1 is shown below:

House (white walls in left of pictures) and building 1

'Sparrow-terracing' has been fitted to the northern elevation of building 1 and is currently being used by nesting blue-tits. It can be seen in the second photograph above.

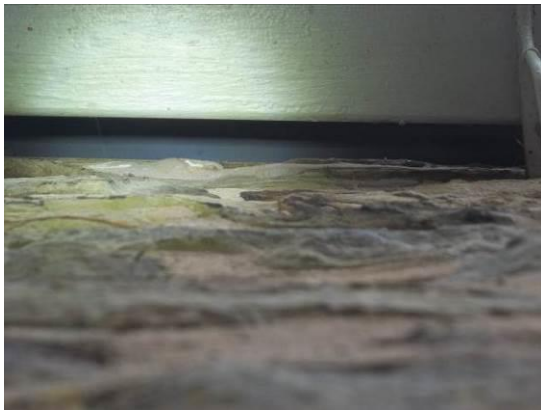
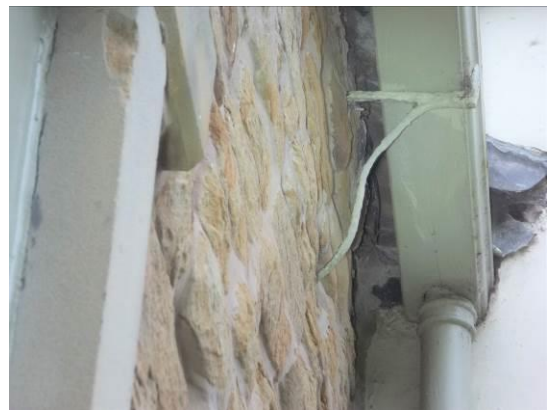
There is access apparently available for bats at the south-facing eaves and probably the north-facing eaves also:

North and south-facing eaves of building 1 respectively

The roof has clearly been lined with breathable membrane

Otherwise only the south-facing and north-facing eaves of building 1 appear suitable to allow bat access.

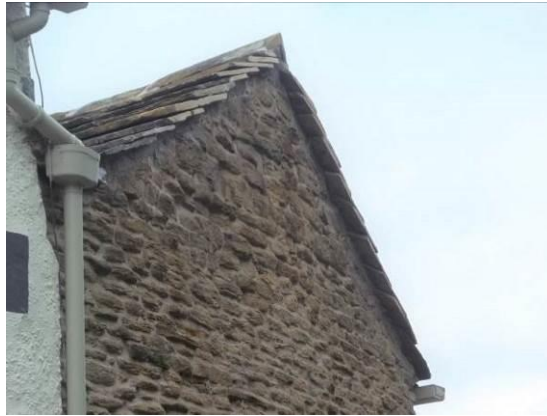
The east-facing eaves of building 1 appear sealed:

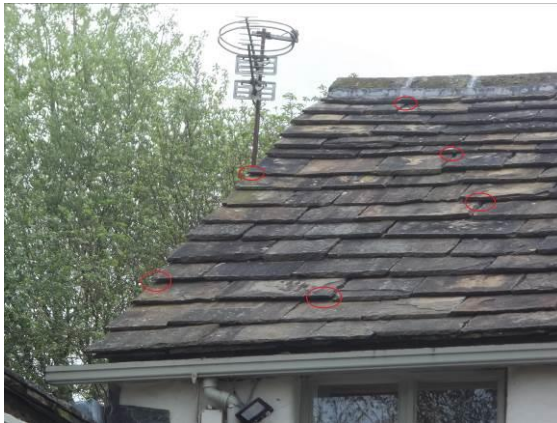
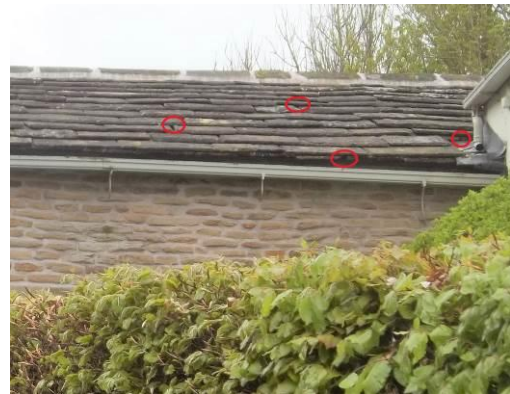
It has a roof of stone and there are some potential bat access places present:

Examples of gaps large enough for bats illustrated in red

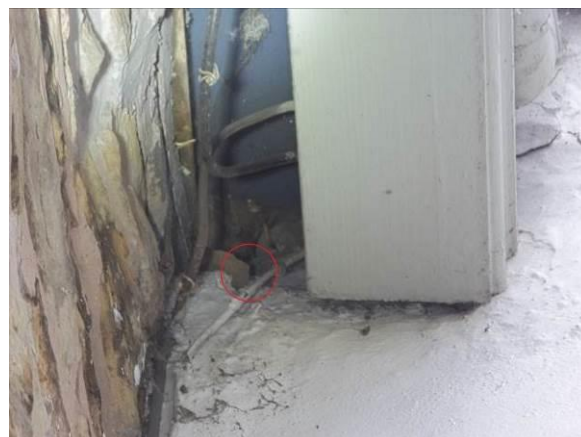
There was also apparently a gap at the junction between building 1 and the house, on the south side:

Gap illustrated in red

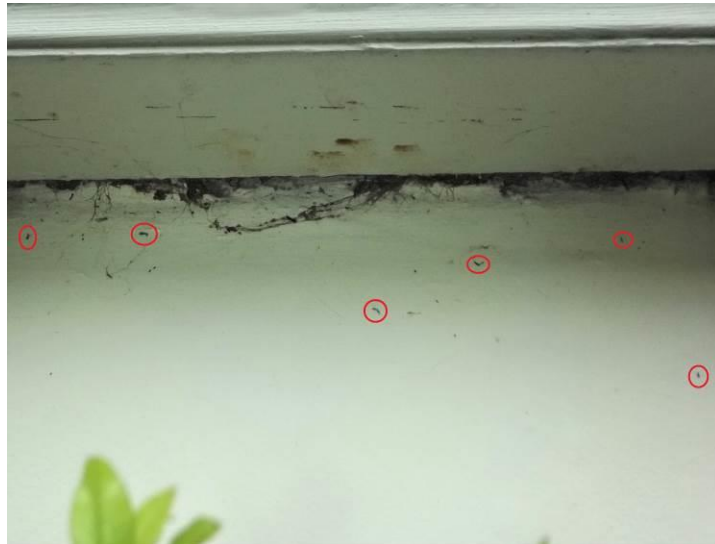
The easterly elevation of building 2 appeared to show bat droppings on the wall. It was hard to photograph these well, partly due to the hedge growing alongside the wall. There were clearly also debris and cobwebs present, but I was satisfied that a few bat droppings were there also. An attempt has been made to illustrate this below:

Features thought to be bat droppings illustrated in red

The east-facing eaves of building 2 have access available for bats and there appeared to be a few bat droppings on the wall towards eaves level. The client reports that birds nest there. There was no clear evidence of this on the day but the photographic evidence showed what appeared to be traces of bird whitewash on the wall. This did not appear to be fresh.

Given that bat droppings seemed to be present I've had no choice but to assess building 2 as being at high risk of some roosting activity; pending the results of further survey work.

I'm provisionally recommending two. As bats use buildings in different ways over the course of the season, often changing roost; if more than one survey is necessary it is my usual practice to undertake one in both the first and second half of the accepted bat survey period (May to August/September) inclusive and to separate them by at least a month; leaving enough time for a third before the end of the September if necessary. This also reduces the chance of missing pipistrelle mating roosts, if present, in the later part of the summer. Although surveys can be spaced at two-weekly intervals, this is only acceptable from a good practice perspective if such close spacing can be justified.

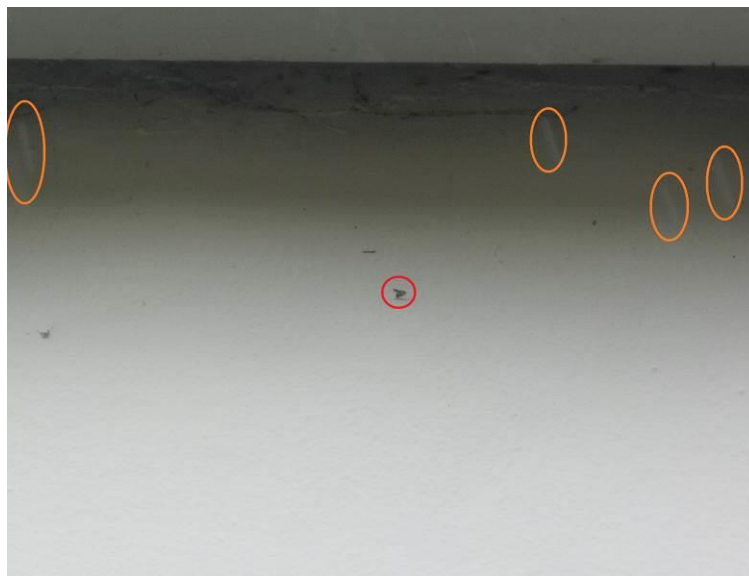
The client mentioned that birds nest at the eaves. At the time I saw no evidence of this, but in the photo below it appears there is some bird white-wash on the wall.

Possible bird white-wash shown in orange; probable bat droppings shown in red

Either way there is certainly access available for bats to roost.

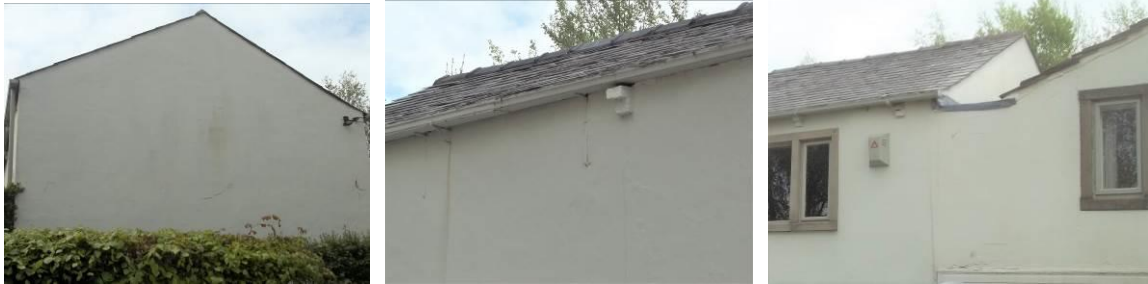
In contrast the north-facing, west-facing and south-facing eaves are sealed, including the west-facing eaves of building 1:

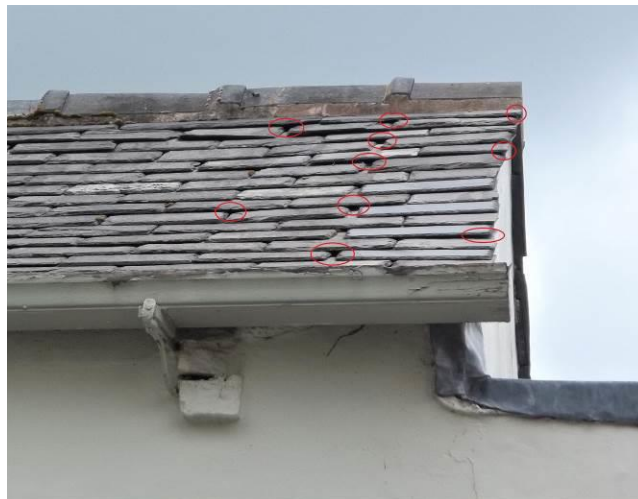
The roof of building 2 is of slate and is in generally good condition, but there are some available gaps that would allow bats beneath the slates:

Examples of gaps large enough for bats illustrated in red
