## HERITAGE & CONSERVATION CONSULTATION RESPONSE

| <b>Application Reference</b> | 25/00433/ADV |
| <b>Address</b> | 15 Fleece Street, Rochdale, OL16 1LY |
| <b>Proposal</b> | Internally illuminated fascia sign (retrospective) |

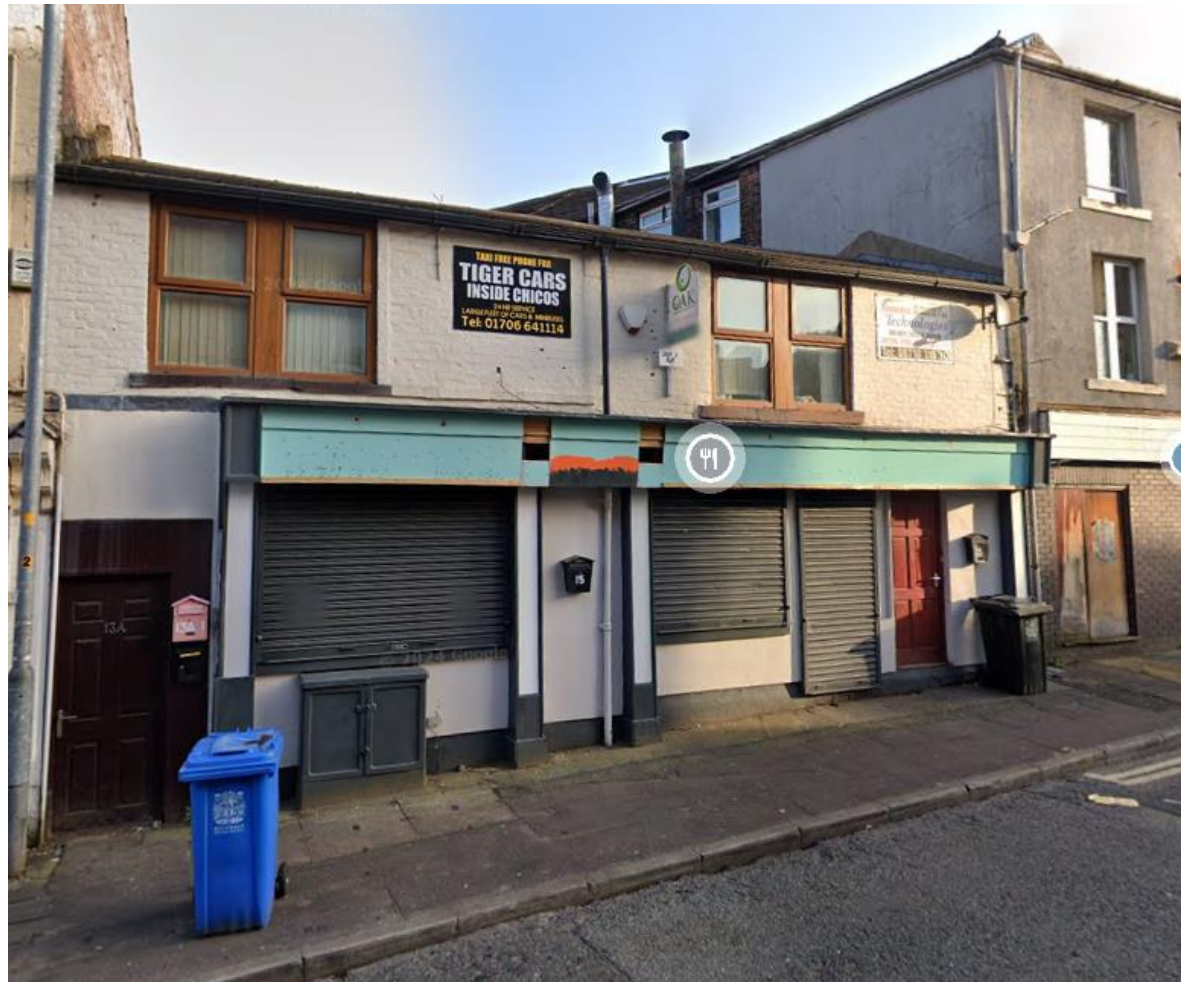
The sign extends along the full width of the fascia sign. It is fabricated of aluminium with projecting lettering, illuminated by LEDs. The sign exceeds the dimensions of the fascia and as a result projects slightly below the top of the pilasters. The top of the central pilaster is obscured by the sign. The result is a disproportionate sign which is overly large for the fascia, obscures key architectural features and sits awkwardly on the building.

The 2021 google Streetview extract shows the extent of the fascia prior to the installation of the existing and previous signage:

signage on the existing fascias and not over the pilasters, could have resulted in a scheme which sat far more comfortably on the host building. Similarly, it would have been preferable for the sign to be placed on a timber fascia board with individually applied and illuminated lettering.
