## GARDEN VALIDATION – ROYLE ROAD

| <b>Project Name:</b> | Royle Road |
| <b>Project Number:</b> | 11-778 |
| <b>Plots:</b> | 8, 120-134 |

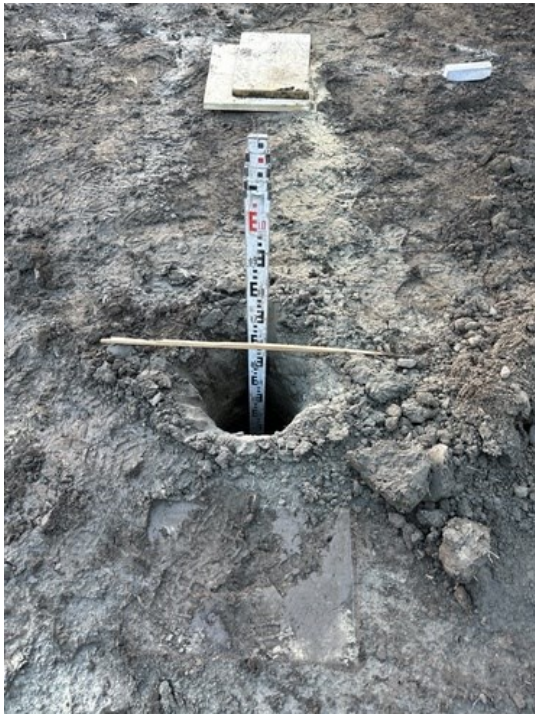
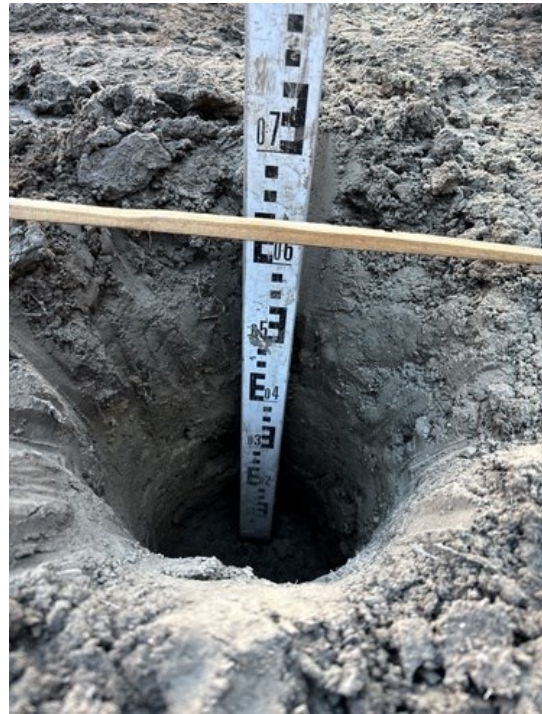
**Depth of Cover System Materials (record the depth and support with Photo down the hole)**

650

**Depth of Topsoil (mm)**

200

**Depth of Subsoil (mm)**

450

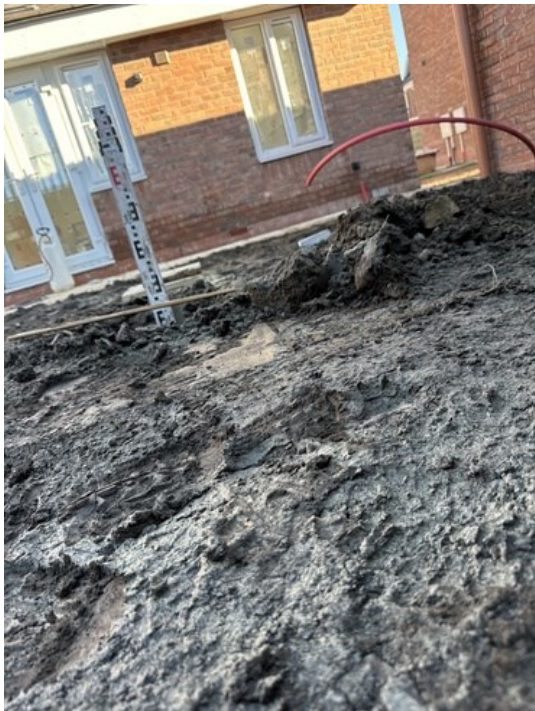
Photo 3

**Depth of Cover System at Ground Level (Photo)**

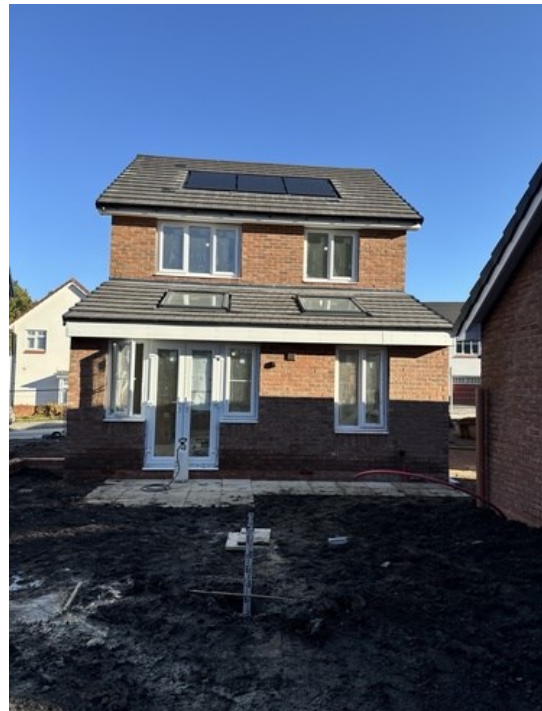
Photo 4

**Depth of Cover System in Relation to Plot (Ensure the whole plot can be seen in the photo)**

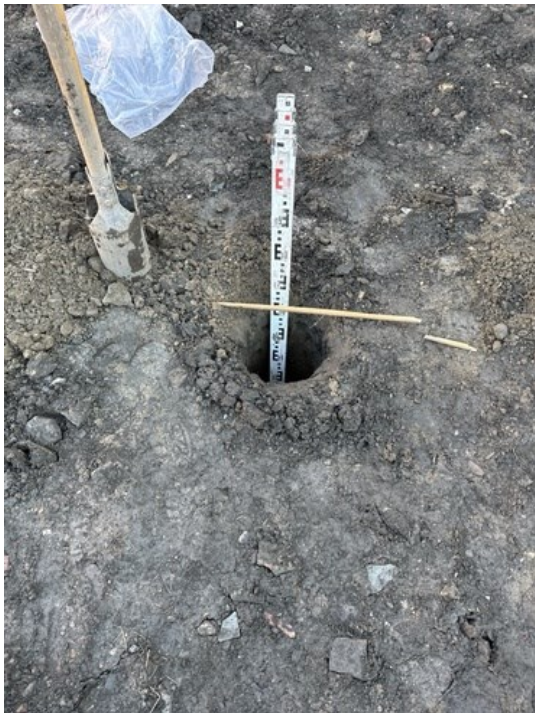
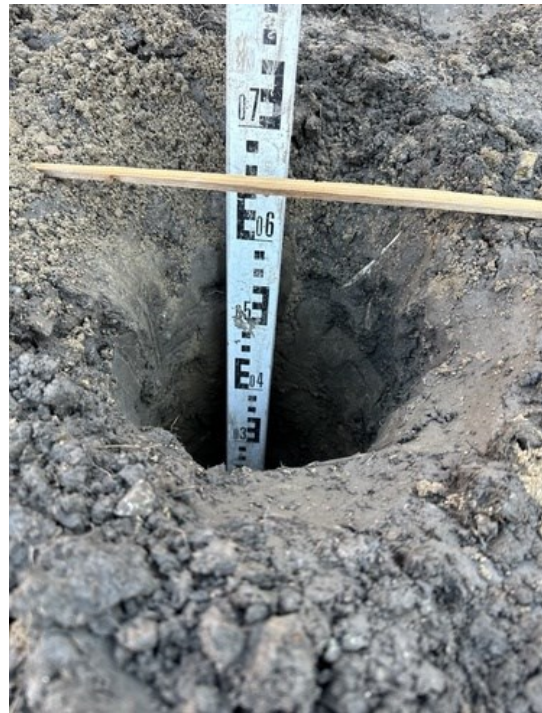
| <b>Depth of Cover System Materials (record the depth and support with Photo down the hole)</b> | 650 |
| <b>Depth of Topsoil (mm)</b> | 200 |
| <b>Depth of Subsoil (mm)</b> | 450 |

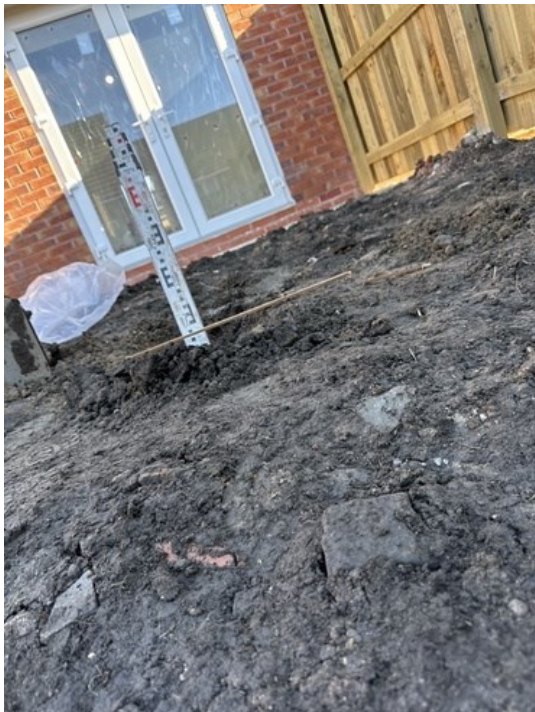
Photo 7

| <b>Depth of Cover System at Ground Level (Photo)</b> | <input checked="" type="checkbox"/> |

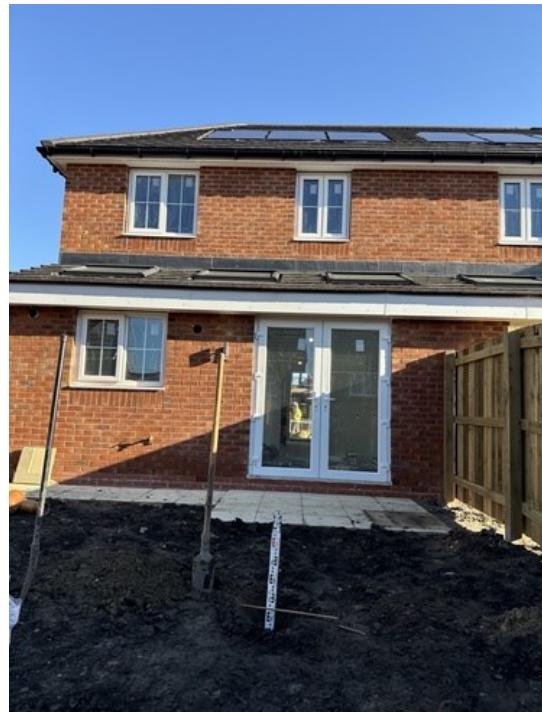
Photo 8

| <b>Depth of Cover System in Relation to Plot (Ensure the whole plot can be seen in the photo)</b> | <input checked="" type="checkbox"/> |

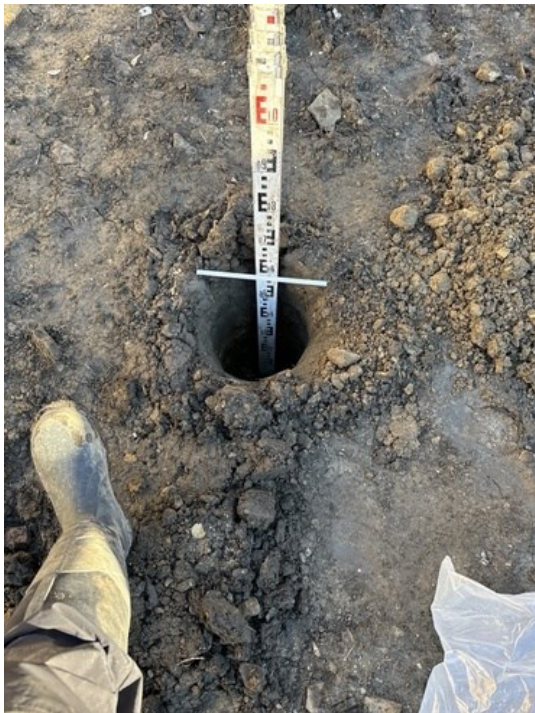
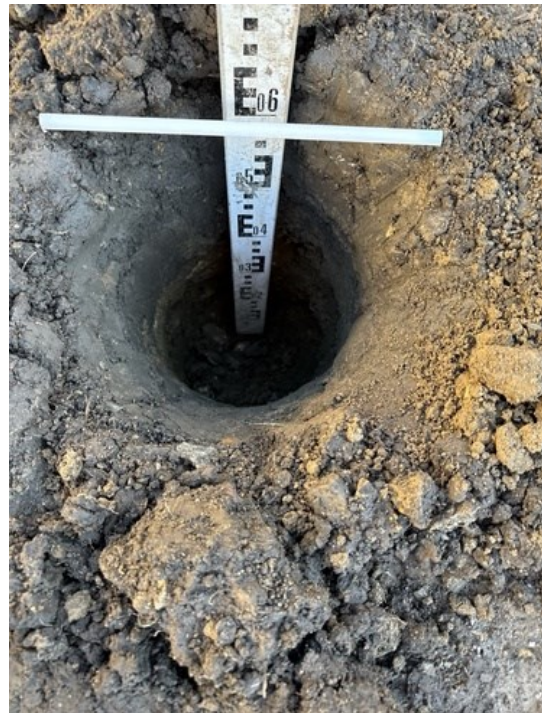
| Depth of Cover System Materials (record the depth and support with Photo down the hole) | 600 |
| Depth of Topsoil (mm) | 200 |
| Depth of Subsoil (mm) | 400 |

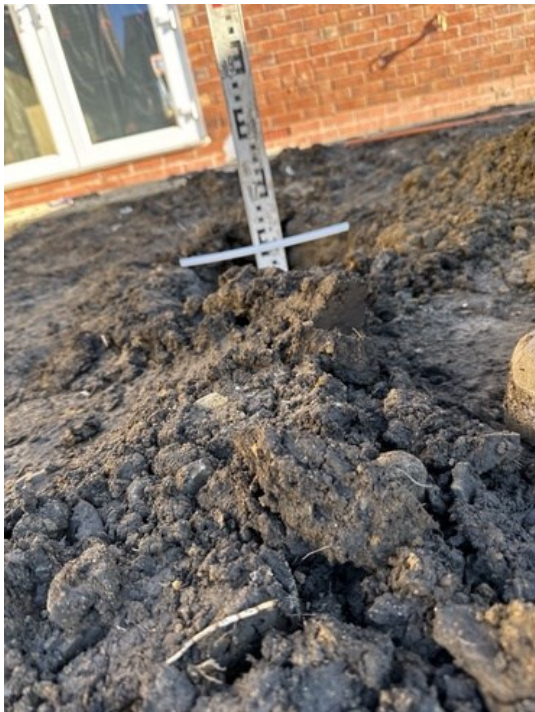
Photo 11

| Depth of Cover System at Ground Level (Photo) | <input checked="" type="checkbox"/> |

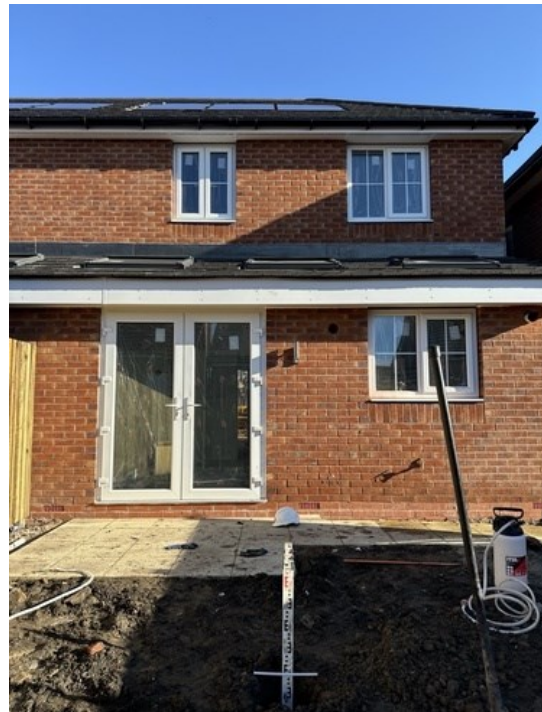
Photo 12

| Depth of Cover System in Relation to Plot (Ensure the whole plot can be seen in the photo) | <input checked="" type="checkbox"/> |

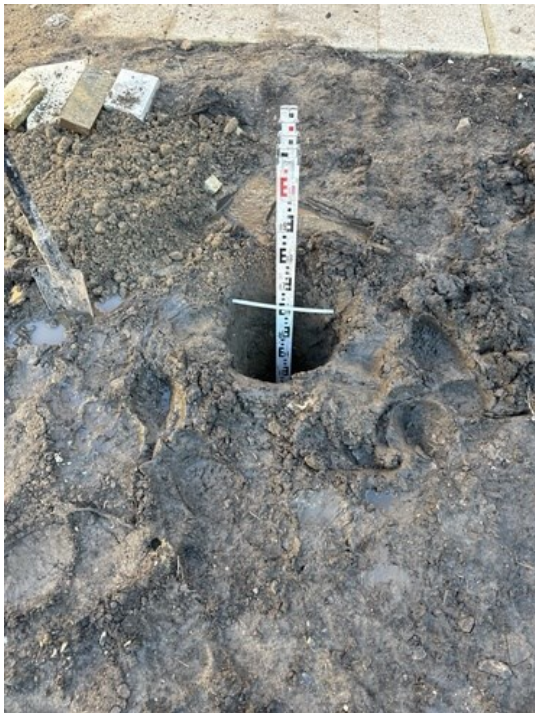
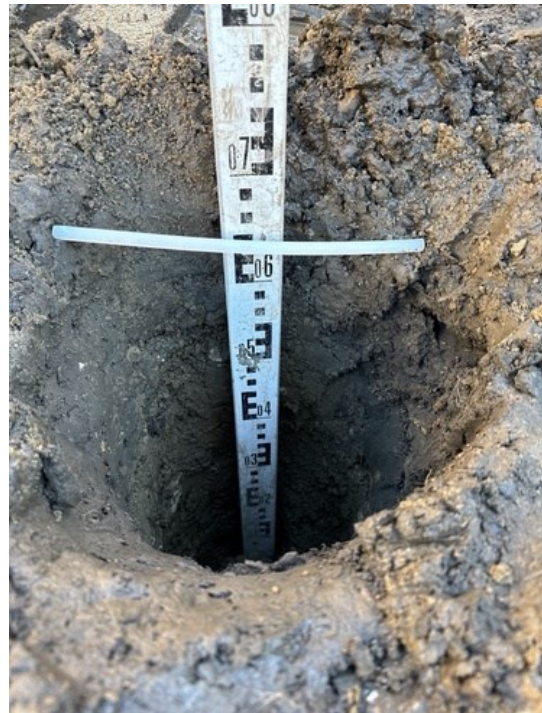
| Depth of Cover System Materials (record the depth and support with Photo down the hole) | | 630 |
| Depth of Topsoil (mm) | | 180 |
| Depth of Subsoil (mm) | | 450 |

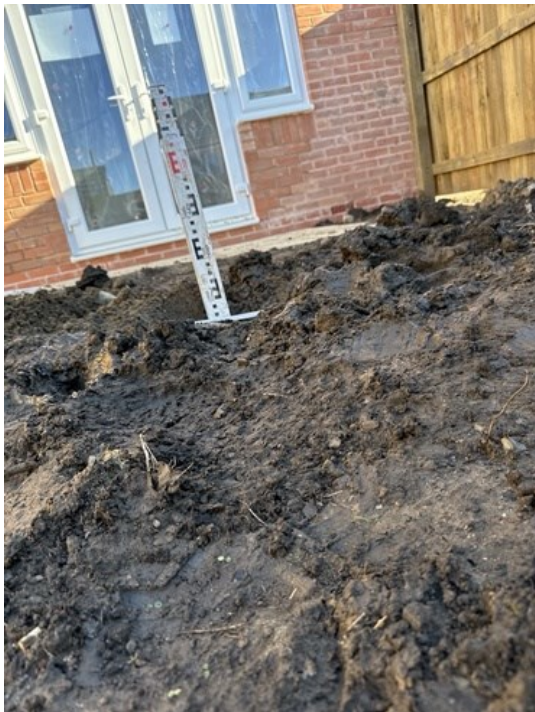
Photo 15

| Depth of Cover System at Ground Level (Photo) | | <input checked="" type="checkbox"/> |

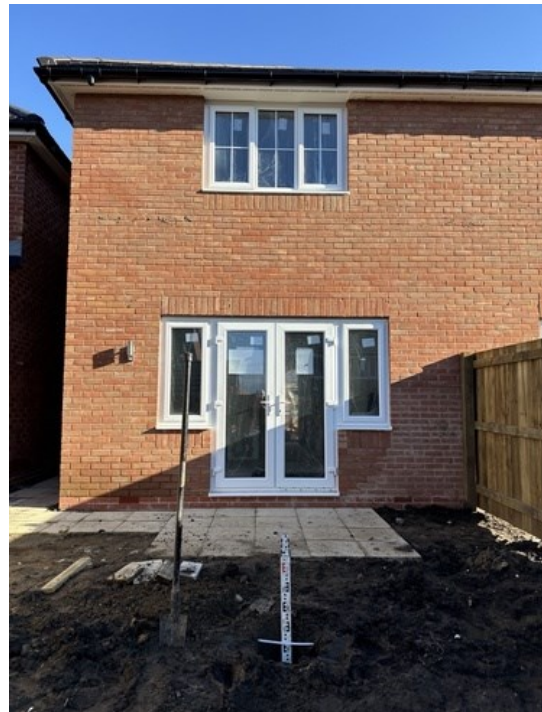
Photo 16

| Depth of Cover System in Relation to Plot (Ensure the whole plot can be seen in the photo) | | <input checked="" type="checkbox"/> |

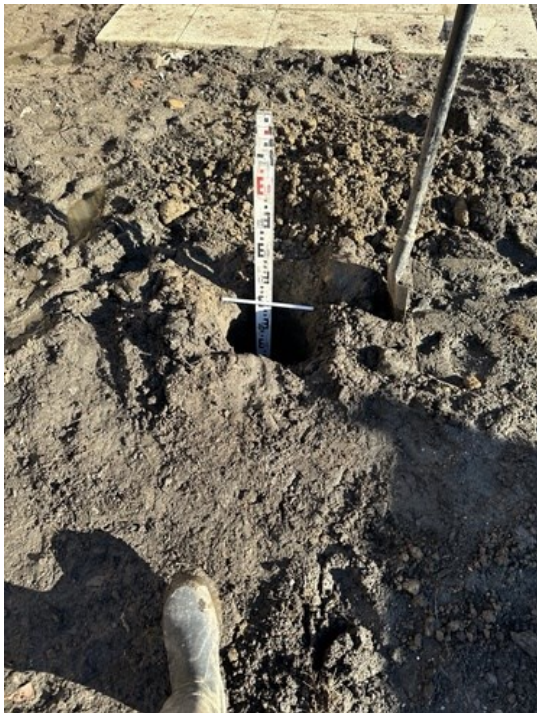
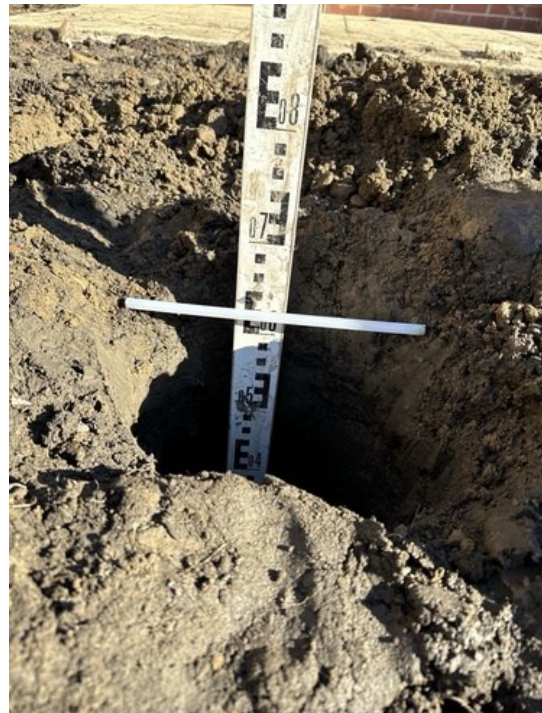
| <b>Depth of Cover System Materials (record the depth and support with Photo down the hole)</b> | 620 |
| <b>Depth of Topsoil (mm)</b> | 170 |
| <b>Depth of Subsoil (mm)</b> | 450 |

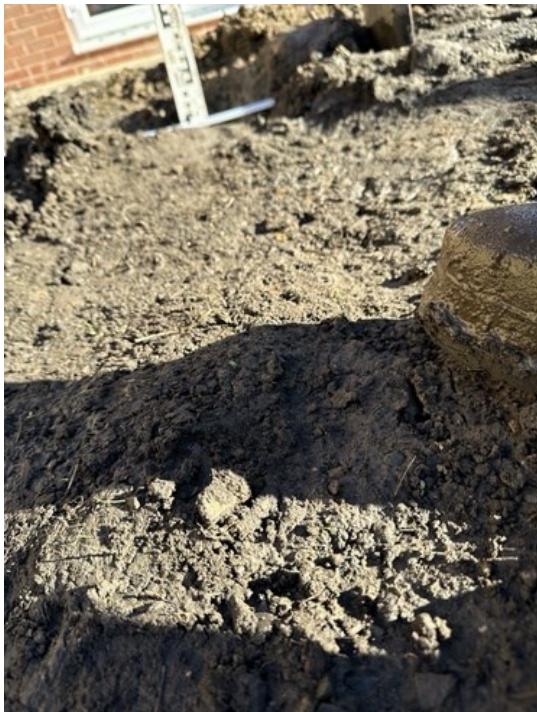
Photo 19

| <b>Depth of Cover System at Ground Level (Photo)</b> | ☒ |

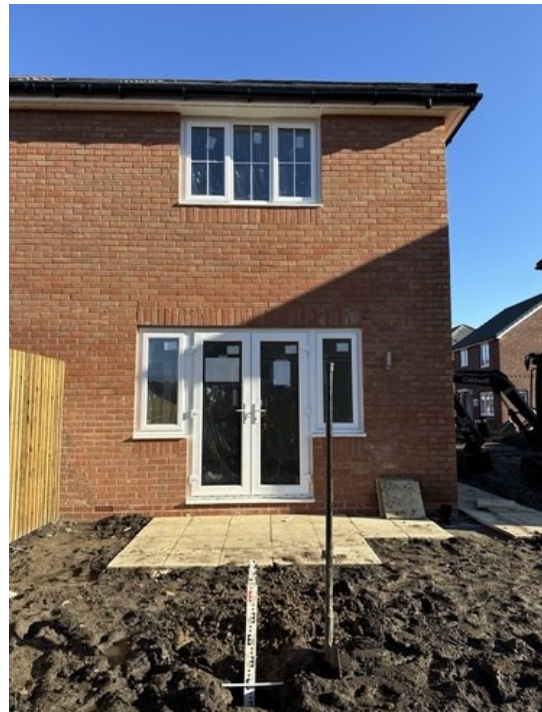
Photo 20

| <b>Depth of Cover System in Relation to Plot (Ensure the whole plot can be seen in the photo)</b> | ☒ |

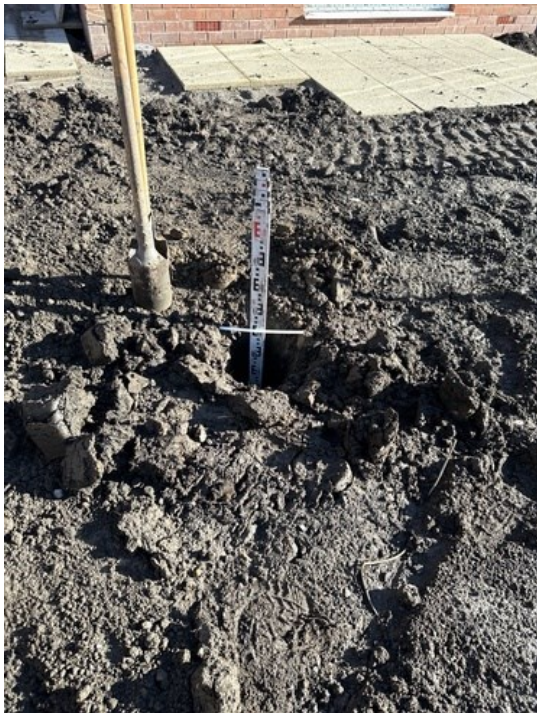
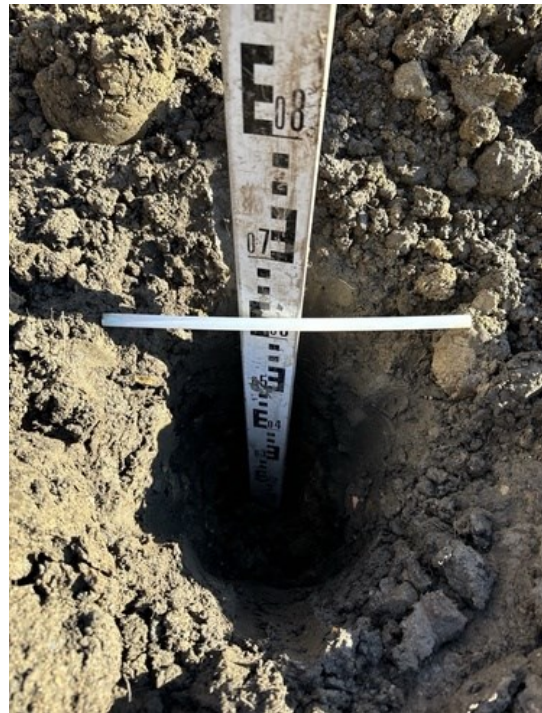
| <b>Depth of Cover System Materials (record the depth and support with Photo down the hole)</b> | 620 |

| Depth of Topsoil (mm) | 220 |

| Depth of Subsoil (mm) | 400 |

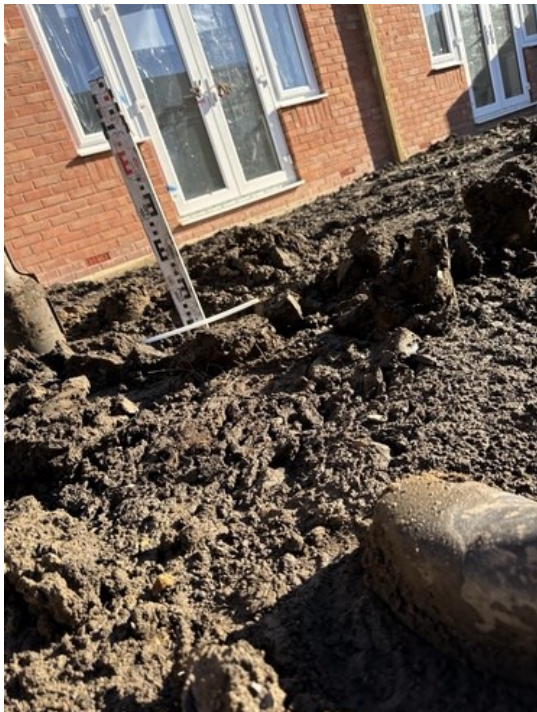
Photo 23

| Depth of Cover System at Ground Level (Photo) | <input checked="" type="checkbox"/> |

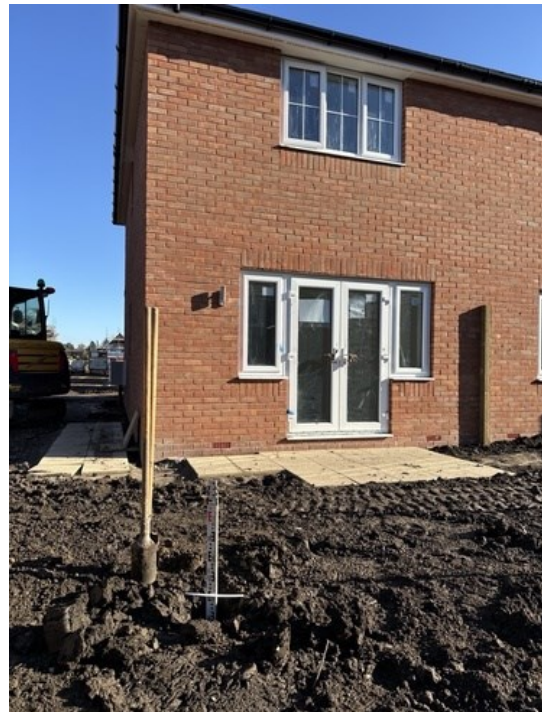
Photo 24

| Depth of Cover System in Relation to Plot (Ensure the whole plot can be seen in the photo) | <input checked="" type="checkbox"/> |

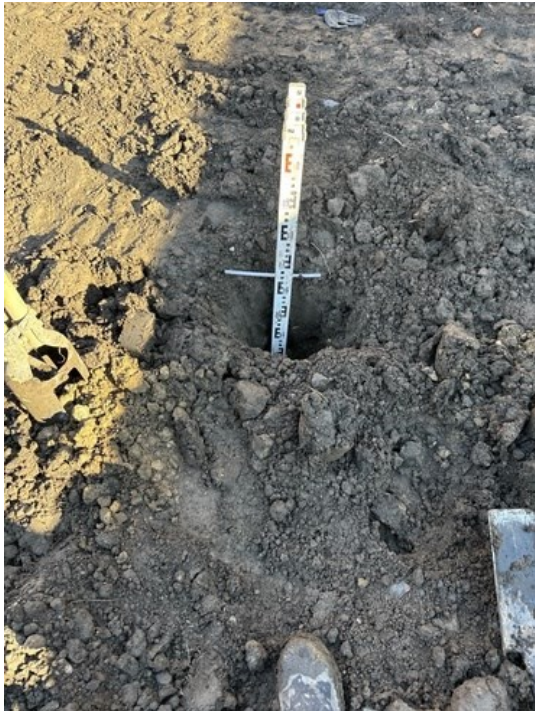
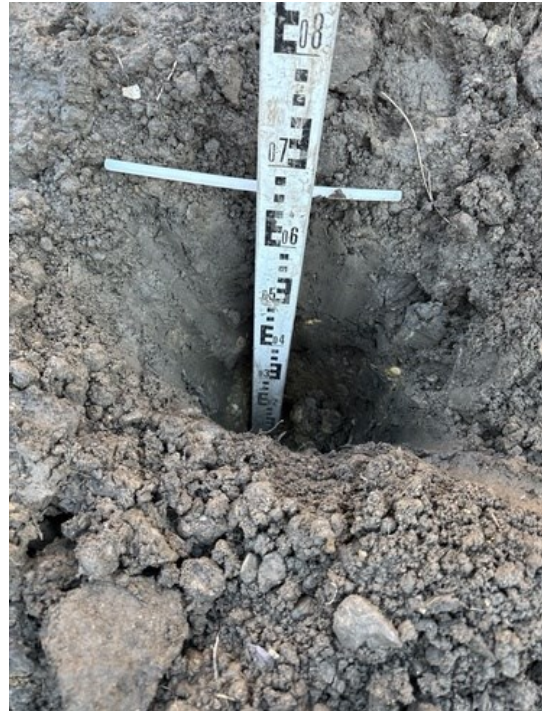
| Depth of Cover System Materials (record the depth and support with Photo down the hole) | 650 |

| Depth of Topsoil (mm) | 350 |
| Depth of Subsoil (mm) | 300 |

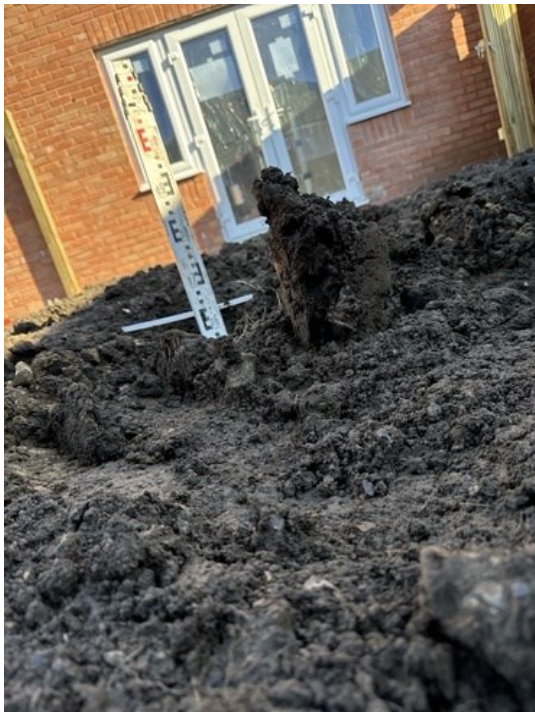
Photo 27

| Depth of Cover System at Ground Level (Photo) | <input checked="" type="checkbox"/> |

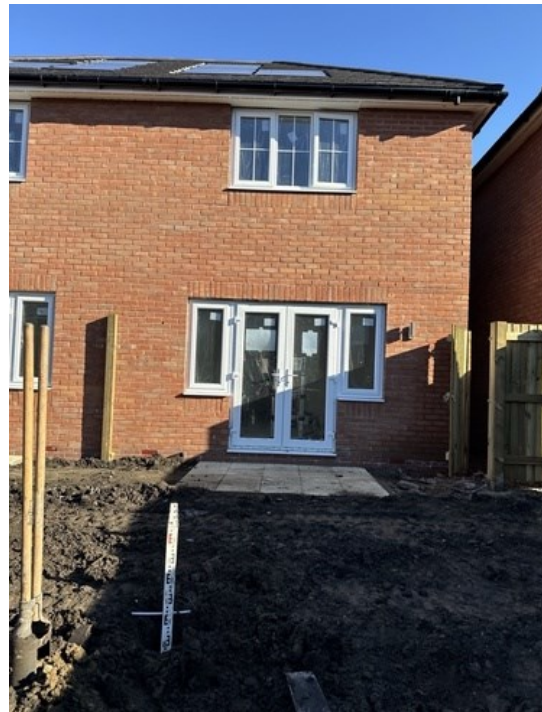
Photo 28

| Depth of Cover System in Relation to Plot (Ensure the whole plot can be seen in the photo) | <input checked="" type="checkbox"/> |

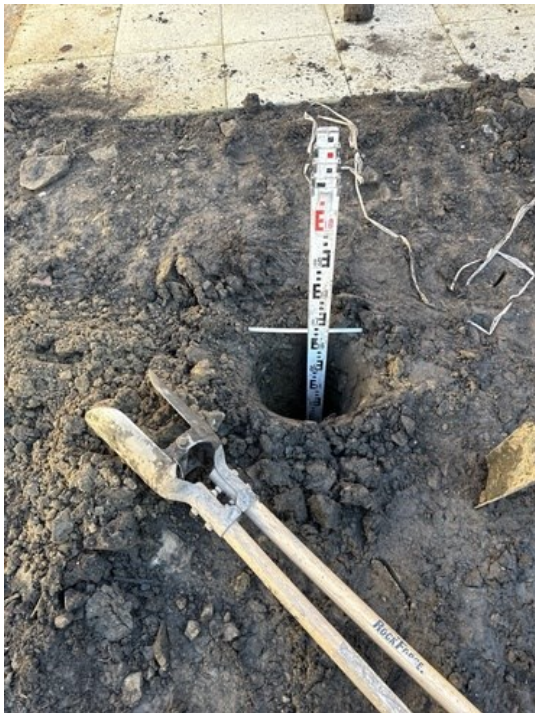
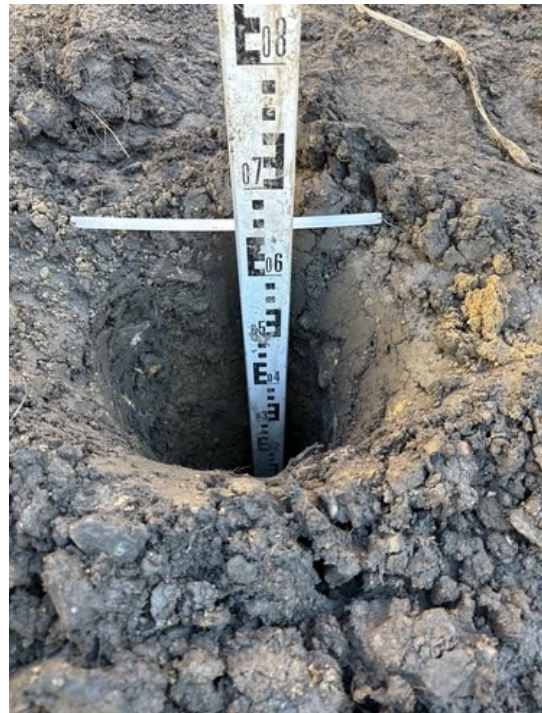
| Depth of Cover System Materials (record the depth and support with Photo down the hole) | 620 |
| Depth of Topsoil (mm) | 220 |
| Depth of Subsoil (mm) | 400 |

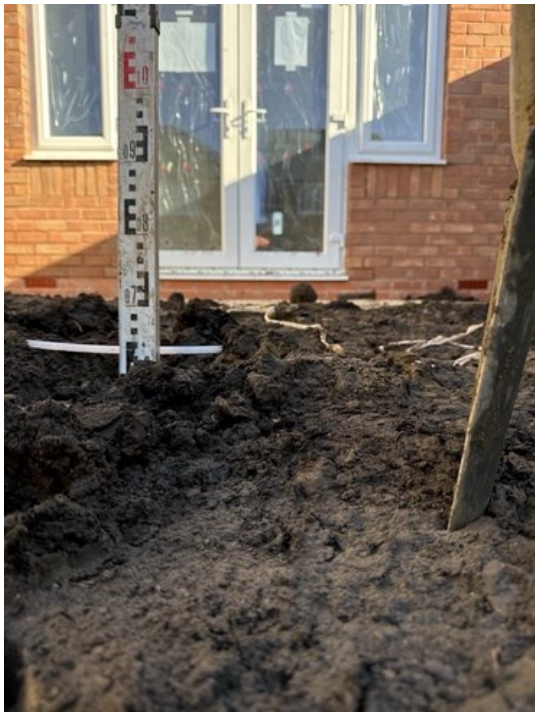
Photo 31

| Depth of Cover System at Ground Level (Photo) | <input checked="" type="checkbox"/> |

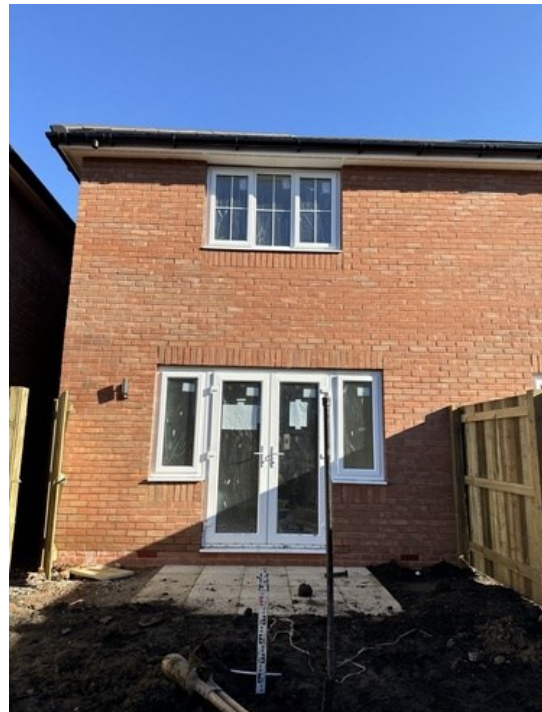
Photo 32

**Depth of Cover System in Relation to Plot (Ensure the whole plot can be seen in the photo)**

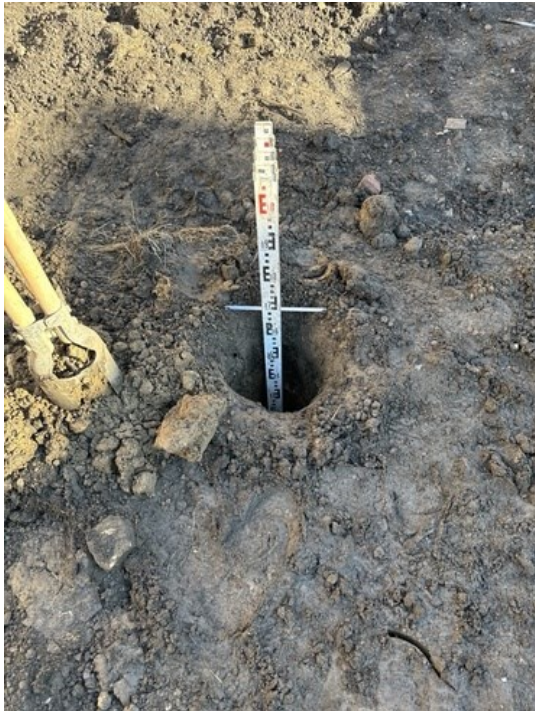
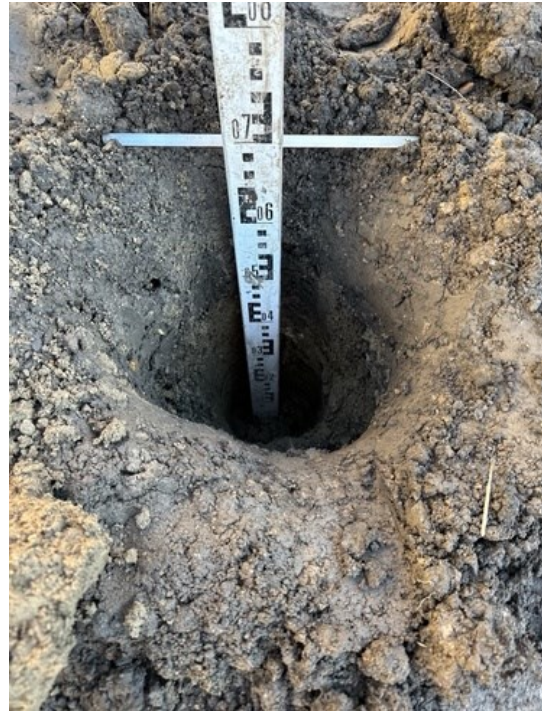
**Depth of Cover System Materials (record the depth and support with Photo down the hole)**

680

**Depth of Topsoil (mm)**

230

**Depth of Subsoil (mm)**

450

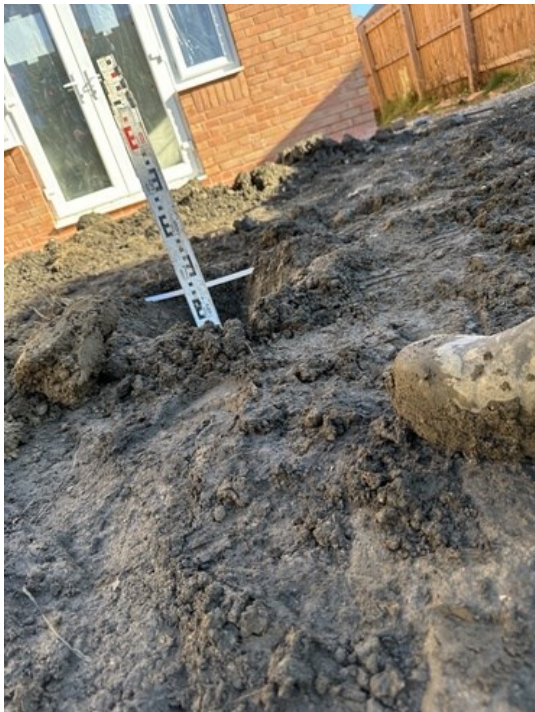
Photo 35

**Depth of Cover System at Ground Level (Photo)**

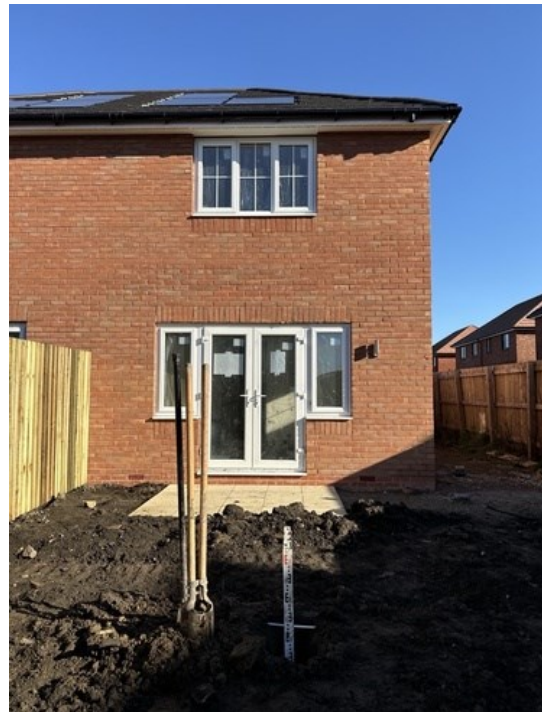
Photo 36

**Depth of Cover System in Relation to Plot (Ensure the whole plot can be seen in the photo)**

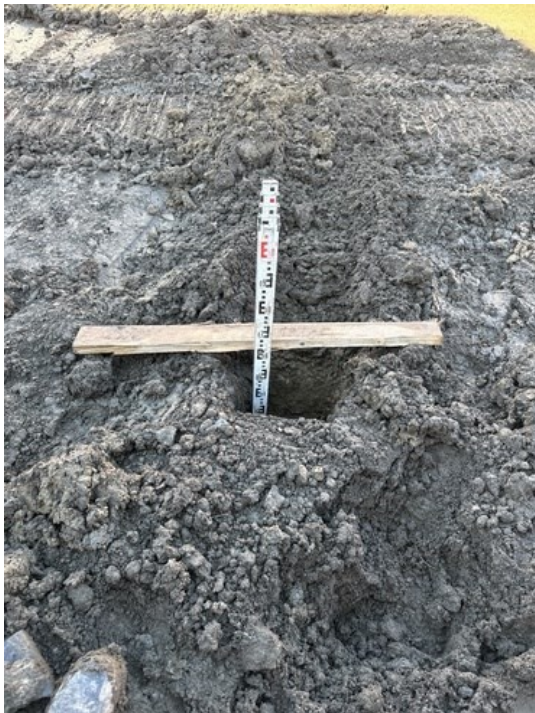
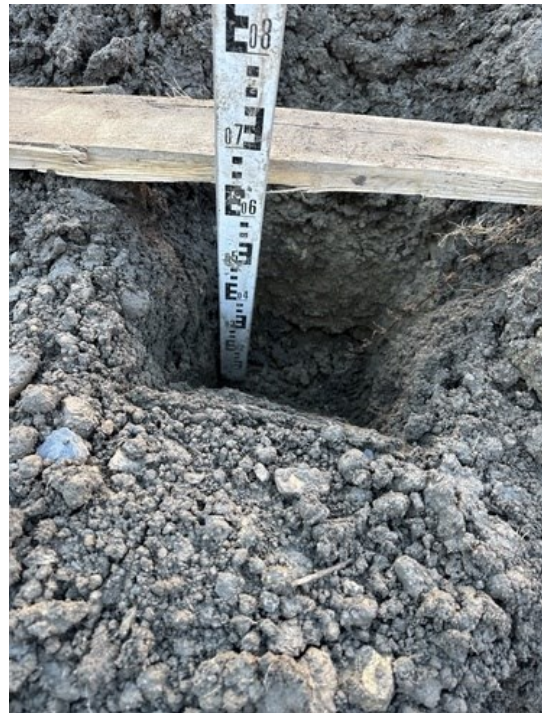
**Depth of Cover System Materials (record the depth and support with Photo down the hole)**

600

**Depth of Topsoil (mm)**

150

**Depth of Subsoil (mm)**

450

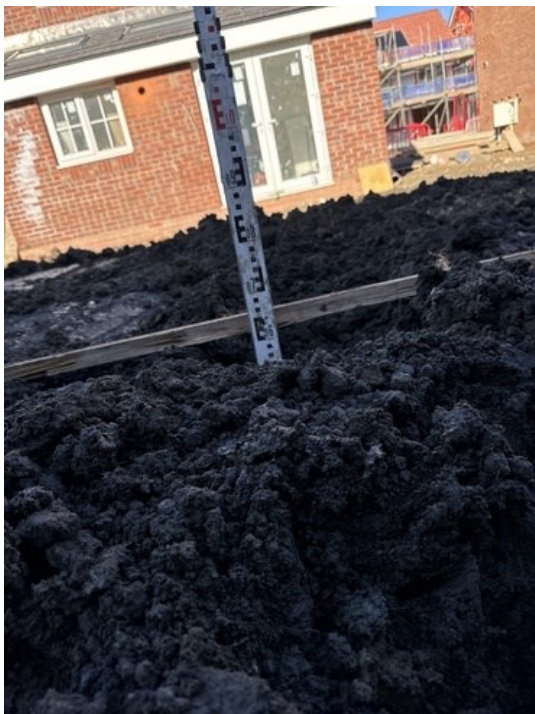
Photo 39

**Depth of Cover System at Ground Level (Photo)**

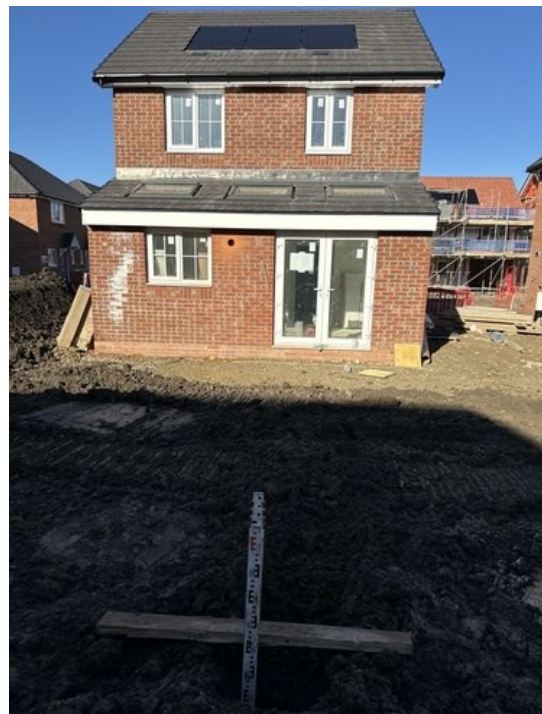
Photo 40

**Depth of Cover System in Relation to Plot (Ensure the whole plot can be seen in the photo)**

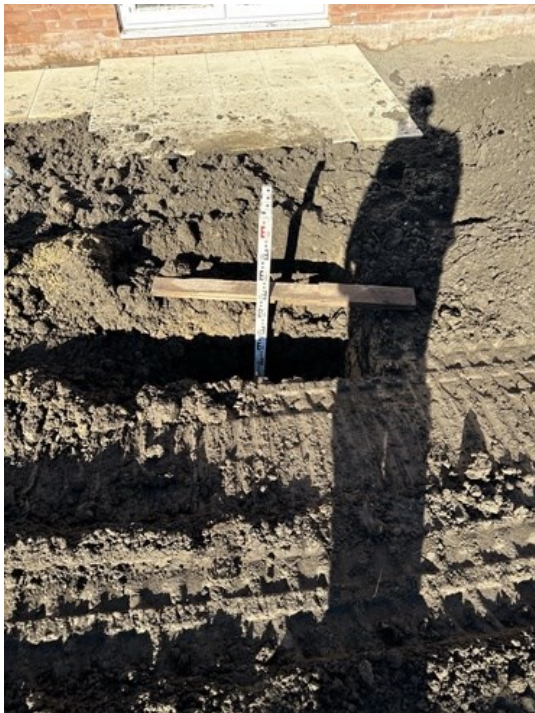
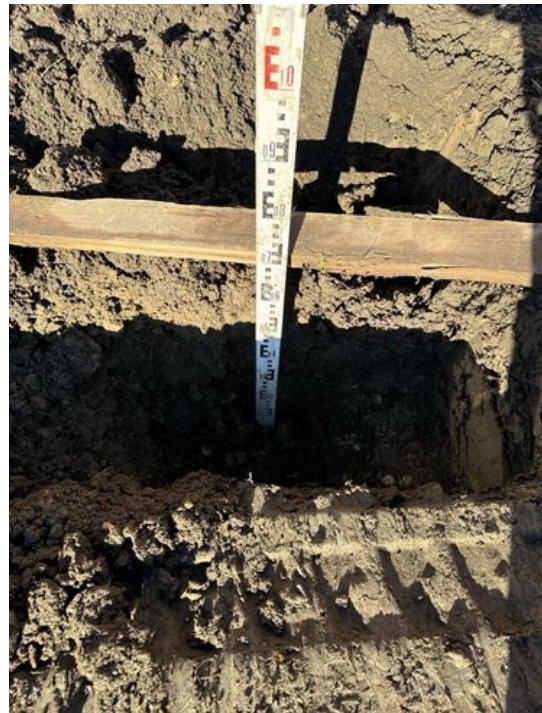
| <b>Depth of Cover System Materials (record the depth and support with Photo down the hole)</b> | 660 |
| <b>Depth of Topsoil (mm)</b> | 160 |
| <b>Depth of Subsoil (mm)</b> | 500 |

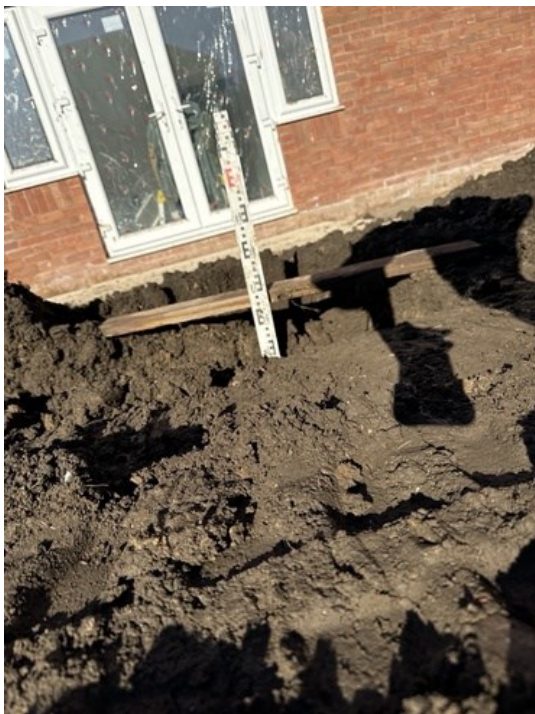
Photo 43

| <b>Depth of Cover System at Ground Level (Photo)</b> | <input checked="" type="checkbox"/> |

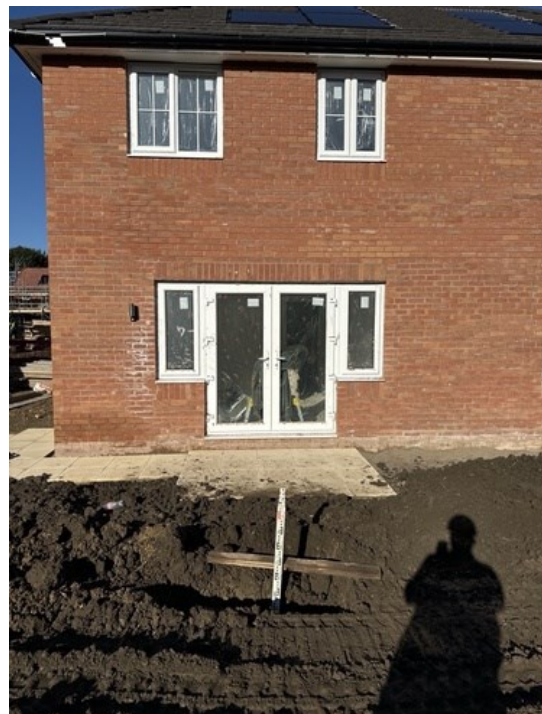
Photo 44

| <b>Depth of Cover System in Relation to Plot (Ensure the whole plot can be seen in the photo)</b> | <input checked="" type="checkbox"/> |

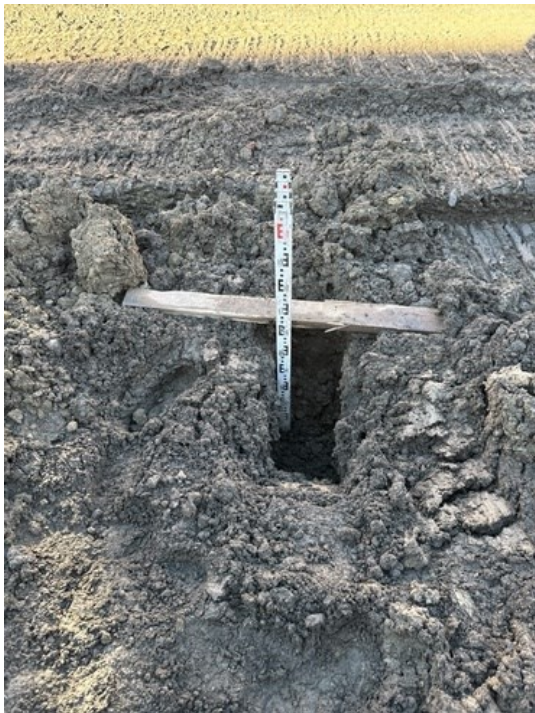
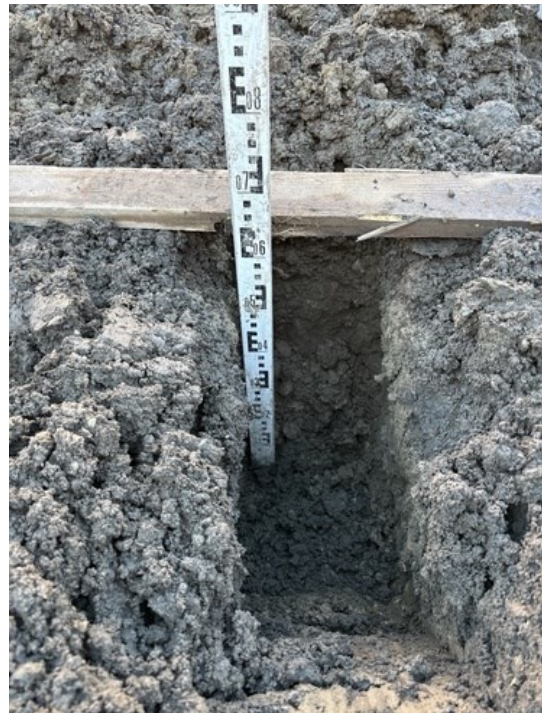
| Depth of Cover System Materials (record the depth and support with Photo down the hole) | 620 |
| Depth of Topsoil (mm) | 170 |
| Depth of Subsoil (mm) | 450 |

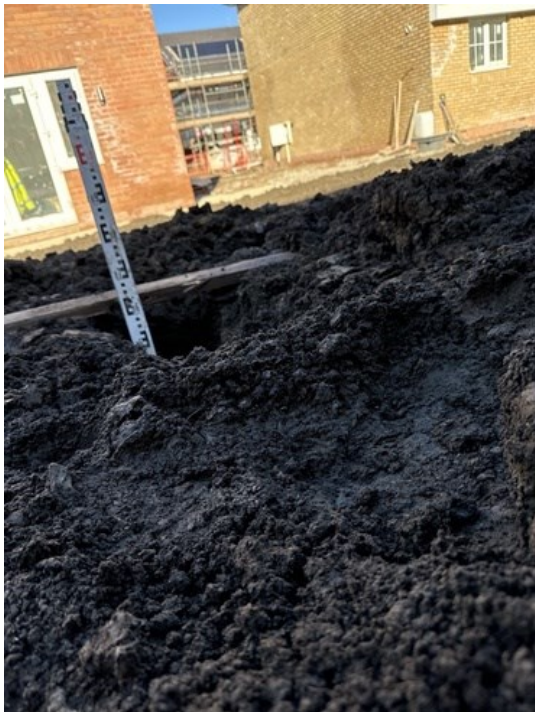
Photo 47

| Depth of Cover System at Ground Level (Photo) | <input checked="" type="checkbox"/> |

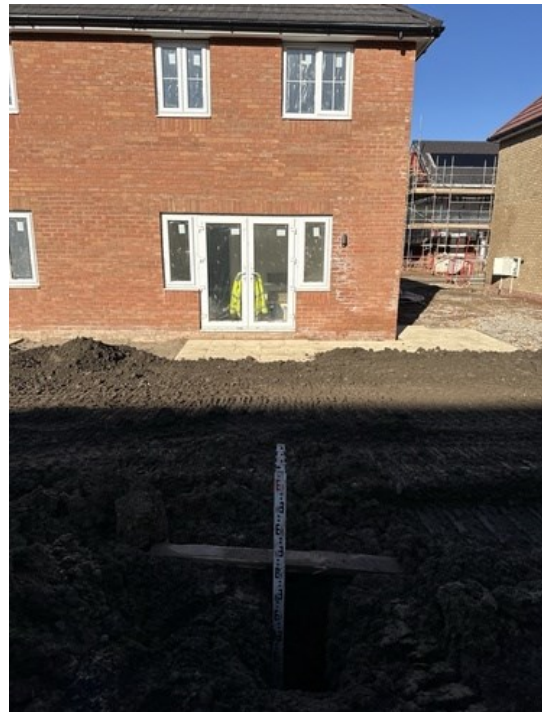
Photo 48

| Depth of Cover System in Relation to Plot (Ensure the whole plot can be seen in the photo) | <input checked="" type="checkbox"/> |

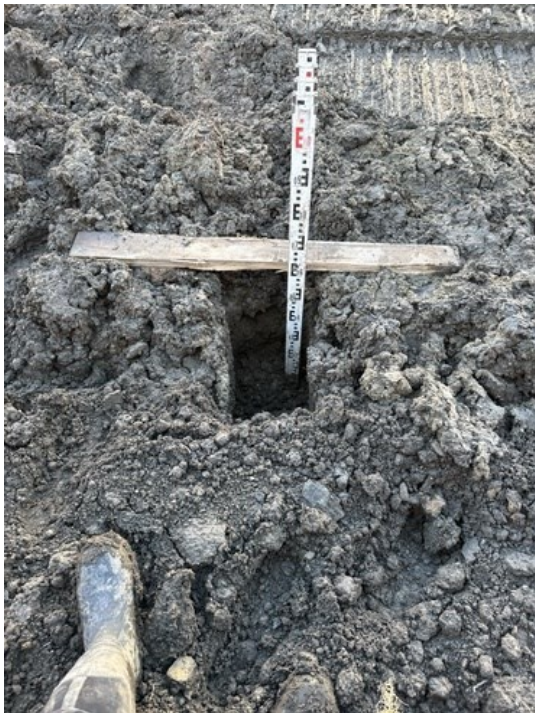
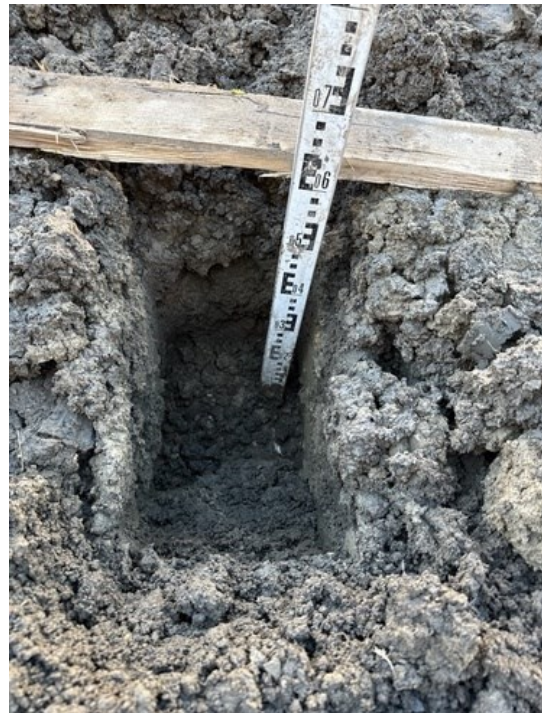
| Depth of Cover System Materials (record the depth and support with Photo down the hole) | | 600 |
| Depth of Topsoil (mm) | | 150 |
| Depth of Subsoil (mm) | | 450 |

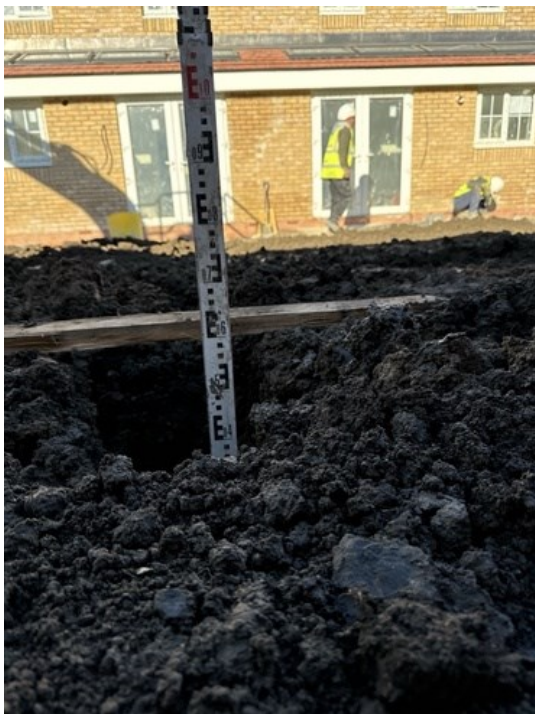
Photo 51

| Depth of Cover System at Ground Level (Photo) | | <input checked="" type="checkbox"/> |

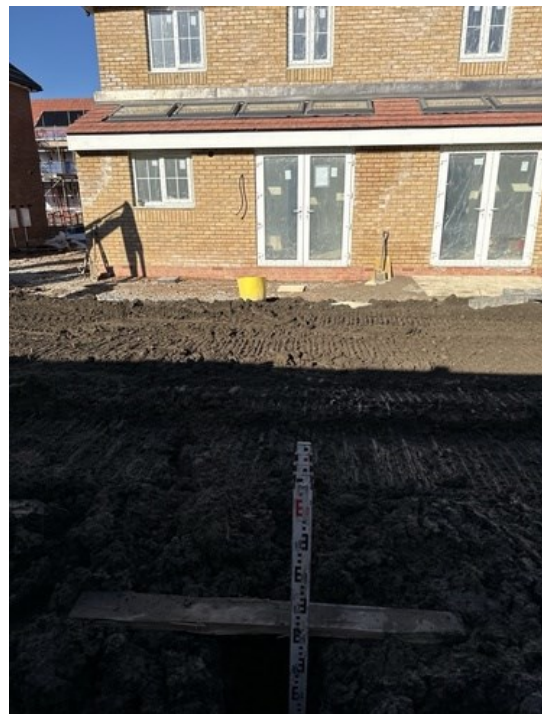
Photo 52

| Depth of Cover System in Relation to Plot (Ensure the whole plot can be seen in the photo) | | <input checked="" type="checkbox"/> |

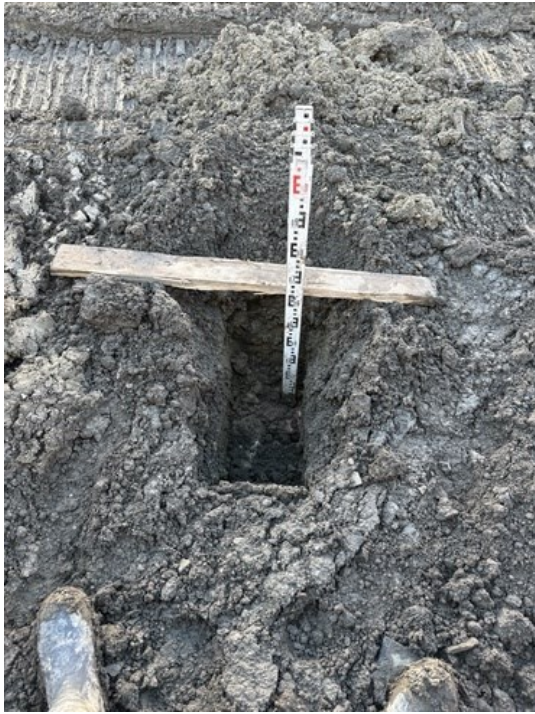
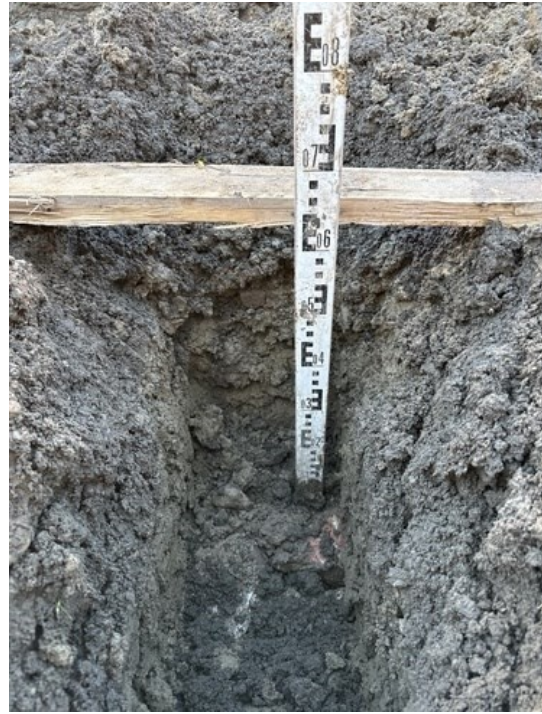
| <b>Depth of Cover System Materials (record the depth and support with Photo down the hole)</b> | 610 |
| <b>Depth of Topsoil (mm)</b> | 160 |
| <b>Depth of Subsoil (mm)</b> | 450 |

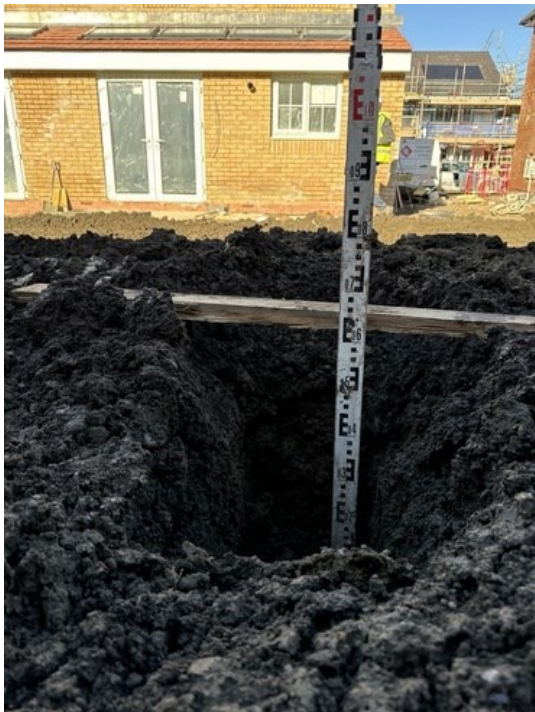
Photo 55

| <b>Depth of Cover System at Ground Level (Photo)</b> | ☒ |

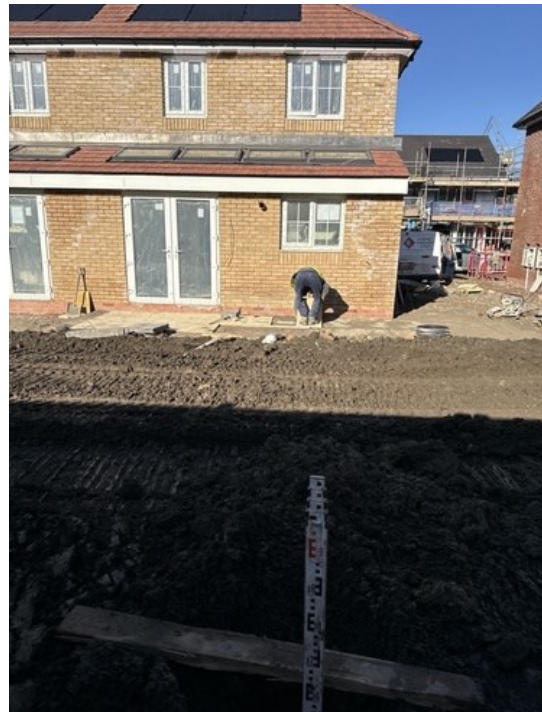
Photo 56

| <b>Depth of Cover System in Relation to Plot (Ensure the whole plot can be seen in the photo)</b> | ☒ |
