## GARDEN VALIDATION – ROYLE ROAD

| <b>Project Name:</b> | Royle Road |
| <b>Project Number:</b> | 11-778 |
| <b>Plots:</b> | 8, 120-134 |

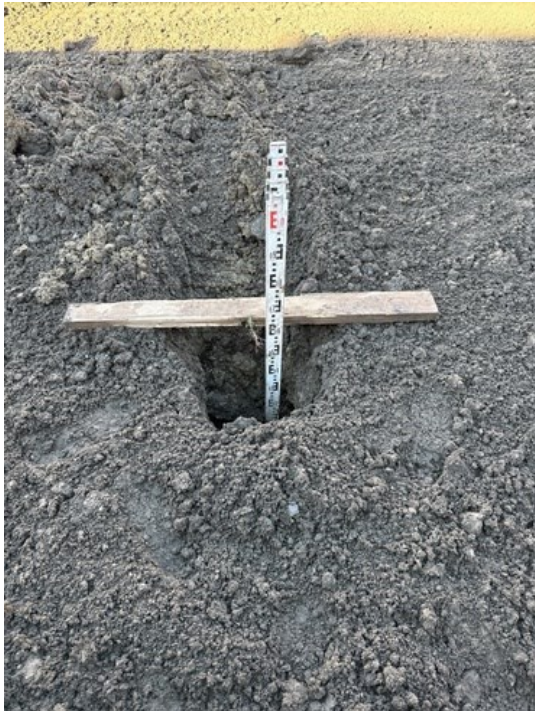
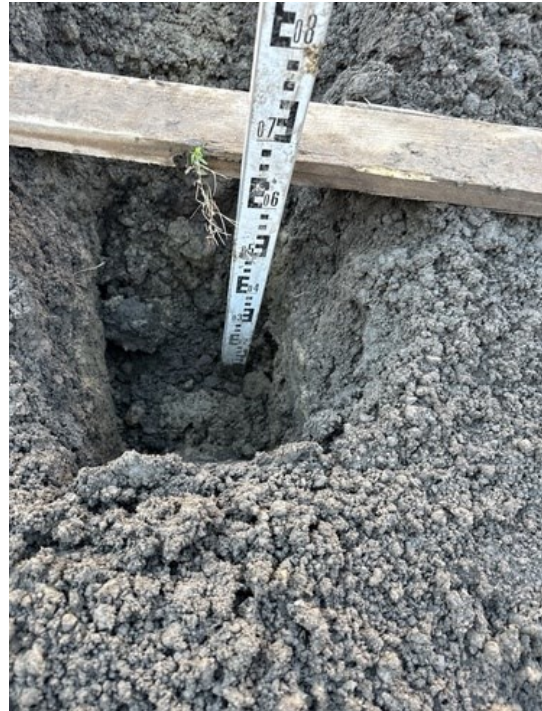
| <b>Depth of Cover System Materials (record the depth and support with Photo down the hole)</b> | 600 |

| Depth of Topsoil (mm) | 150 |

| Depth of Subsoil (mm) | 450 |

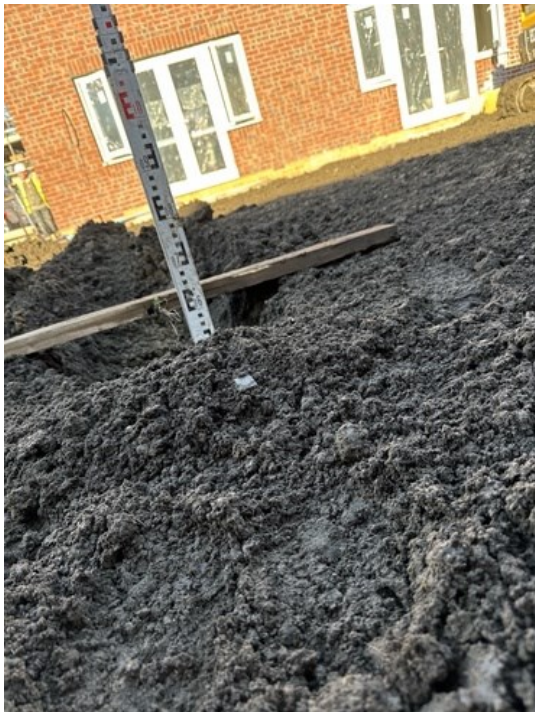
Photo 59

| Depth of Cover System at Ground Level (Photo) | <input checked="" type="checkbox"/> |

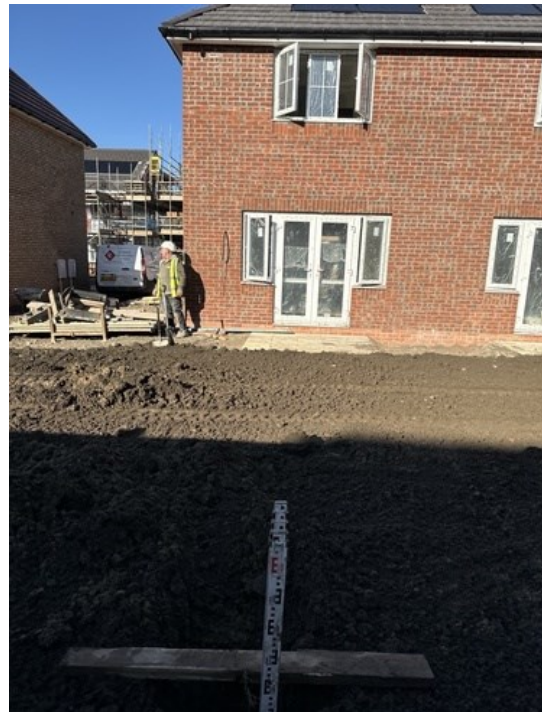
Photo 60

| Depth of Cover System in Relation to Plot (Ensure the whole plot can be seen in the photo) | <input checked="" type="checkbox"/> |

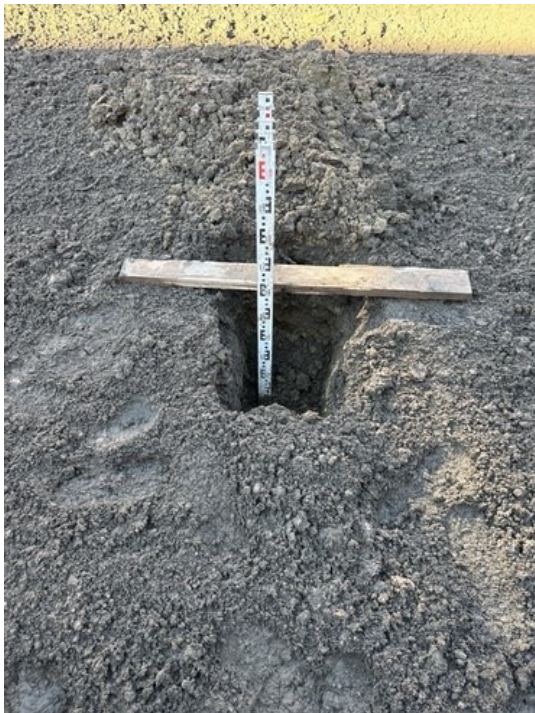
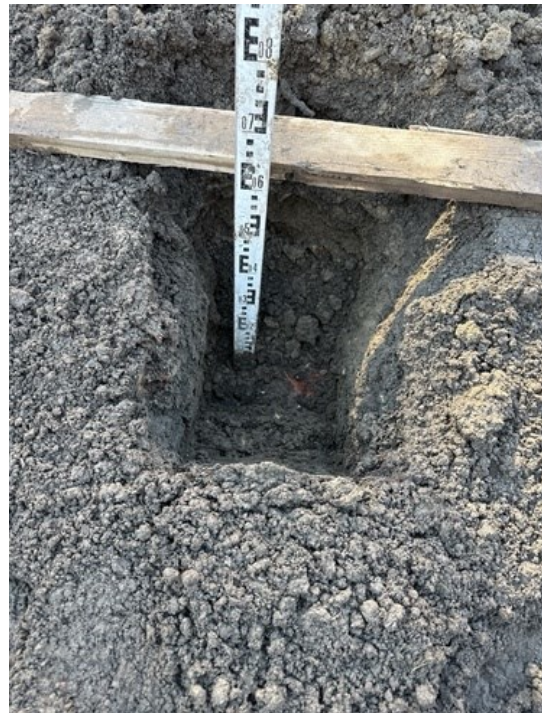
| Depth of Cover System Materials (record the depth and support with Photo down the hole) | 600 |

| Depth of Topsoil (mm) | 150 |

| Depth of Subsoil (mm) | 450 |

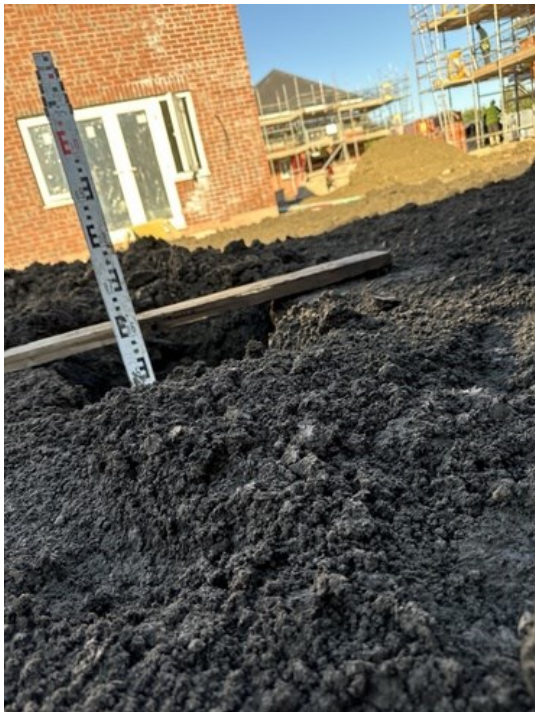
Photo 63

| Depth of Cover System at Ground Level (Photo) | <input checked="" type="checkbox"/> |

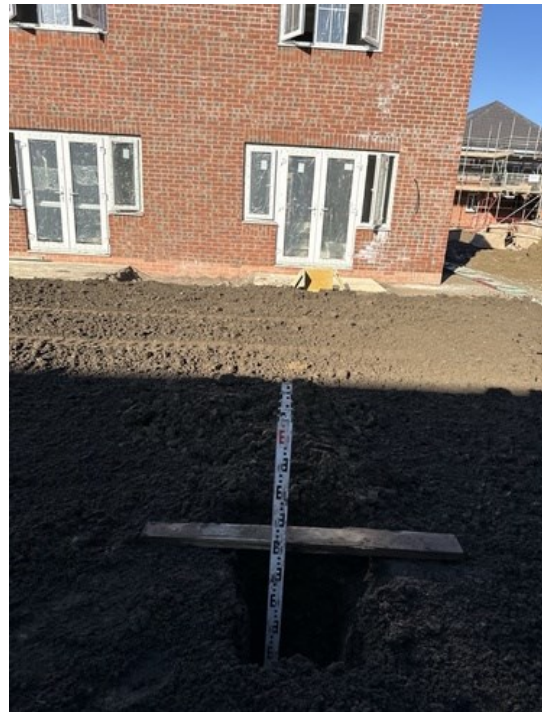
Photo 64

| Depth of Cover System in Relation to Plot (Ensure the whole plot can be seen in the photo) | <input checked="" type="checkbox"/> |
