**COWM TOP, CASTLETON**

**STAGE 1**

**Geoenvironmental Appraisal**

**R2228-R01-v2**

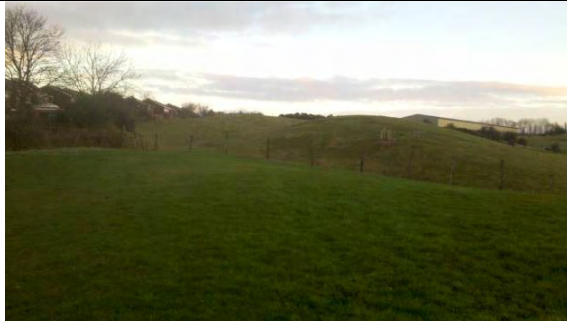
View north from mid-way along western boundary. Adjacent housing visible to west with industrial estate visible beyond northern boundary. Significant undulations in level within the site.

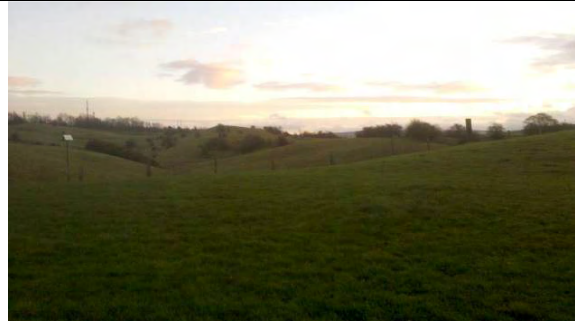
View north from mid-way along western boundary. Significant undulations in level within the site.

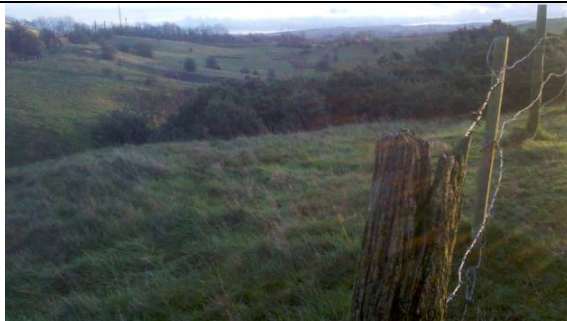
View east from near northwest corner. Significant undulations in level within the site.

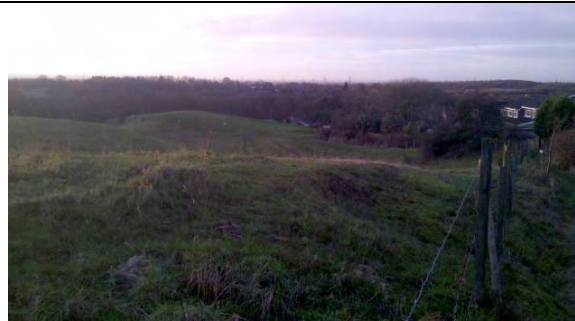
View east from near northwest corner. Significant undulations in level within the site.

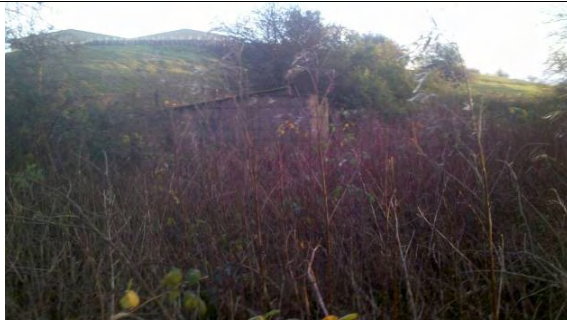
Northwest corner of site. Derelict building present in overgrown enclosure.

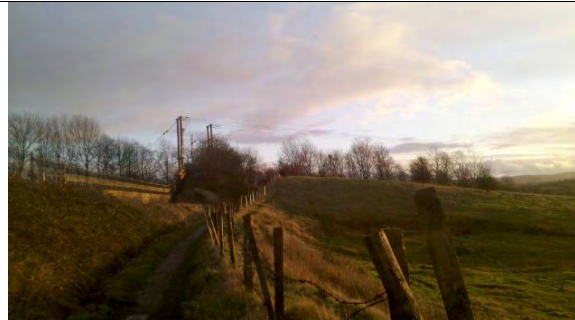
View east along cripple gate Lane which forms northern boundary.

- 5.6.3. Asbestos containing materials could be present in the fabric of the single remaining building on the site and if so could include damaged and therefore friable materials. Any loose fibrous asbestos on the site could pose a health risk to site workers if disturbed and not properly managed; furthermore the potential from off-site migration via wind blown dust exists from such materials. If the historical buildings present on or near the site boundary contained such materials and were demolished in an uncontrolled manner asbestos residues could be present in shallow soils. There is a general requirement to reduce asbestos exposure to as low as is reasonably practicable and the presence of any detectable concentrations of asbestos is not generally tolerated in shallow soils in a residential setting, in the absence of robust and defensible risk assessment techniques/criteria.

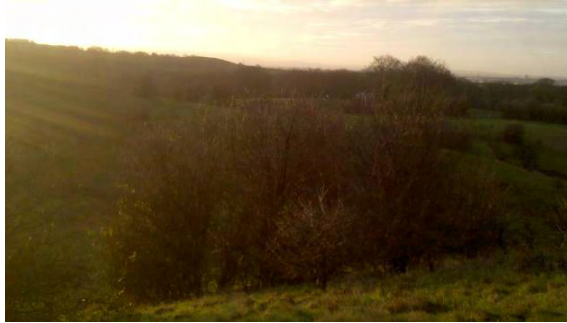
View south-southeast from central part of northern boundary. Significant undulations in level within the site.

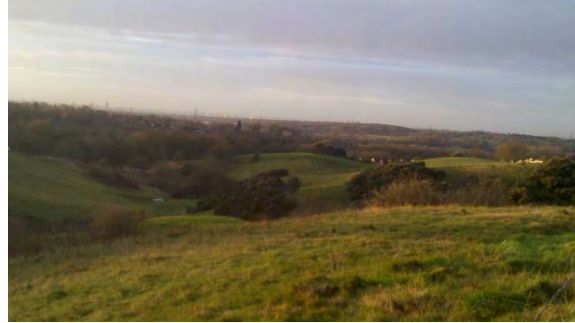
View south-southwest from central part of northern boundary. Significant undulations in level within the site. Farm and dwellings to south of site visible

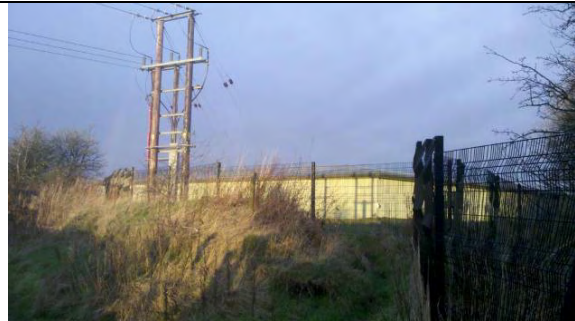
A627 (M) viewed from footbridge at end of Cripple Gate Lane near northeast corner of site.

Large building forming part of adjacent industrial estate to the north of Cripple Gate Lane near northeast corner of site. 2 overhead electricity lines enter site from the north.

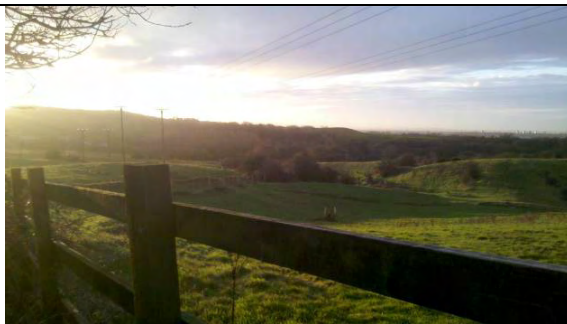
View south from northeast corner of the site. Overhead electricity lines cross eastern parts of site.

| <b>Industrial Land use and Infrastructure</b> | <p>On-site activities appear to have been restricted to agricultural uses of the land. Infrastructure identified within the site are restricted to the high pressure gas pipeline and overhead electricity lines observed during the site walkover, although other utility services could exist.</p> <p>Off-site to the south a large former print works was present, parts of which are now used for vehicle repair, light manufacturing and metal processing. A large, modern industrial estate has been constructed to the north of the site which appears to be mainly used for warehousing and storage. It appears unlikely that either of these would have impacted the site in any way.</p> <p>Major roads exist to the east and south of the site, although these are not immediately adjacent to the potentially developable areas being separated by a large steep cutting slope and the Trows Lane and the adjacent reservoirs and embankment.</p> |

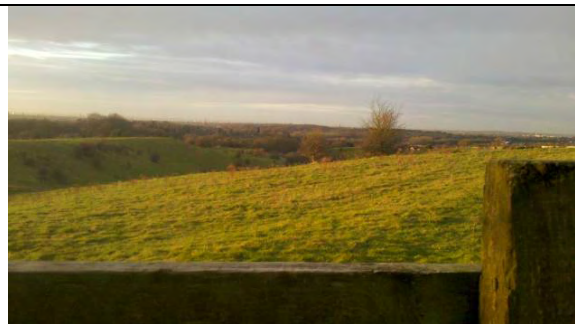
View south from northeast corner of the site.

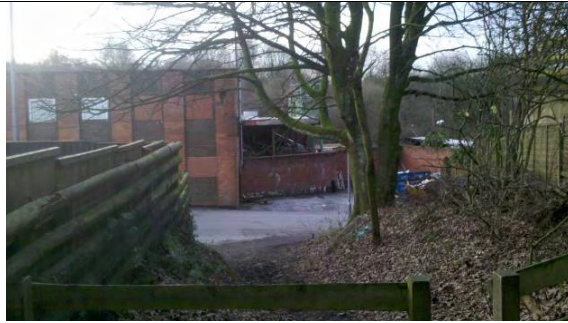
View south from southern end of footpath which bounds west of site. Trows house (off site) to east. Die cast works with bulk storage tanks opposite on south of Trows Lane

5.3.3. Minor volumes of fuels, hydrocarbons and other potentially mobile contaminants may be associated with the light industry and vehicle repair further up the valley to the south of the eastern parts of the south boundary.

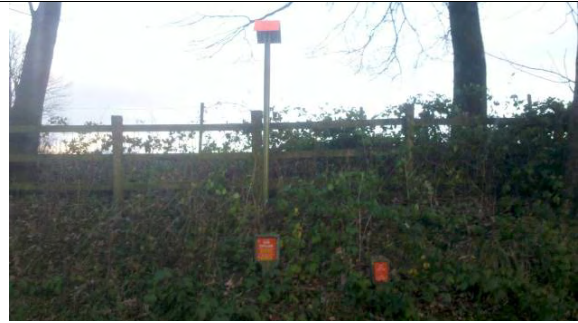
Marker for high pressure gas pipeline on north of Trows Lane at western end of southern boundary.

| <b>Services and Utilities</b> | SGP noted warning signs and marker posts for a high pressure gas main near the western ends of the southern and northern site boundaries: a number of marker posts are also present within the site which appear to link these two locations, indicating the presence of a high pressure gas pipeline crossing the west of the site. Two overhead electricity lines enter the site from the northeast corner and cross the northeast part of the site although the location where they exit the site to the east or south was not confirmed during the site walkover. Other indicators of utilities crossing the site were not observed, however the survey does not constitute a comprehensive utility services search and other energy, drainage, water supply and communications equipment may be present on the site. |

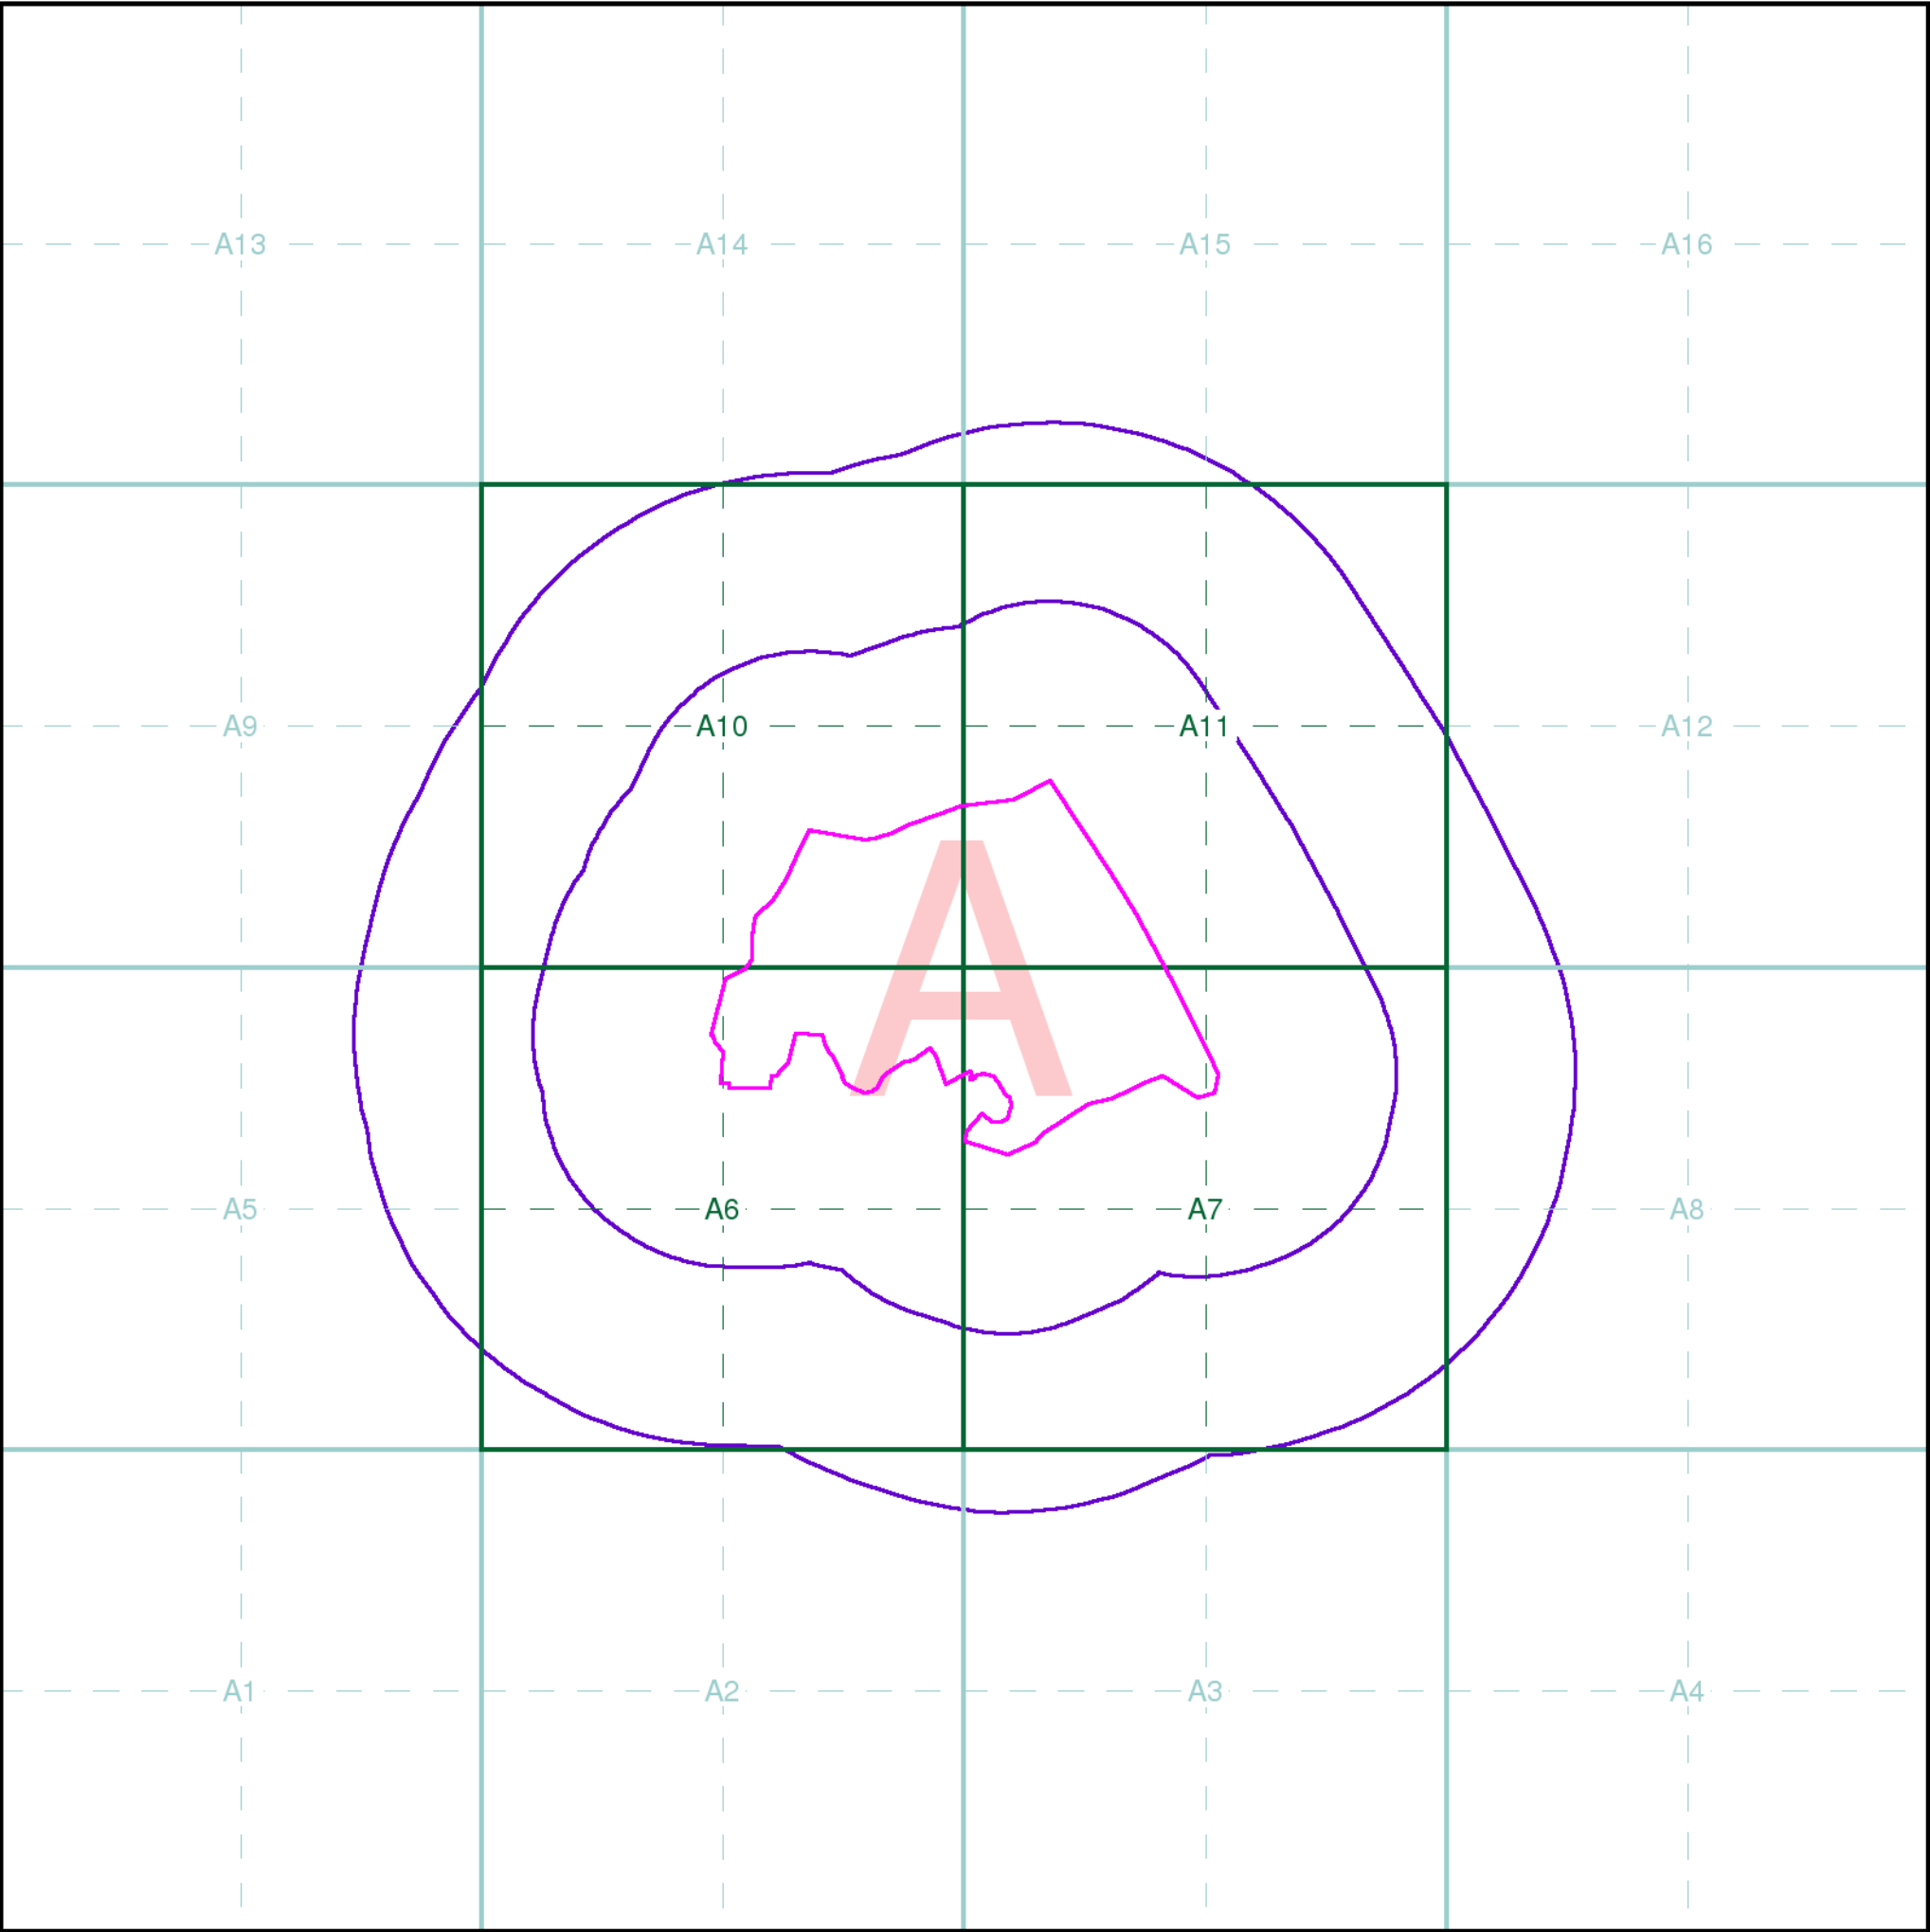
For ease of identification, your site and buffer have been split into Slices, Segments and Quadrants. These are illustrated on the Index Map opposite and explained further below.

**Quadrant**  
A quadrant is a quarter of a segment. These are labelled as NW, NE, SW, SE and are referenced in the datasheet to allow features to be quickly located on plots. Therefore a feature that has a quadrant reference of A7NW will be in Slice A, Segment 7 and the NW Quadrant.

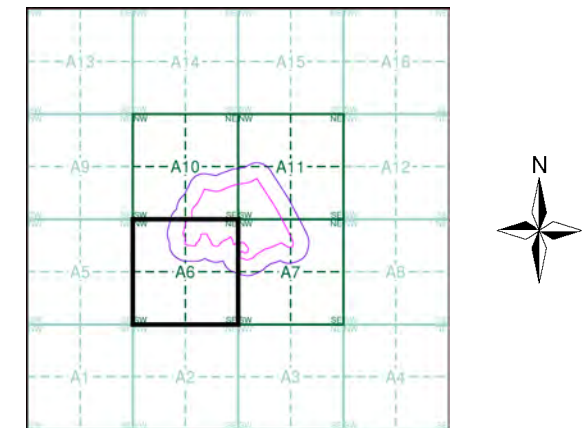
### Mining and Ground Stability - Segment A6

- Upward Movement > 3.5mm per year ●
- Upward Movement 1.5mm to 3.5mm per year ●
- Stable 1.5mm to -1.5mm per year ●
- Downward Movement -1.5mm to -3.5mm per year ●
- Downward Movement > -3.5mm per year ●

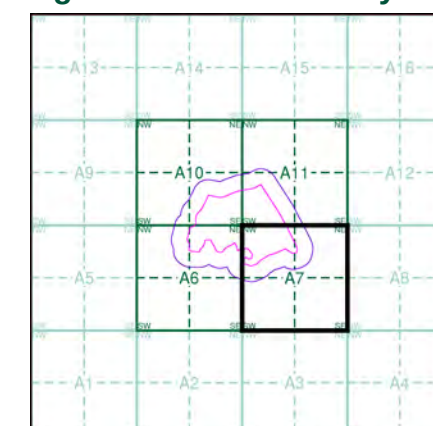
## Mining and Ground Stability - Segment A7

- Upward Movement > 3.5mm per year ●
- Upward Movement 1.5mm to 3.5mm per year ●
- Stable 1.5mm to -1.5mm per year ●
- Downward Movement -1.5mm to -3.5mm per year ●
- Downward Movement > -3.5mm per year ●

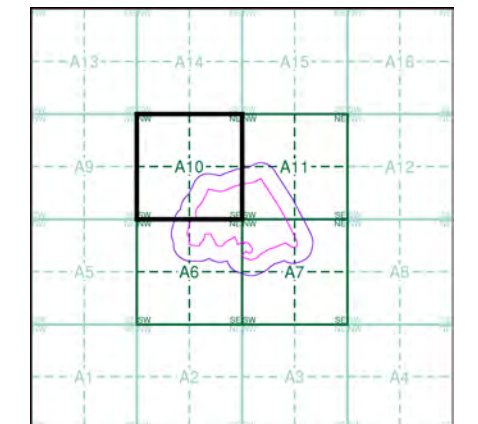
## Mining and Ground Stability - Segment A10

- Upward Movement > 3.5mm per year ●
- Upward Movement 1.5mm to 3.5mm per year ●
- Stable 1.5mm to -1.5mm per year ●
- Downward Movement -1.5mm to -3.5mm per year ●
- Downward Movement > -3.5mm per year ●

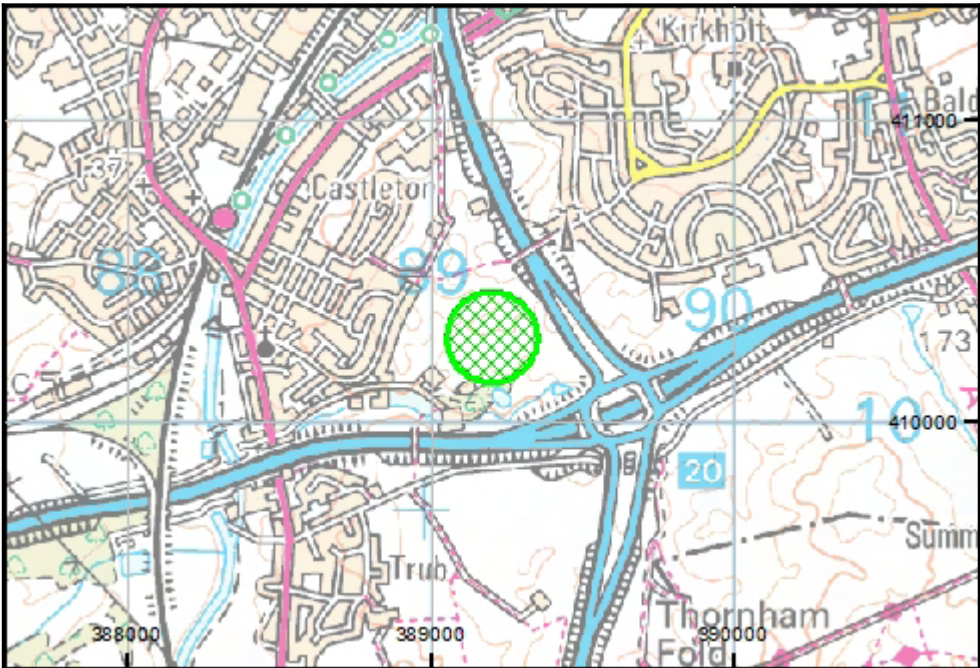
Approximate position of property

Enquiry boundary
