# LITTLEBOROUGH FIRE STATION LITTLEBOROUGH

## PHASE 2 GEO-ENVIRONMENTAL INVESTIGATION, RISK ASSESSMENT AND REMEDIATION STRATEGY

**Job Number:** LKC 21 1310

**Client:** Greater Manchester Combined Authority

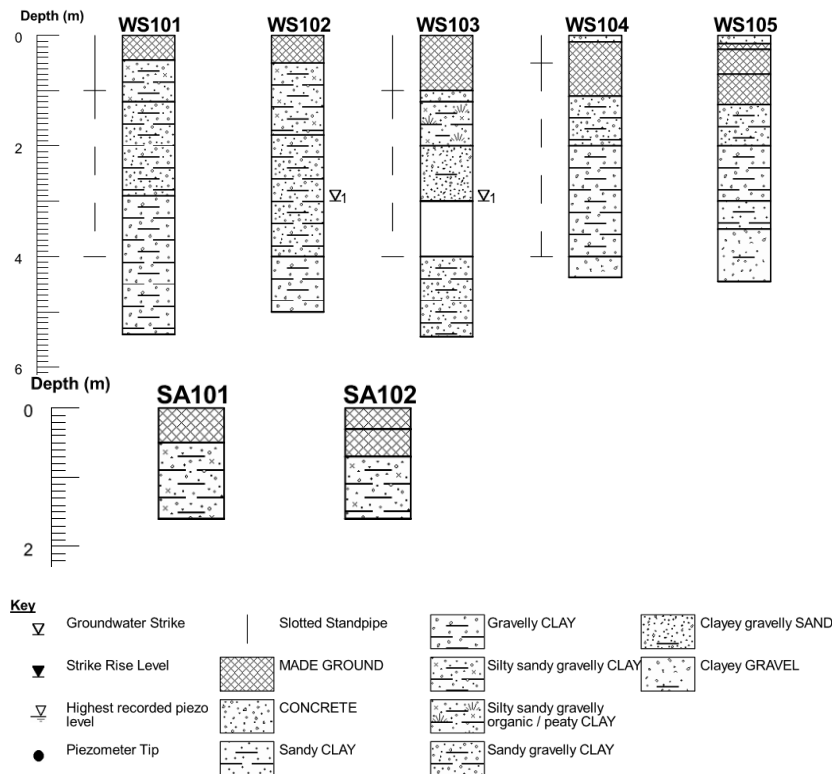
Plate 4-1: Summary of ground conditions.

- Made Ground was recorded to depths of 0.45-1.25mbgl and generally consisted of variably sandy gravelly silt with clinker and slightly gravelly sandy silty clay. WS104 and WS105 were noted to have a hardstanding layer of tarmacadam. Exceptions to this were:

- A land drain was encountered in SA102 at 0.40mbgl.
- Slight surfactant type odour noted in WS104 0.15-1.00mbgl.
- Slight organic odour noted in WS105 1.25-2.00mbgl.

- Foundation pits observed concrete footing stepping out 0.20mbgl in both pits at 1.20mbgl. A clay pipe was encountered in FTP1 0.50mbgl.

Ground conditions identified at the site are detailed in Section 4.1, and typically comprises Made Ground up to 1.25mbgl over natural cohesive superficial deposits of CLAY. Organic CLAY was encountered at a depth of between 1.20-2.00mbgl within WS103. It is believed that bedrock may have been encountered at the locations of WS104 and WS105 at depths of between 3.50m and 4.00mbgl.

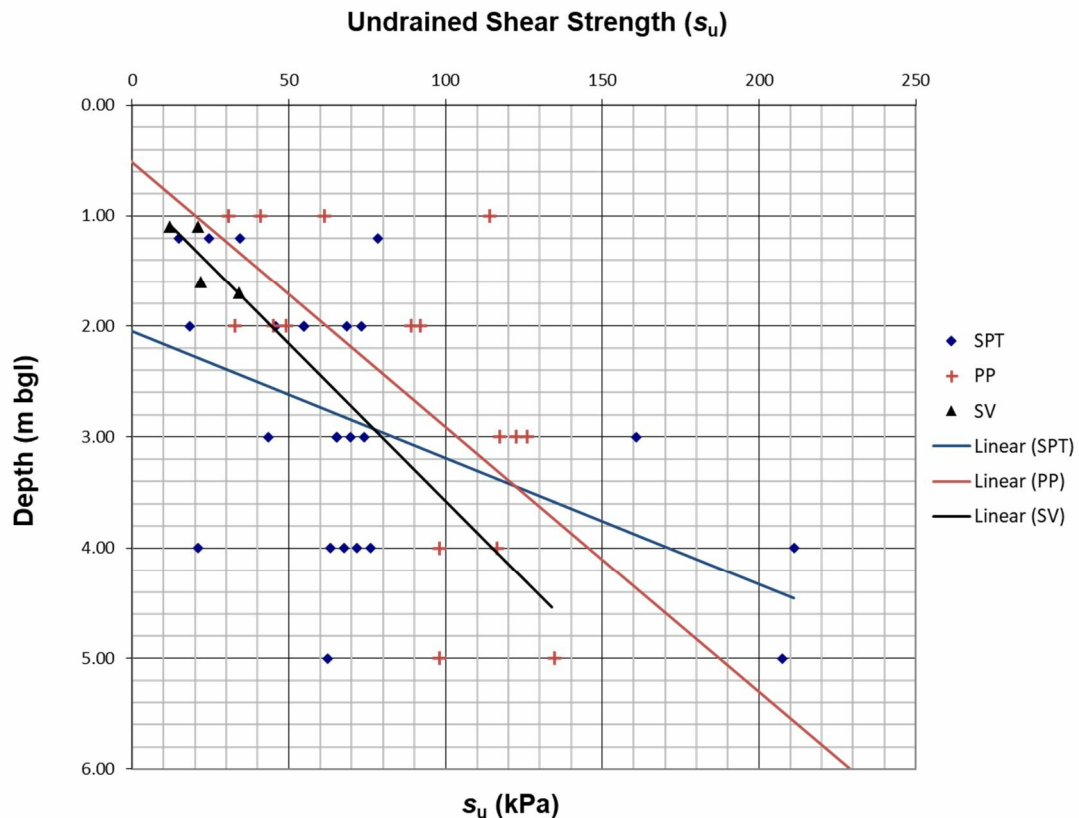
Graph 5-1: Summary of  $s_u$  vs depth from in-situ SPT, PP and SV testing.

From Graph 5-1 it can be seen that the strength of the cohesive deposits typically increase with depth in all three types of in-situ testing.

A conservative  $s_u$  of 30kPa is assigned to the cohesive material from a depth of c. 1.2mbgl for the natural superficial deposits, returning an allowable bearing capacity (ABC) of 62kN/m<sup>2</sup> for strip/trench fill foundations.

Strip foundations should be constructed at least 150mm in to the underlying firm CLAY. At this depth an allowable bearing capacity of 62kN/m<sup>2</sup> has been calculated using a Factor of safety of 2.5 and an undrained shear strength ( $s_u$ ) of 30kN/m<sup>2</sup> taken from Graph 5-1.

Should foundations be taken to 2.00mbgl by deep strip/trench, then an ABC of 103kN/m<sup>2</sup> could be achieved, utilising an  $s_u$  of 50kPa.

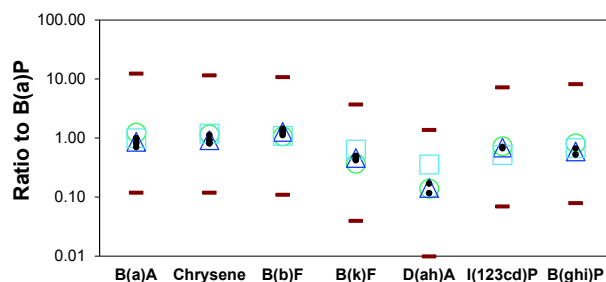
Graph 6-1: The ratio of PAH to B(a)P in soil for all available data at the site based on 6 samples (where values were >LOD to allow the calculation of a ratio).

Graph 6-1 summarises the study site data with respect to how the ratios of carcinogenic PAHs relate to B(a)P, within the confidence limits provided in the HPA document.

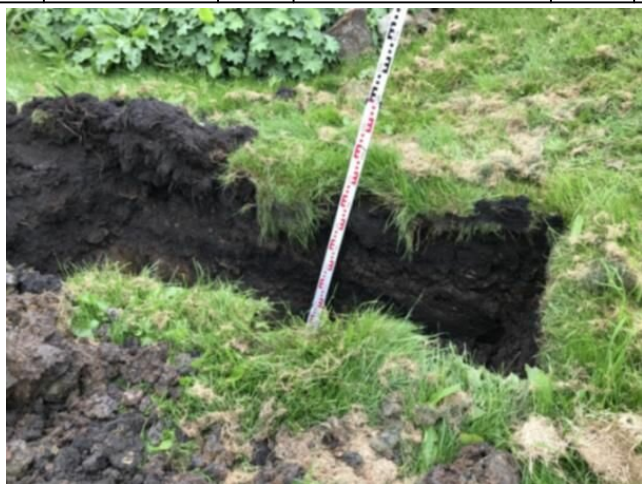
Elevation estimated using [www.freemaptools.com/elevation-finder.htm](http://www.freemaptools.com/elevation-finder.htm)  
Grid reference accurate for 3-5 meters.  
Pit was stable and dry.  
Soakaway test carried out within pit, see separate sheet.  
Clay strata noted to contain a high gravel content and to be friable.

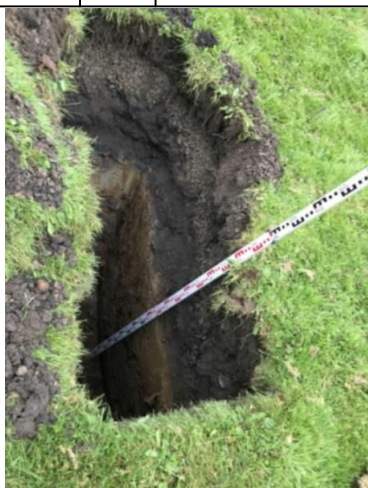
Elevation estimated using [www.freemaptools.com/elevation-finder.htm](http://www.freemaptools.com/elevation-finder.htm)  
Grid reference accurate for 3-5 meters.  
Pit was stable and dry.  
Soakaway test carried out within pit, see separate sheet.  
Clay strata noted to contain a high gravel content and to be friable.

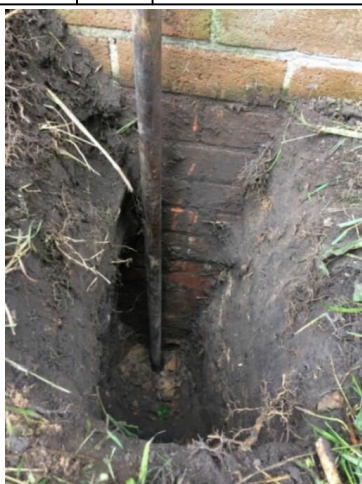
Location is from handheld GPS and is accurate to 3-5m.  
Elevation estimated using [www.freemaptools.com/elevation-finder.htm](http://www.freemaptools.com/elevation-finder.htm)  
Trial pit stable.  
Water encountered at 1.20mbgl beside concrete footing.  
Concrete footing encountered at 1.20 mbgl stepping out 0.20m.  
Thickness of footing not determined due to depth and presence of groundwater.

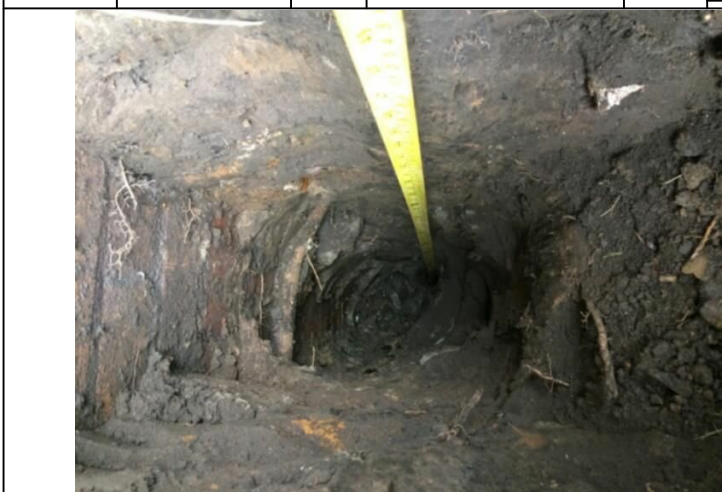
Location is from handheld GPS and is accurate to 3-5m.  
Grid reference estimated using www.gridreferencefinder.com  
Trial pit is stable.  
Water encountered perched on concrete footing.  
Concrete footing encountered at 1.20 mbgf stepping out 0.20m.  
Thickness of footing not determined due to depth and presence of groundwater.
