**Rochdale Town Hall  
Restoration and Transformation**

**Mammal Excavation  
Precautionary Working  
Method Statement**

**October 2022**

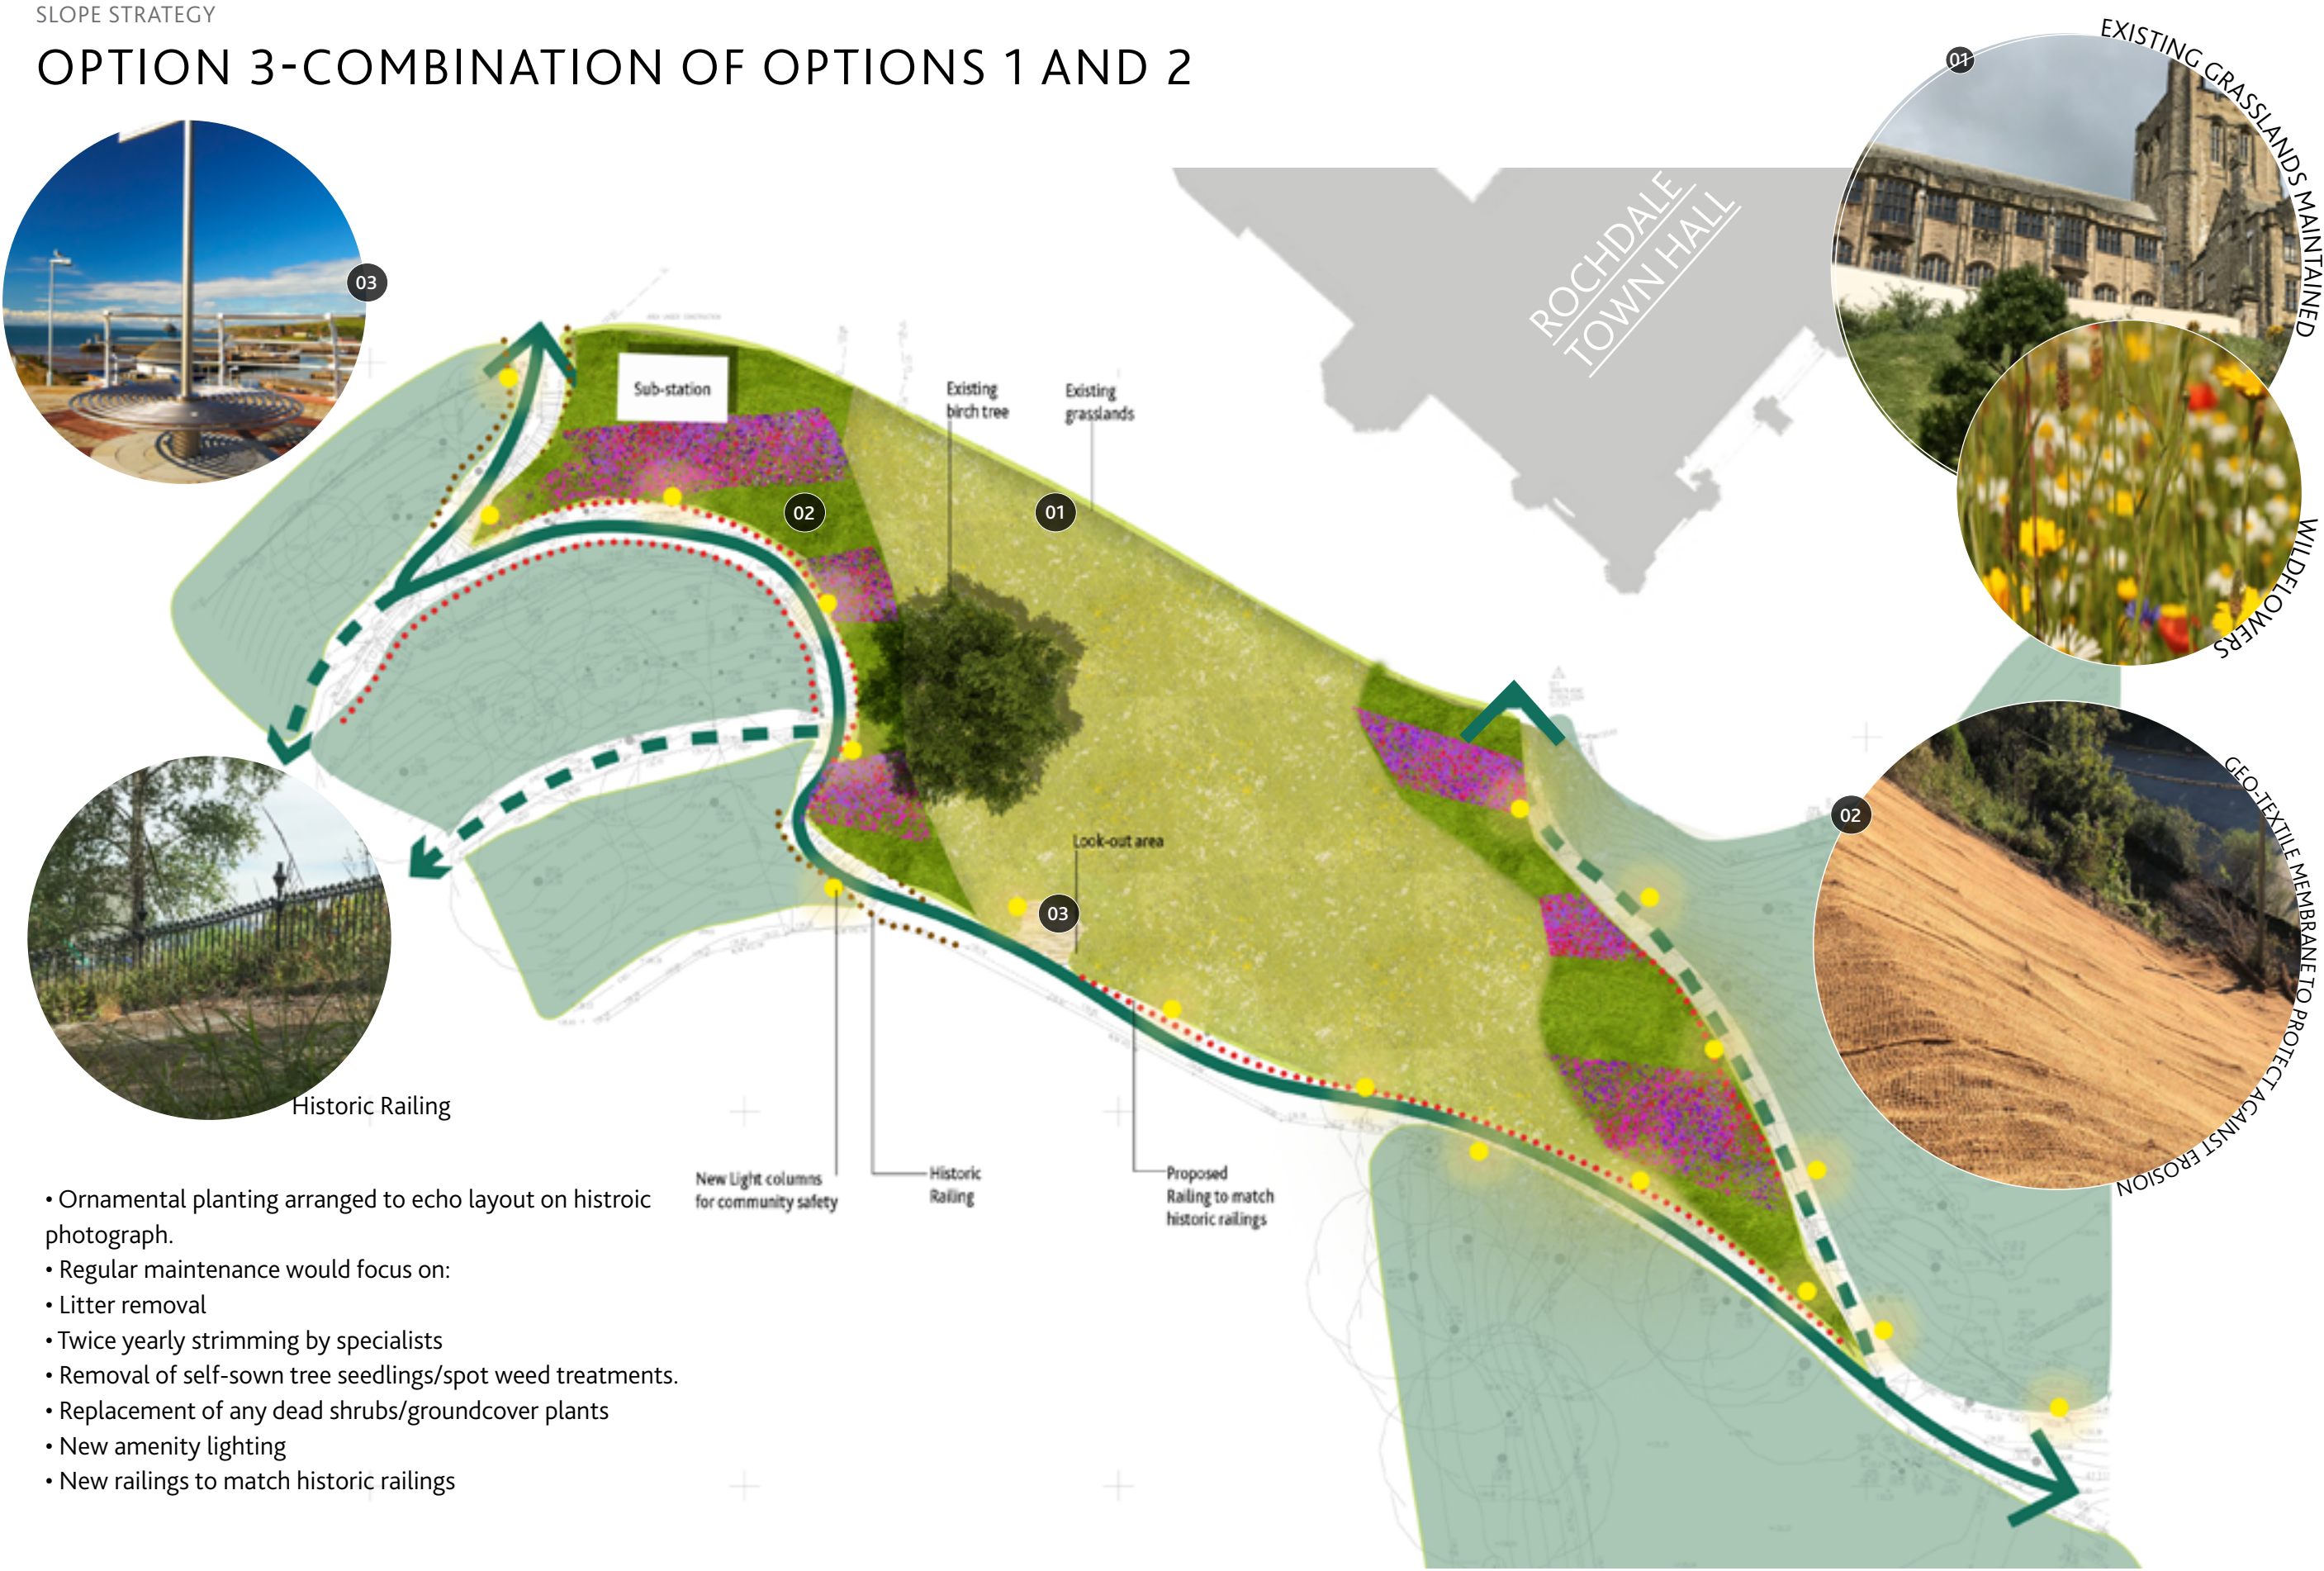
OPTION 3-COMBINATION OF OPTIONS 1 AND 2

- Ornamental planting arranged to echo layout on historic photograph.
- Regular maintenance would focus on:
  - Litter removal
  - Twice yearly strimming by specialists
  - Removal of self-sown tree seedlings/spot weed treatments.
  - Replacement of any dead shrubs/groundcover plants
- New amenity lighting
- New railings to match historic railings
