# ARBORICULTURAL IMPLICATIONS ASSESSMENT

PROPOSED DEVELOPMENT

West Hill House, 158-170 Manchester Road  
Rochdale

Author: C. Salisbury  
Date: 27 February 2025  
Ref: TRE/WHHMR/Rev A

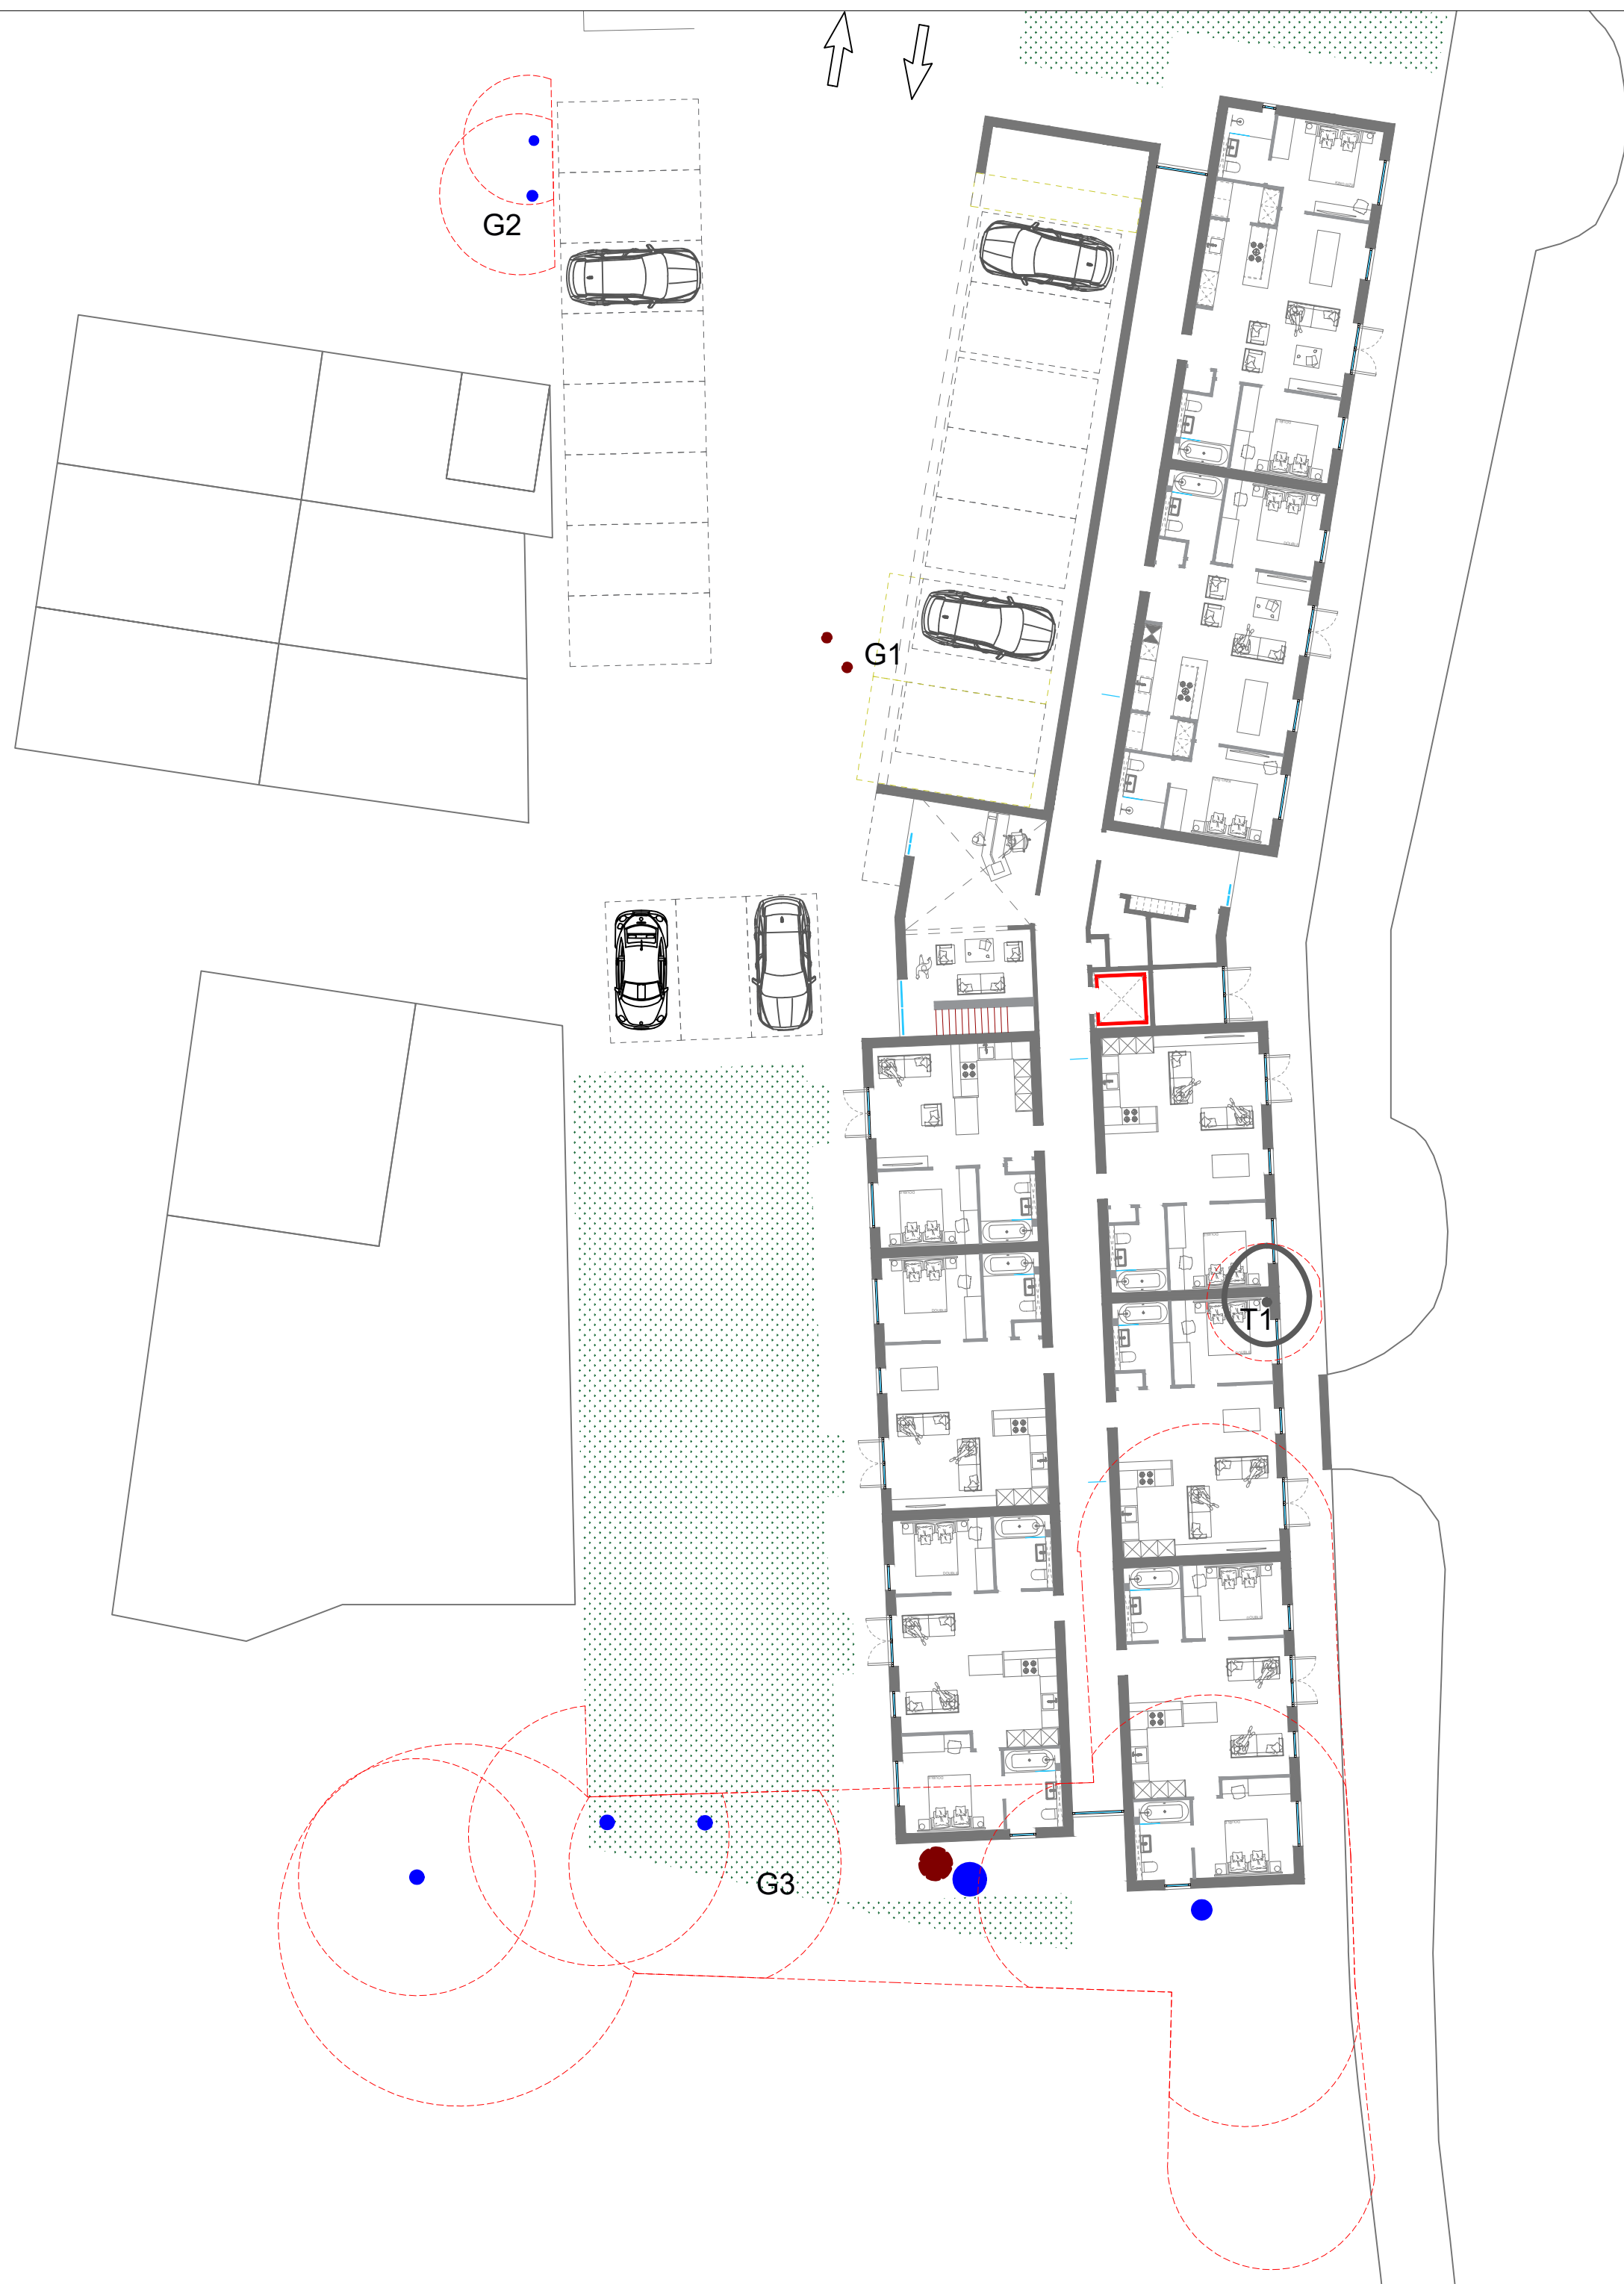
Drawing No:  
WHHR/AIS/01 Rev A

- 3.1 Due to the proposed development and its associated infrastructure there are a number of locations where the proposals are in close proximity to the trees surveyed. The Site Layout Plan within appendix three identifies the trees in relation to the proposed development.
- 3.2 In order to fully assess the impact of the proposals an Impact Table has been created detailing each tree, which shows the proximity of the associated works to the tree.
- 3.3 This can then be assessed in accordance with BS 5837:2012 to determine whether the development will have a detrimental impact on the health of each tree. Once this has been determined remedial measures can be detailed to reduce the impact the proposals will have on the treescape.

Drawing Title:  
AIS Plan
