# ARBORICULTURAL IMPLICATIONS ASSESSMENT

LAND TO THE WEST OF NEW STREET  
LITTLEBOROUGH

Author: C. Salisbury  
Date: 21 July 2022  
Ref: TRE/P3NL/Rev B

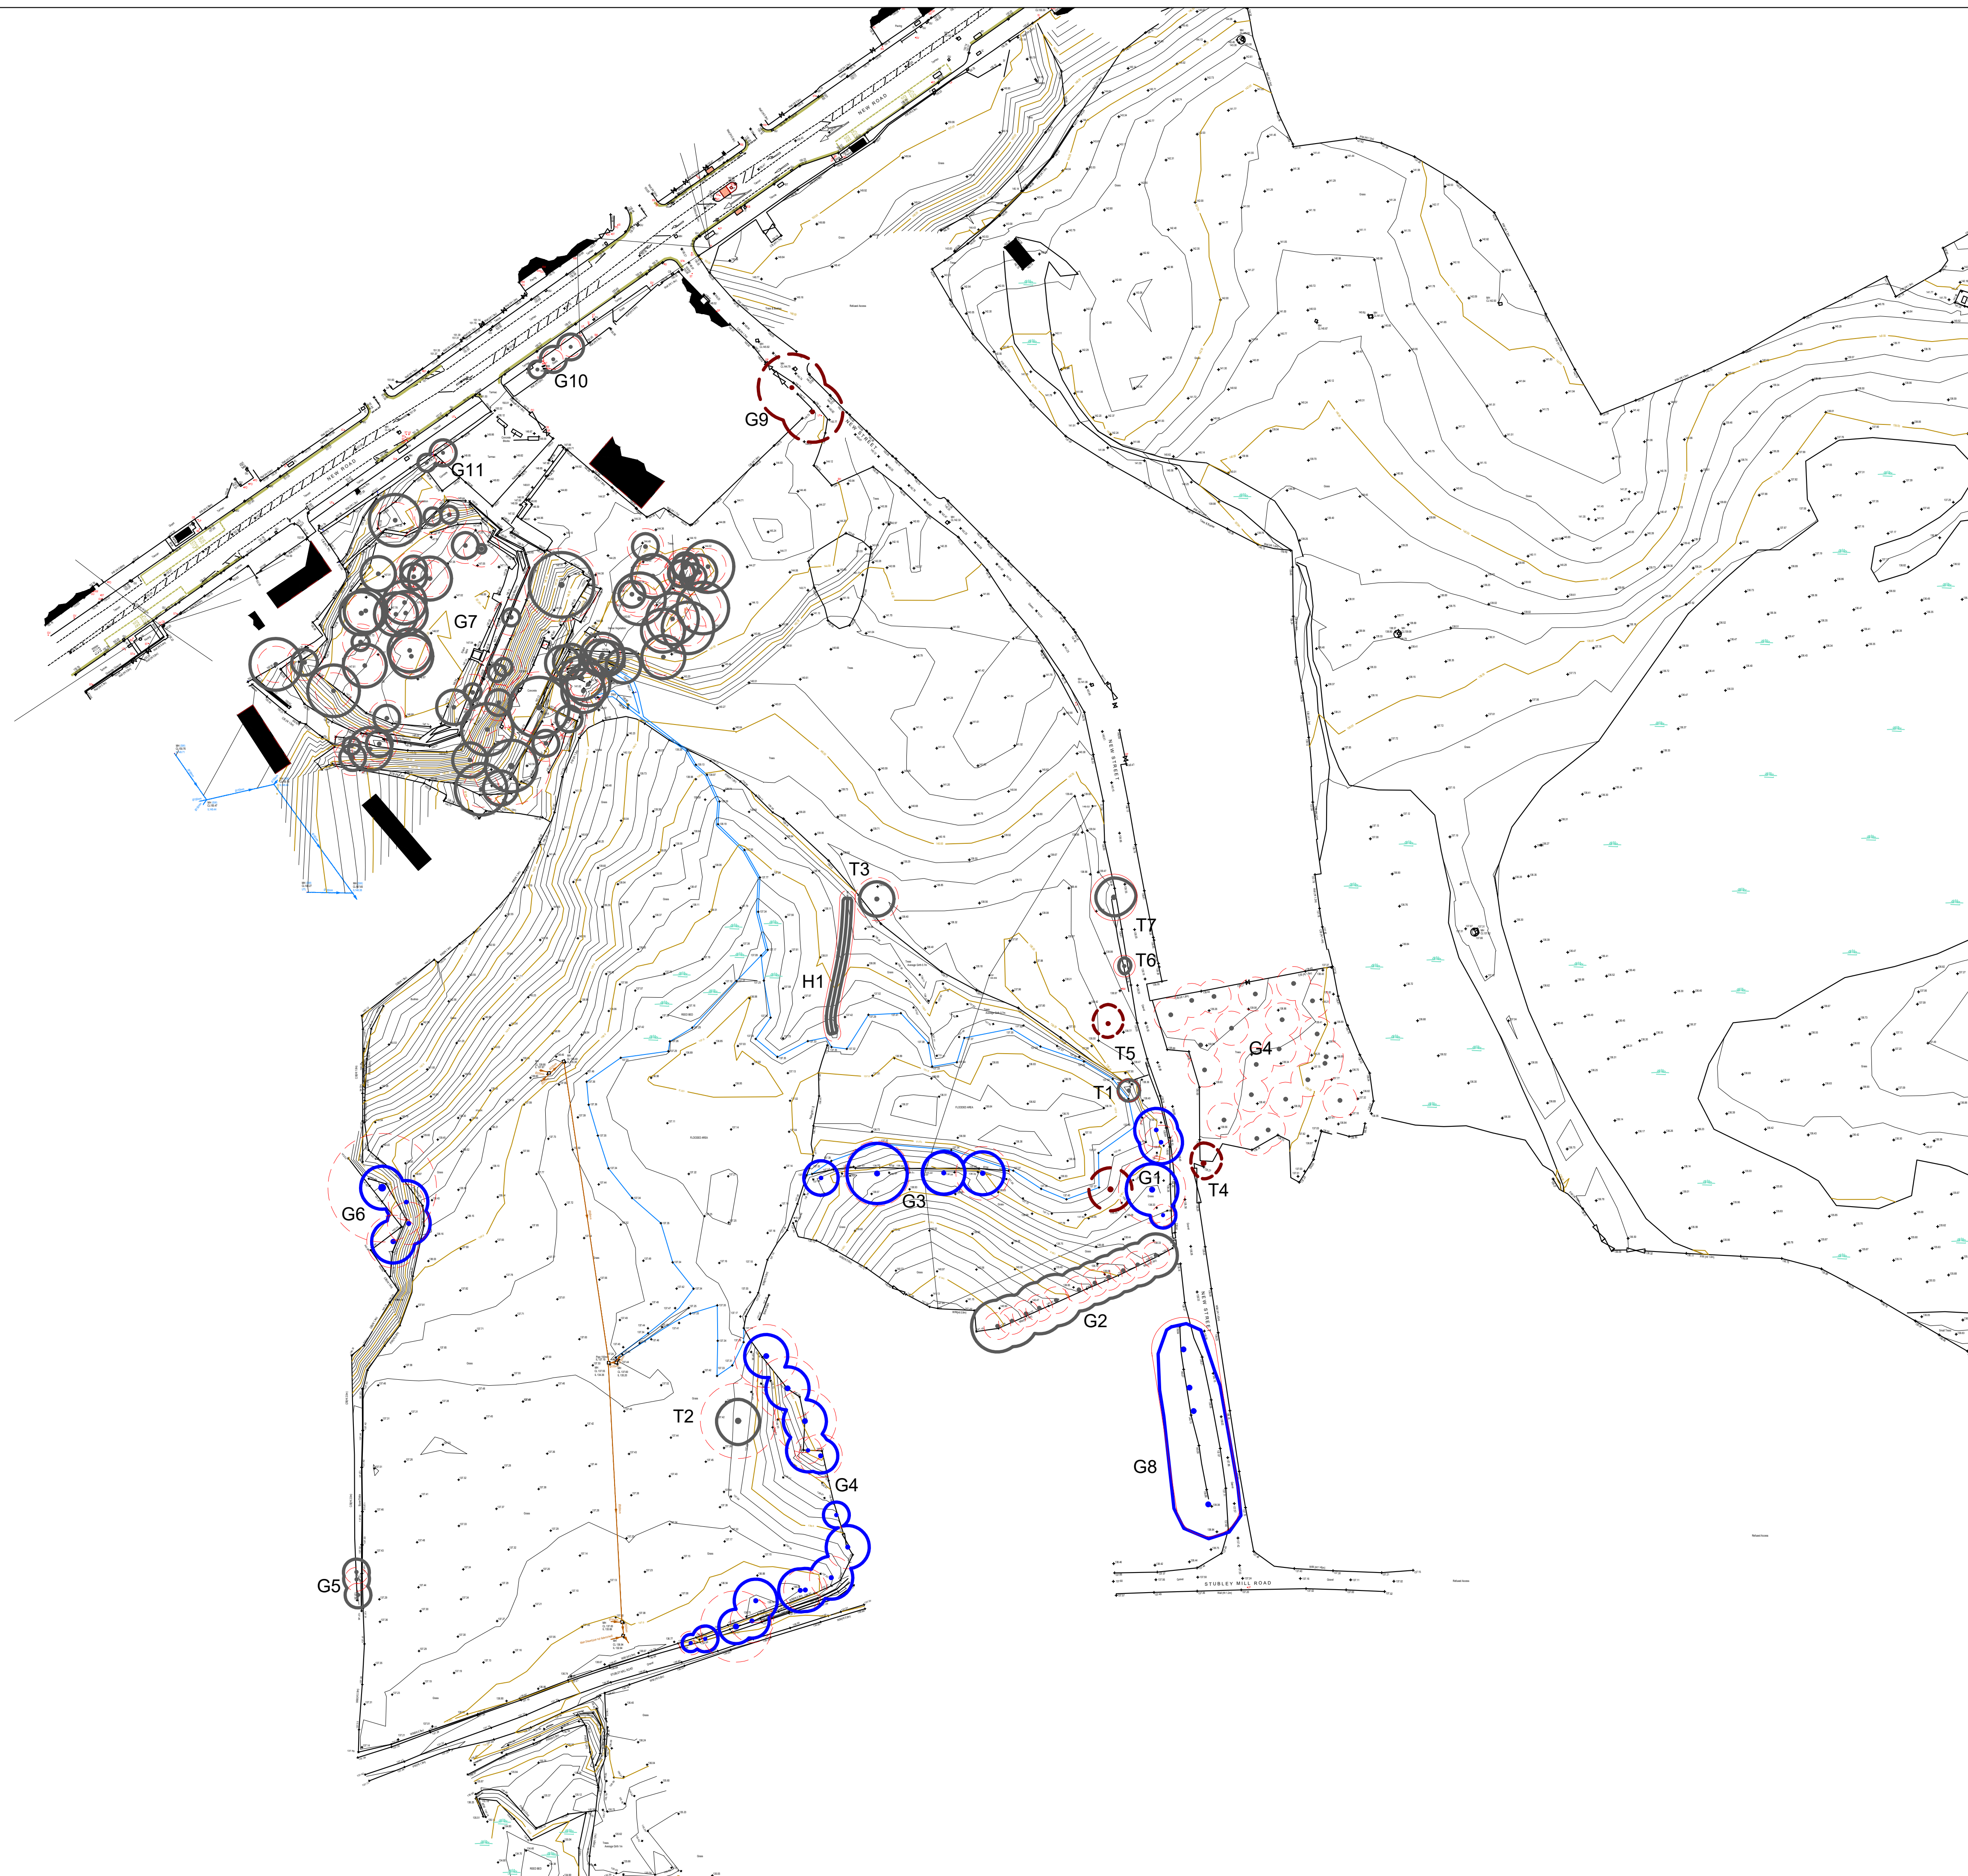
Drawing No:  
NL/BS/01 Rev. B

Drawing Title:  
BS5837 Plan

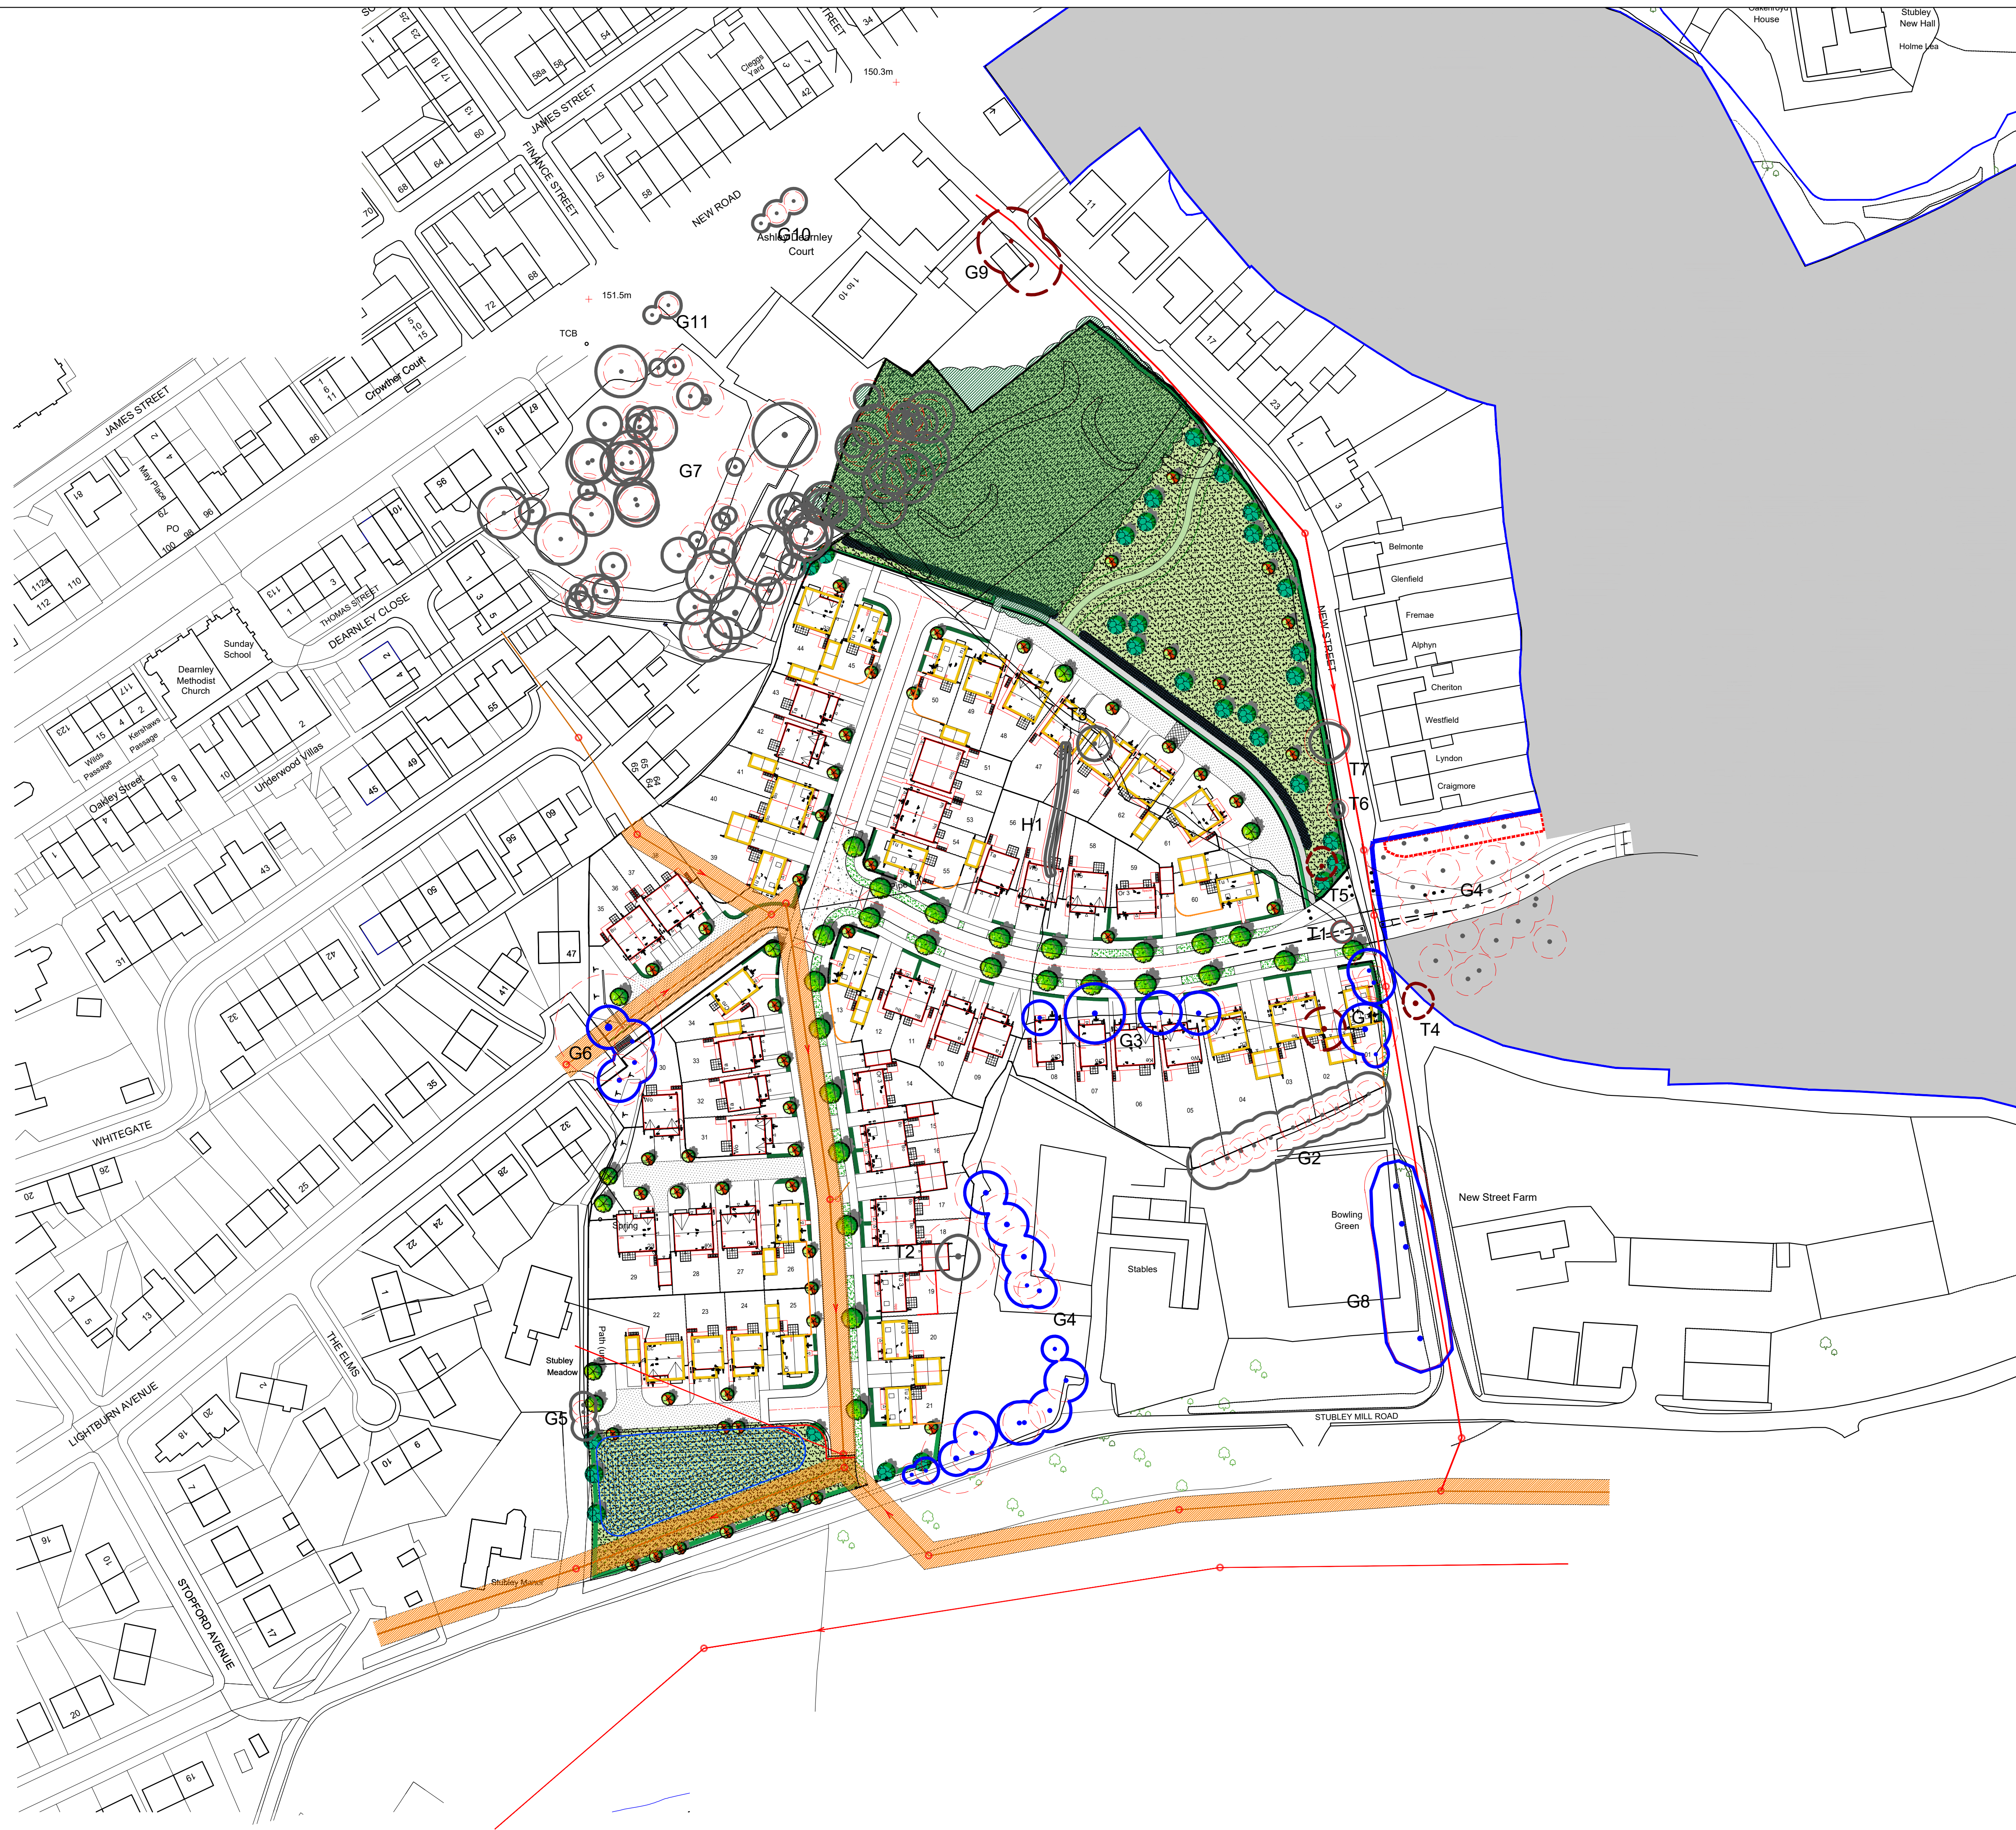
Drawing No:  
NL/AIS/01 Rev. B

Drawing Title:  
AIS Plan

- 3.1 Due to the proposed development and its associated infrastructure there are a number of locations where the proposals are in close proximity to the trees surveyed. The Site Layout Plan within appendix three identifies the trees in relation to the proposed development.
- 3.2 In order to fully assess the impact of the proposals an Impact Table has been created detailing each tree, which shows the proximity of the associated works to the tree.
- 3.3 This can then be assessed in accordance with BS 5837:2012 to determine whether the development will have a detrimental impact on the health of each tree. Once this has been determined remedial measures can be detailed to reduce the impact the proposals will have on the treescape.
