Arboricultural  
Impact Assessment  
with  
Arboricultural Method Statement

**11a Bramhall Close  
Milnrow  
OL16 4BX**

Project No. AIA.13971.02

14<sup>th</sup> May 2025

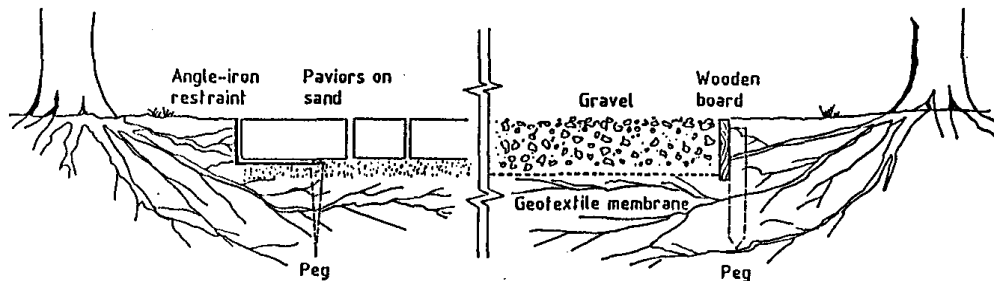
Example of a light-duty drive constructed using the **Minimum Dig Method**.

- 4.3.1. It is recommended that the proposed driveway within the RPA of **G1**, **T2** and **T13** be constructed in a manner that would not cause the adjacent tree any long-term harm. In this instance, it is recommended that a 'Minimum-Dig' method is used.

- 4.3.2. Excavations within the RPA must only be undertaken by hand to establish the presence of roots. Any tree roots exposed within the RPA must be left as intact as careful digging with hand tools will allow, avoiding the use of heavy machinery within the RPA.

- 4.3.3. No more than 100mm of soil should be removed before the ground is inspected for roots. Depending on the presence of roots it may then be acceptable to remove a further 50mm of soil down to the required depth.

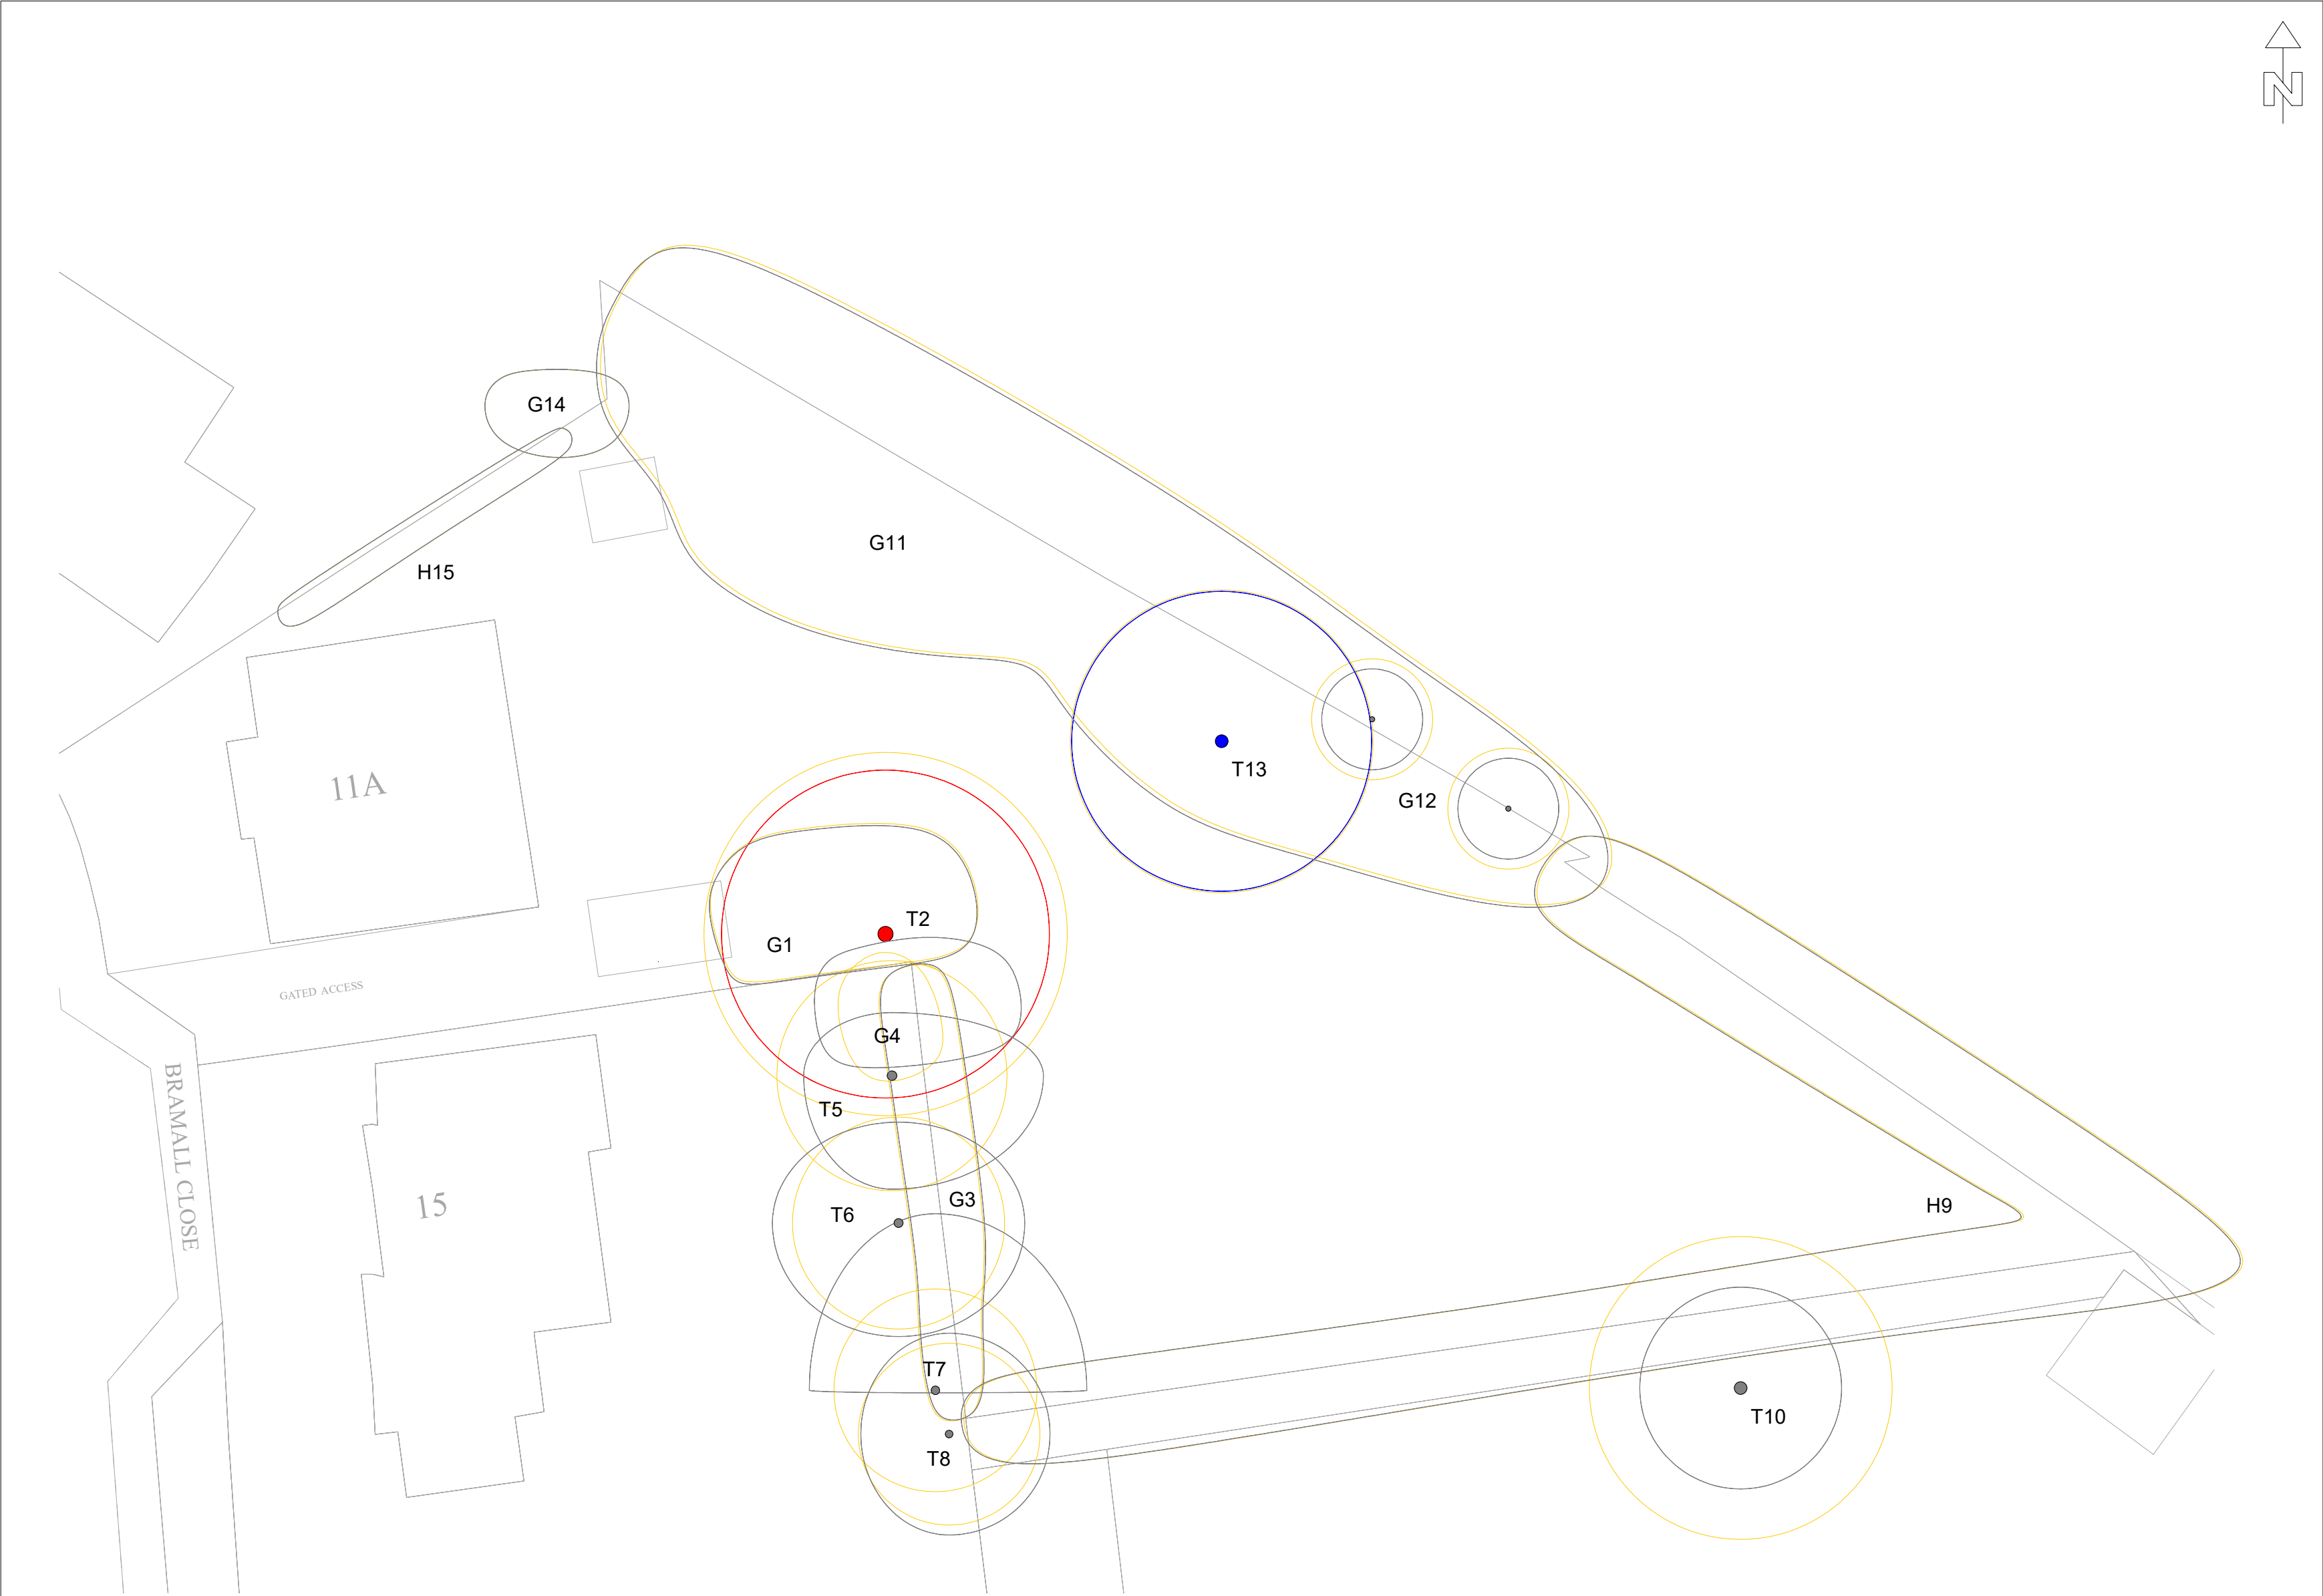
## **Drawing 1. Tree Constraints Plan**

2.2.1. Please see *Appendix 1* for the detailed list of existing species, age class, dimensions and condition of trees within the site, and *Appendix 2* for an explanation of retention category criteria. Tree locations can be seen on the *Tree Constraints Plan* at the rear of this report (*Drawing 1*).

- 2.3.1. The tree Root Protection Area (RPA) is a layout design tool indicating the area around a tree that, along with the tree stem and branches, must be considered during development. The protection of the roots and soil structure within the RPA should be treated as a priority. The RPA of each tree or group is marked on the *Tree Constraints Plan* at the rear of this report.

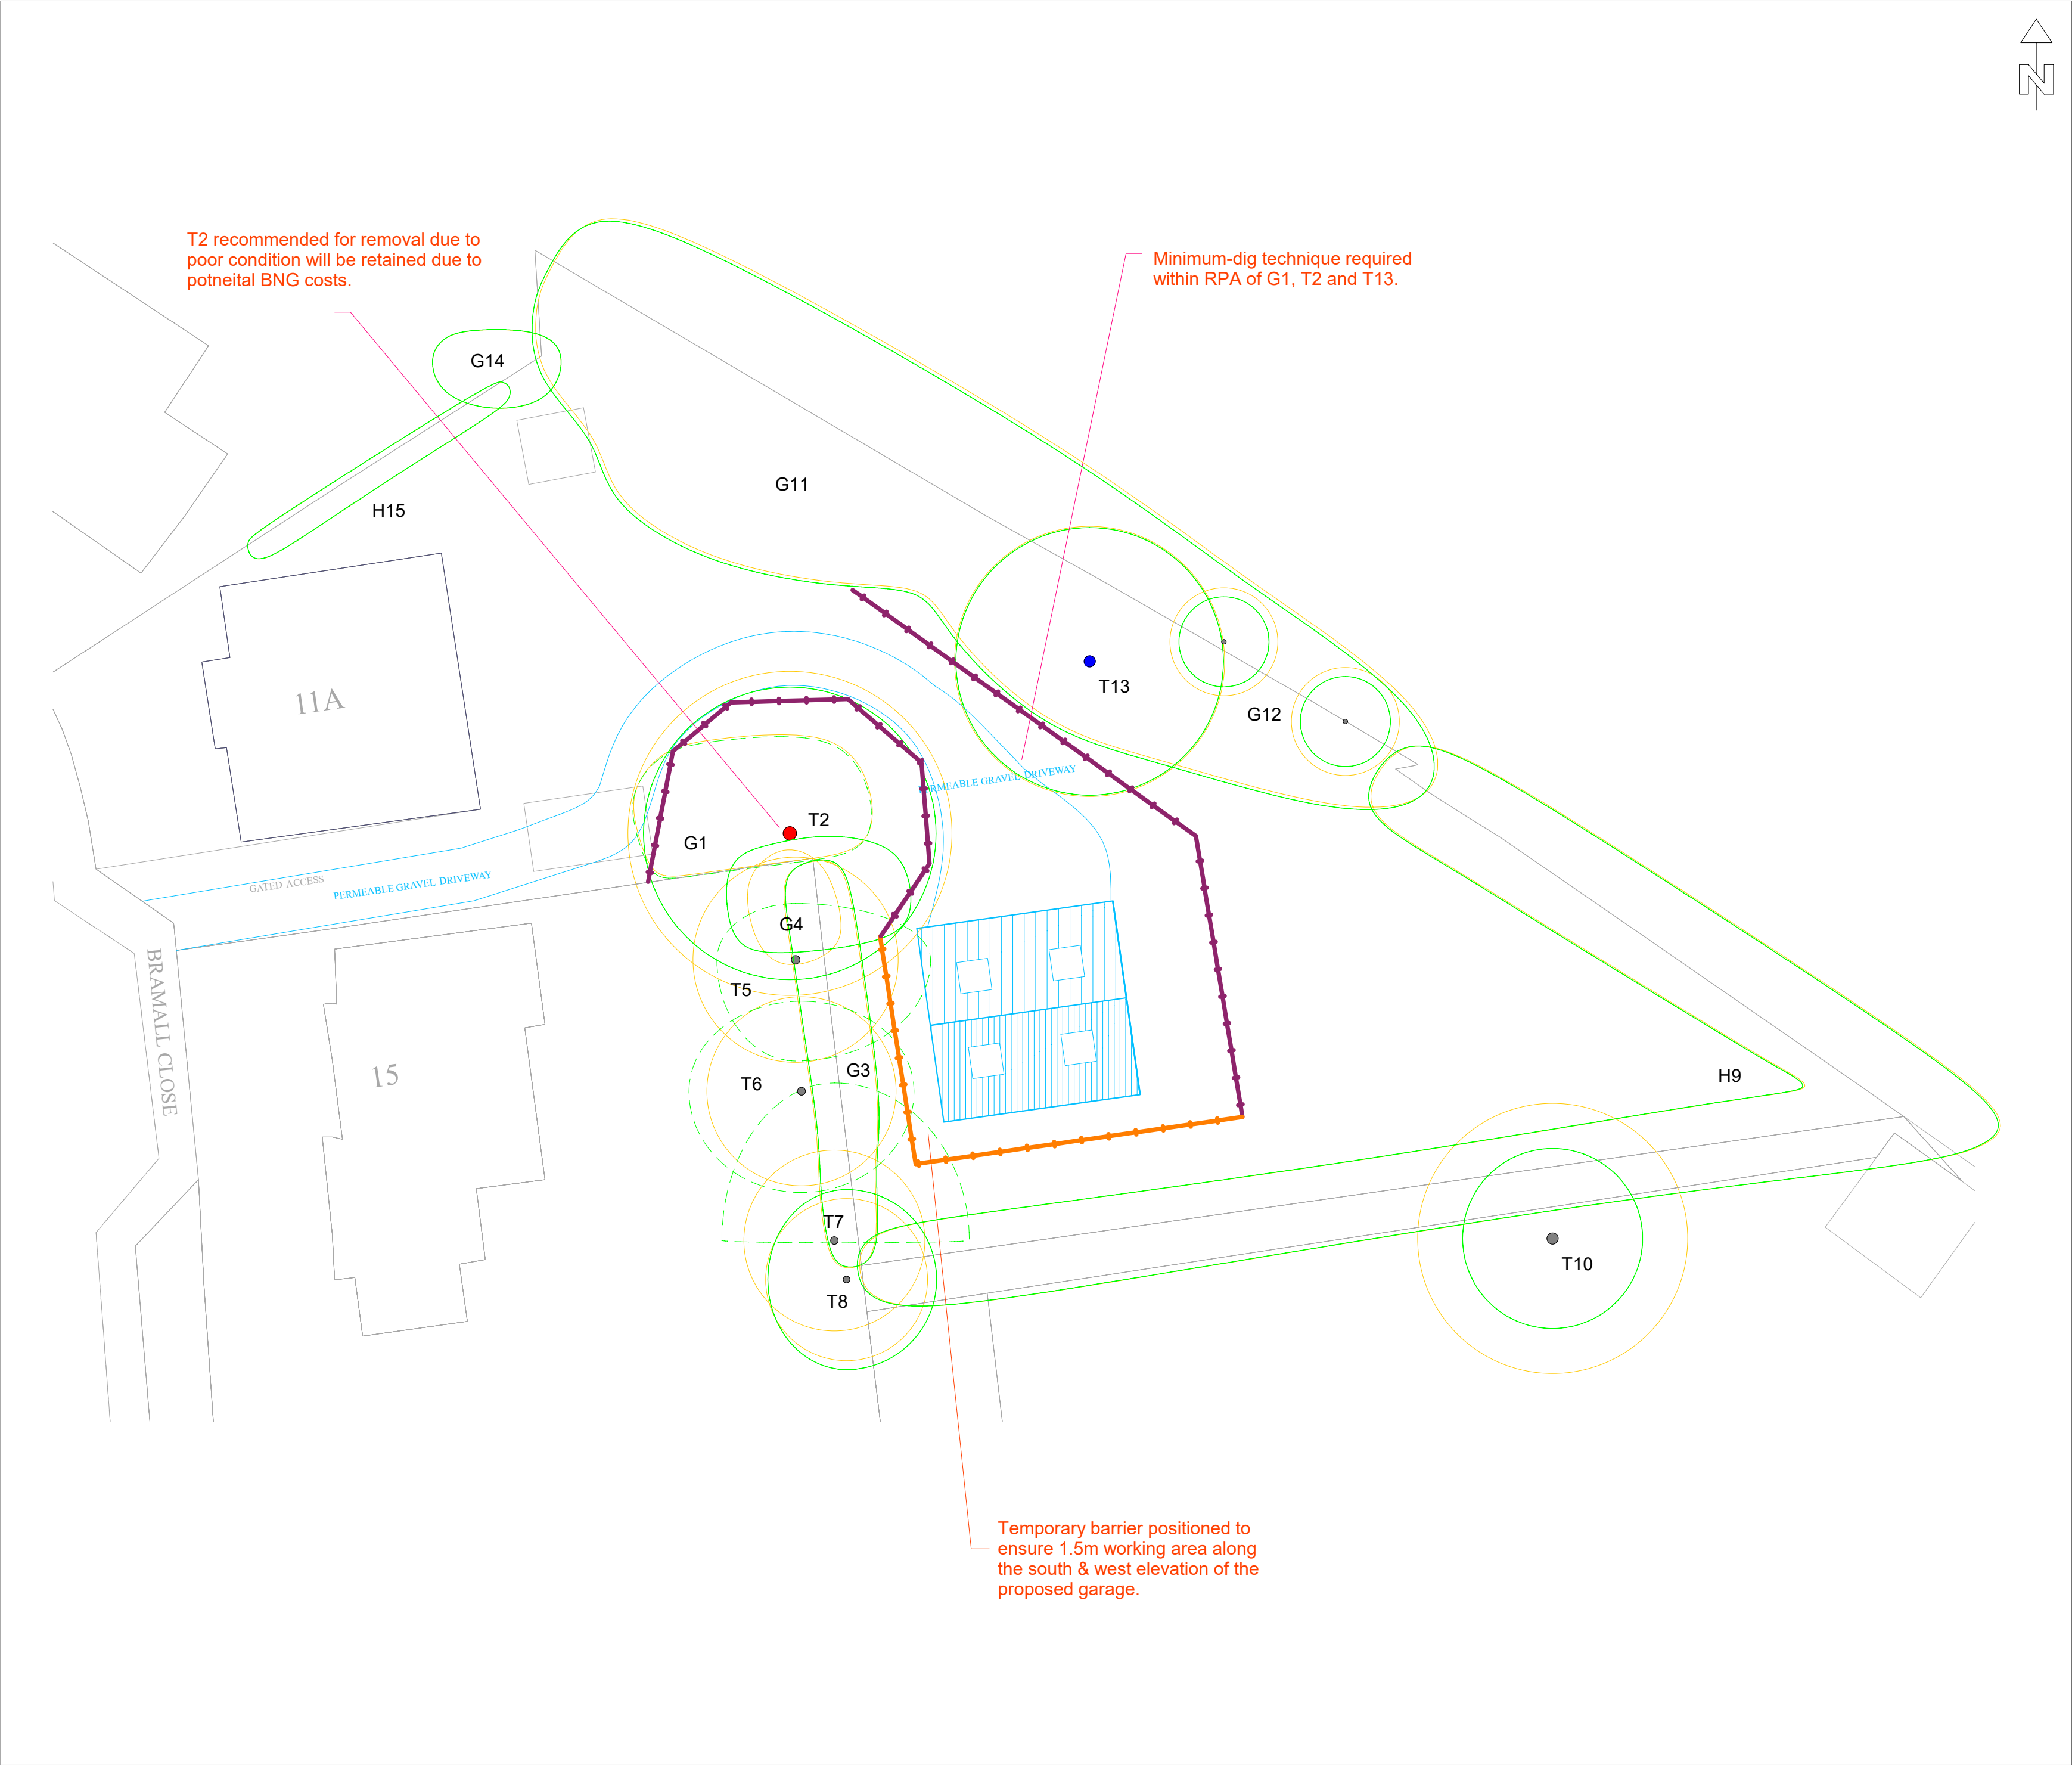
## Drawing 2. Tree Protection Plan

- 3.1.1. The demolition of the existing garage and the construction of an extended driveway and new garage is proposed. The proposed layout drawing can be seen within the *Tree Protection Plan* to the rear of this report. This drawing has been used to assess the potential direct and indirect arboricultural impacts.

- 3.2.1. No trees shall be removed to enable the construction of the proposed development.
- 3.2.2. The formative pruning of trees **T5**, **T6** and **T7** is recommended to ensure sufficient clearance between the proposed garage and adjacent branches. The pruning back of shrubs within **G1** will also be required to enable the temporary barrier.

- 4.2.3. Please see *Appendix 4* for suggested barrier construction details. It is recommended that, in this instance, the protective barrier shown in *Figure 2* would be appropriate for the majority of the site, whilst the protective barrier shown in *Figure 3* would be more appropriate along the south and west of the proposed garage. The suggested locations for protective fencing (*Figure 2* purple, and *Figure 3* orange) are shown on the *Tree Protection Plan (Drawing 2)*.

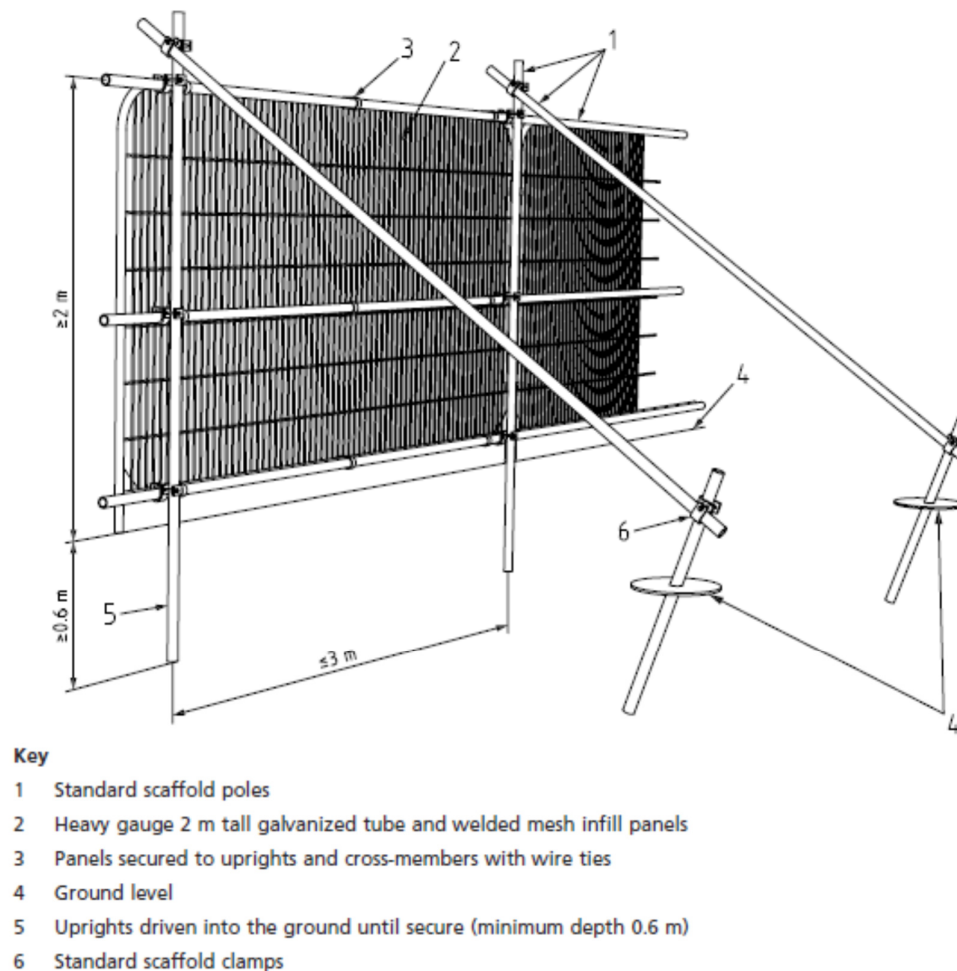
Figure 1. Default protective fencing barrier as detailed in BS 5837: 2012.

- A4.1 The default specification for protective barriers should consist of a vertical and horizontal scaffold framework, well-braced to resist impacts, as illustrated below. The vertical tubes should be spaced at a *maximum* interval of 3 m and driven securely into the ground. Onto this framework, welded mesh panels should be securely fixed. Care should be exercised when locating the vertical poles to avoid underground services and, in the case of the bracing poles, also to avoid contact with structural roots.

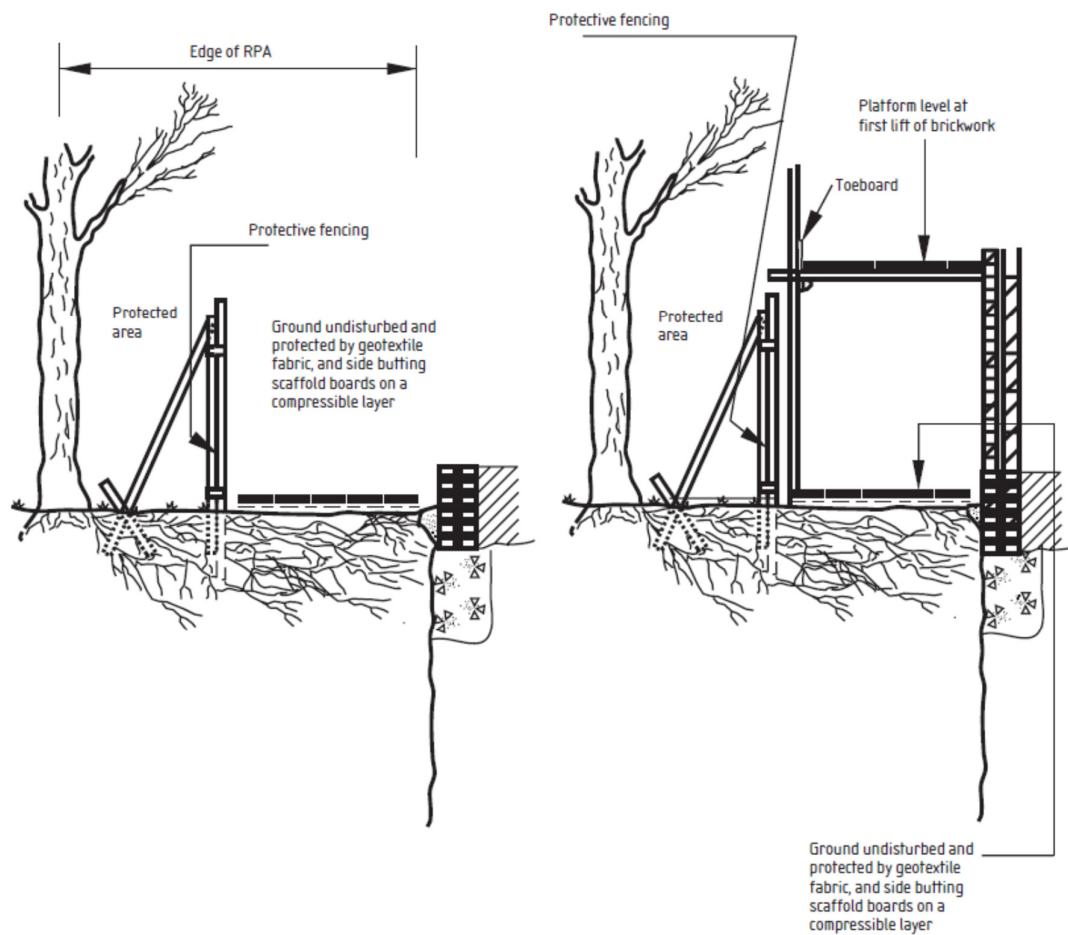
Figure 3. Ground protection and scaffold construction within an RPA.

A4.3 Figure 3 (below) shows the technique for ground protection recommended where RPAs lie outside of the protective fencing barrier.
