## GROUND INVESTIGATION REPORT HOPWOOD HALL COLLEGE, ROCHDALE

**TE1880-TE-00-XX-RP-GE-002-V02**

**03 MARCH 2025**

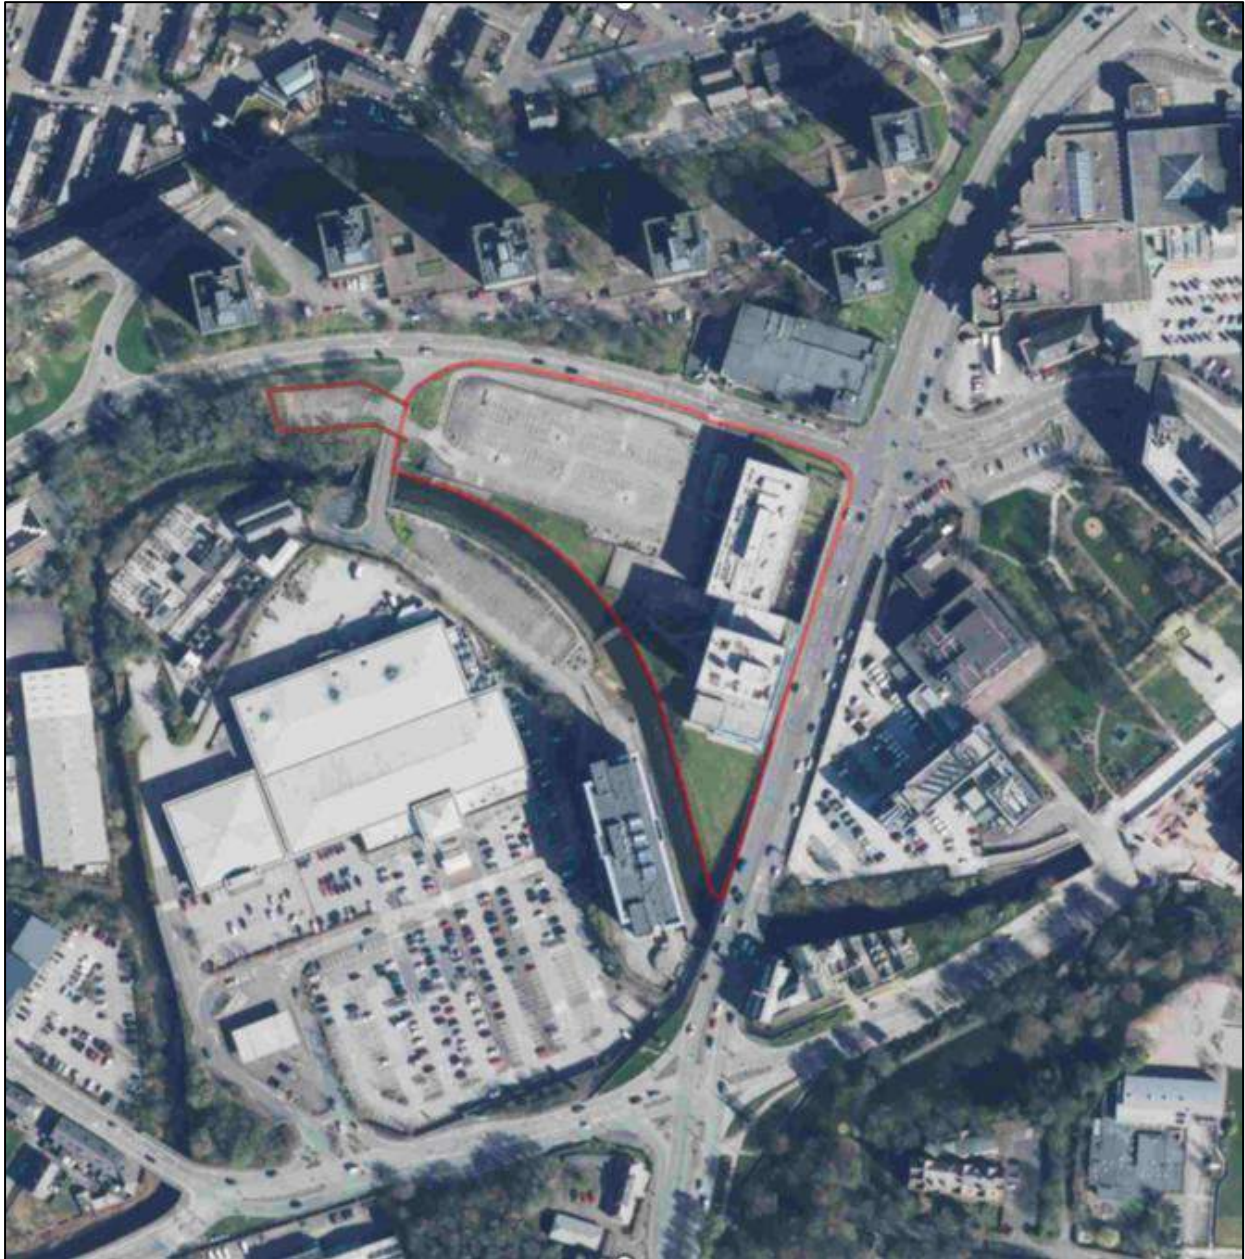
**Figure 2.1 Recent Aerial Photograph from Groundsure**

An aerial photograph (from the Groundsure report) of the site and site boundary is shown below. Relevant site photographs are presented in Appendix G.

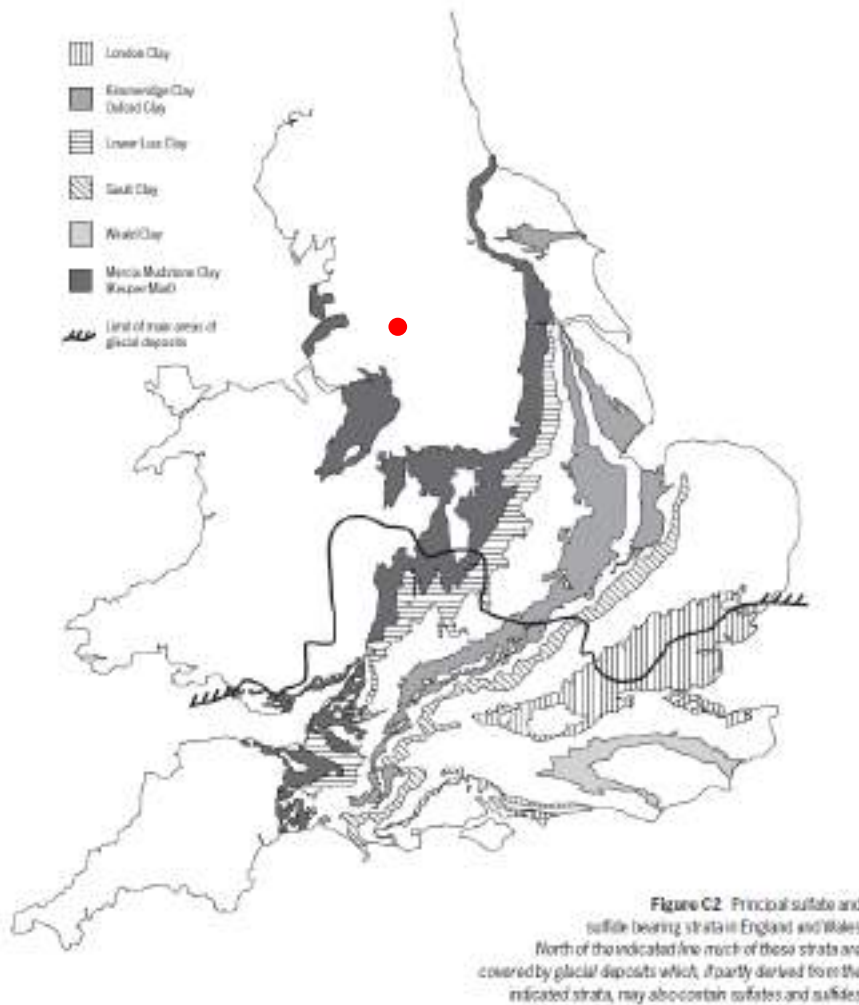
**Figure 7.1 Site Location Plotted on Principal Sulphate and Sulphide Bearing Strata in England and Wales (Extracted from BRE SD1)**

Firstly, the site location has been plotted on the extracted figure from BRE SD1 that shows the Principal Sulphate and Sulphide Bearing Strata in England and Wales, as shown on Figure 7.1 below.

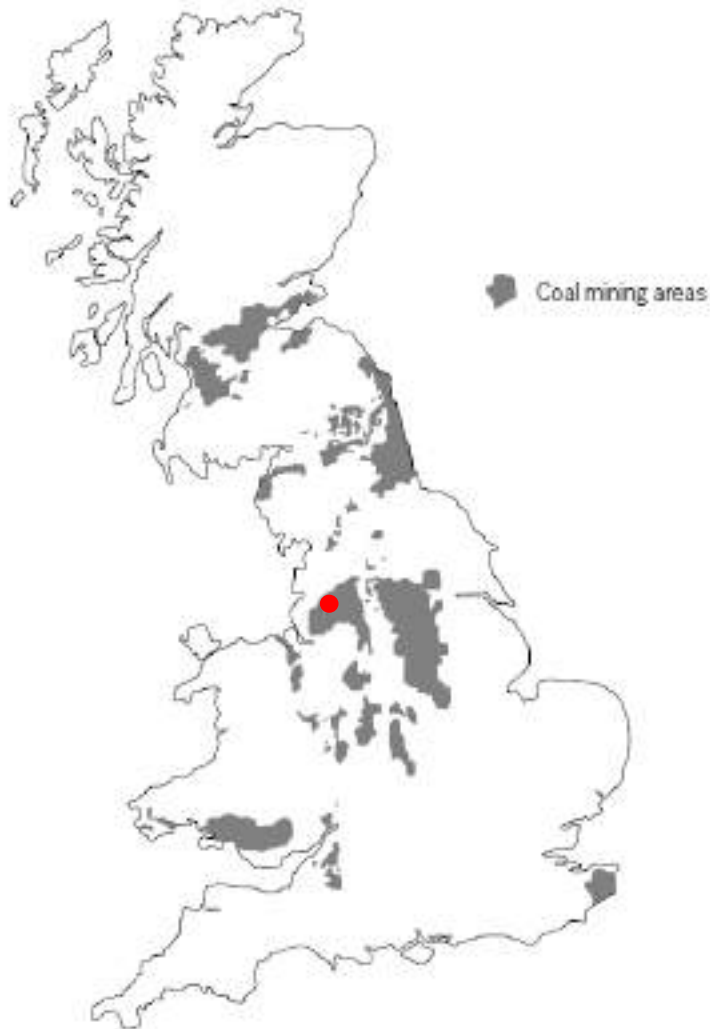
**Figure 7.2 Site Location Plotted Relative to Coal Mining Areas of Great Britain (Extracted from BRE SD1)**

Secondly, an assessment has been made of the site's location relative to coal mining areas of Great Britain on the figure below. This has been done because these represent areas where sulphate bearing coal mining wastes and metal processing slags are most likely to be encountered.

**Figure C3** Coal mining areas of Great Britain where sulfate bearing, coal mining wastes and metal processing slags are most likely to be encountered

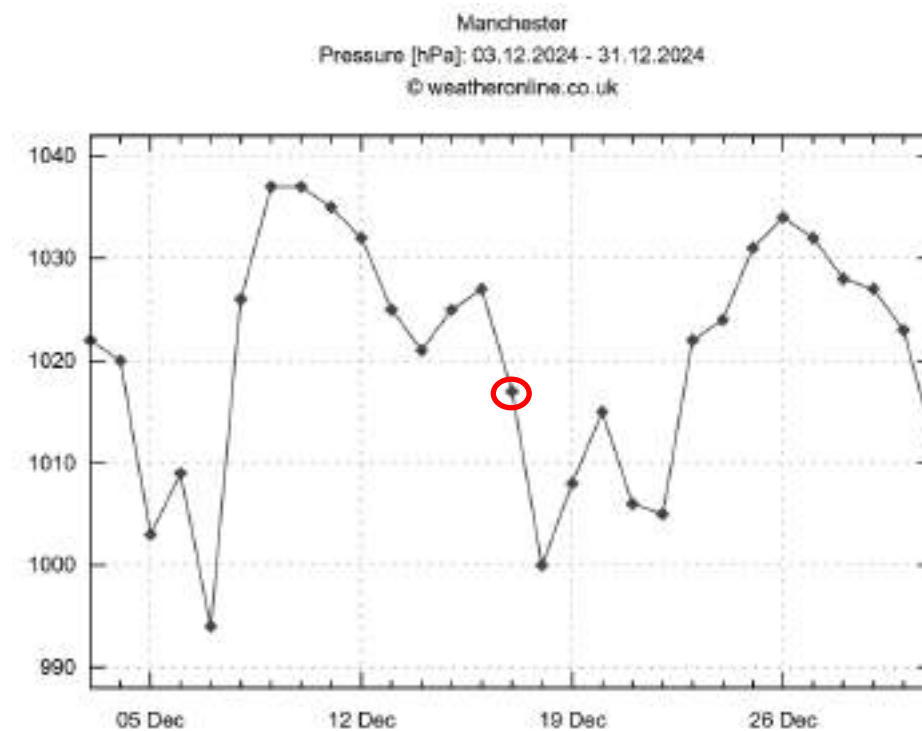
#### Visit 1 – 17.12.24

The pressure graphs information is from the *nearest* available weather station (relative to the site) and therefore indicative of *regional* pressure trends. The below does not represent direct atmospheric pressure conditions on the site.
