Project Silver Hill Farm  
Rochdale

Drawing Title Barn  
Roof Layout with Temporary Works

Project No. 5410

Drawing No. 022

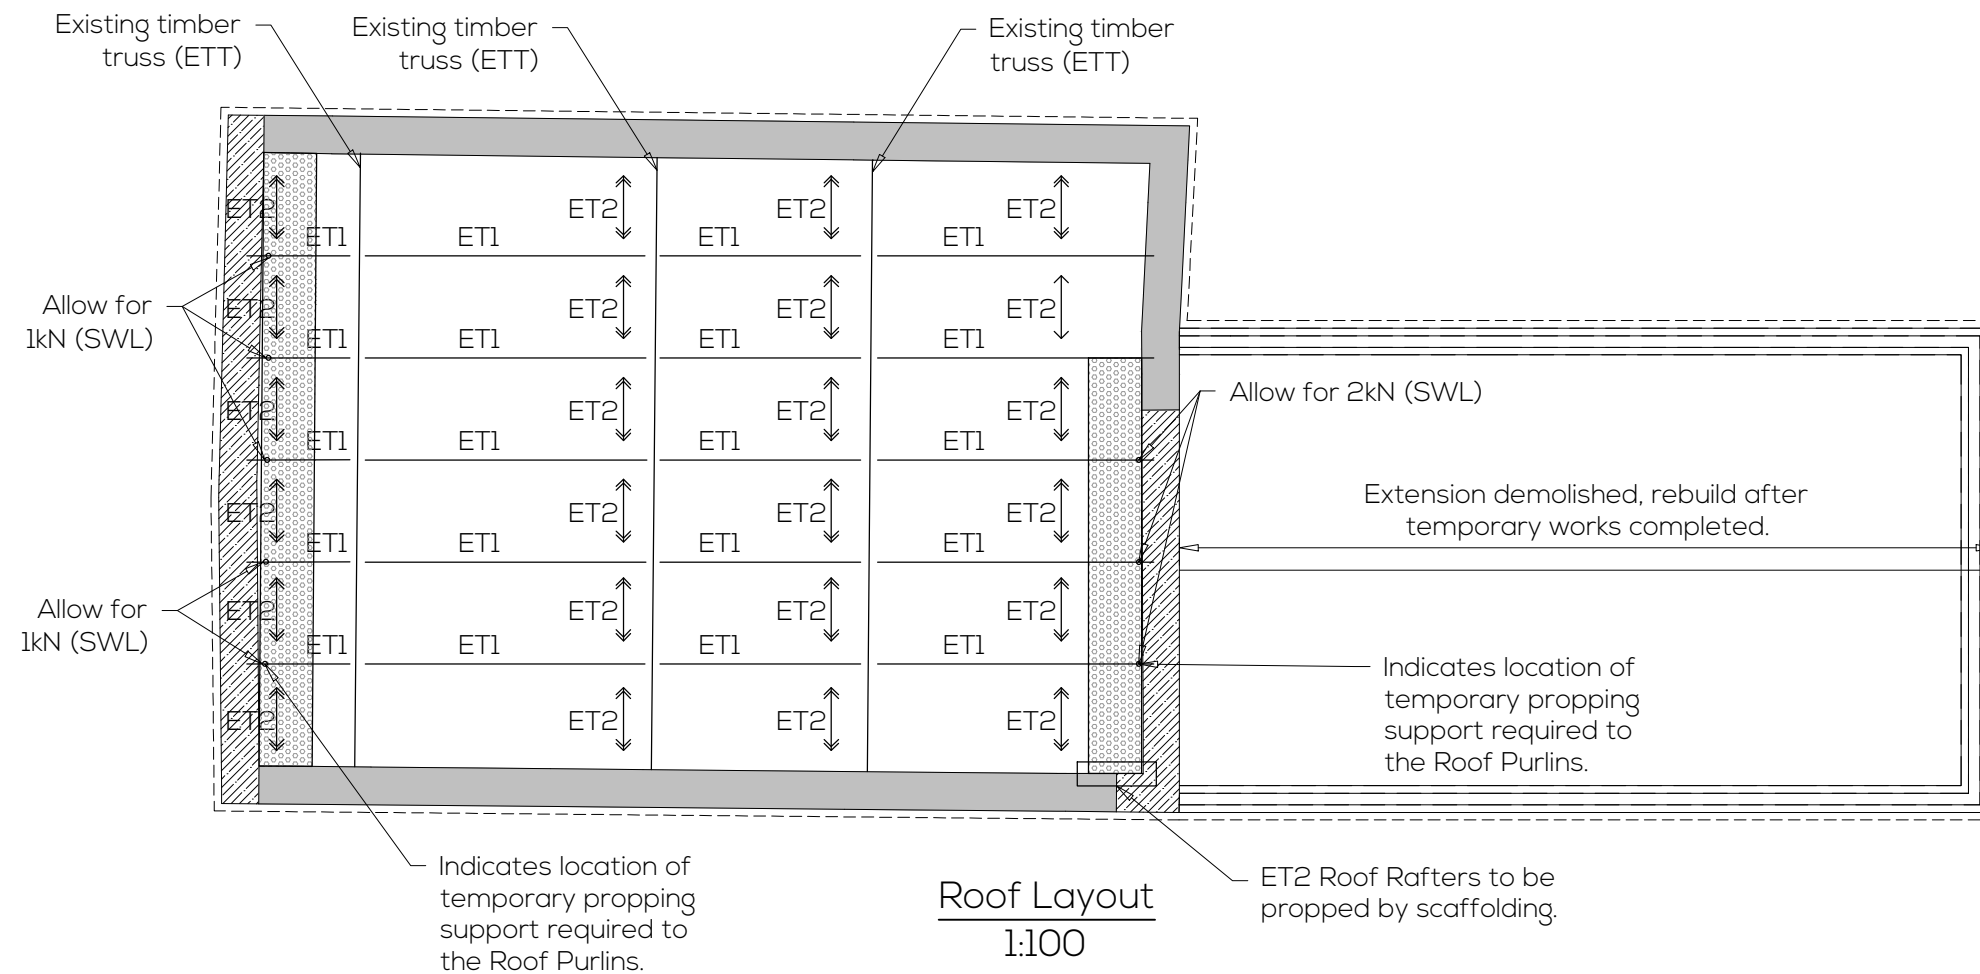
Loading Note: SWL assumes sequencing for works is followed as stated on this drawing. If an alternate sequence is taken, the loading may increase.

Note: Extents of masonry to be rebuilt are shown indicatively and actual extents to be confirmed on site.

1. Setup scaffolding around outside perimeter of building.
2. Remove roof tiles, completely.
3. Outside scaffolding to remain in place.
4. Setup scaffolding within the building as indicated on the layout.
5. All Roof Purlins and Floor Beams must be propped at the ends.
6. Masonry (where required for rectification) can be removed by hand starting at the top and working downwards.
7. Masonry to be retained for the rebuild to ensure the appearance of the building is maintained.
8. Walls can be rebuilt allowing for new / existing window and door openings. All masonry to be fully bonded with existing.
9. Strapping to be installed between the Roof Purlins and Masonry Walls.
