## External Materials Statement

*Refurbishment and external alterations to an existing farmhouse, part demolition and conversion of an existing barn to form a residential dwelling and associated works*

*Silver Hill Farm, Lower Lane, Rochdale*

Date: July 2025  
Our Ref: 1517/EMS  
Revision:

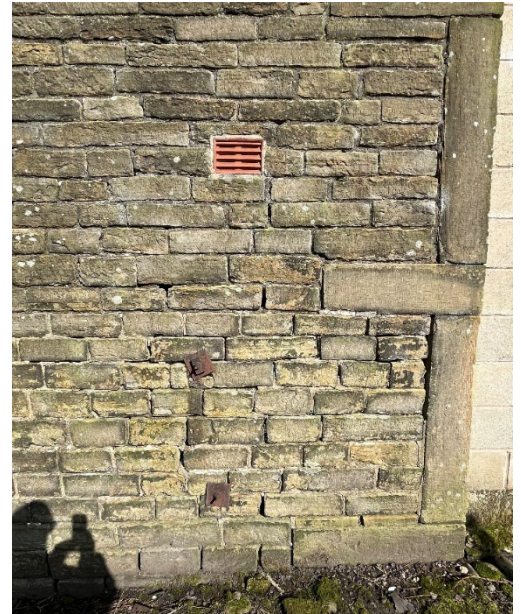
Figure 01 – Existing natural facing stone

The external walls of the existing farmhouse and barn are constructed from natural facing stone (Figure 01). Upon inspection the stone appears to be in good condition, with no obvious signs of damage or areas of requiring substantial repair or cleaning and will be able to be retained as part of the works.

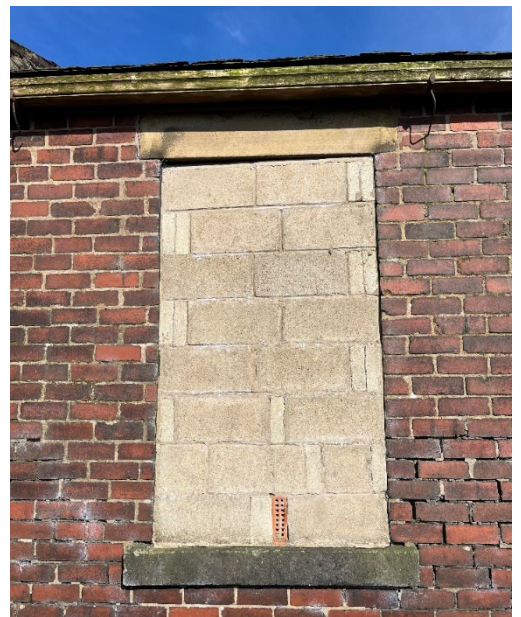
Figure 02 – Existing red facing brick

There are existing single-storey outbuildings connected to the south east side of the barn, the external walls of these outbuildings were constructed from red facing brick (Figure 02). The structural stability of these outbuildings deteriorated significantly and posed a risk to safety and so have since been demolished under Section 78 (Emergency Powers) of The Building Act 1984. During demolition the walls were carefully deconstructed with the bricks being set aside and stored, intended to be reused within the construction of the new extension on where the outbuildings previously stood. Unfortunately site operatives carrying out the demolition works confirmed the vast majority of the existing bricks had deteriorated beyond salvage and deemed not to be fit for retention.

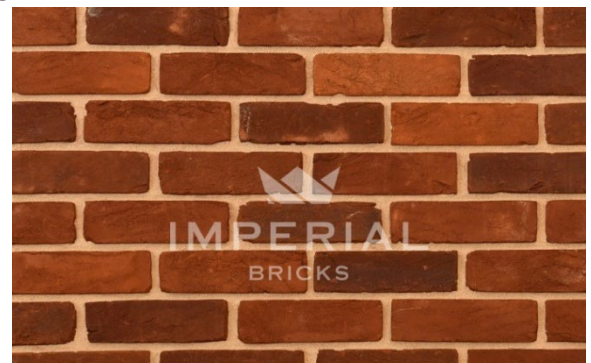
Figure 03 – Imperial Bricks Reclamation Weathered Red Rubber bricks

It is therefore anticipated there will not be enough of the bricks salvaged from the demolished outbuildings to construct the new extension to the barn, the shortfall will need to be made up using new bricks. The proposed new bricks are to comprise 'Imperial Bricks Reclamation Weathered Red Rubber' (Figure 03) which have been deemed to be consistent with the existing bricks and are as close a match as possible in terms of size, texture and colour.

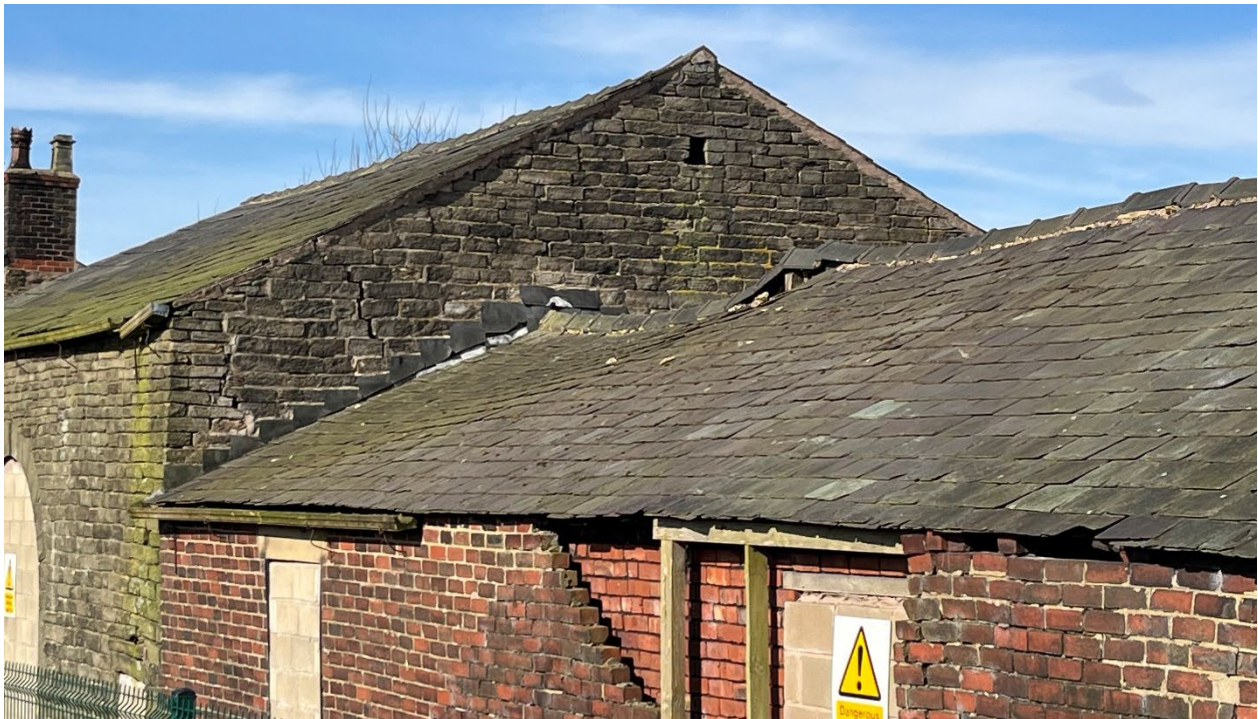
*Figure 04 – Existing blue/grey slate*

The roof finish of the existing farmhouse and barn consists of natural blue/grey slate. The existing slate finish is to be carefully removed and stored to one side for re-use, once an assessment of the existing roof structure and any subsequent works have been carried out, the existing slate finish is to be reinstalled.

Upon inspection, most of the existing slate appears to be in good condition. During demolition of the outbuildings, some small areas were discovered to contain damaged slates which have had to be removed from site as they were beyond repair and deemed unsuitable for reuse however it is anticipated there will be no shortfall as the roof area of the existing outbuildings is larger than the proposed extension and there will be enough left over to replace any damaged areas.

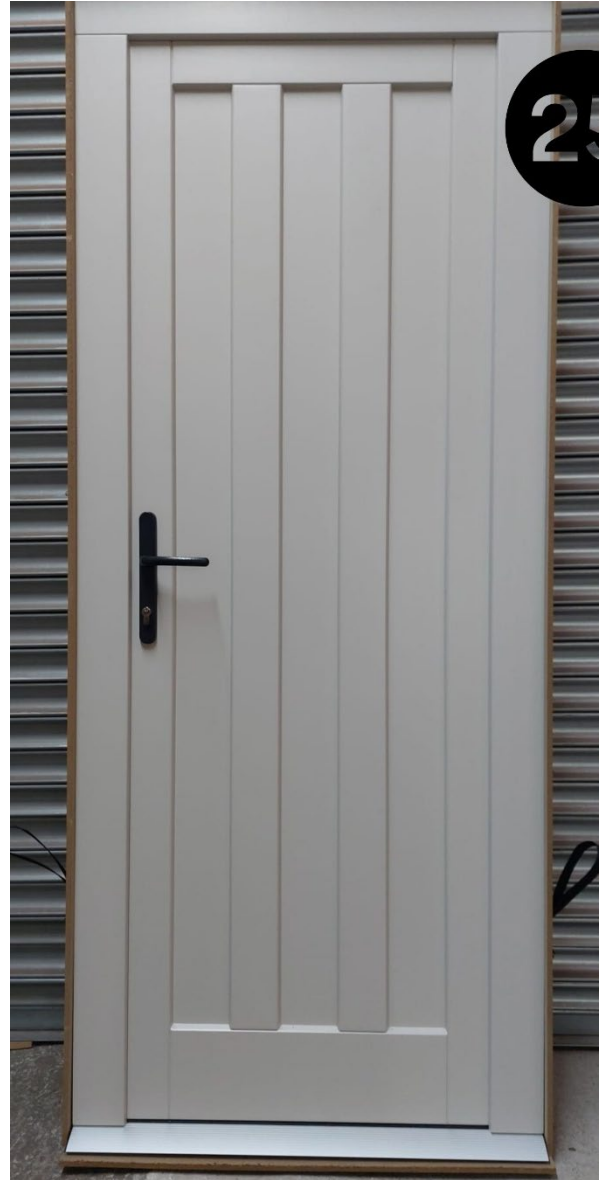
Figure 05 – Timber door example

The frames of all external doors (excluding garage doors) and windows being installed as part of the works are to be manufactured from high-quality softwood which is to receive a factory-finished spray-painted finish. The timber is to be appropriately treated and primed prior to receiving the topcoat finish comprising of a suitable external grade paint; the frames are to be painted 'pure white' (RAL 9010) on the inside and 'Pebble Grey' (RAL 7032) (Figure 08) on the outside. The frames are to incorporate areas of integrated glazing comprising double-glazed sealed units which are to be bedded using black butyl glazing tape and sealed using Hogson Heritage Putty (or similar specification) to fill the void between the glazing unit and the frame. Any associated timber beading is to be applied internally using black butyl glazing tape and pins.

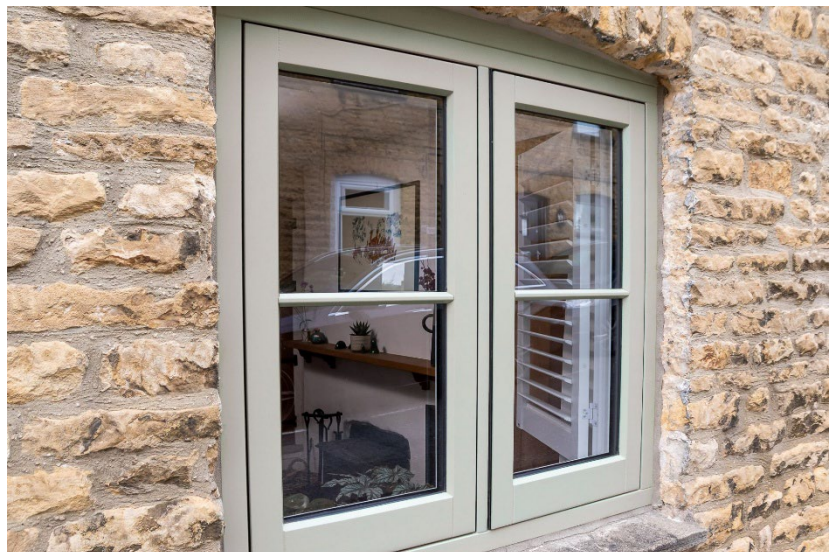
Figure 06 – Example of a timber window within a stone wall

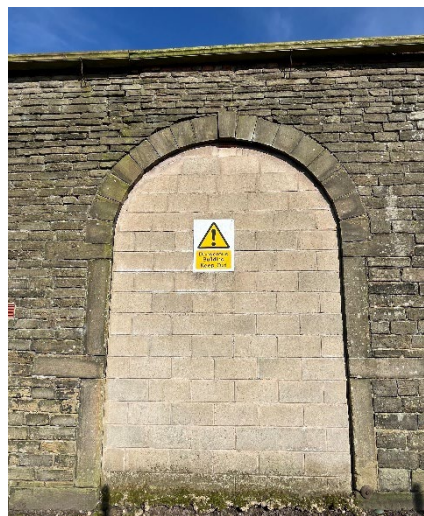
Figure 10 – Existing stone surrounds to arched opening within the barn

The openings within the existing external walls have been constructed with stone surrounds which include, as a minimum, stone heads and sills (Figure 09). The majority of the openings of the farmhouse also incorporate stone jambs and intermediate mullions; there are also stone jambs to the large arched openings within the barn which are topped with a segmental arched head comprising a central stone keystone and 8no. stone voissiors to both sides (Figure 10). As with the existing external walls, the stone surrounds, including the barn arch stones, appear to be in good condition, with no obvious signs of damage or areas of requiring substantial repair or cleaning, and can be retained and incorporated within the development. Any existing masonry (blockwork) blocking-up the existing openings, plus any existing external doors and window frames/casings are to be carefully removed as to not cause damage to the existing external walls/stone surrounds.

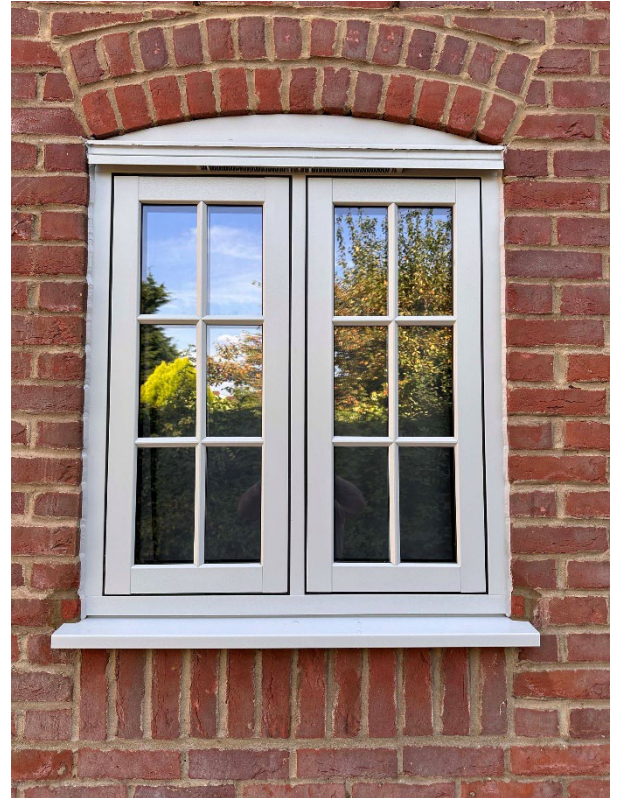
Figure 07 – Example of a timber window within a brick wall

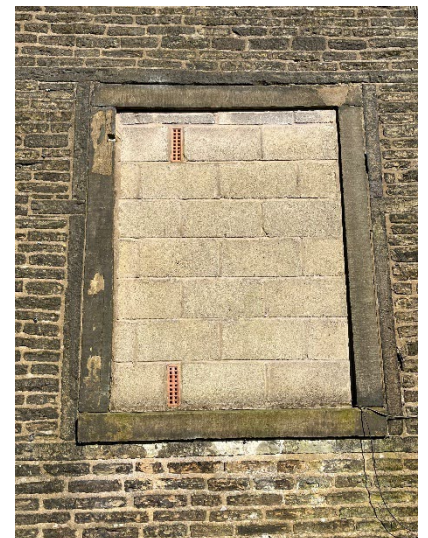
Figure 09 – Existing stone surrounds

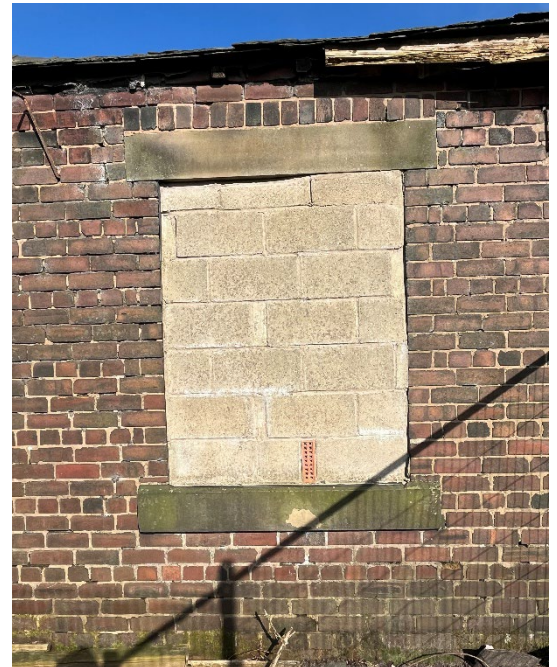
*Figure 11 – Opening within former outbuilding, surrounds intended for reuse within the development*

During demolition of the outbuildings the existing surrounds (Figure 11) were carefully removed and have been set to one side in order that they can be reinstalled as part of the works. Openings being formed within the new extensions to the farmhouse and barn are to be constructed using the retained stone heads and sills of the previous outbuildings wherever possible; this is particularly applicable to the opening which will form the main entrance into the barn on the North East Elevation. There was a similar sized opening within the outbuilding (Figure 12) which once stood where the extension and new entrance is to be constructed, the existing surrounds of this former opening are to be reinstalled and form the new entrance as part of the works.

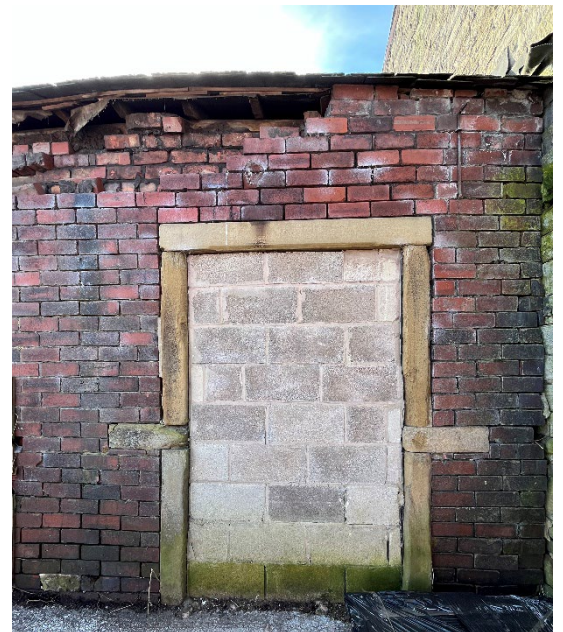
*Figure 12 – Opening within former outbuilding, surrounds to be reused to form main entrance into the converted barn within the new extension*

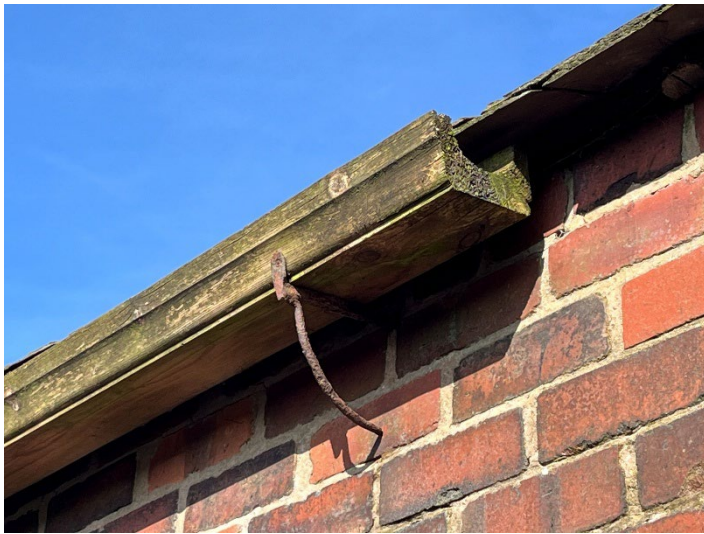
*Figure 14 – Broken and rotting existing gutter on the former outbuildings supported by rusting brackets*

The existing rainwater goods comprise of wooden ogee profile gutters connected to round black metal downpipes. The gutters are secured to the external walls via black metal brackets or stone corbels. Upon inspection the existing gutters and downpipes appear to be in poor condition and are breaking apart and beyond salvage. Large sections of the existing wooden guttering appear to be missing and what sections remain seem to be suffering from rot and moss growth. Many of the downpipes are missing entirely, what sections of pipe remain appear to be succumbing to rust attack.

All existing surface water rainwater goods (i.e. gutters, hoppers, downpipes, etc) are to be removed and replaced as part of the works. Replacement rainwater goods are to be a similar style and size to the existing and to be produced from cast aluminium (in accordance with Condition 07 of listed building consent 22/00999/LBC) having received a factory applied textured black cast iron effect polyester powder coat finish e.g. Alumasc 'Heritage Range'. New rainwater goods to comprise Alumasc 'Heritage Moulded' 100x75mm (4x3") (ref: MG2) gutters and Alumasc 'Heritage Circular' 63mm (2.5") (ref: RW1) downpipes, all to be coated in a 'BLACK/TXT Black Textured' polyester powder coat painted finish. Gutters to be supported on complimentary Alumasc 'Rise and Fall – Moulded' traditional style black metal brackets; any existing hopper heads are to be replaced with Alumasc 'Flat Back (Fluted Edge)' hopper heads (ref: RW1/HOP/FBPPC), brackets and hopper heads to receive same factory-applied textured black polyester powder coat finish as the gutters and downpipes.

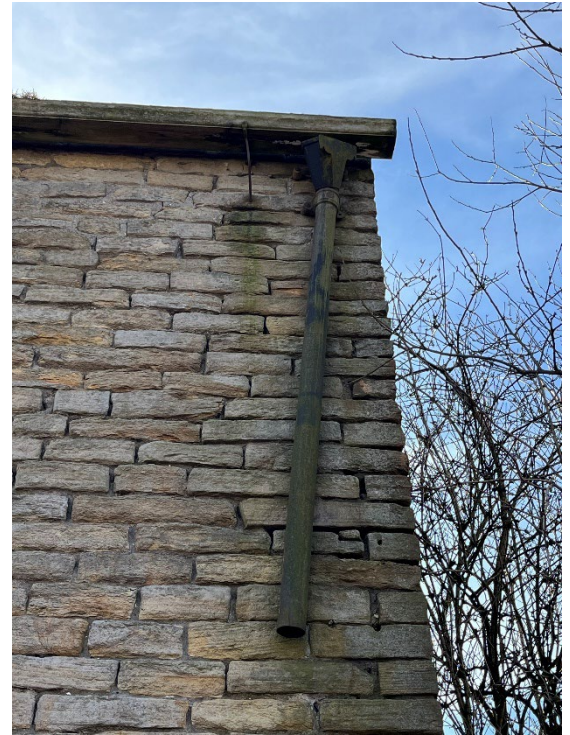
*Figure 13 – Broken and rusting existing downpipe on the corner of the farmhouse*

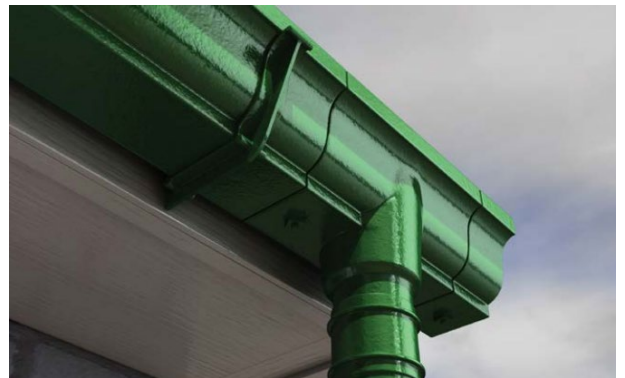
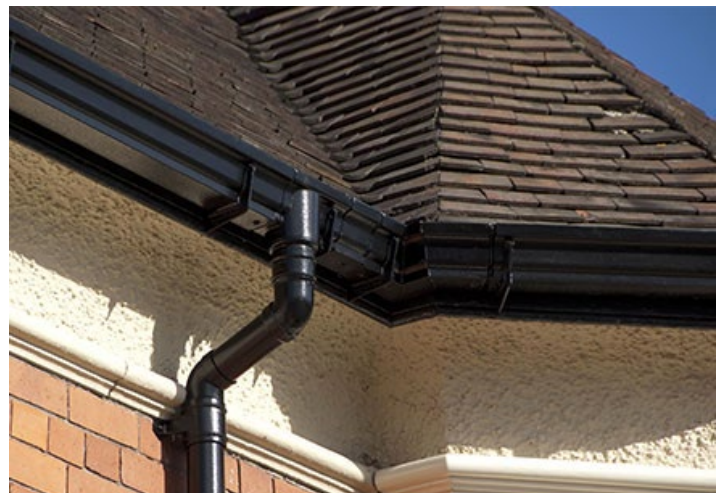
*Figure 15 – Alumasc Heritage range*

*Figure 16 – Alumasc Heritage range*
