Project  
Silver Hill Farm  
Rochdale

Drawing Title  
Barn  
Elevations sheet 1

Project No.  
5410

Drawing No.  
006

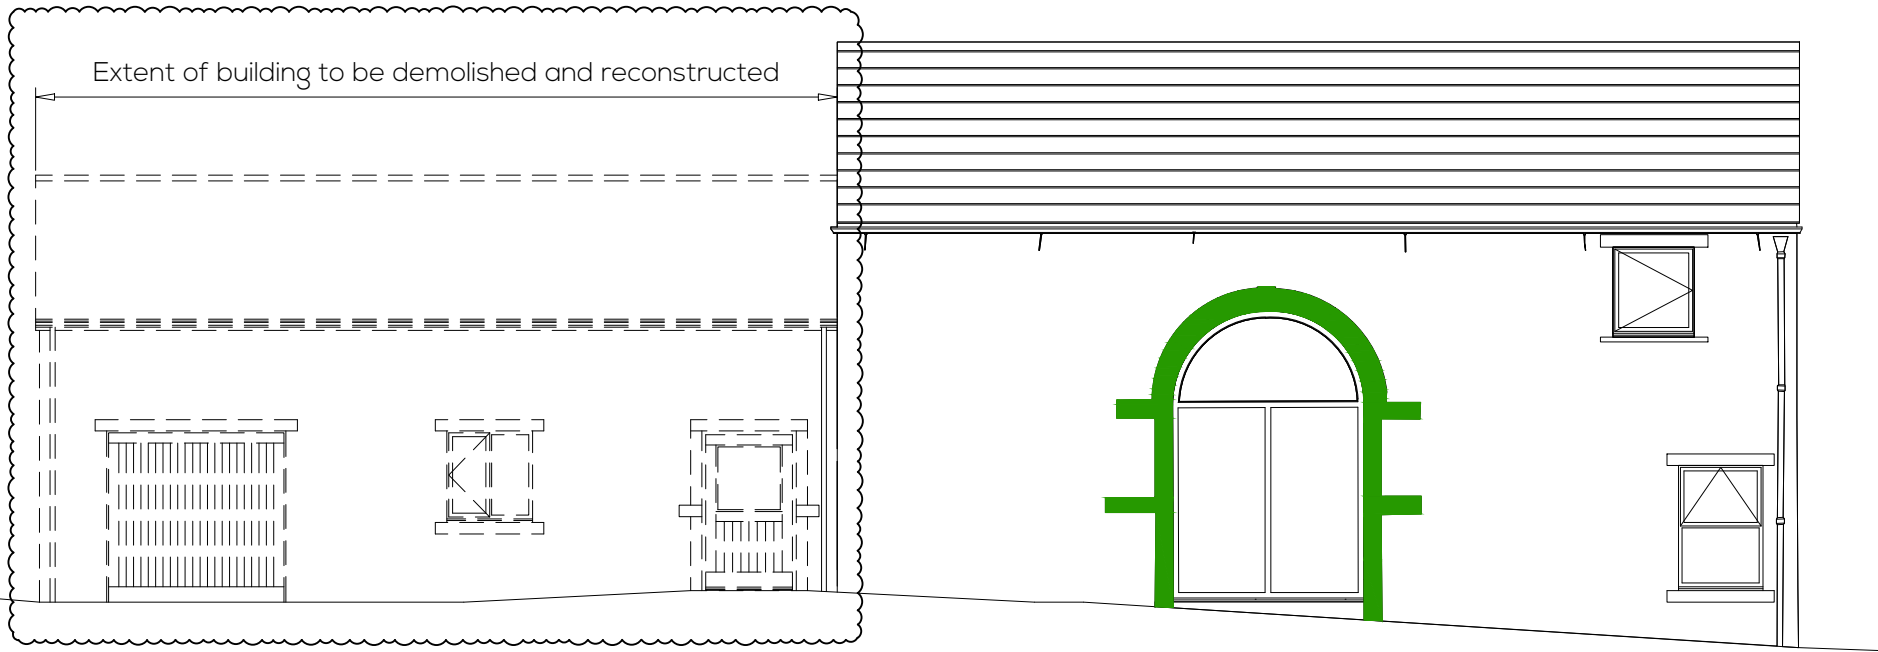
North East Elevation  
1:100

Denotes mortar to be repointed and  
masonry rebuilt as required.

Refer to ESD report 5410 Structural  
Repairs & methodology
