Project Silver Hill Farm  
Rochdale

Drawing Title Farmhouse  
Elevations sheet 1

Project No. 5410

Drawing No. 016

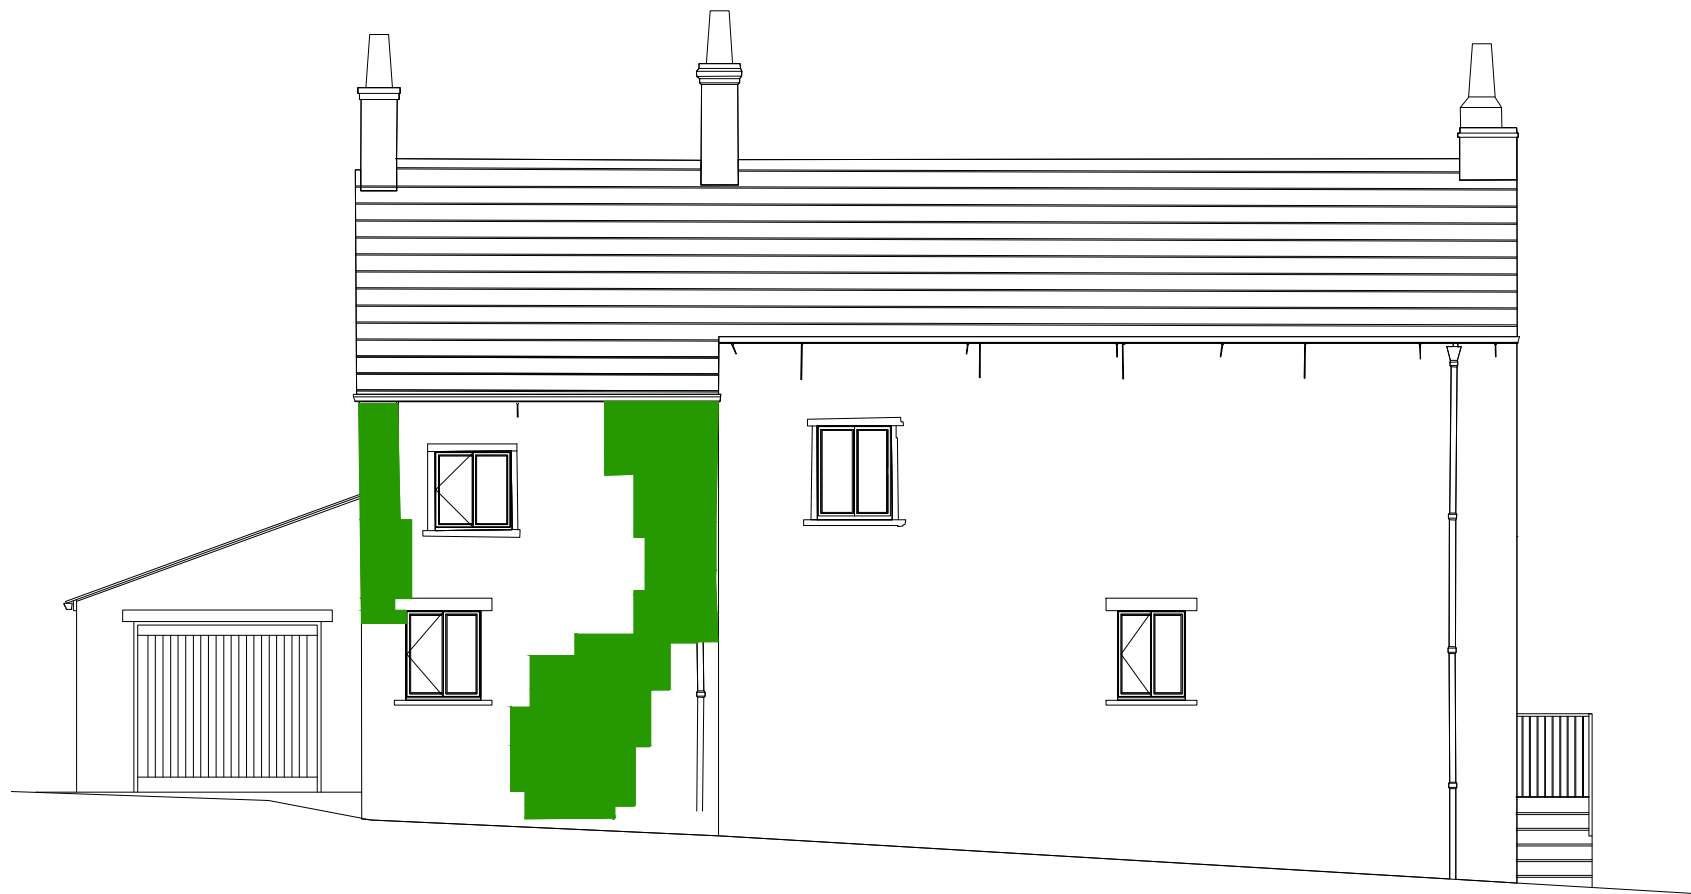
North East Elevation  
1:100

Denotes mortar to be repointed and  
masonry rebuilt as required.

Refer to ESD report 5410 Structural  
Repairs & methodology
