**EDGE**  
CIVIL & STRUCTURAL CONSULTANCY

Client Grandstream Properties Ltd

Project Silver Hill Farm  
Rochdale

Drawing Title Barn  
Elevations sheet 2

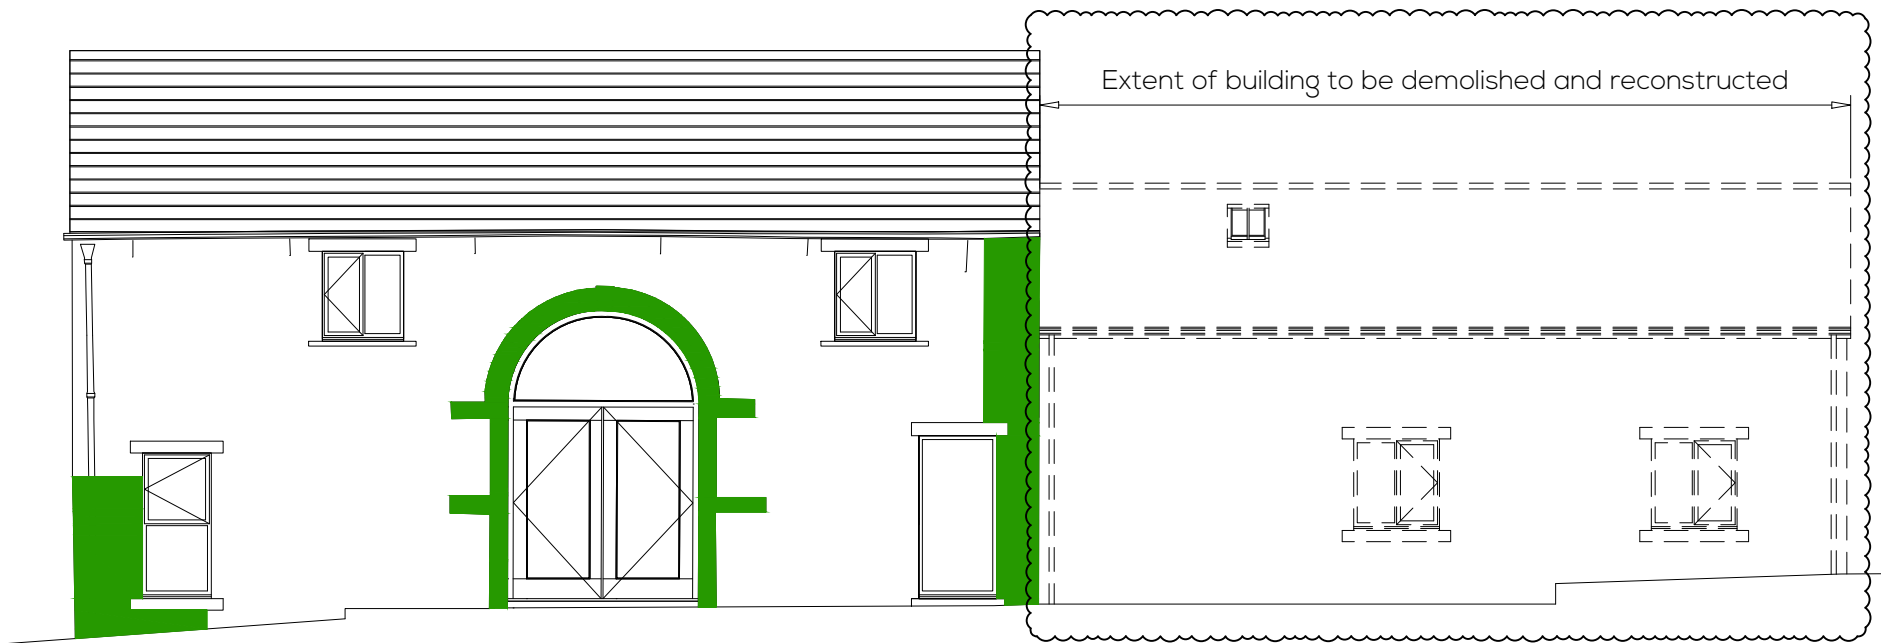
South West Elevation  
1:100

Denotes mortar to be repointed and  
masonry rebuilt as required.

Refer to ESD report 5410 Structural  
Repairs & methodology
