Alterations to Existing Dwelling

Manor Farm,

Window Schedule

26-013- 302

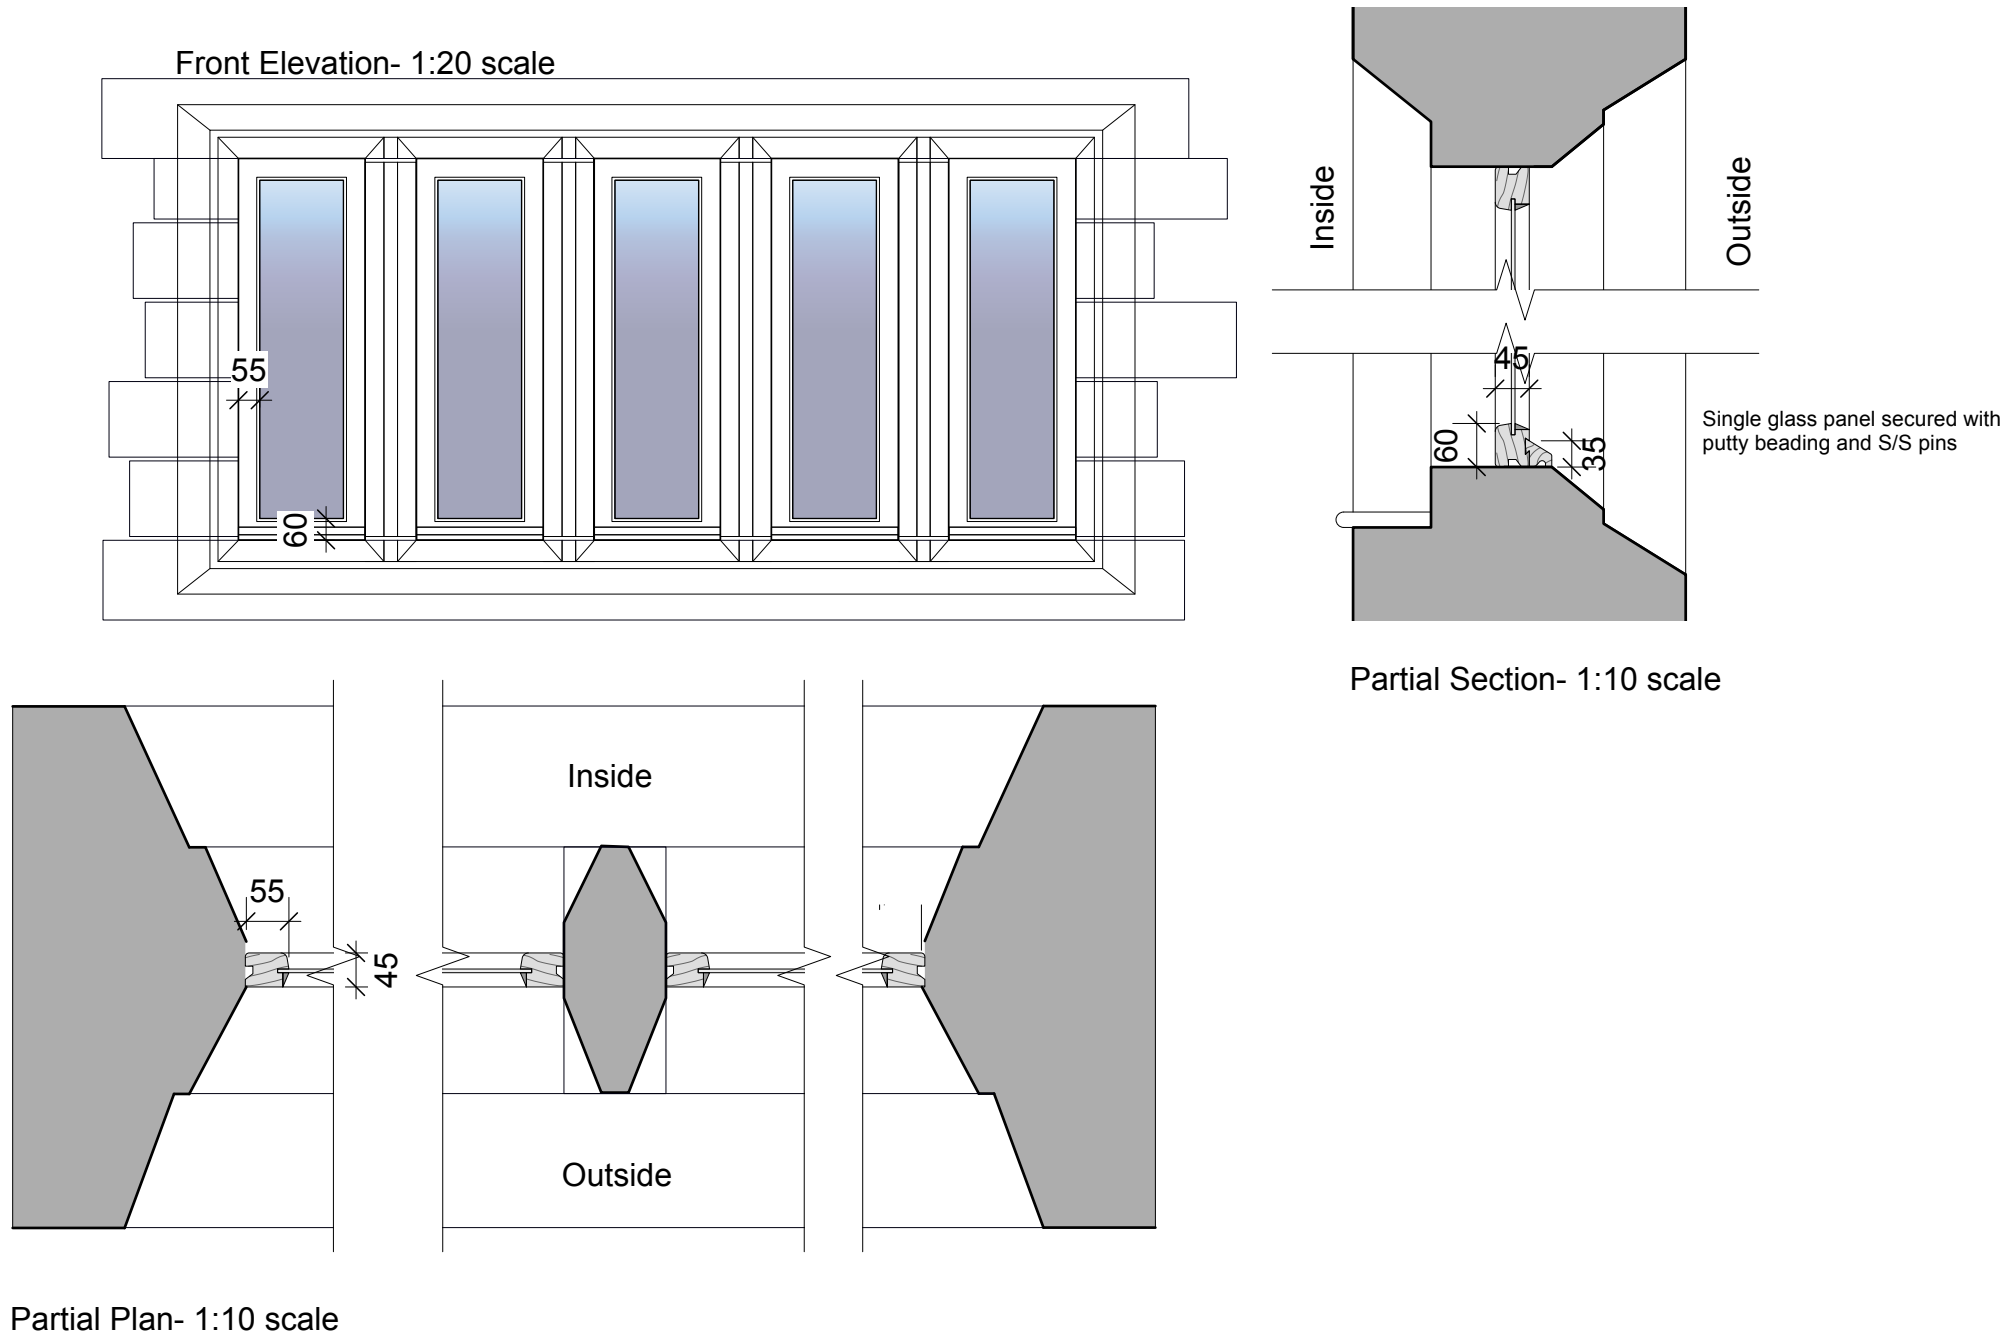
### Original Fenestration- prior to refurbishment

| Original Fenestration | | | | |
| WG-1 | Ground floor Kitchen | | Three light wndow. Central pane is top hung, outward opener. Hardwood frames, white painted. | Single pane glazing overpainted with white gloss. Stuck shut. |
| WG-2 | Ground floor Living Room | | Five light wndow. all panes are fixed frames. Hardwood frames, white painted. | Single pane glazing overpainted with white gloss. |
| WG-3 | Ground floor Living Room | | Two light wndow. Left pane is top hung, outward opener. Hardwood frames, white painted. | Single pane glazing overpainted with white gloss. Difficult to open. |
| WG-4 | Ground floor Living Room | | Window split into two panes, with fixed bottom pane and top hung, outward opener to the upper section | Single pane glazing overpainted with white gloss. |
| WG-5 | Ground floor Kitchen | | Three light window. Central pane is top hung, outward opener. Hardwood frames, white painted. | Single pane glazing overpainted with white gloss. |
| WG-6 | Rear Elevation- Barn | | Single panel, fixed window. Hardwood frame, brown painted. | Single pane glazing overpainted with white gloss. Stuck shut. |
| WG-7 | Rear Elevation- Barn | | Three light window. All panes are fixed Hardwood frames, painted brown. | Single pane glazing overpainted with white gloss. |
| WG-8 | Rear Elevation- Barn | | Window split into two panes, with fixed bottom pane and top hung, outward opener to the upper section, each divided with astragal bars. | Single pane glazing overpainted with white gloss. Stuck shut. |
| WG-9 | Rear Elevation- Barn | | Window split into two panes, with fixed bottom pane and top hung, outward opener to the upper section | Single pane glazing overpainted with white gloss. |
| W1-01 | First floor Bedroom 03 | | Pair of two light windows, each with one side hung opener and a fixed panel. divided by a central stone mullion | Single pane glazing overpainted with white gloss. |
| W1-02 | First floor Bedroom 02 | | Two light window, with the RHS side hung opener and a fixed panel to the LHS. | Single pane glazing overpainted with white gloss. Stuck shut. |
| W1-03 | First floor Bedroom 01 | | Pair of two light windows, each with one side hung opener and a fixed panel. divided by a central stone mullion | Single pane glazing overpainted with white gloss. |
| W1-04 | First floor Landing | | Three light window. Central pane is top hung, outward opener. Hardwood frames, white painted. | Single pane glazing overpainted with white gloss. |
| W1-05 | First Floor En Suite | | Two light window, with the RHS top hung opener and a fixed panel to the LHS. | Single pane glazing overpainted with white gloss. |
| W1-06 | Barn- Side Elevation | | UPVC doors with sealed double glazed units, set within the arch. a fixed side panel to either side of a pair of outward opening french doors. | Single pane glazing overpainted with white gloss. |

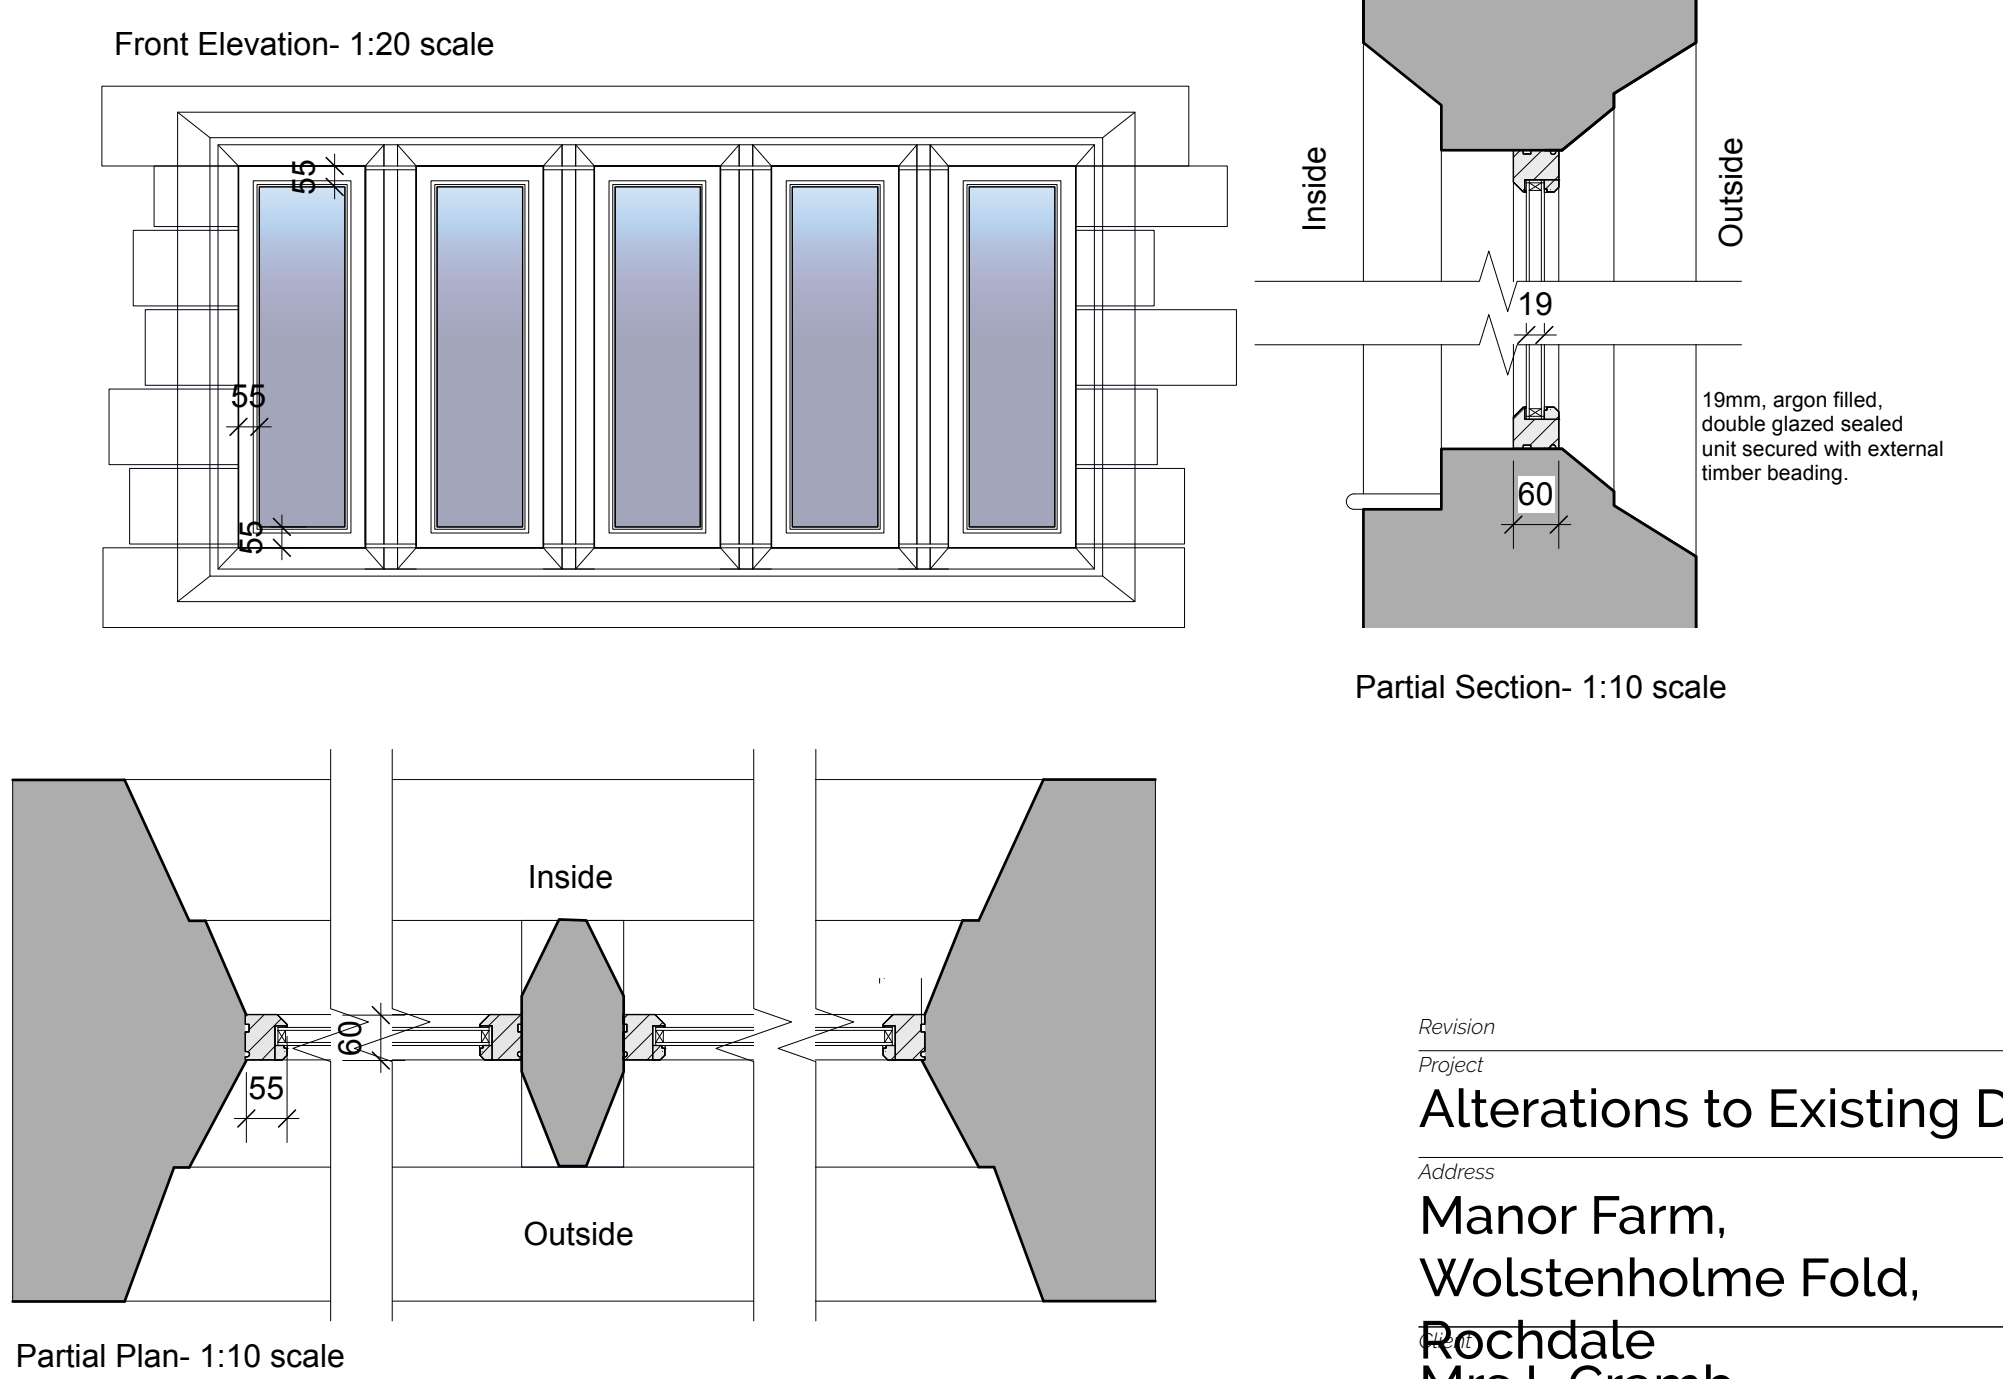
### Surveyed Fenestration- April 2026

| Survey 2026 | | | | |
| WG-1 | Ground floor Kitchen | | Three light wndow. Central pane is top hung, outward opener. Hardwood frames, white painted. | Double glazed units in white painted hardwood frames. Format and opening method retained. |
| WG-2 | Ground floor Living Room | | Five light wndow. all panes are fixed frames. Hardwood frames, white painted. | Double glazed units in white painted hardwood frames. Format and opening method retained. |
| WG-3 | Ground floor Living Room | | Two light wndow. Left pane is top hung, outward opener. Hardwood frames, white painted. | Double glazed units in white painted hardwood frames. Format and opening method retained. |
| WG-4 | Ground floor Living Room | | Window split into two panes, with fixed bottom pane and top hung, outward opener to the upper section | Double glazed units in white painted hardwood frames. Format and opening method retained. |
| WG-5 | Ground floor Kitchen | | Three light window. Central pane is top hung, outward opener. Hardwood frames, white painted. | Double glazed units in white painted hardwood frames. Format and opening method retained. |
| WG-6 | Rear Elevation- Barn | | Single panel, fixed window. Hardwood frame, brown painted. | Double glazed units in white painted hardwood frames. Format and opening method retained. |
| WG-7 | Rear Elevation- Barn | | Three light window. All panes are fixed Hardwood frames, painted brown. | Double glazed units in white painted hardwood frames. Format and opening method retained. |
| WG-8 | Rear Elevation- Barn | | Window split into two panes, with fixed bottom pane and top hung, outward opener to the upper section, each divided with astragal bars. | Double glazed units in white painted hardwood frames. Format and opening method retained. |
| WG-9 | Rear Elevation- Barn | | Window split into two panes, with fixed bottom pane and top hung, outward opener to the upper section | Double glazed units in white painted hardwood frames. Format and opening method retained. |
| W1-01 | First floor Bedroom 03 | | Pair of two light windows, each with one side hung opener and a fixed panel. divided by a central stone mullion | Double glazed units in white painted hardwood frames. Format and opening method retained. |
| W1-02 | First floor Bedroom 02 | | Two light window, with the RHS side hung opener and a fixed panel to the LHS. | Double glazed units in white painted hardwood frames. Format and opening method retained. |
| W1-03 | First floor Bedroom 01 | | Pair of two light windows, each with one side hung opener and a fixed panel. divided by a central stone mullion | Double glazed units in white painted hardwood frames. Format and opening method retained. |
| W1-04 | First floor Landing | | Three light window. Central pane is top hung, outward opener. Hardwood frames, white painted. | Double glazed units in white painted hardwood frames. Format and opening method retained. |
| W1-05 | First Floor En Suite | | Two light window, with the RHS top hung opener and a fixed panel to the LHS. | Double glazed units in white painted hardwood frames. Format and opening method retained. |
| W1-06 | Barn- Side Elevation | | UPVC doors with sealed double glazed units, set within the arch. a fixed side panel to either side of a pair of outward opening french doors. | Double glazed units in white painted hardwood frames. Format and opening method retained. |
