01 South Elevation - Window Repairs  
2210 1:50 @ A1

Touchstones Art Gallery, Rochdale

Roof Zone 1  
South Elevation - Window Repair

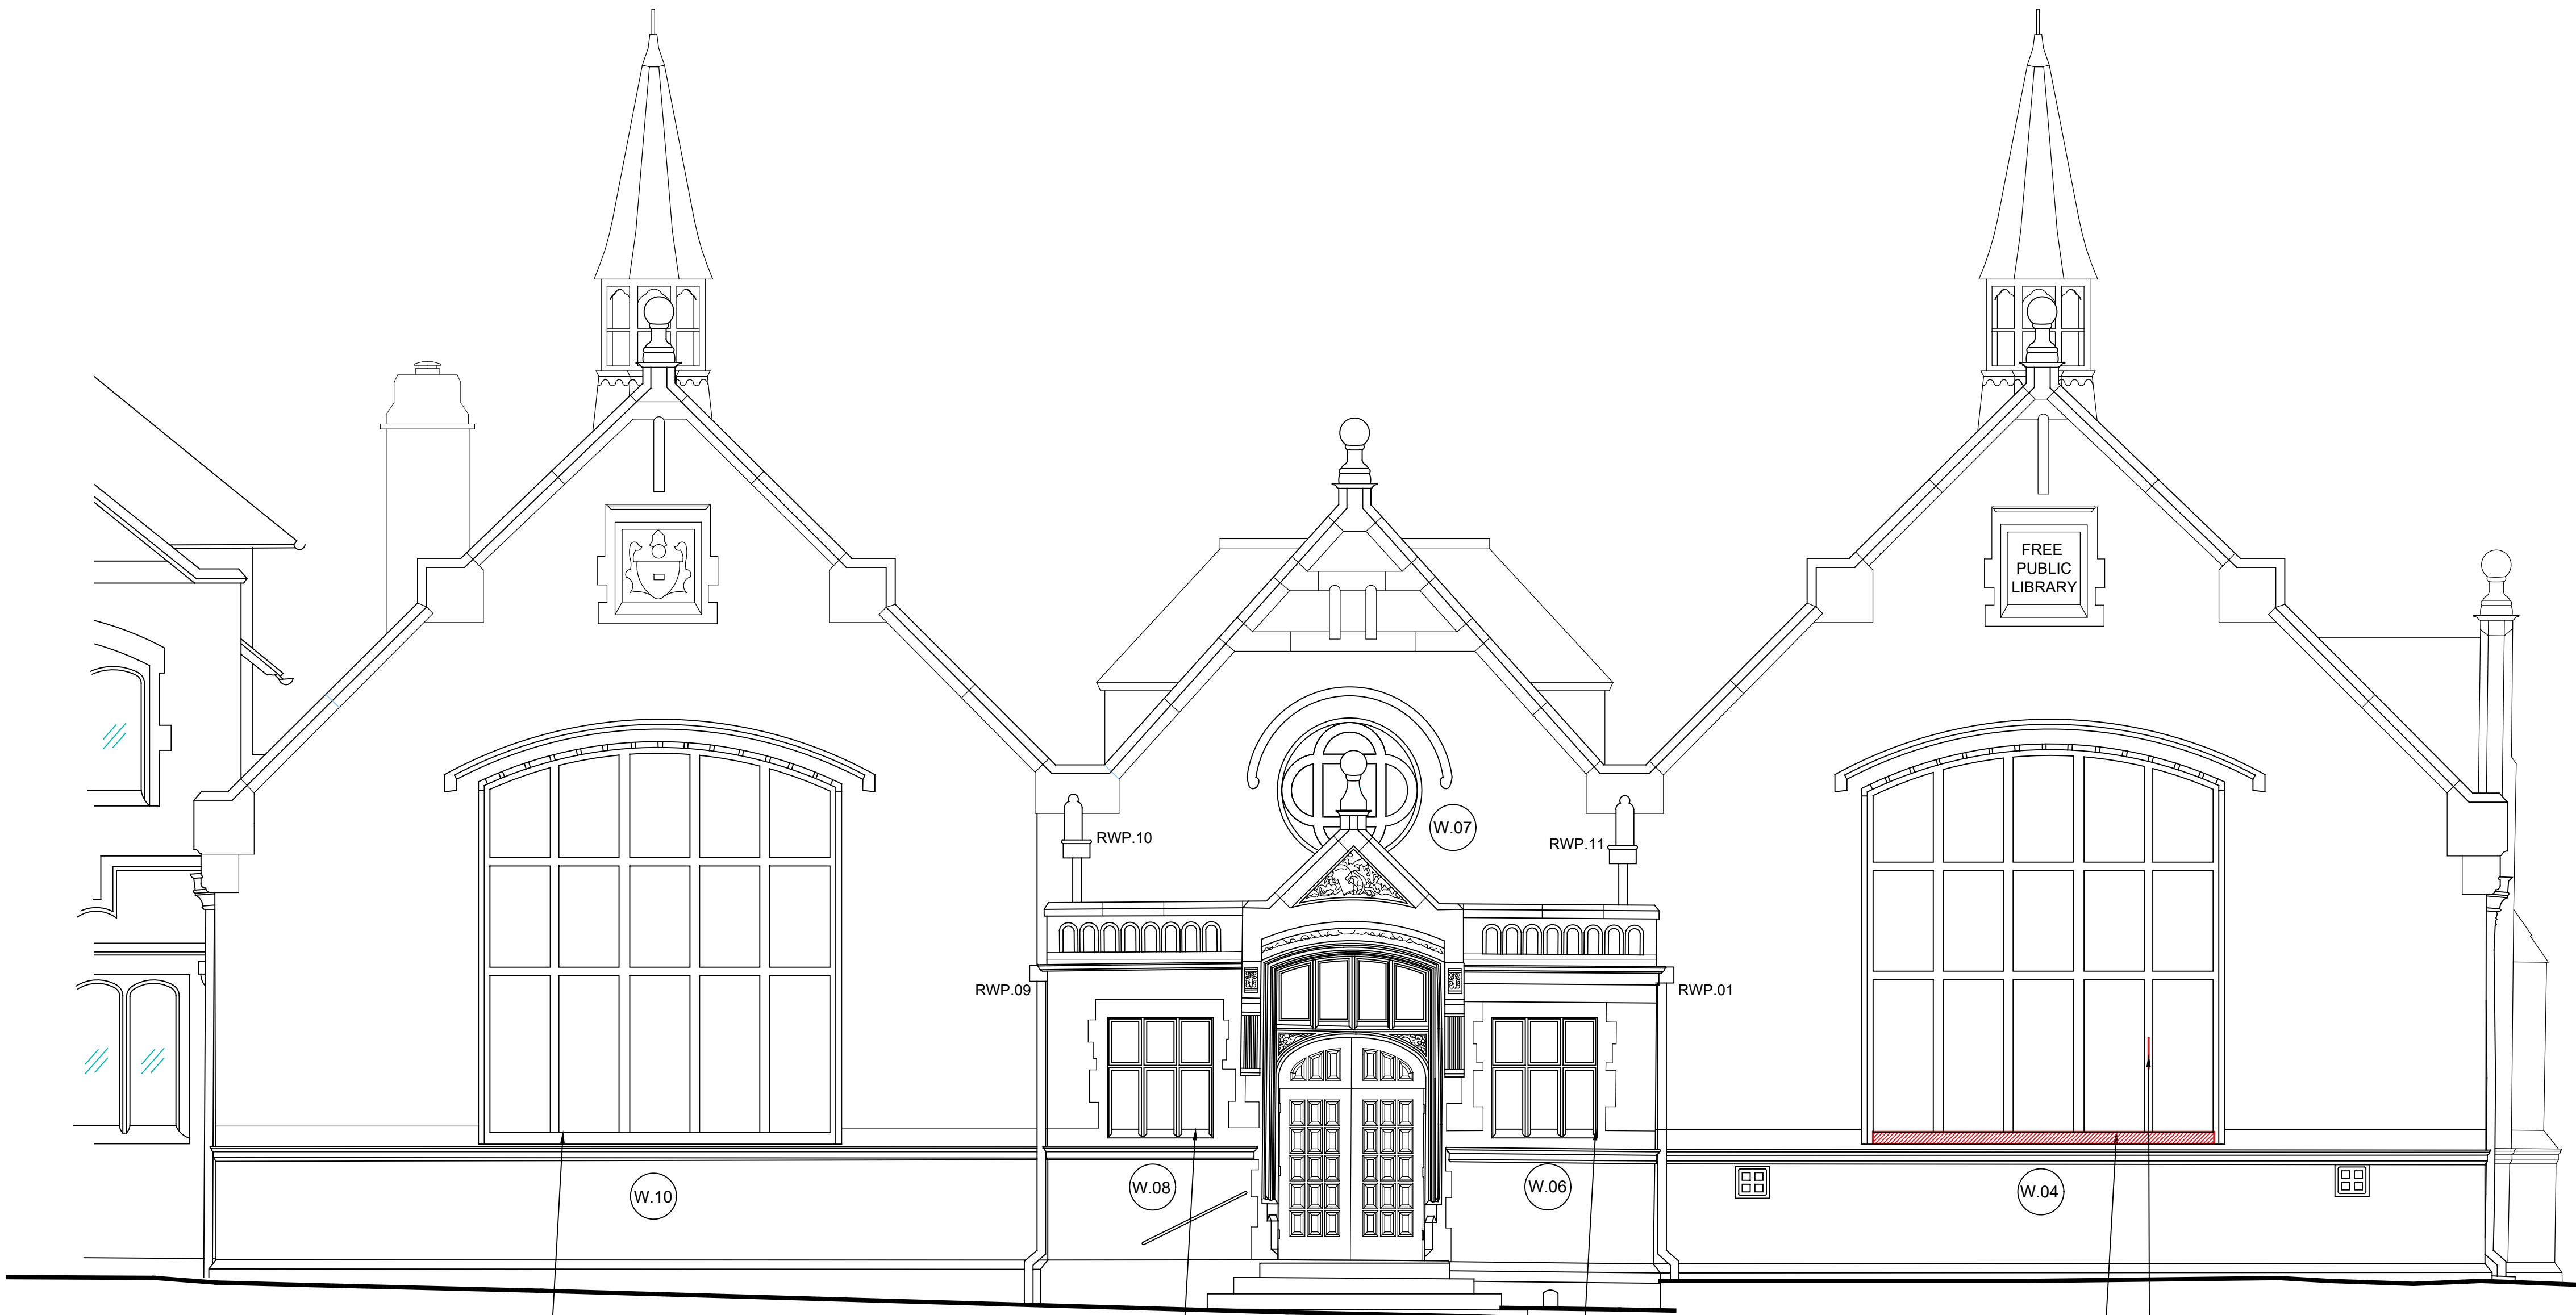
Limited access due to current scaffold layout  
Allow for Architects Inspection when  
access is available.

Rot to multiple sections of bottom rail to timber  
window. Replace entire bottom cill as NBS C51 to  
match existing profile.

Crack at timber mullion. Fill with 2  
part epoxy as NBS M60/160.

Repaint timber members of window  
to match existing as NBS M60

Renew burnt sand mastic joint as  
NBS Z20 to joint between window and masonry  
as per manufacturers recommendations.
