# Heritage Assessment

Lower Cleggswood Farm, Heald Lane,  
Littleborough

May 2025

# Building Condition Report - Farm houses and stone barn Revision 2

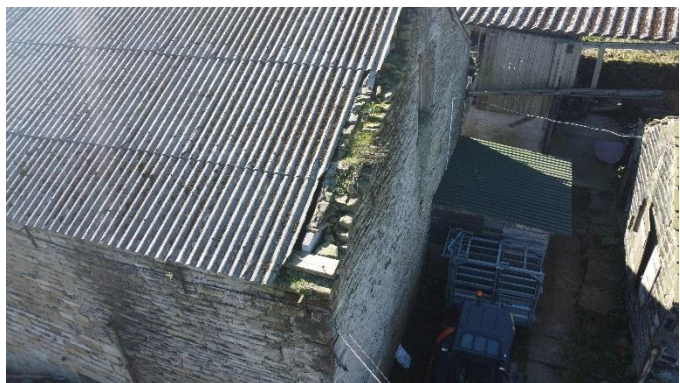
### 2. Barn

Roof sheets dislodged/unfixed.

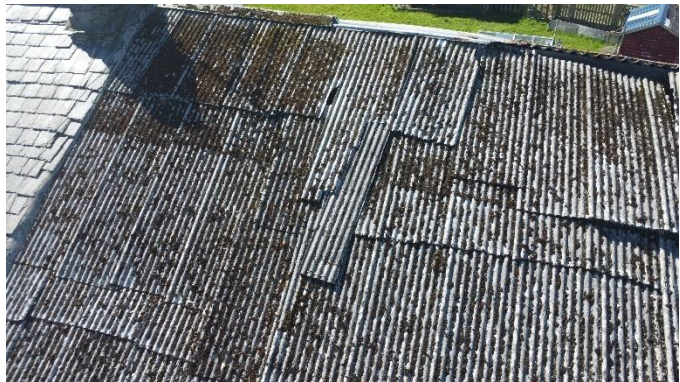
### 3. Barn

Large opening to roof at ridge

Section of rebuilt gable visible to left side beneath coverings.

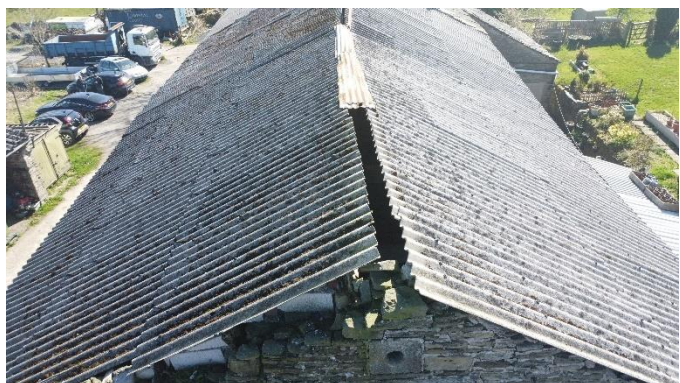
4. Barn  
Bowling/lean to walls/roof  
visible from above.

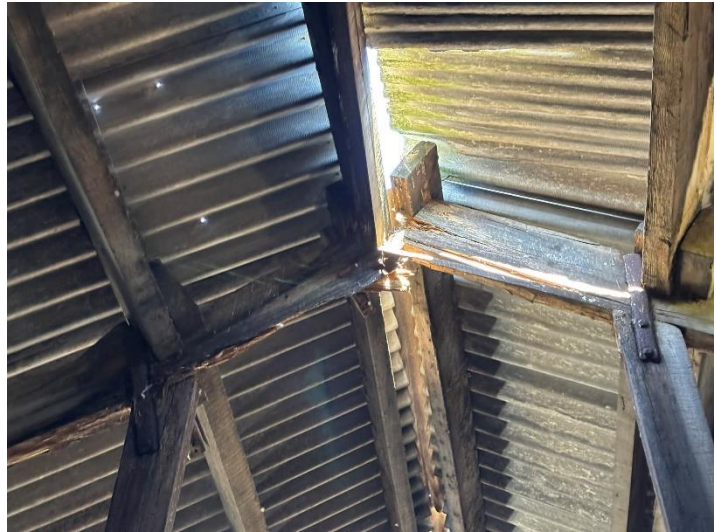
11. Barn – First floor

General view of upper floor.

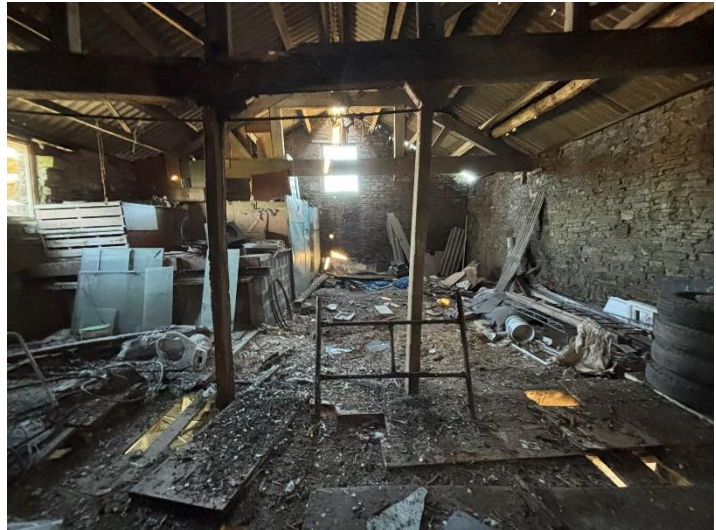
12. Barn – First floor

Section of upper floorboards missing.

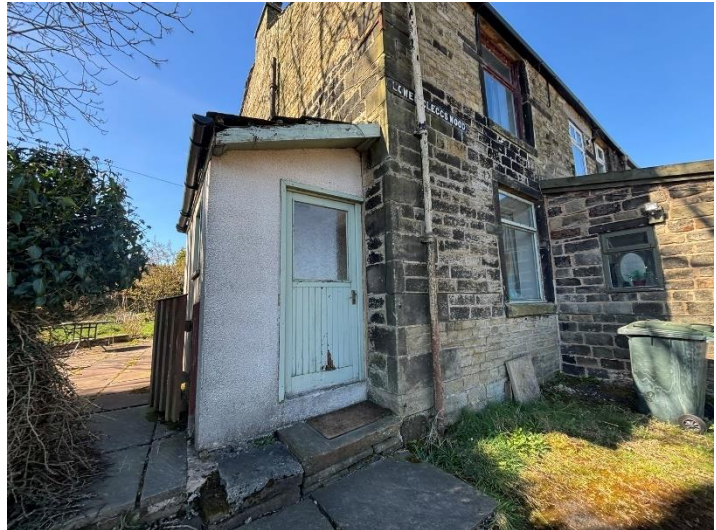
26. House 01 – Front elevation

Paving to entrance in poor condition.

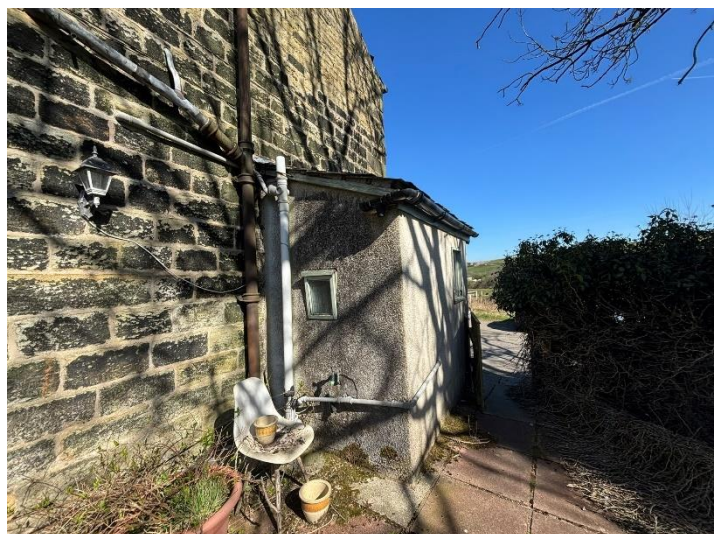
28. House 01 – Side elevation

Overview.

Ivy growth visible.

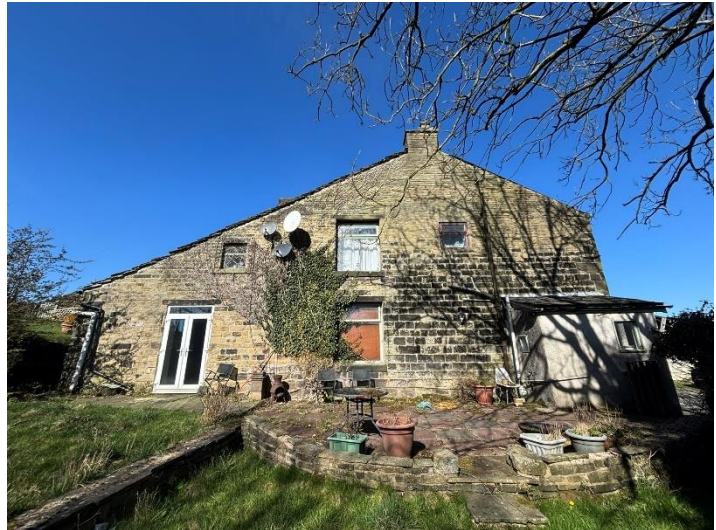
29. House 01 – Side elevation

Open pointing at high level.

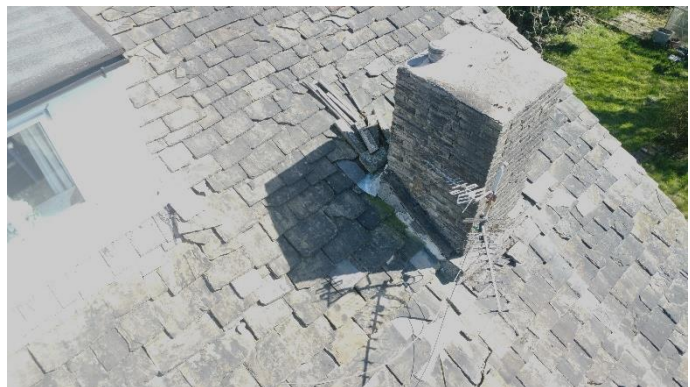
Poor detailing to rear of chimney with evidence of prior repairs.

Cracking present to wall of the chimney.

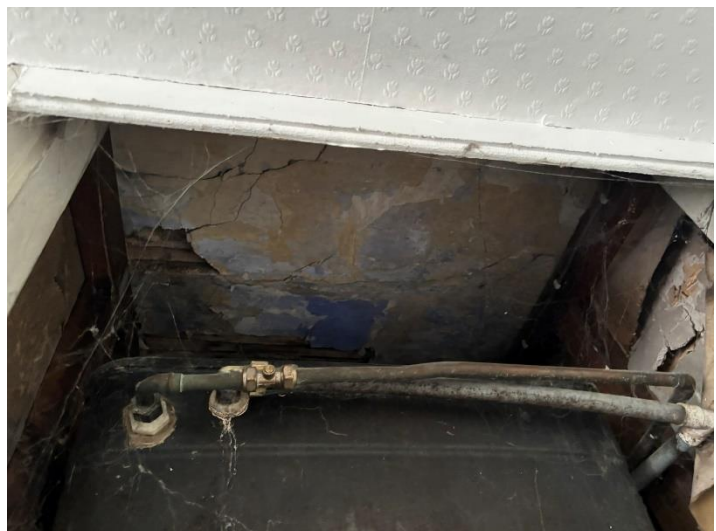
Damage to ceiling above water  
tank.

Lath and plaster construction  
visible.

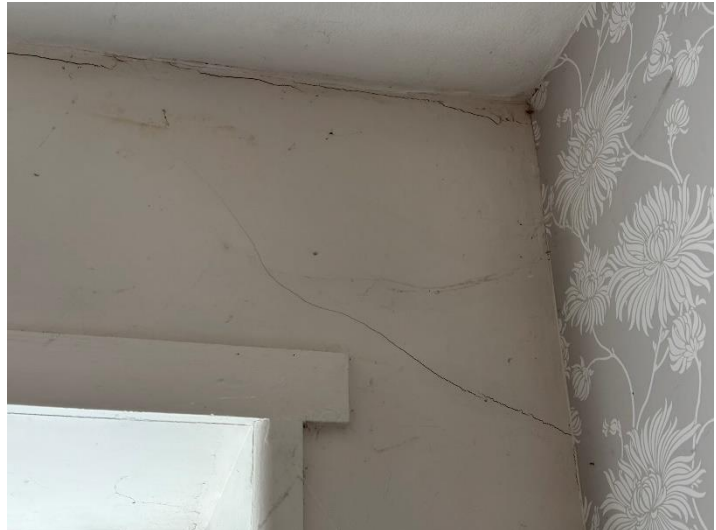
41. House 01 – Bathroom

Cracking to plaster above  
bathroom window.

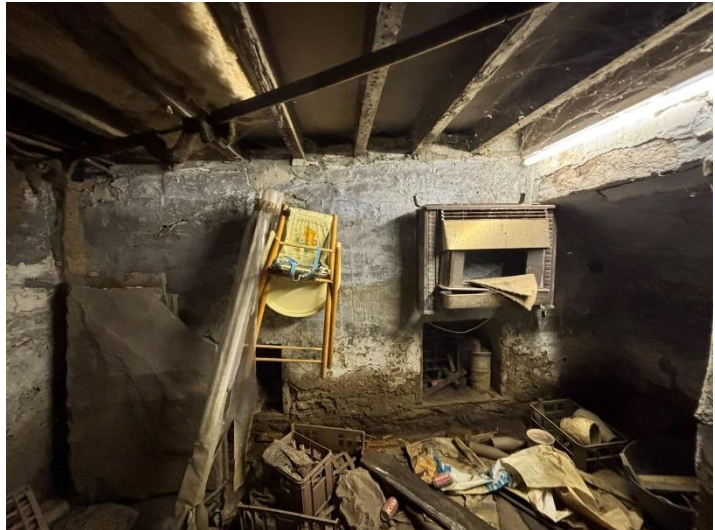
47. House 01 – Basement

Overview.

Tide mark visible to walls.

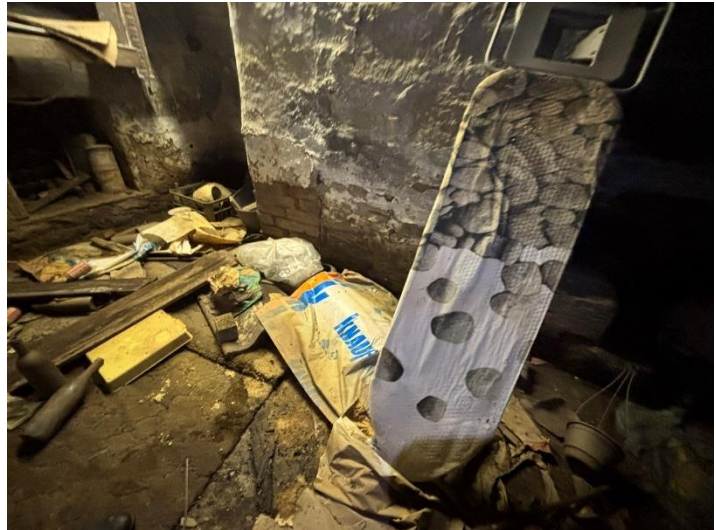
Floor obscured by debris.

Stone slabs visible as floor structure.

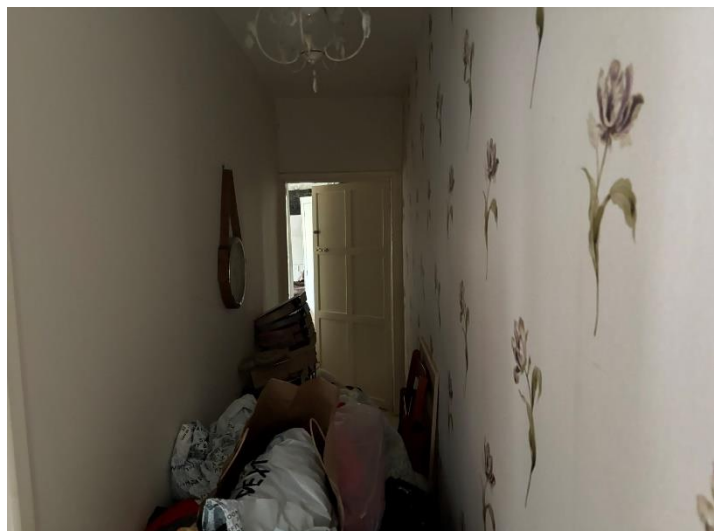
51. House 01 – First Floor Landing

Access to rear bedroom blocked by resident belongings.

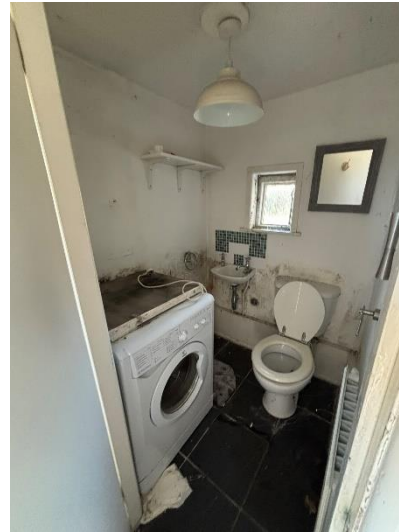
52. House 01 – Utility Room

Overview.

Damp staining visible to walls.

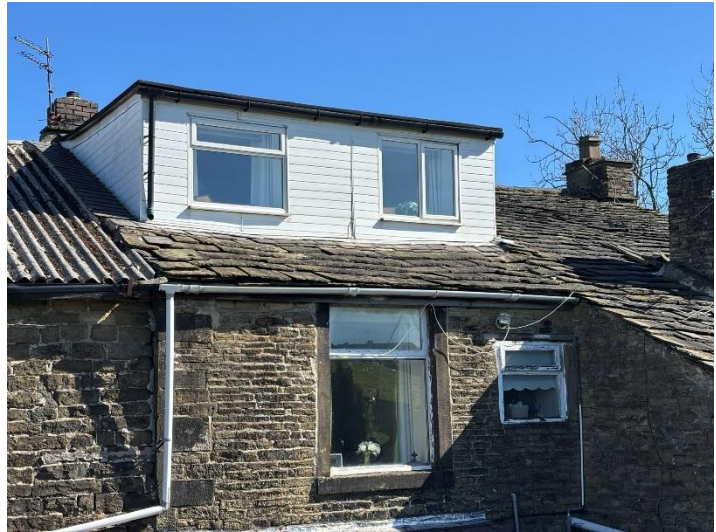
Stone roof tiles below in poor condition.

Windows to first floor suffering wet rot to frames.

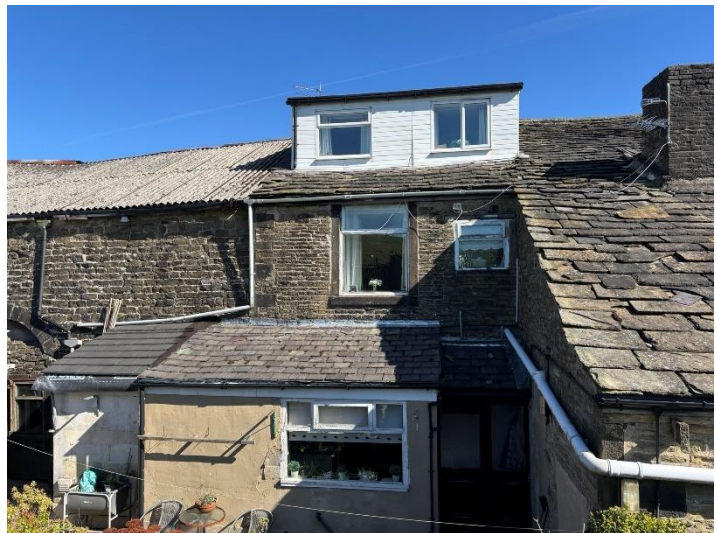
59. House 02 – Rear elevation

Overview of rear elevation of House 02.

Note the down pipe arrangement which wraps around house 01 from the first floor of house 02.

| Element | Description |
|---|---|
| Rainwater Goods | Replace gutters to rear elevation, lean to roofs and entrance lobby roofs.<br>Replace down pipe to front elevation with new cast iron down pipe.<br>Consider consolidation of downpipe runs to the rear to minimise turns and bends within the pipework. |

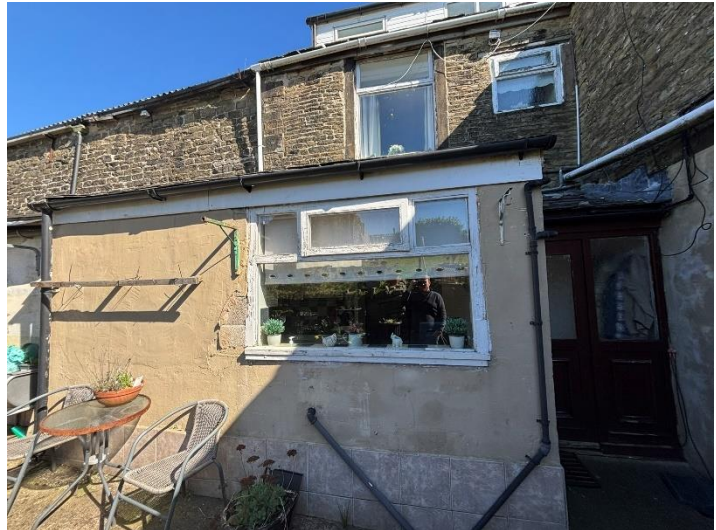
61. House 02 – Rear elevation

Central lean to extension.

Render debonded in isolated areas.

Timber wood frame suffering from weathering.

| External decorations | Replace render to lean to extensions.<br>Decorate previously decorated external surfaces throughout. |

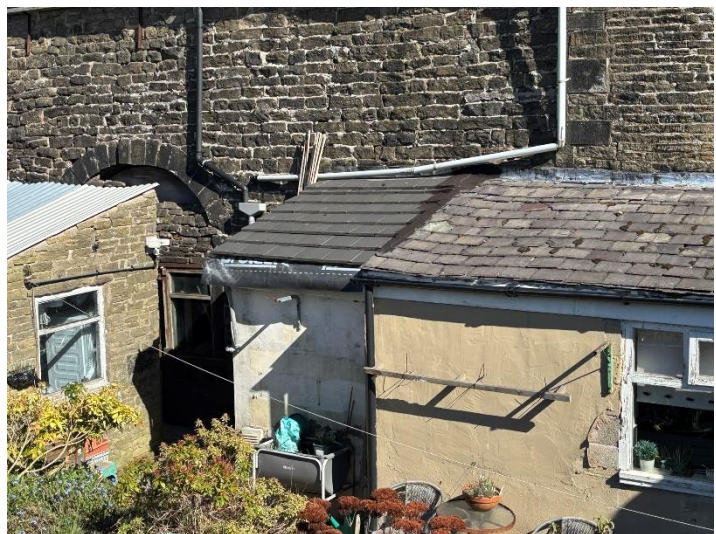
63. House 02 – Rear elevation

Liquid plastic coating applied between roof sections of lean to.

| Element | Description |
|---|---|
| Roof – Lean to | Replace roof coverings with new and reform junction details throughout. |

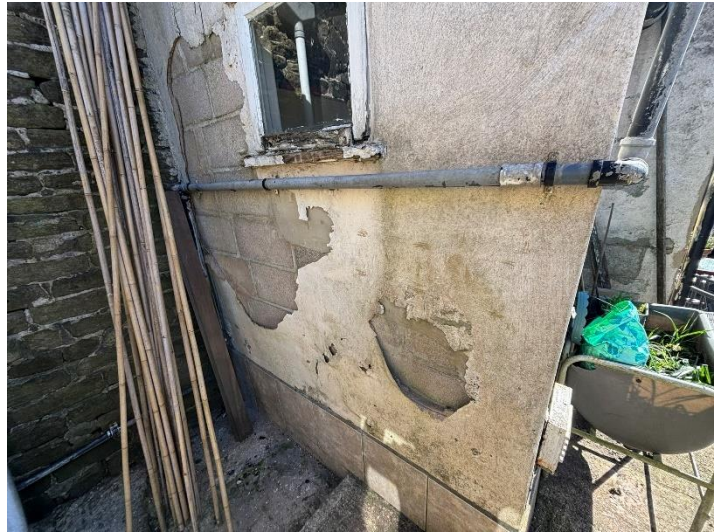
64. House 02 – Rear elevation

Render debonding from  
blockwork to left end lean to.

Substantial wet rot visible to  
window frame above.

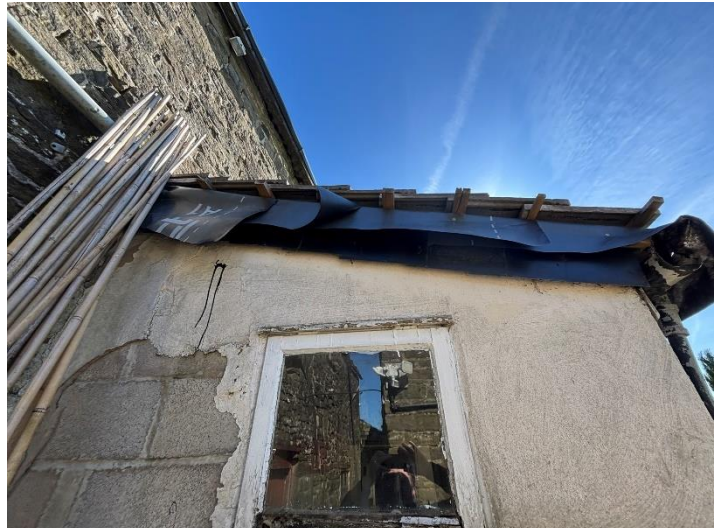
65. House 02 – Rear elevation

Roof appears to be unfinished  
with membranes overhanging  
the walls.

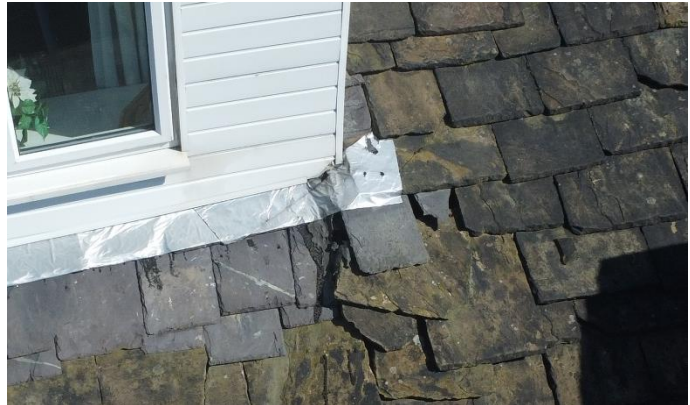
67. House 02 – Roof

Detailing between dormer walls and main roof covering appears poorly formed.

| Element | Description |
|---|---|
| Roof – main | Replace detailing between the pitched roof and dormer walls with a typical industry standard detail using suitable materials. |

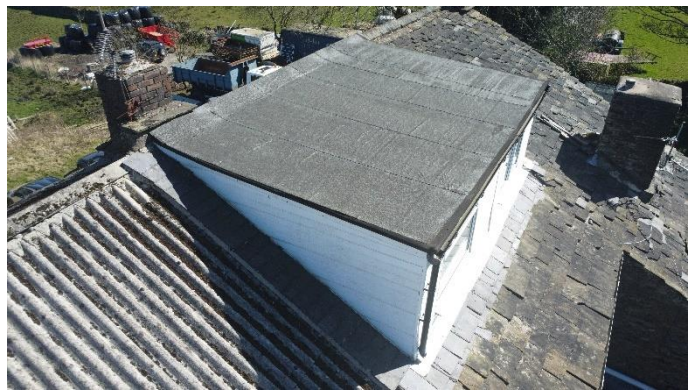
68. House 02 – Roof

Felt covering to dormer extension is sagging and rucked.

| Element | Description |
|---|---|
| Roof - dormer | Replace felt roof covering to the flat roof of the dormer and reform the detail at the junction with the ridge to an industry standard detail. |

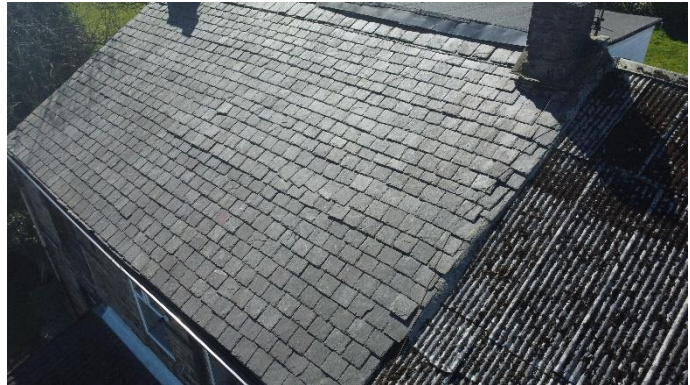
71. House 02 – Roof

Isolated slipped slates noted to the main roof.

| Element | Description |
|---|---|
| Roof – main | Replace stone roof coverings beneath dormer. |

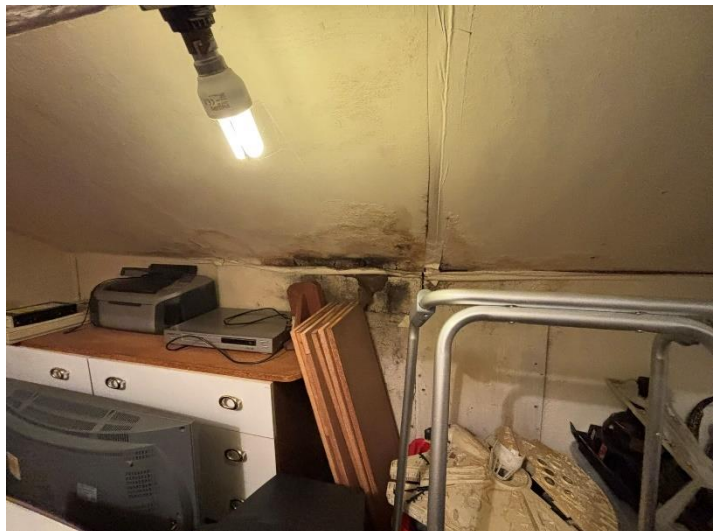
75. House 02 – Top Floor Store  
room

Water damage from roof leak  
noted. Appeared dry during  
our inspection.

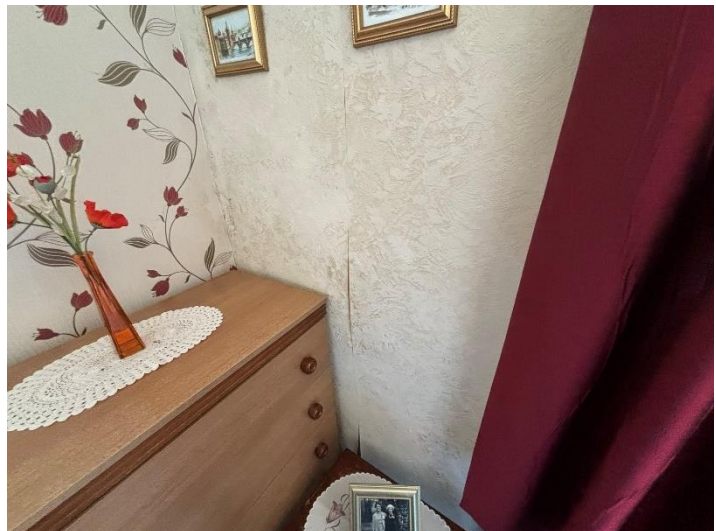
78. House 02 – First floor front bedroom

Damage to internal finished from external downpipe leak.

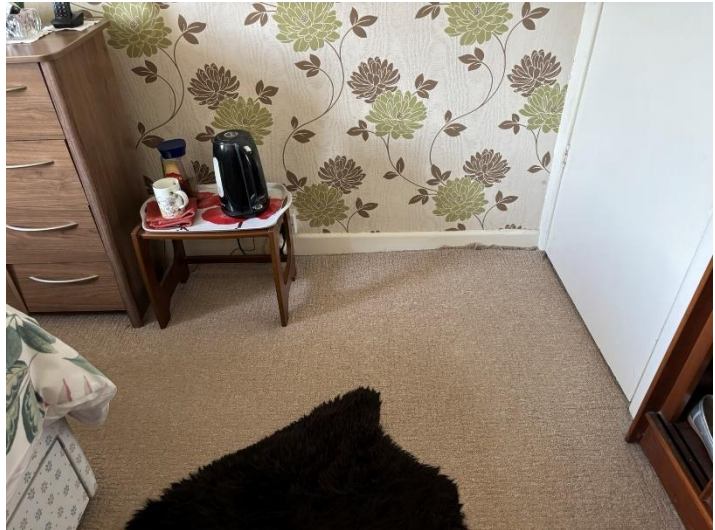
80. House 02 – First floor rear bedroom

Unevenness to the floor visible. Sloping right to left on the photograph.

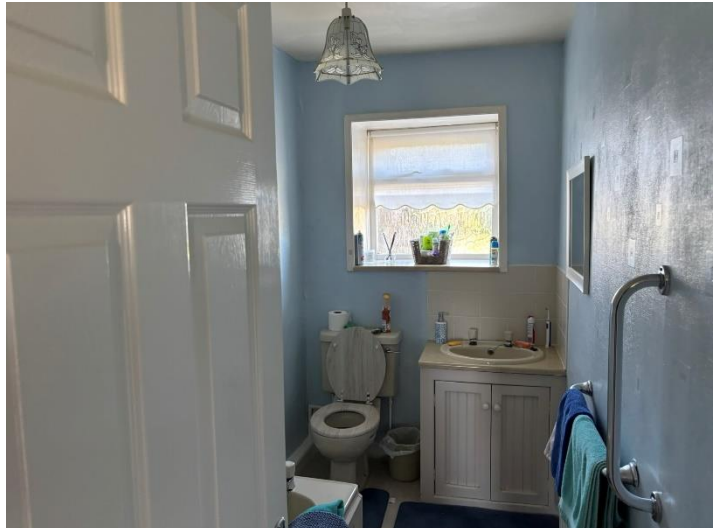
81. House 02 – Bathroom

Overview.

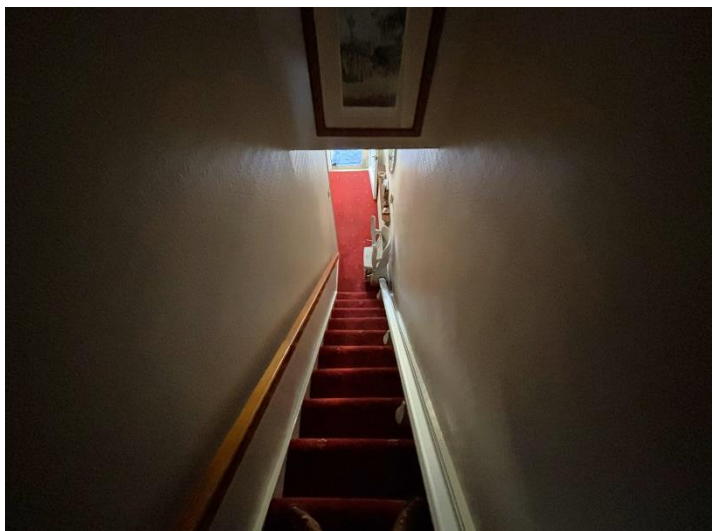
82. House 02 – Staircase

Overview.

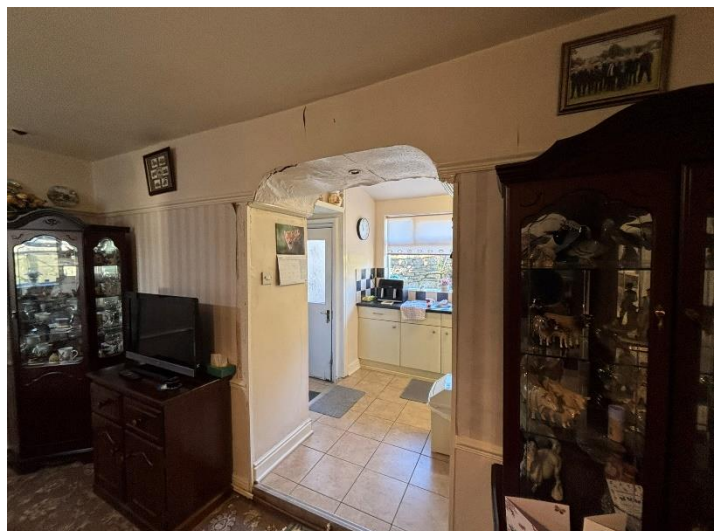
85. House 02 – Reception room 02

Damage to ceiling at opening  
to kitchen.

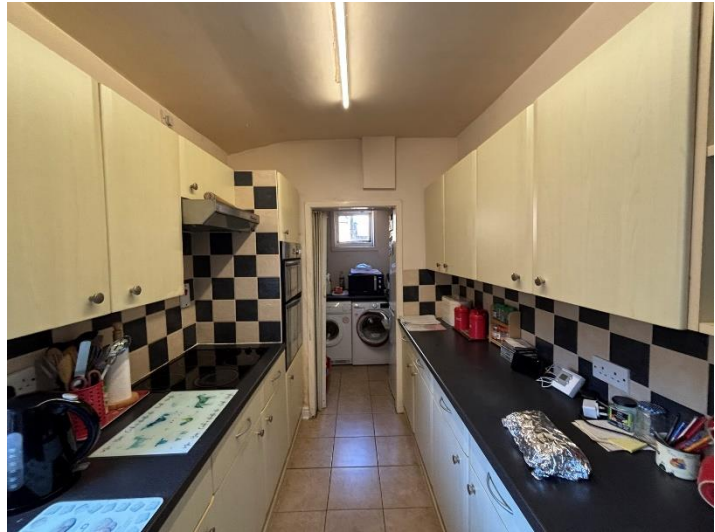
86. House 02 – Kitchen

Overview.

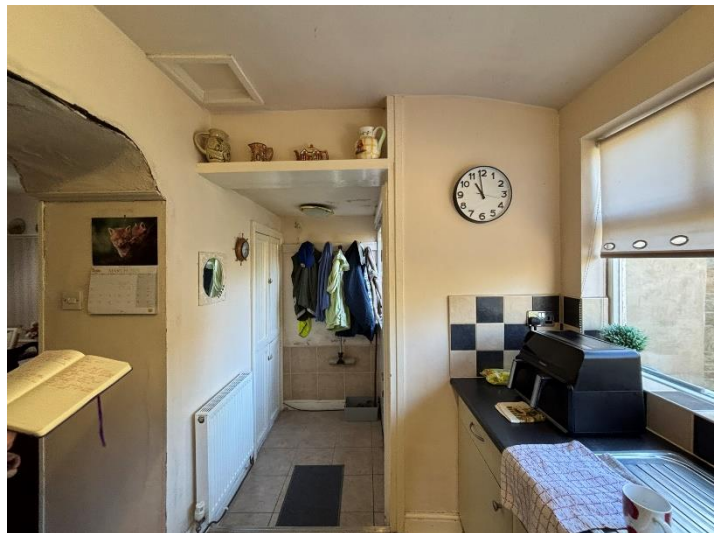
87. House 02 – Kitchen

Overview.

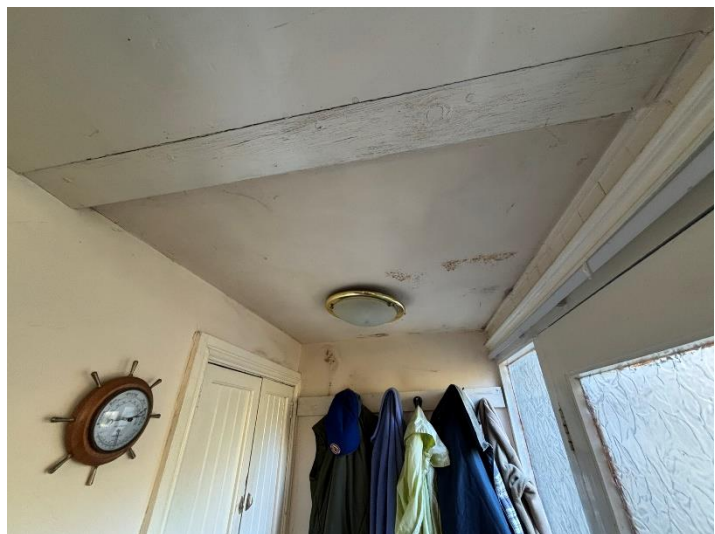
88. House 02 – Kitchen

Water ingress to ceiling at lean to.

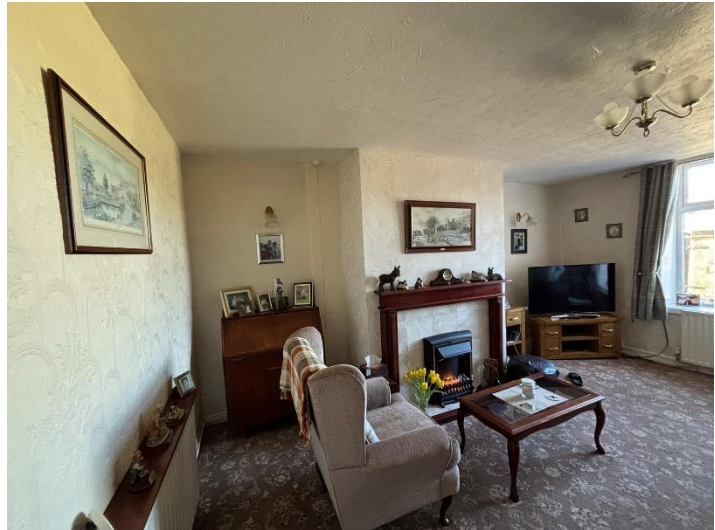
89. House 02 – Front reception room.

Overview.

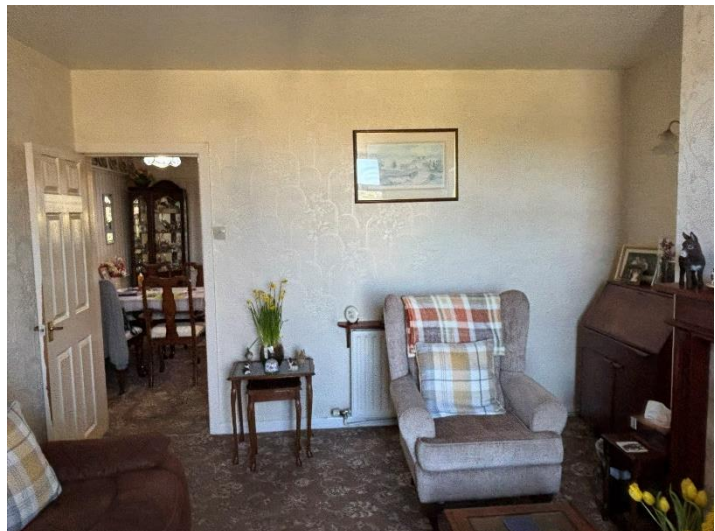
90. House 02 – Front reception room.

Overview.

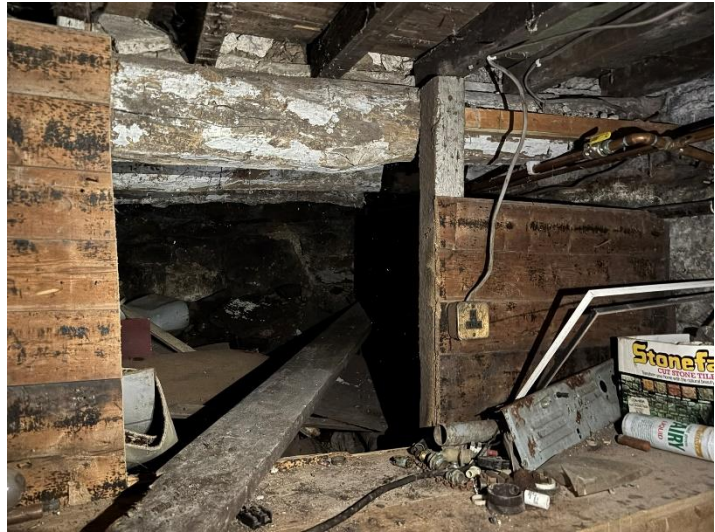
92. House 02 – Basement

Overview.

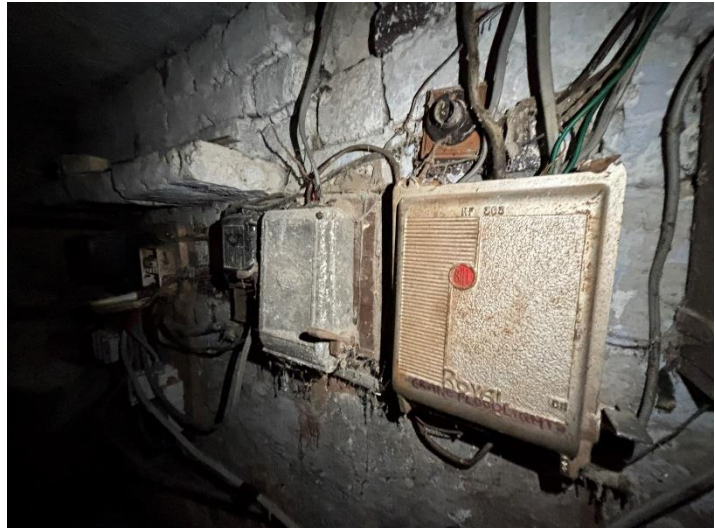
93. House 02 – Basement

Electrical incoming supply.
