## **SYKE HOUSE BARN**

## **Archaeological Building Recording**

**North Star Archaeology**

**February 2024**

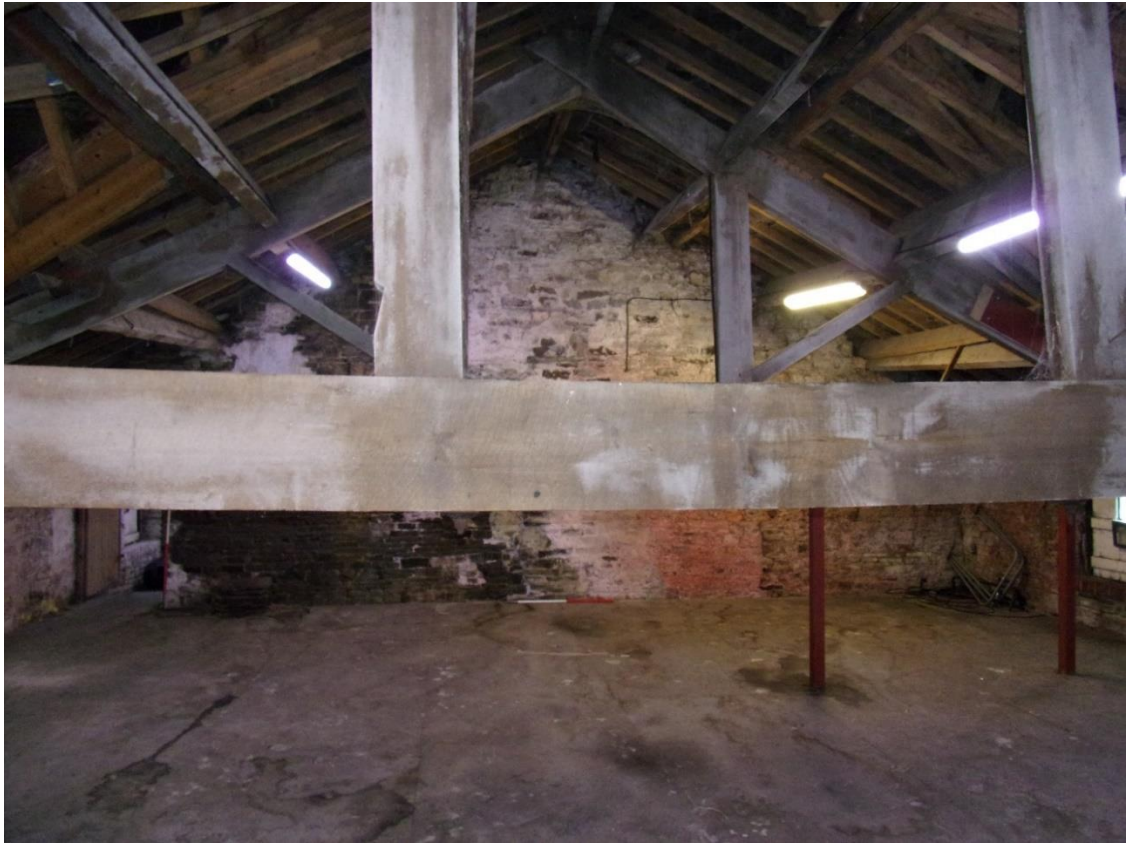
*Plate 71 West elevation of Room 13, facing west*

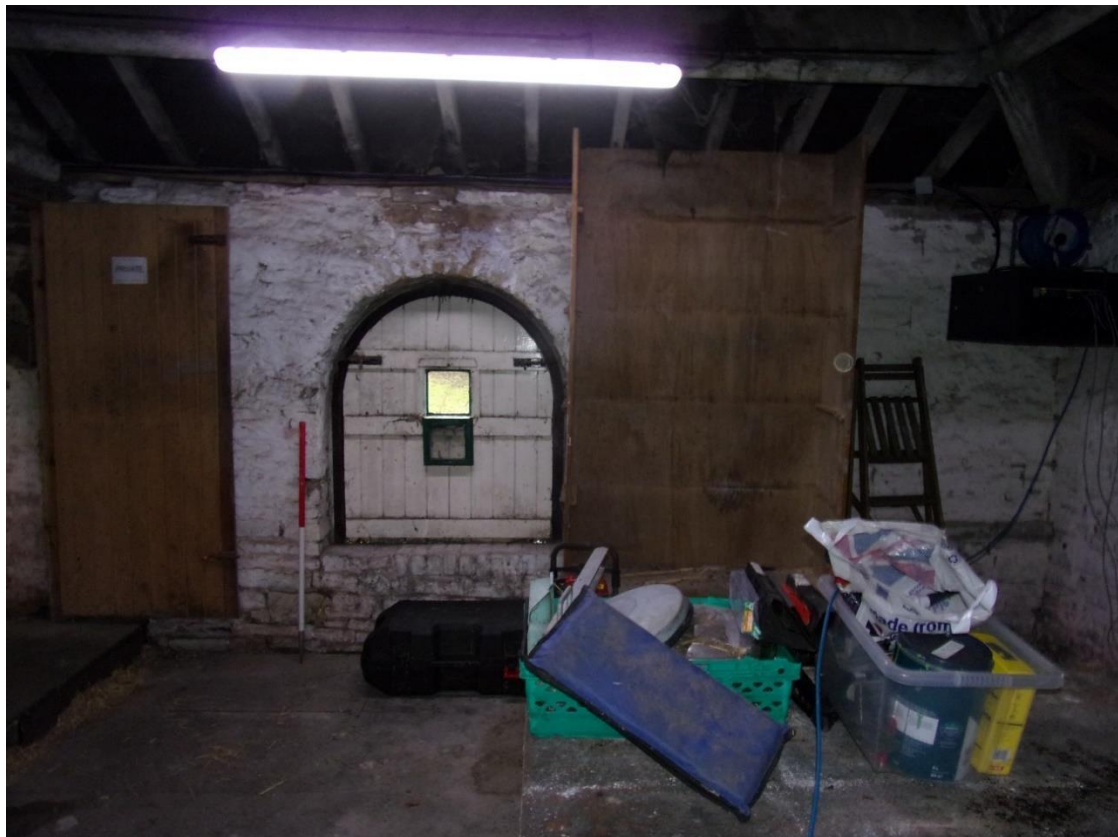
*Plate 77 Room 14 facing south*
