**ENGINEERING REPORT 9179**

**ROBINSONS EQUESTRIAN CENTRE  
HARWOOD FIELD FARM  
CASTLE HILL ROAD  
BURY  
BL9 6UL**

**CLIENT: STEPHEN ROBINSON**

**24.11.2023 MP/CH**

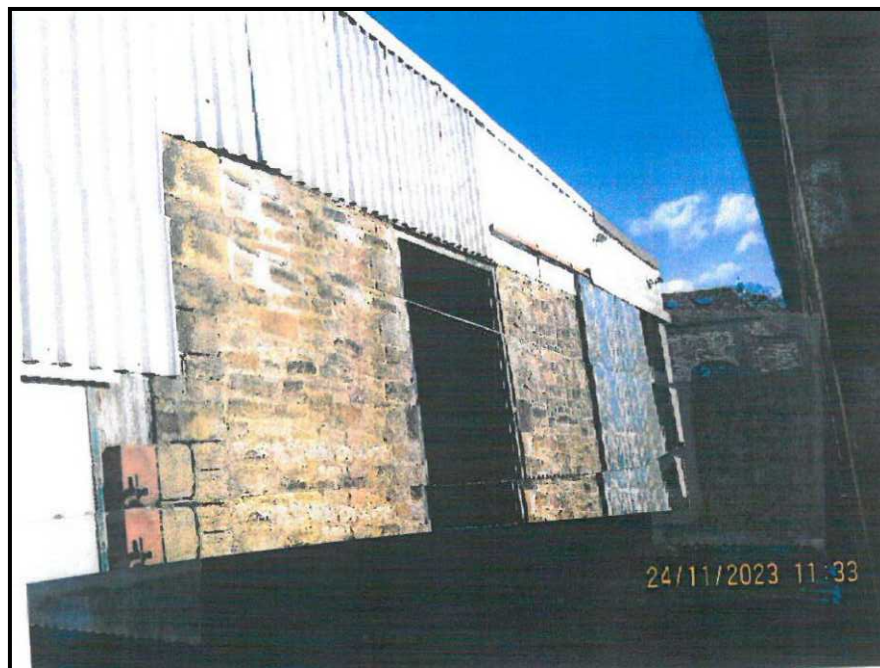
**Photograph 024 Front elevation**

- 3.1 The front elevation extends for a width in the order of 16 metres completed in coursed natural stonework of solid wall construction with a struck pointing, incorporating larger stone quoins on the original corners of the barn (chainage 0 – chainage 16 metres).
- 3.2 The stone facing extends for the full height of the front elevation overlain at eaves level with a variable 2 – 3 metre deep profiled metal cladding from roof level.
- 3.3 The front elevation incorporates a large timber sliding door located between chainage 1.5 – 4 metres with a further doorway to the East (left) at chainage 10 – 12 metres. (Photograph 024)

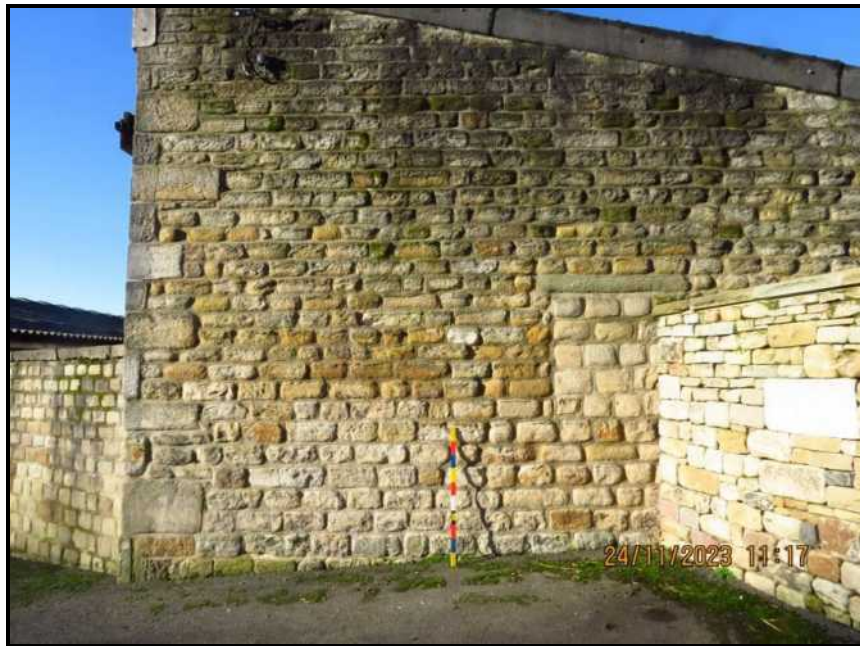
**Photograph 004 Chainage 0 – 5 metres**

- 4.1 The Eastern elevation is half gabled constructed in a randomly coursed stonework, with larger stone sections to the quoins on the front and rear corners, completed with a mono pitched roof.
- 4.2 The Eastern half gable elevation is completed in well maintained coursed stonework with quoin returns on the front and rear wall returns. The wall extends for a length in the order of 9 metres wide, sloping from 5 metres high on the front (South Eastern corner) to 2.5 metres high on the rear North Eastern corner.
- 4.3 The existing ground level rises approximately 1 metre from front to rear. (Photographs 001, 002, 004, 005).

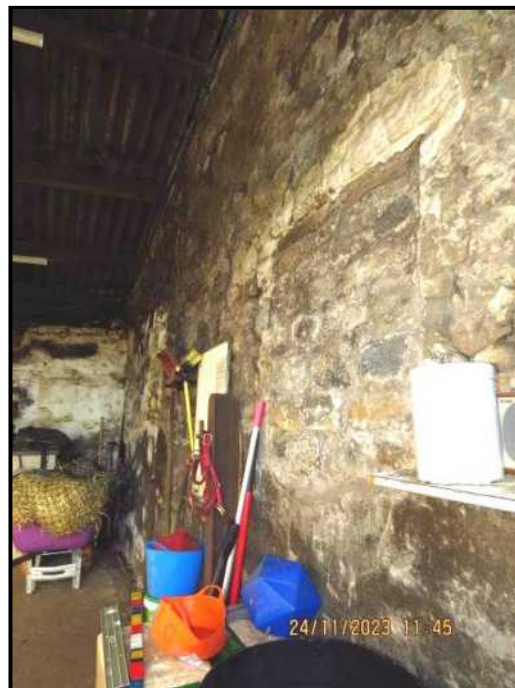
**Photograph 054 Gable elevation looking to rear**

- 7.4 On the inside face of the gable elevation the infilled window opening as identified externally can be traced in the wall finishes with no evidence of any recent movement. (Photographs 053, 054, 055).

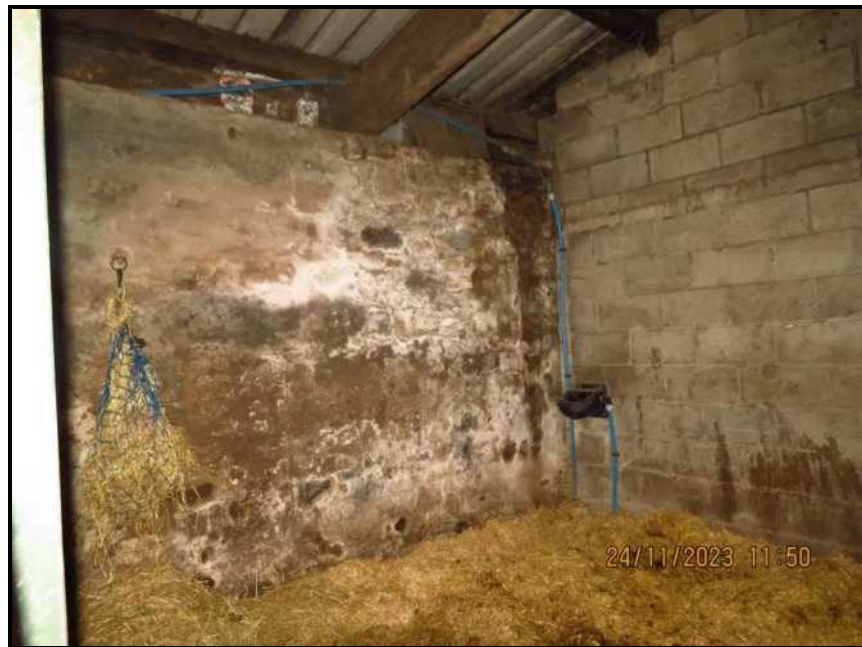
**Photograph 072 Rear wall and party wall North East corner**

- 7.10 Stable No. 2 incorporates two Tack Rooms with limited access to the rear walls. (Photographs 070, 071).
- 7.11 The rear wall of the original building is finished with a weathered and stained render finish, with a reasonable vertical alignment, with the internal party wall completed in satisfactory blockwork.
- 7.12 There are no signs of any separation where the blockwork cross wall adjoins the original rear and front elevations. (Photographs 072, 073, 074).

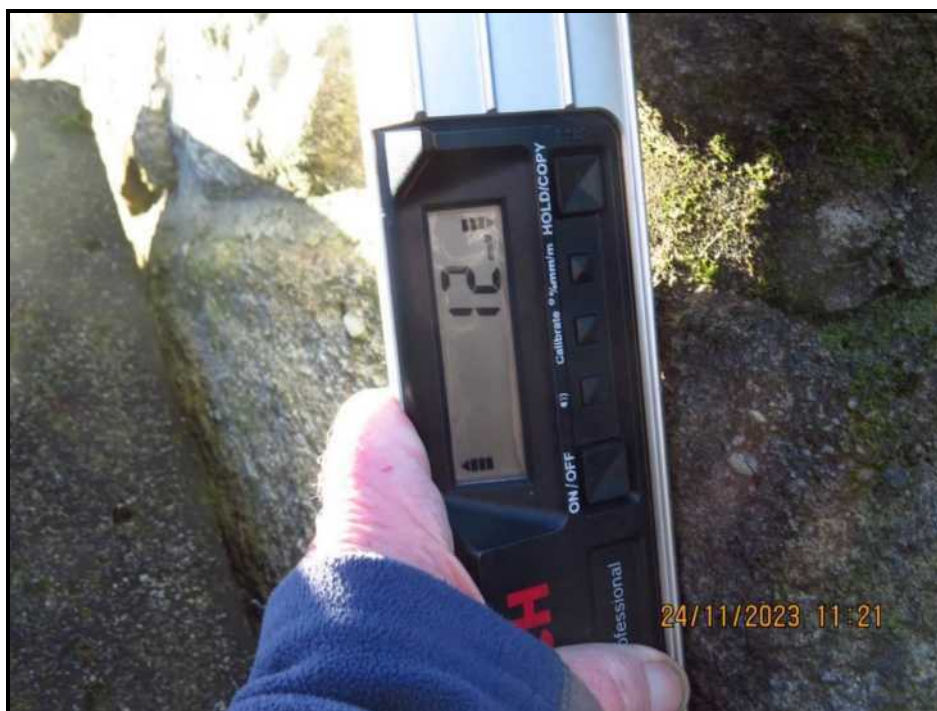
009 Vertical alignment  $\pm$  6mm per metre

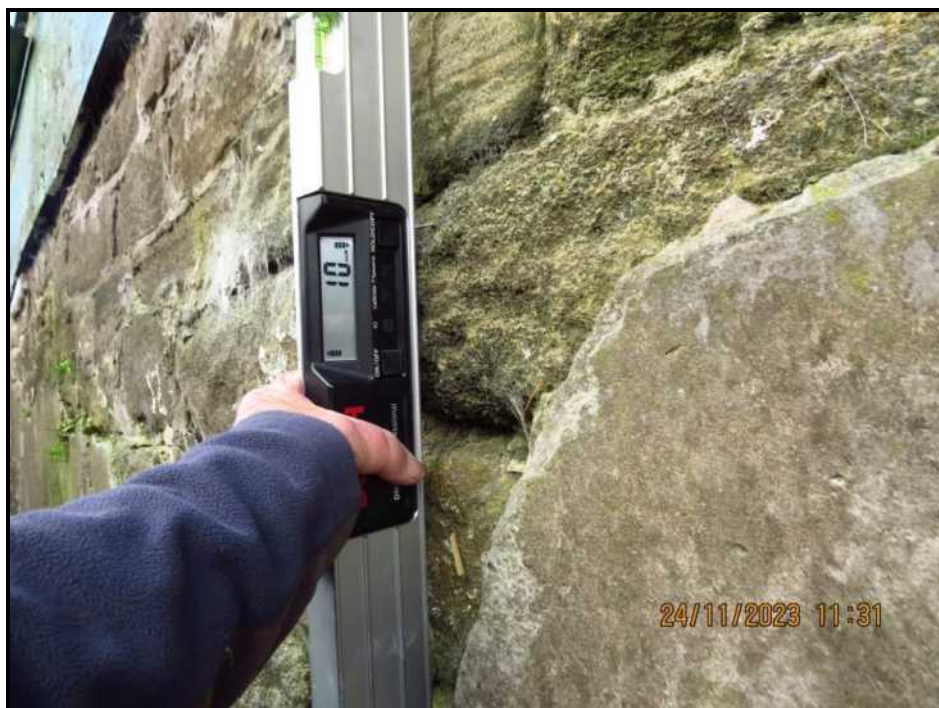
021 Satisfactory vertical alignment,  $\pm 5\text{mm}$  per metre

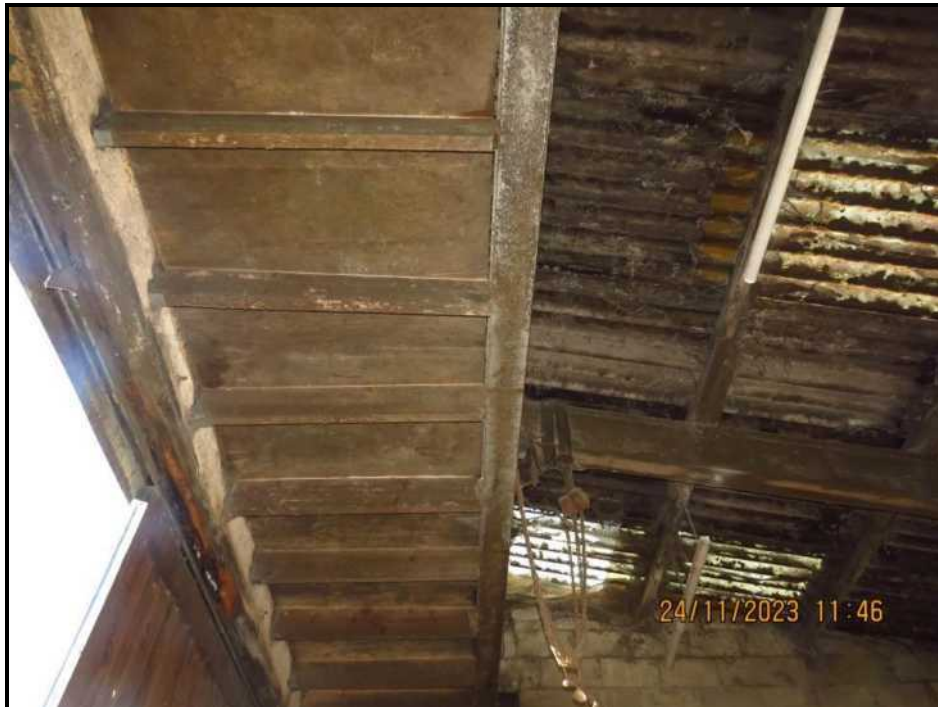
- 7.6 In the front stall the roof incorporates 300mm x 150mm joists spanning longitudinally onto a blockwork seating.
- 7.7 The vertical and horizontal alignment of the internal cross wall is good and the blockwork and pointing in very good condition.
- 7.8 Parallel to the front wall there are suspended beams supporting a timber platform between the gable and the internal cross wall. (Photographs 056, 057, 058).

056 Front elevation supporting timber detail

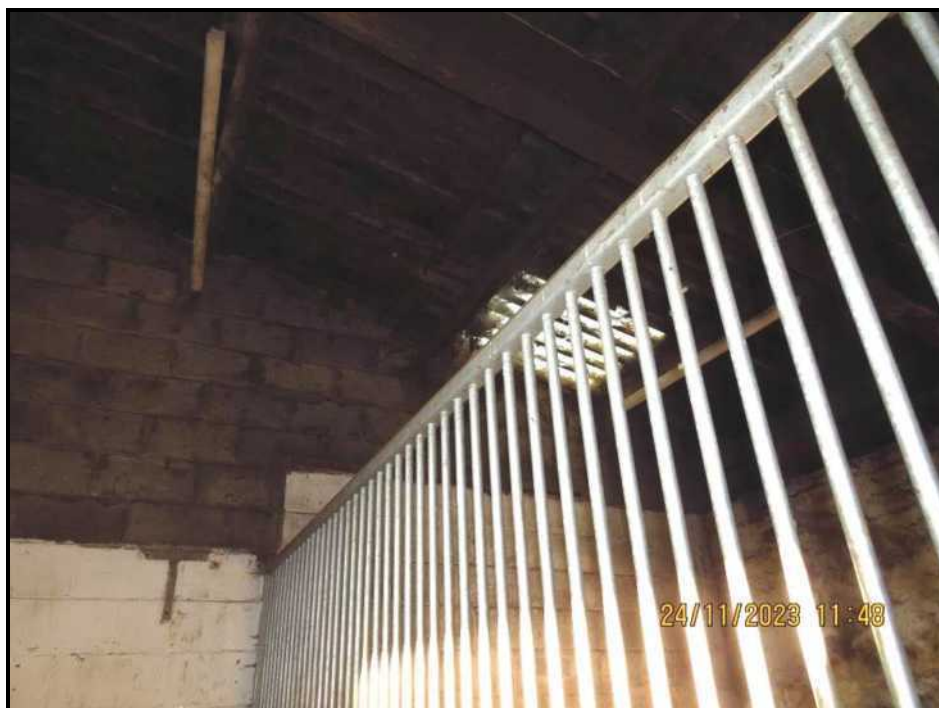
063 Party wall

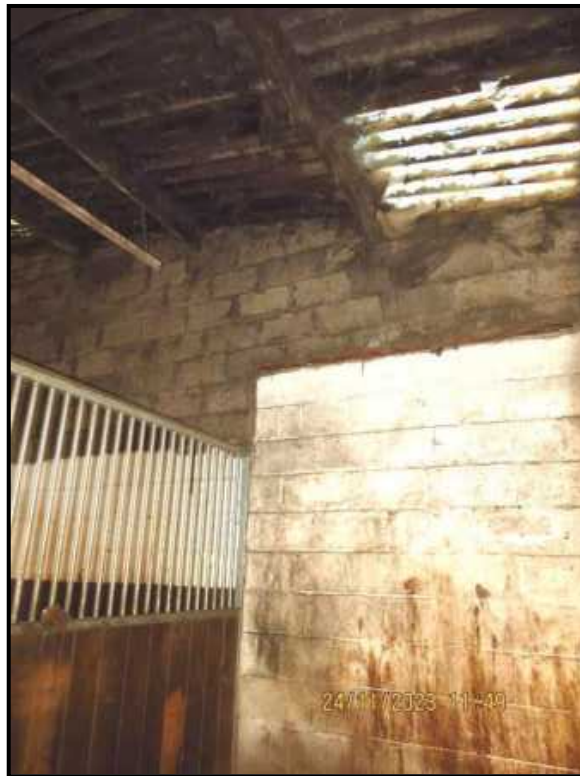
064 Party wall

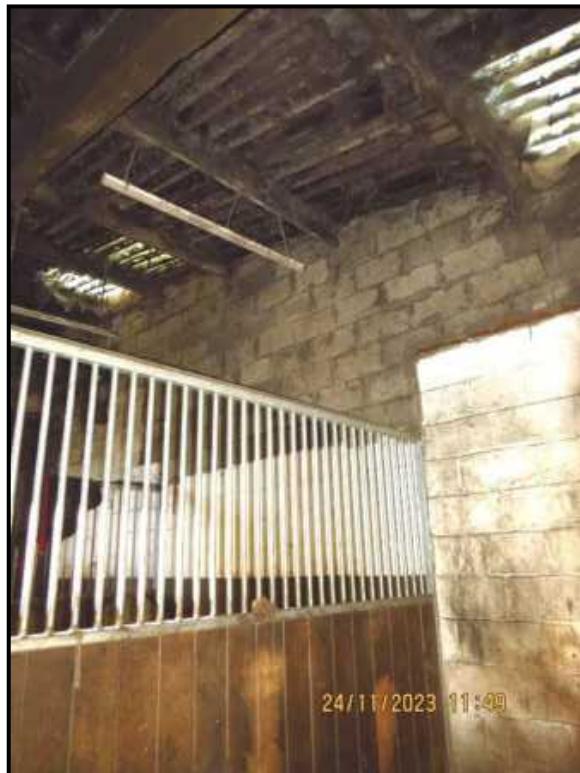
065 Party wall

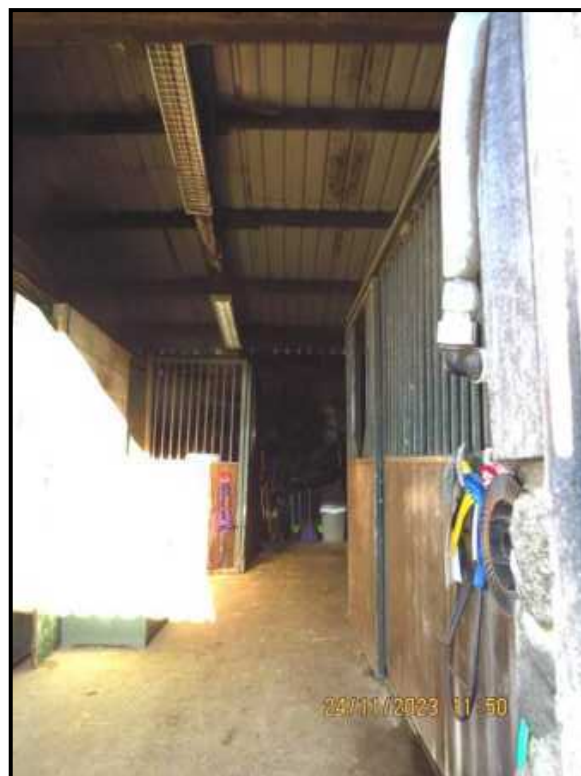
067 Entrance – Stable No. 2

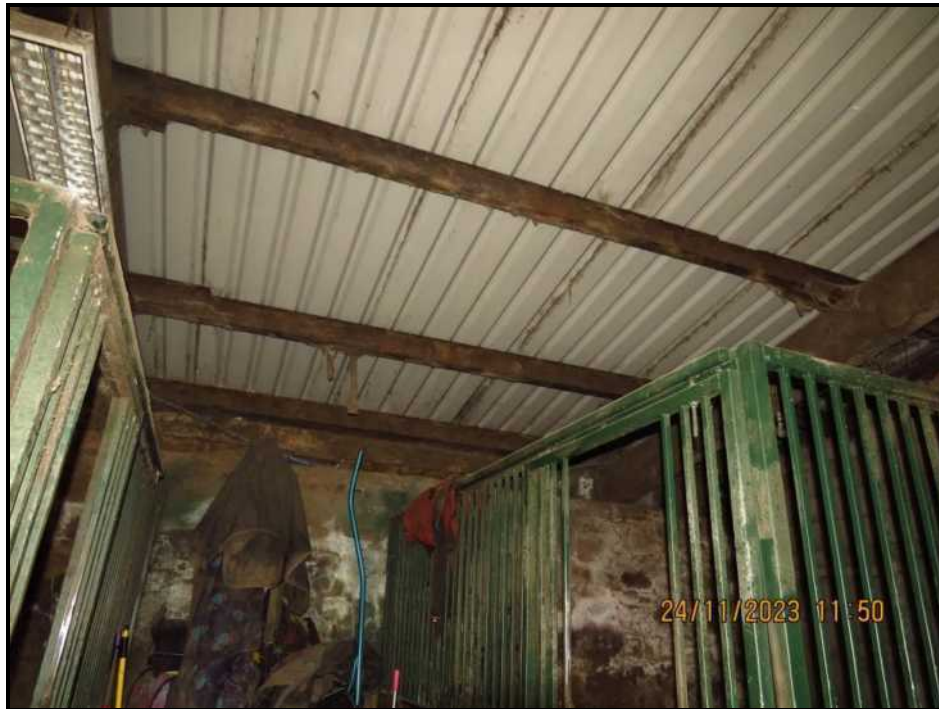
069 Roof detail

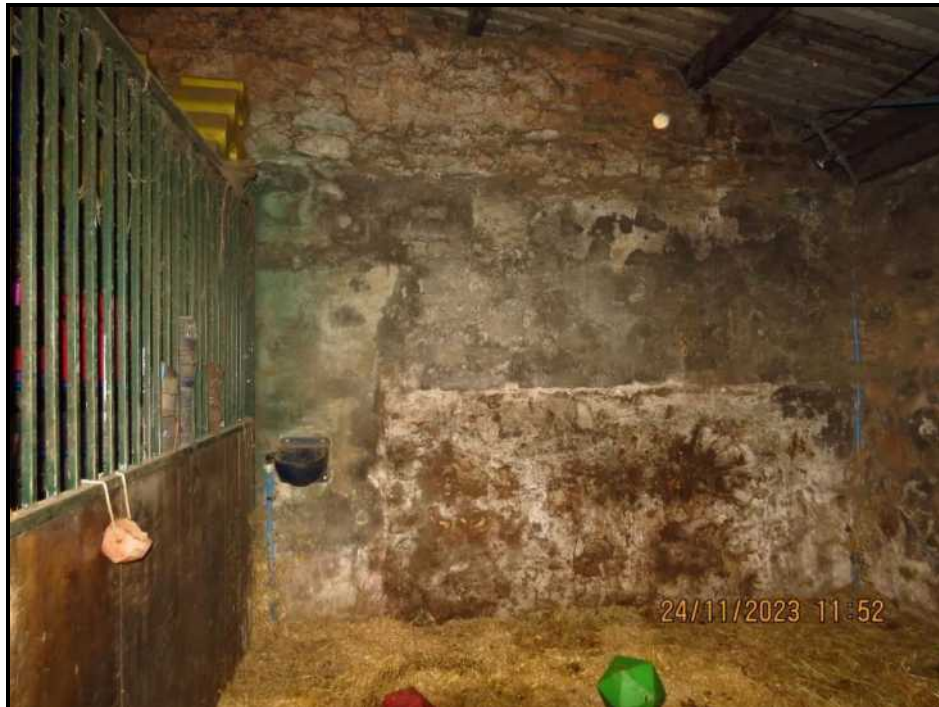
077 Party wall Unit 2/1

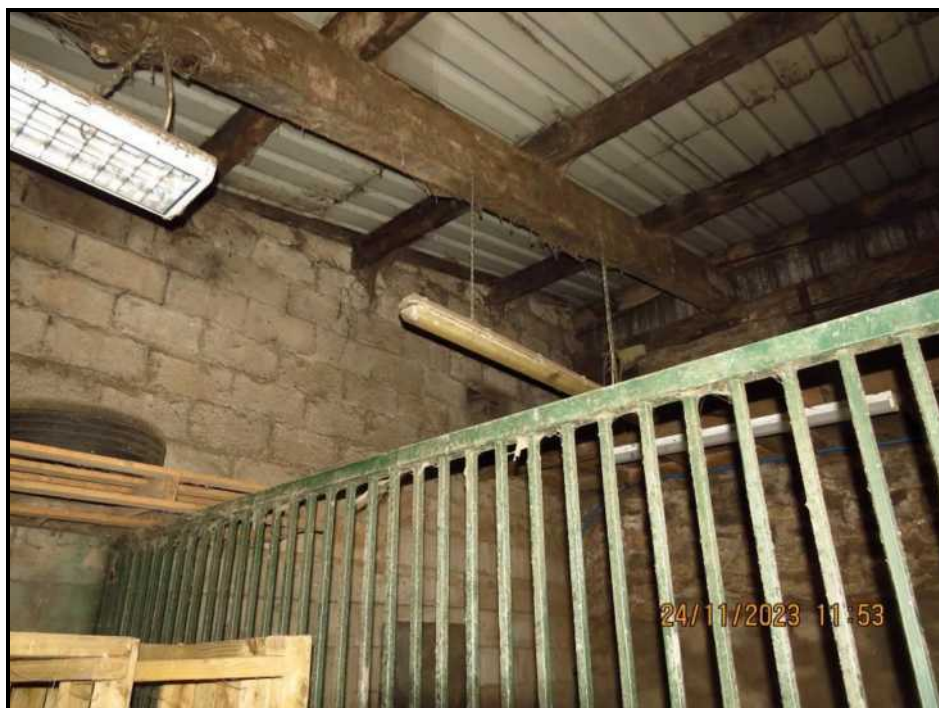
079 Party wall front corner

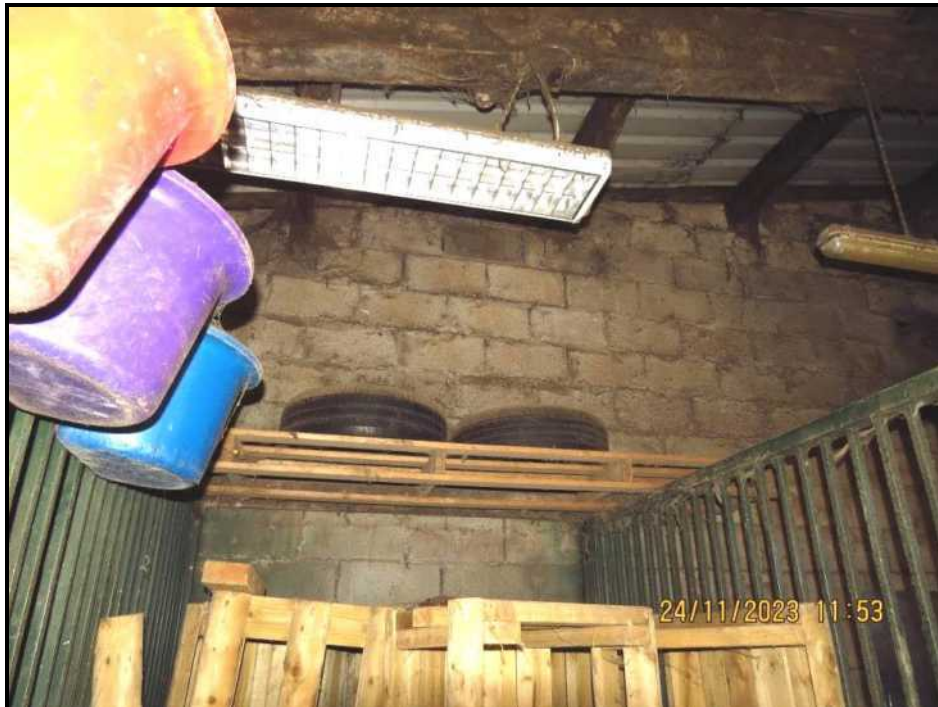
080 Party wall front

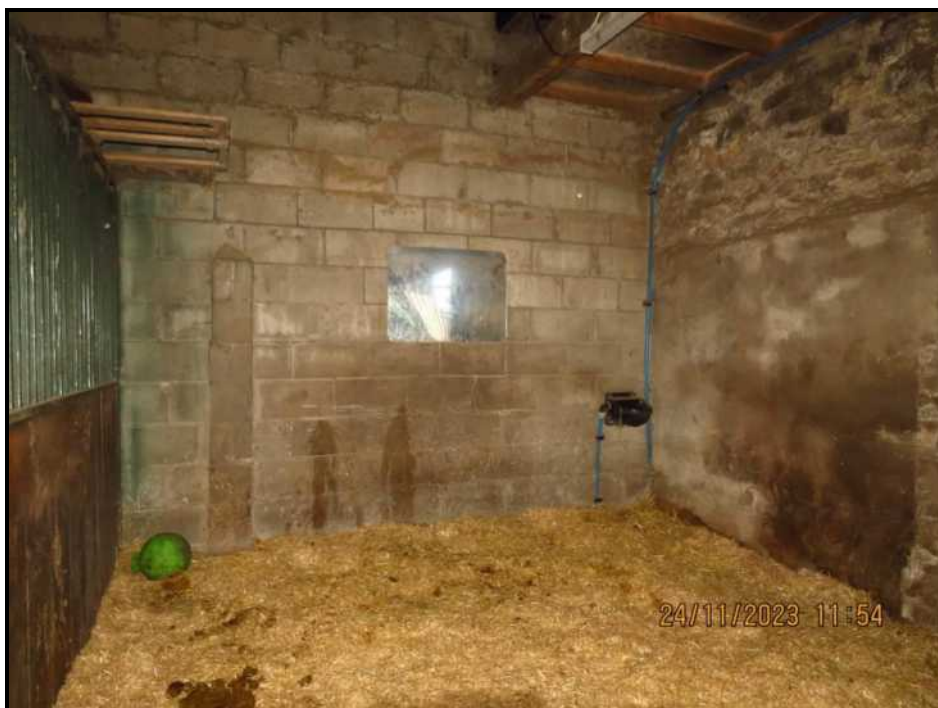
081 Front stall, party wall No. 1

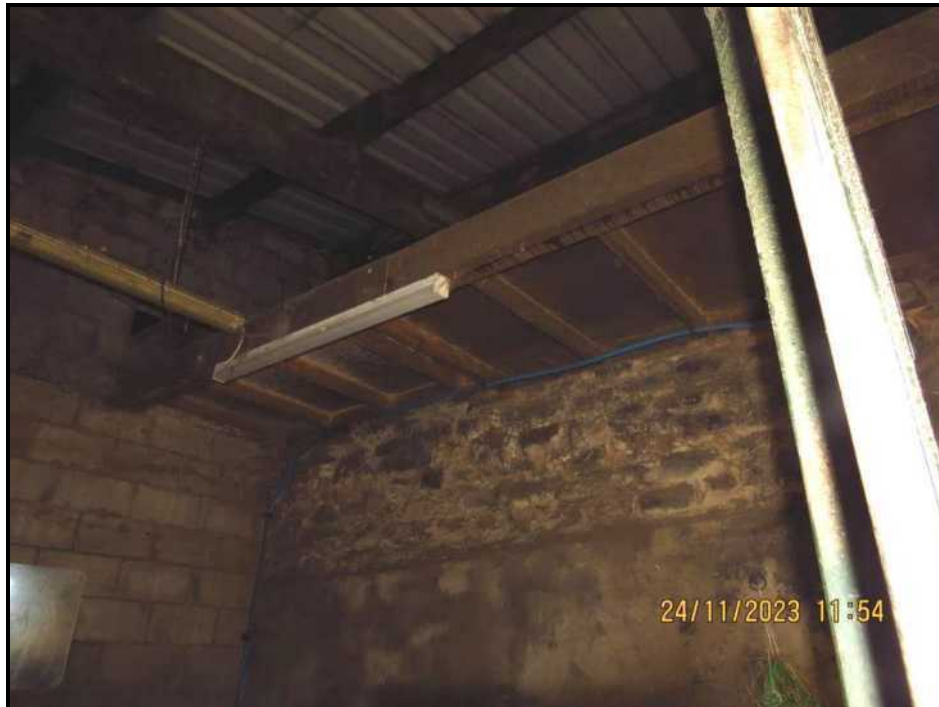
085 Front wall

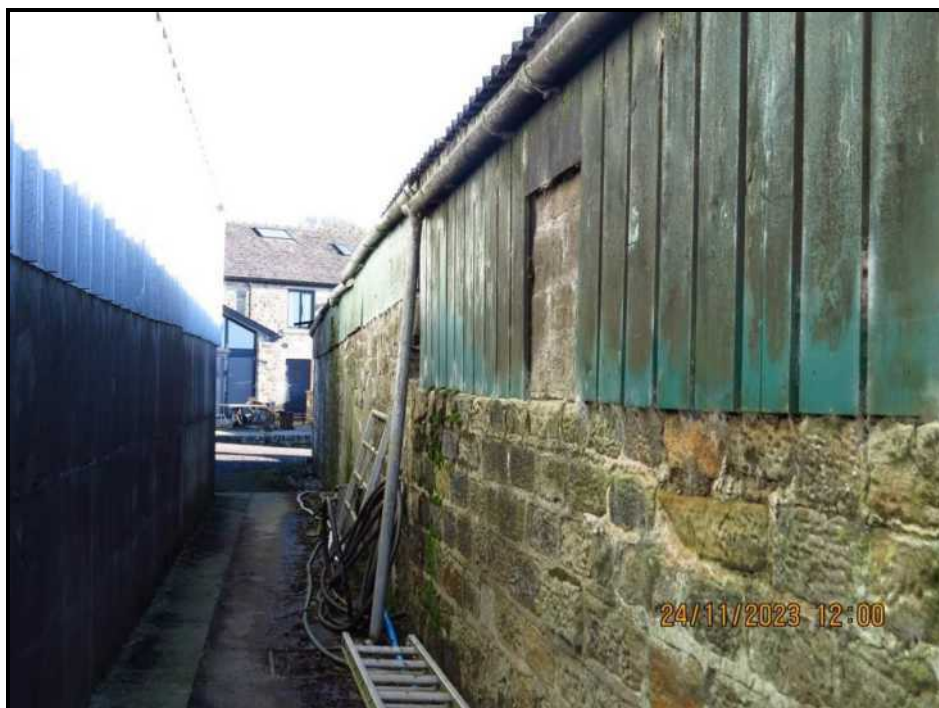
094 Rear elevation
