Validation Report  
Land off Don Street, Middleton

Reference: 14-554-R8-3  
Date: February 2025

# REMEDIATION AND ENABLING WORKS VALIDATION

Land off Don Street  
Middleton  
Greater Manchester  
M24 2DB

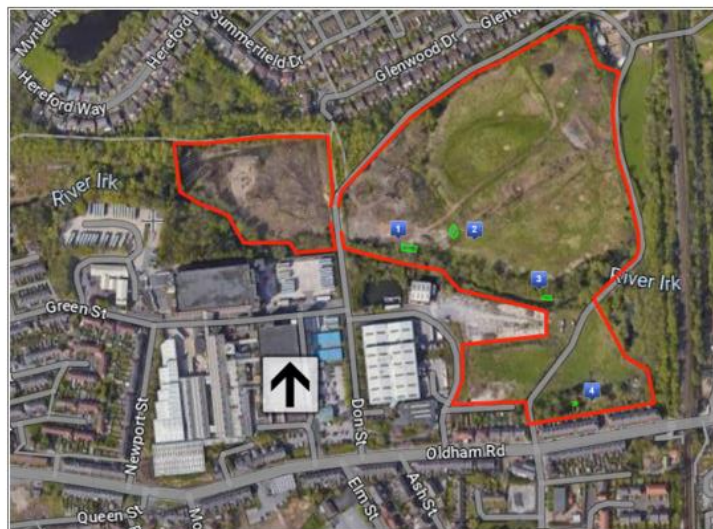
FIGURE 4.3 – JAPANESE KNOTWEED LOCATIONS

Urban Regen contractor employed Knotweed Eradication, a qualified invasive species expert, to investigate the presence of invasive plant species on or adjacent to the site. Knotweed Eradication undertook a site inspection in November 2021 and identified four areas of Japanese knotweed impact within the site boundary. Japanese Knotweed-contaminated material was demarked and signed to avoid any cross-contamination prior to the material being removed from site to a licensed landfill. The location of knotweed stands is shown on Figure 4.3, overleaf, presented in Knotweed Eradication Report Ref: IWMP2255A, dated October 2023.

Japanese Knotweed impacted materials were excavated under the supervision of Knotweed Eradication in April and May 2023. Material excavated in April 2023 was placed in a temporary stockpile area on visqueen sheeting, tested by E3P, and subsequently removed from site. Impacted material excavated in May 2023 was placed directly into wagons and removed from site. A validation report was prepared by Knotweed Eradication (IWMP2255A, dated October 2023) that is available upon request to Kellen Homes or Urban Regen.

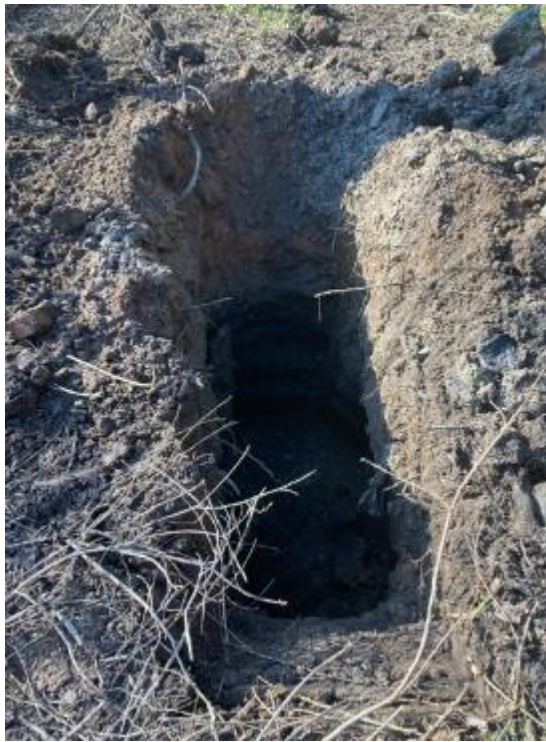
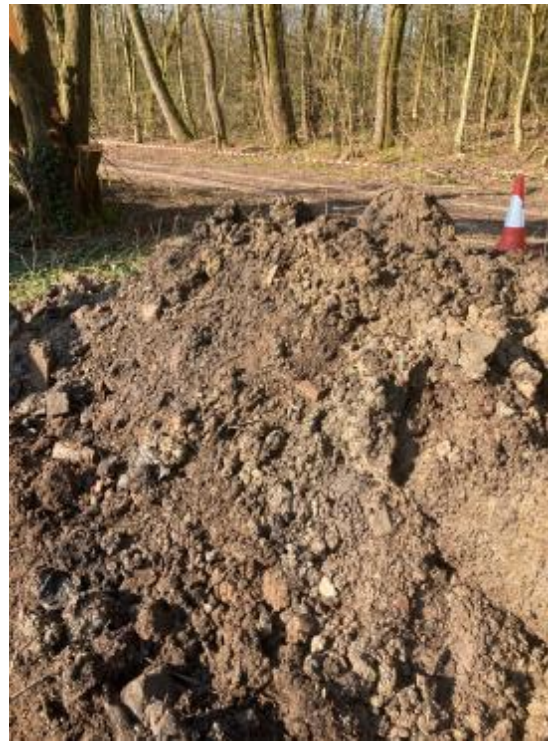
PLATE 1 SUPPLEMENTARY TRIAL PITTING PHASE 1 (AREA 1)

| Within Areas 1-4, as shown on Figure 4.1 overleaf, multiple phases of supplementary trial pitting were undertaken on the 8 <sup>th</sup> and 9 <sup>th</sup> of February 2022, 8 <sup>th</sup> of March 2022 and 10 <sup>th</sup> May 2022 to record ground conditions and obtain geotechnical and geochemical samples. Additional investigation of potential peat deposits in Area 3 (Phase 2A) were undertaken within these phases of supplementary trial pitting. The further investigation did not identify any true peat deposits, only very soft to soft clays with a shear strength value (Cu) of less than 30 kN/m <sup>2</sup> , the material is not suitable for vibro stone columns and requires removal with granular replacement during remedial works in this area. |

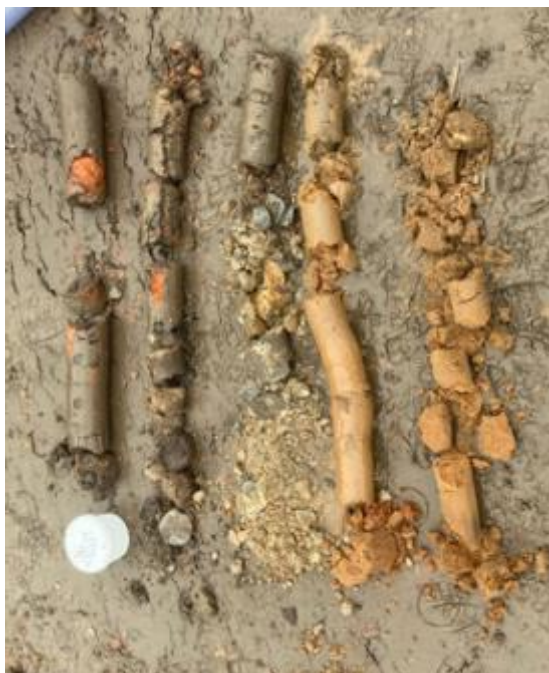
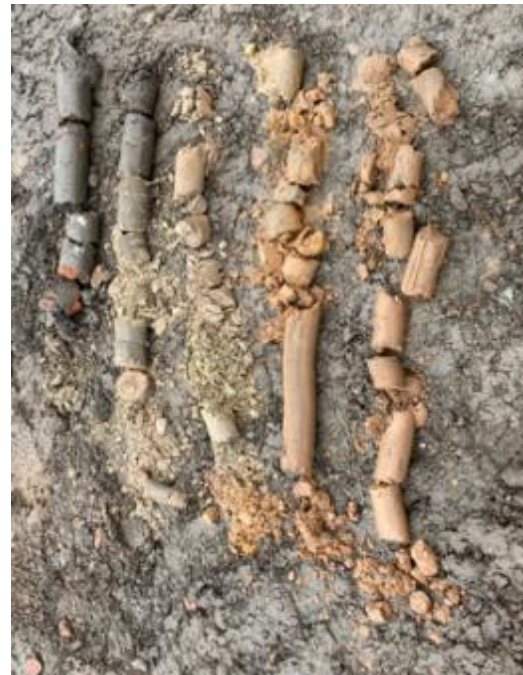
PLATE 4 SUPPLEMENTARY WINDOW SAMPLING PHASE 3 (AREA 5)

Urban Regen demolished and removed the former allotment sheds in December 2022. Following removal of the structures in this area E3P undertook a series of window samples on 16<sup>th</sup> of February 2023 to record ground conditions and obtain in-situ geotechnical data of the underlying soils to aid in foundation design. Window samples (WS901 to WS909) recorded Made Ground of soft to firm gravelly sandy clay to depths between 0.20 m and 2.30 m bgl overlying loose to medium dense medium SAND deposits. Subsequent trial pitting was undertaken on the 6<sup>th</sup> of March 2023 within this area to obtain chemical and geotechnical lab samples, in total six soil samples were sent for chemical analysis. Chemical analysis (i2 Report: 23-21617) identified minor exceedances of non-volatile PAHs benzo(b)fluoranthene and benzo(a)pyrene within shallow Made Ground deposits between 0.25 m and 0.30 metres below ground level (m bgl) within Allotment 101 and Allotment 103 samples. Non-volatile PAHs have primary exposure pathways related to dermal contact and ingestion of soils, the soils are to be used as upfill and therefore the presence of hardstanding and cover systems will ensure no viable pathway is present, as such, no future risk to human health is present.

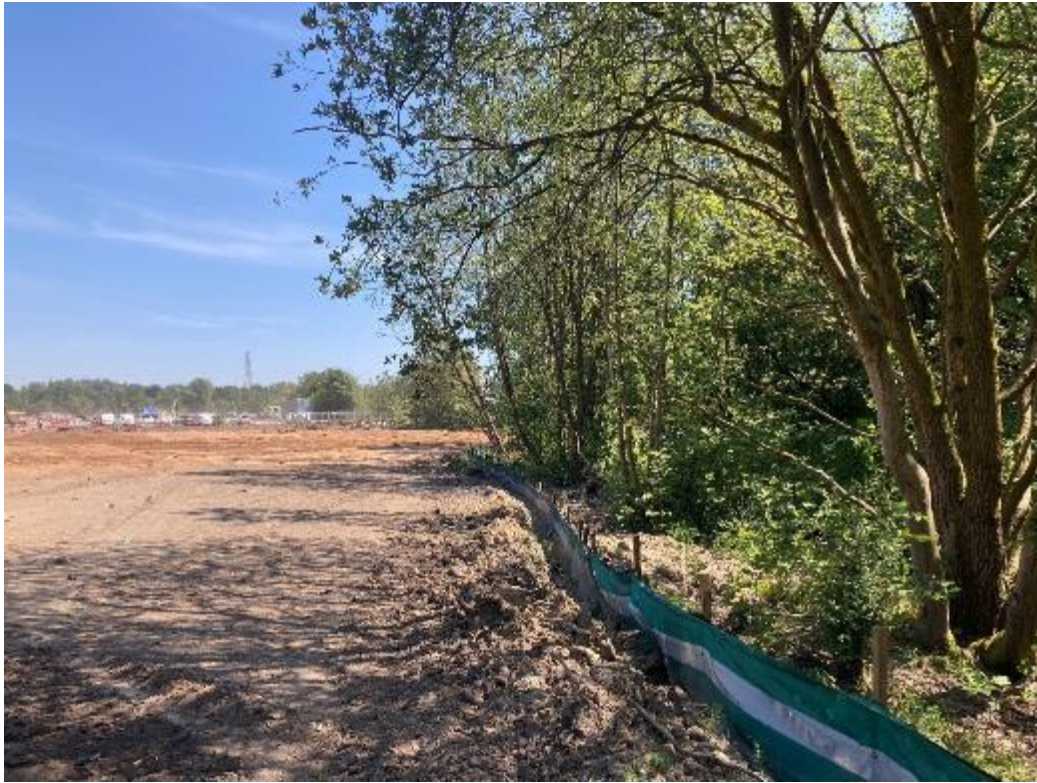
PLATE 7 SILT FENCING ERECTED ALONG THE SOUTHERN BOUNDARY IN PHASE 1

In line with the dewatering plan, silt busters were present on site throughout the works for use in excavations below the water table. Additionally, silt fencing was erected along the boundary of the River Irk during active works and routinely inspected and replaced as necessary.

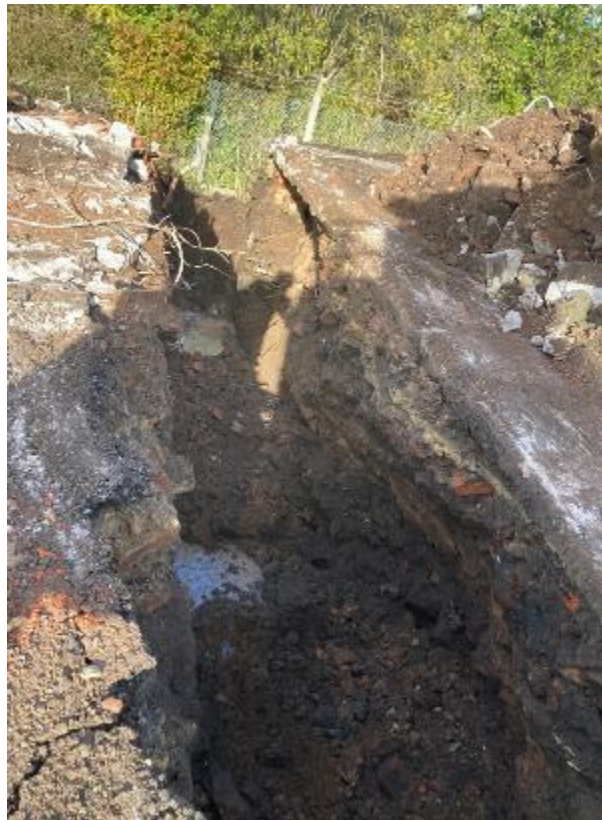
PLATE 13

E3P attended site on the 3<sup>rd</sup> of November 2022, as per the remediation strategy a trench was excavated along the western boundary of Parcel D (Phase 3) within close proximity of WS17. The trench was advanced to a depth of 1.50 m bgl. A perched groundwater strike was noted at the base of the trench, however, not enough water was present to obtain a sample. As such, soil samples were taken from the side and base of the excavation with the arisings stockpiled on Visqueen awaiting results.

Soil samples did not identify elevated TPH values above the level 3 remedial target concentrations for the general made ground with respect to controlled waters for Parcel A, C, D & E (Phase 1, 2A, 2B and 3) as per Appendix IV of the E3P Remediation Strategy (Ref 14-554-R2 Rev 10, dated February 2023). Additionally, no visual or olfactory evidence or point source was noted, given that WS17 is located off site, and no TPH impact was recorded within the site boundary, no further remedial works are required.

WS17 TRENCH

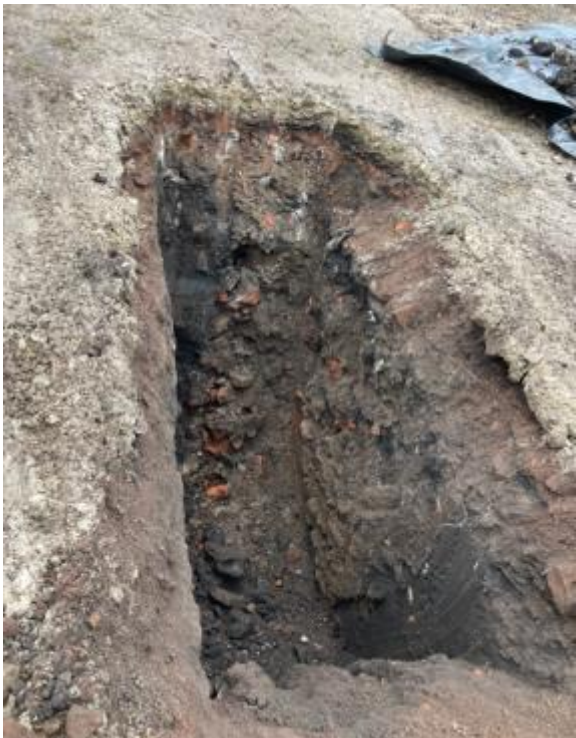
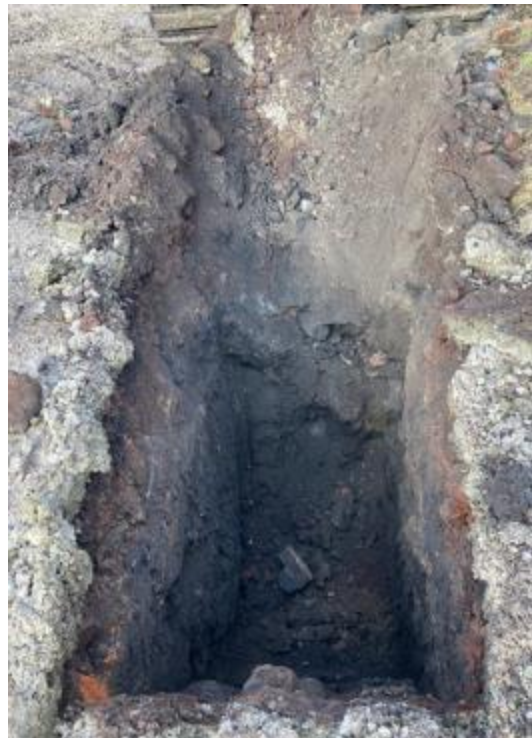
PLATE 16      ASBESTOS HOTSPOTS PHASE 1 (WS402 LEFT & TP516 RIGHT)

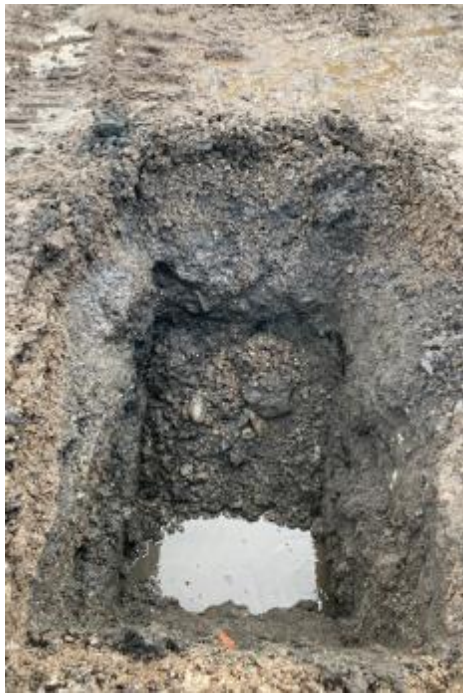
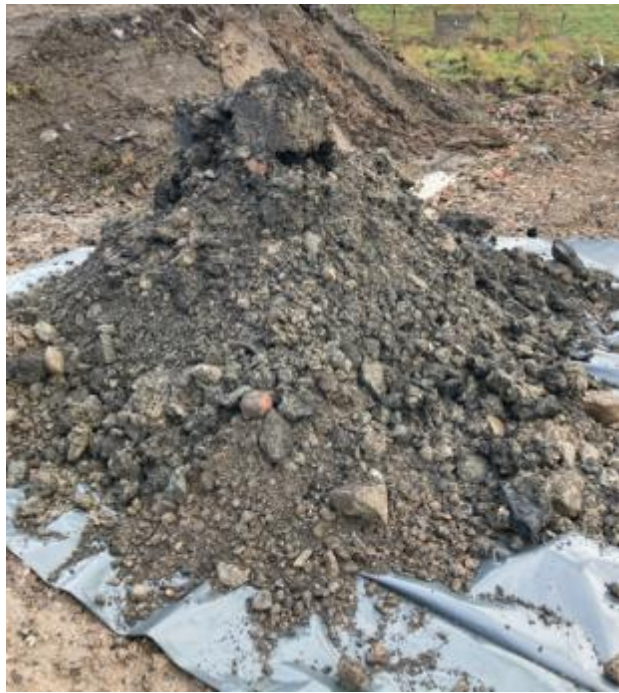
PLATE 17 ASBESTOS HOTSPOTS PHASE 2 (WS305 AND ARISING)

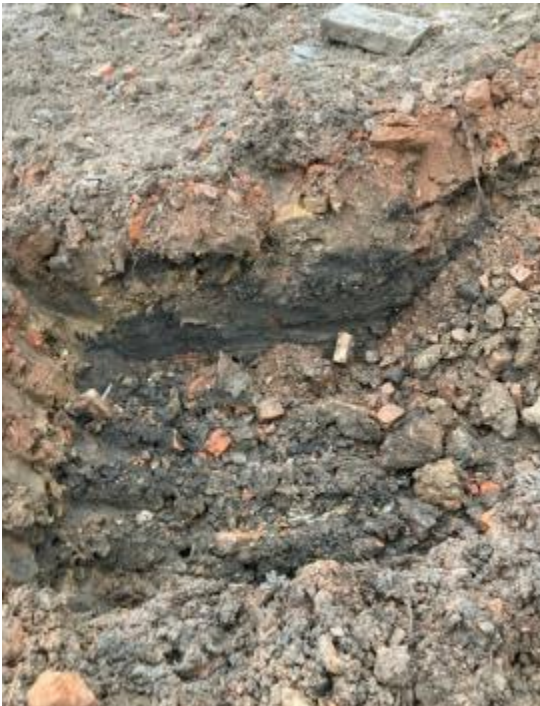
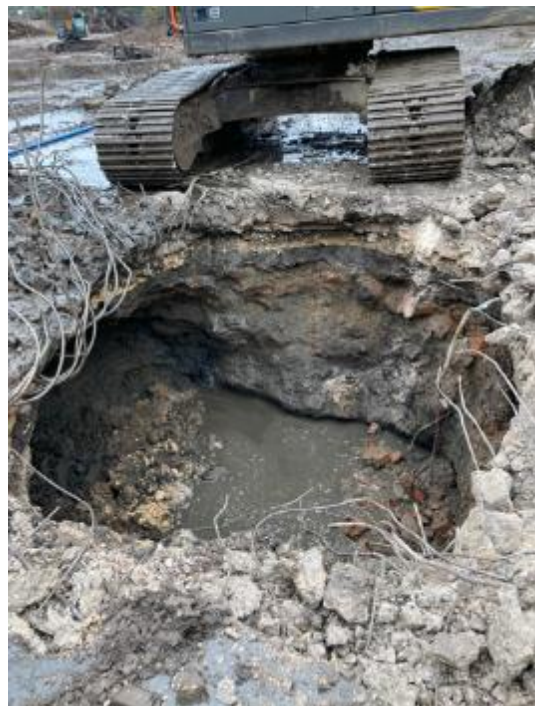
PLATE 18 ASBESTOS HOTSPOTS PHASE 3 (TP48 RIGHT AND WS203 LEFT)

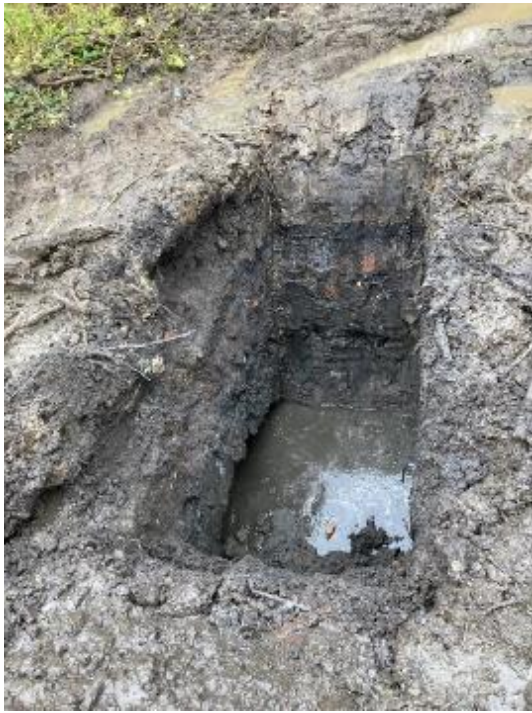
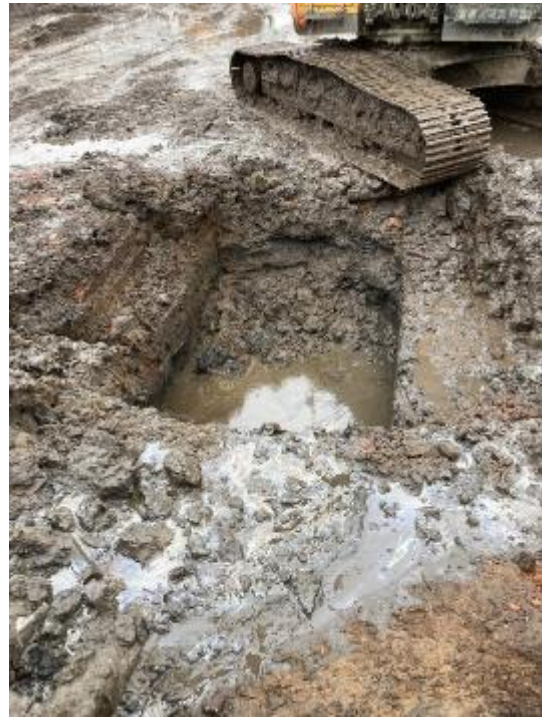
PLATE 19 VOLITILE HOTSPOTS PHASE 1 (TP204 RIGHT AND BH1 LEFT)

All excavations arisings from volatile hotspots within Phase 1 (Parcel A) were stockpiled and removed from site by Urban Regen. E3P undertook a watching brief and PID sampling during the turnover of Made Ground Soils in Phase 1 (Parcel A). No visual or olfactory evidence of contamination was noted during the turnover of soils, no point source was identified. Additionally, no PID readings were noted > 50 ppm, as such, soils outside of hotspot areas were used within the upfill of the development platform in Phase 1.

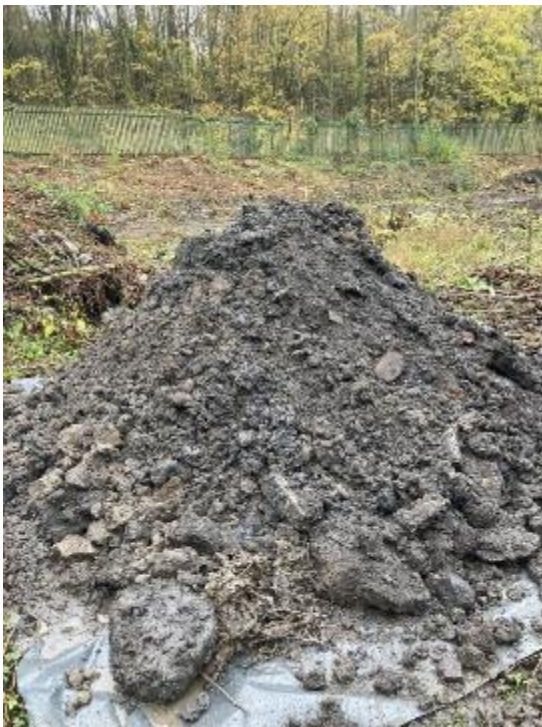
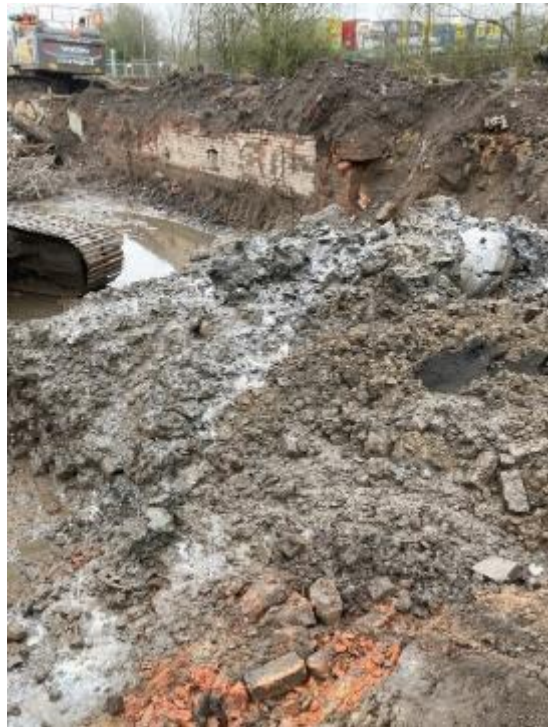
PLATE 20 VOLITILE HOTSPOTS ARSINGS PHASE 1 (TP204 RIGHT AND BH1 LEFT)

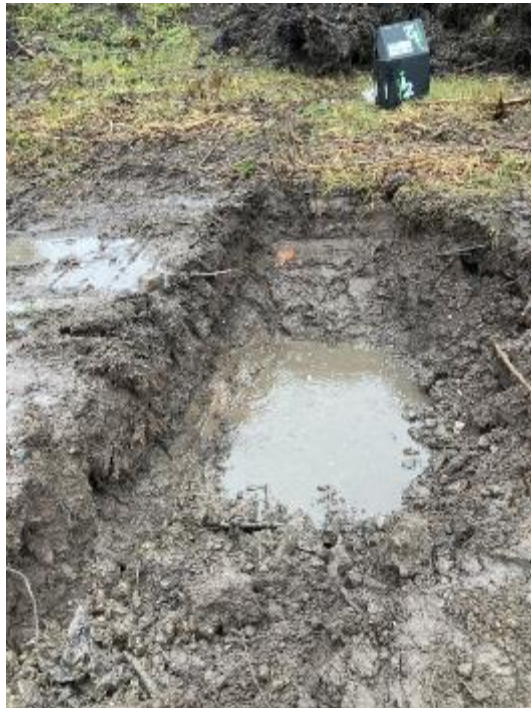
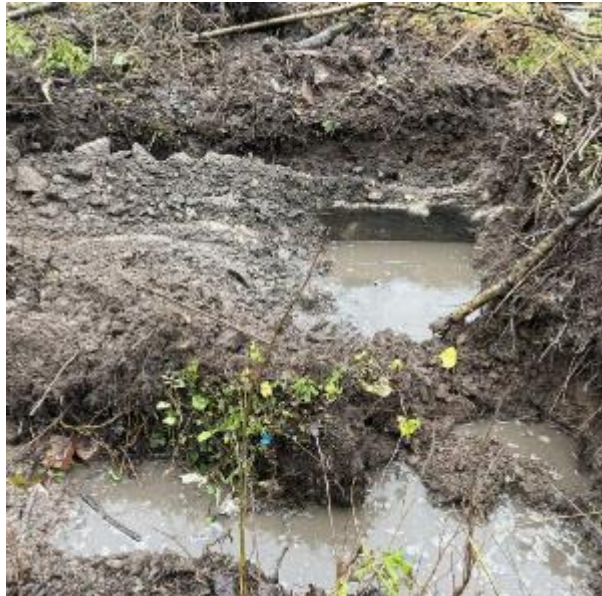
PLATE 21 VOLITILE HOTSPOTS PHASE 1 (TP5 RIGHT AND BH4 LEFT)

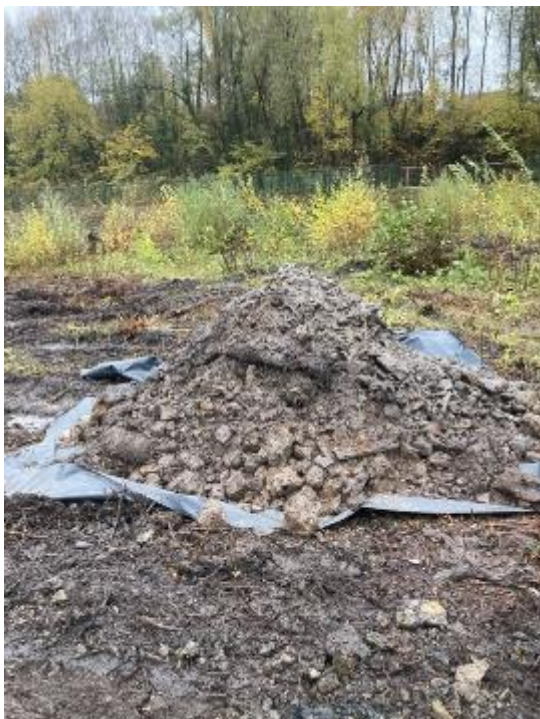
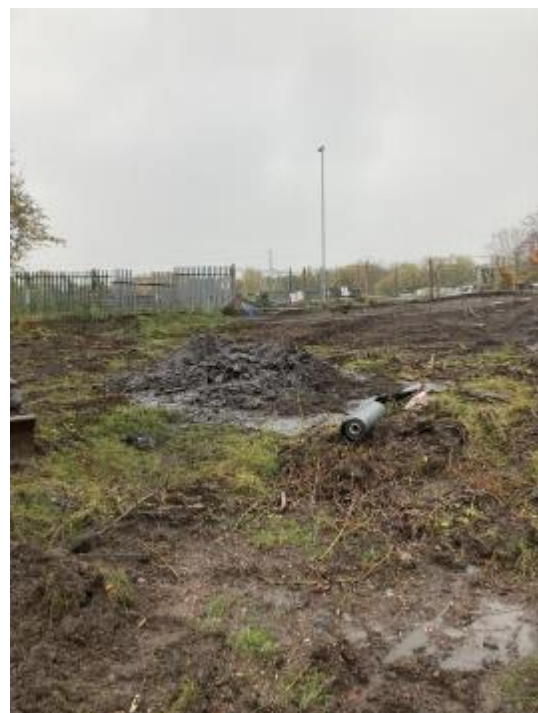
PLATE 22 VOLITILE HOTSPOT ARISING PHASE 1 (TP5 RIGHT AND BH4 LEFT)

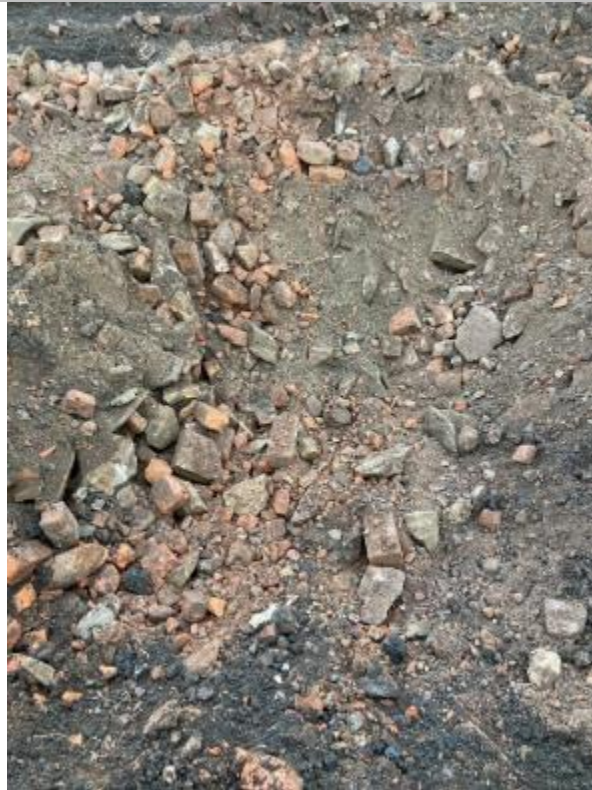
PLATE 23

VOLITILE HOTSPOT PHASE 2A - TP11

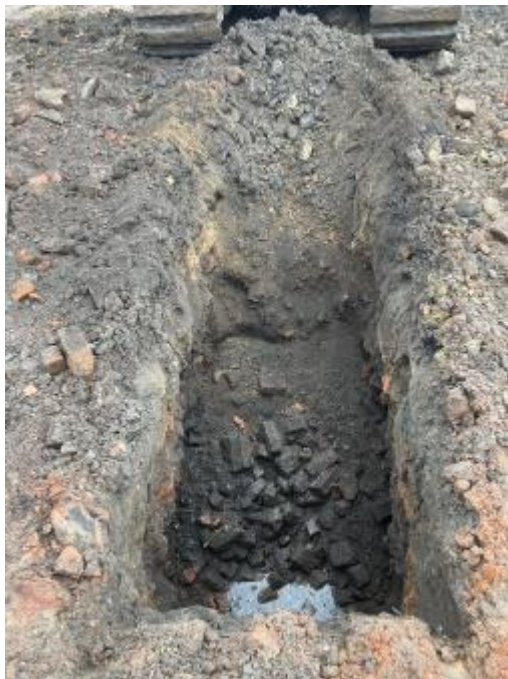
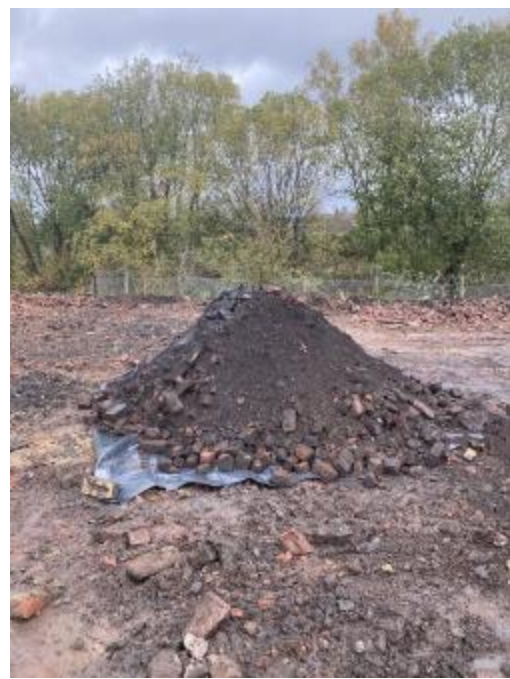
PLATE 24

VOLITILE HOTSPOT PHASE 3 – WS5

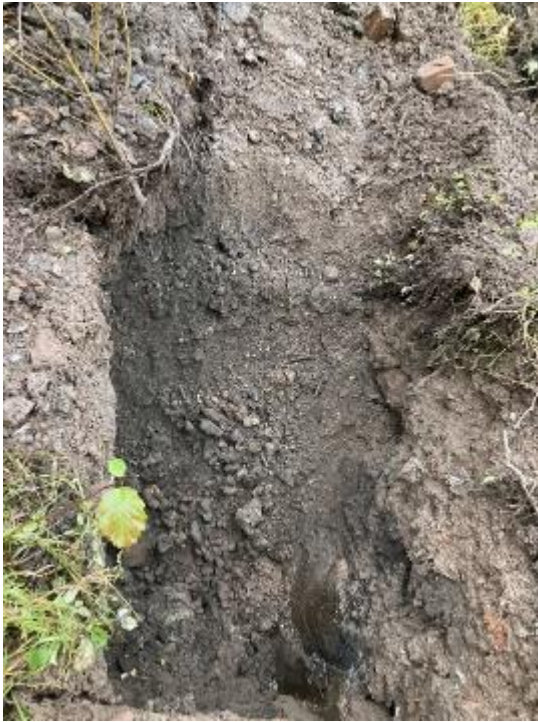
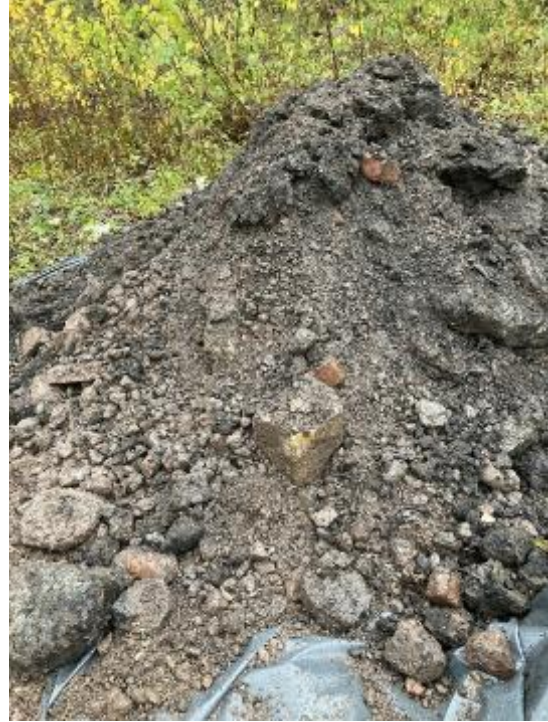
PLATE 25      MERCURY HOTSPOTS PHASE 1 – BH3

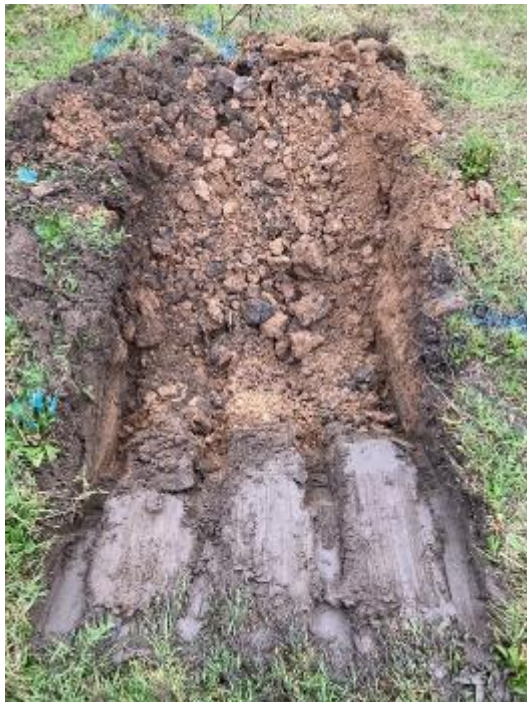
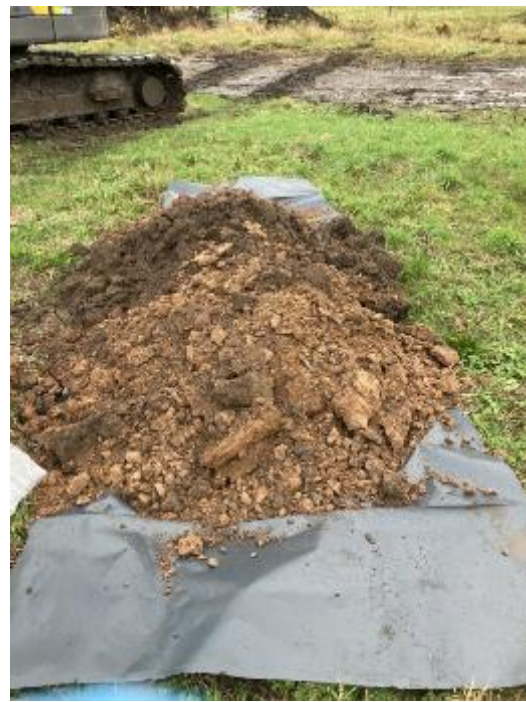
PLATE 26      MERCURY HOTSPOTS – TP342

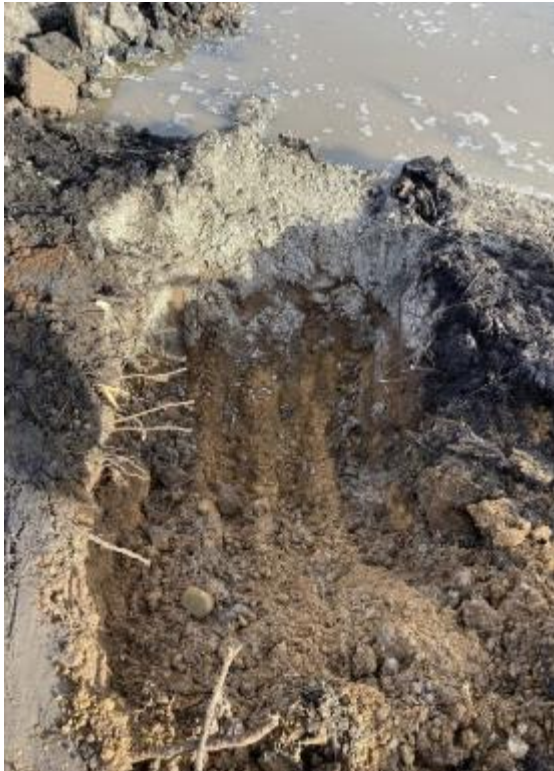
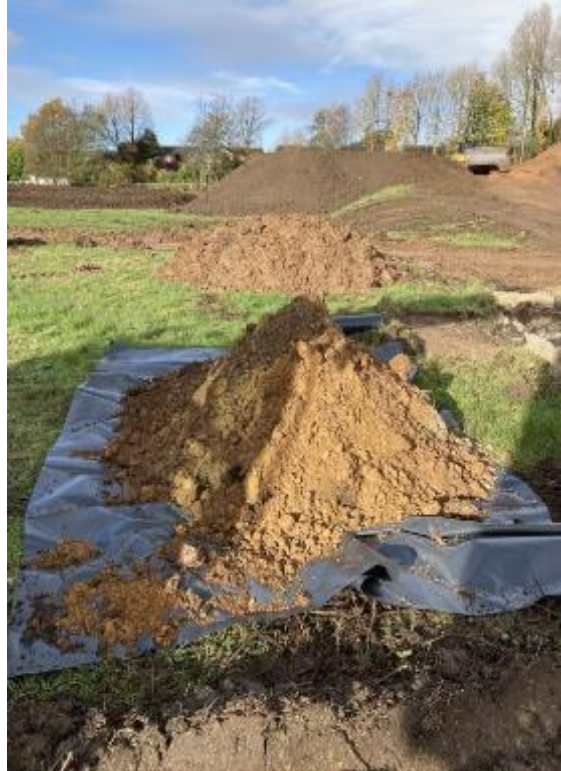
PLATE 27 SUPPLEMENTARY TRIAL PITTING PHASE 2A (AREA 3)

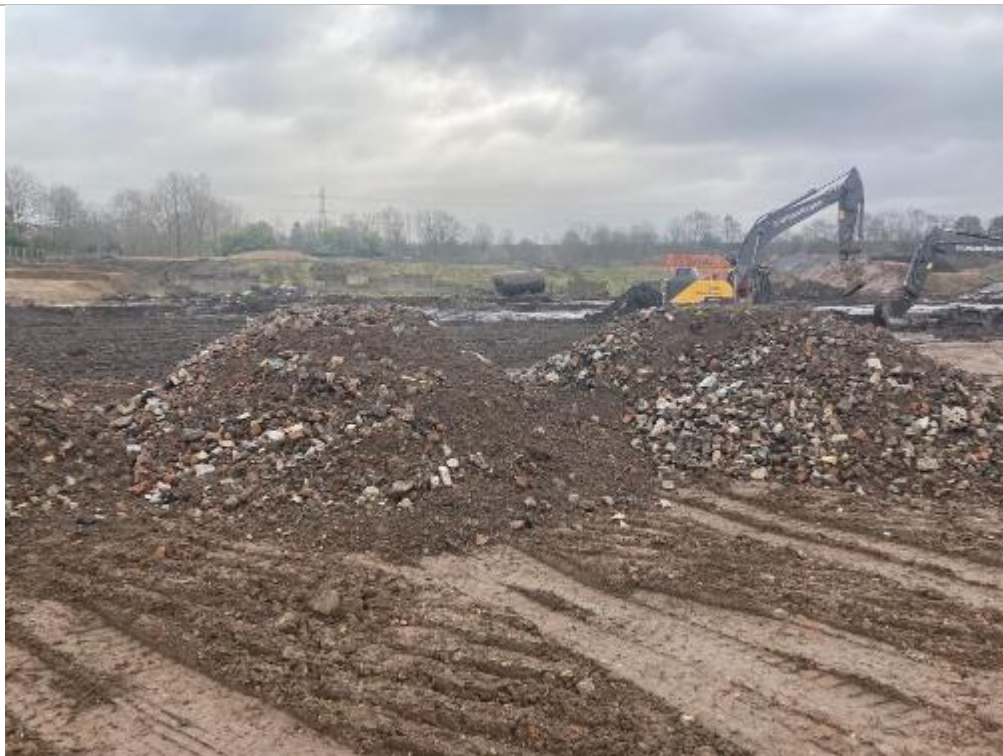
PLATE 28 PROCESSED MADE GROUND FOR RE-USE

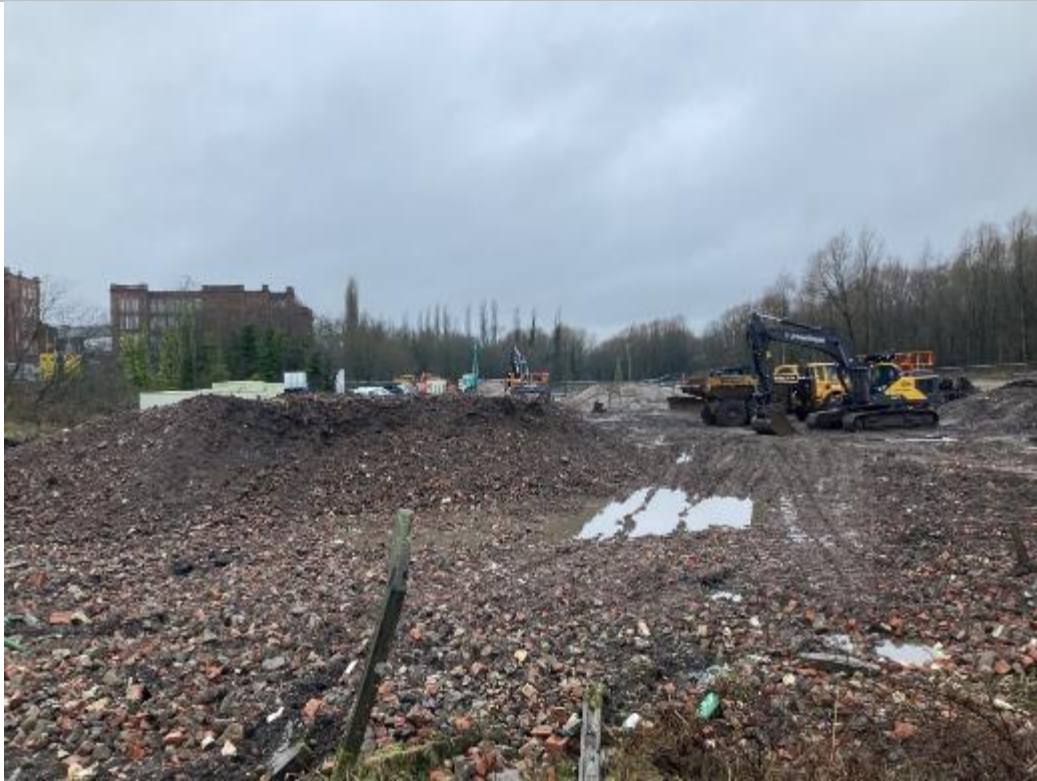
PLATE 29 PROCESSING OF MADE GROUND

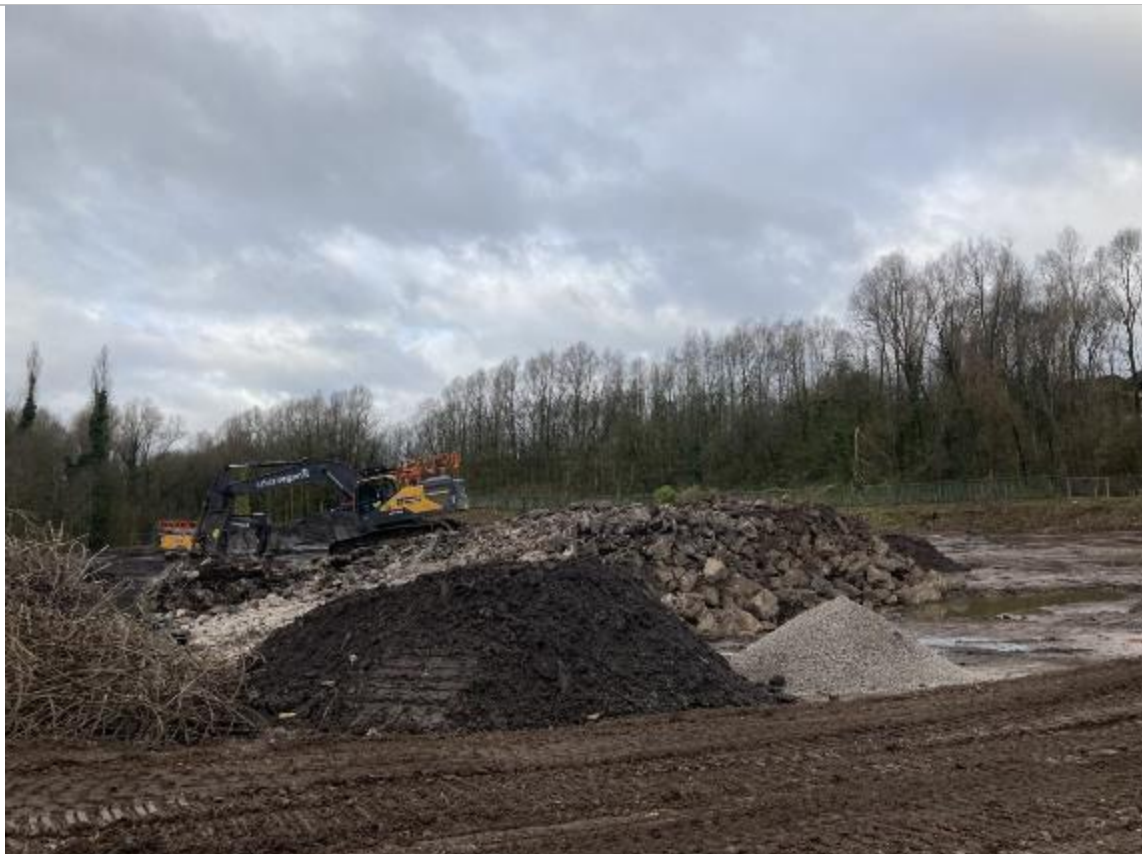
PLATE 30 BREAKING AND PROCESSING OF MADE GROUND

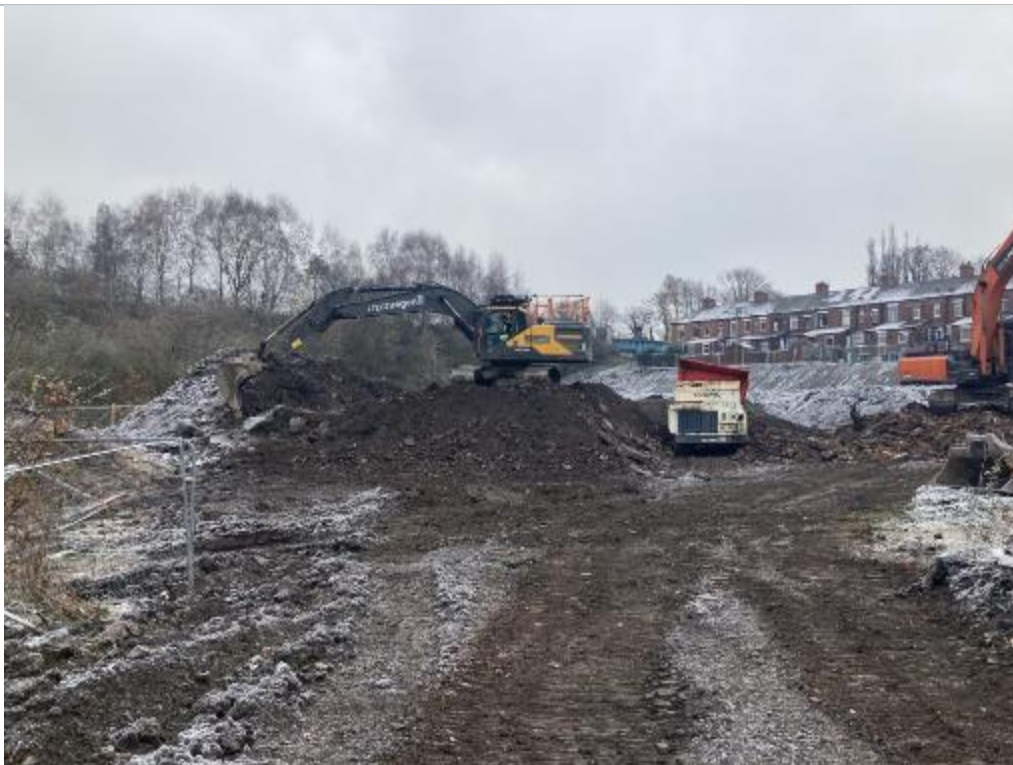
PLATE 32 SUPPLEMENTARY TRIAL PITTING PHASE 3 (AREA 5)

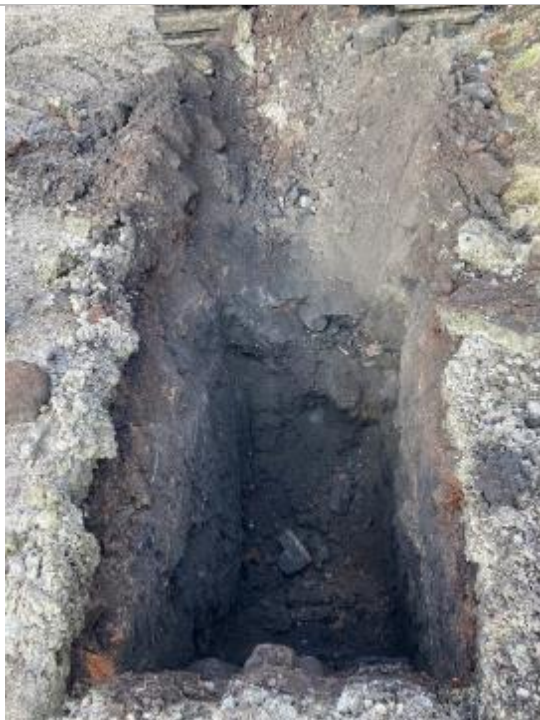
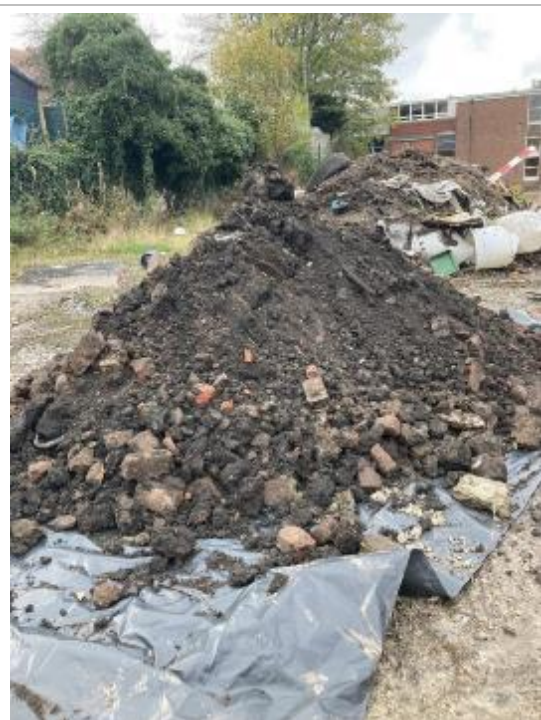
PLATE 36      SUPPLEMENTARY TRIAL PITTING OF IMPACTED SOILS (TP409)

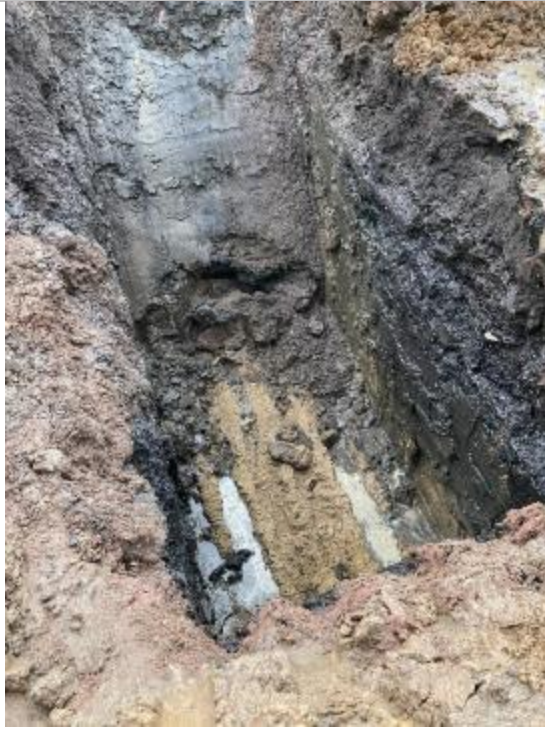
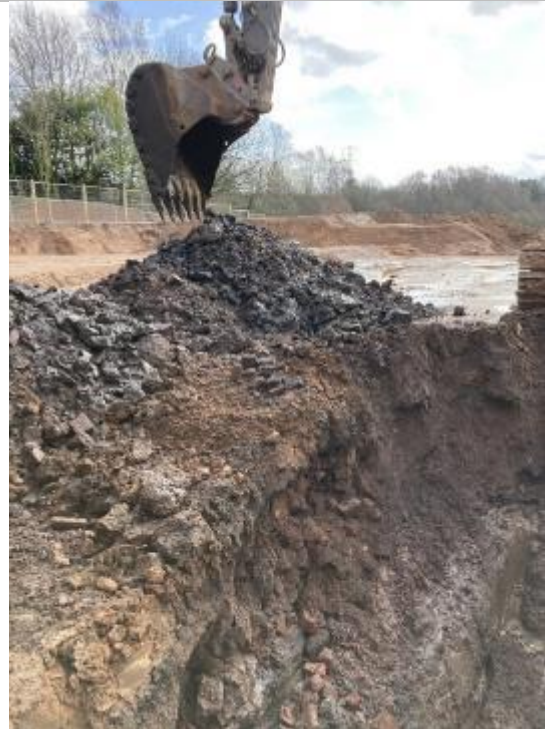
**PLATE 41** DELINEATION, EXCAVATION AND TREATMENT OF INFILLED HISTORICAL PONDS AND STREAMS

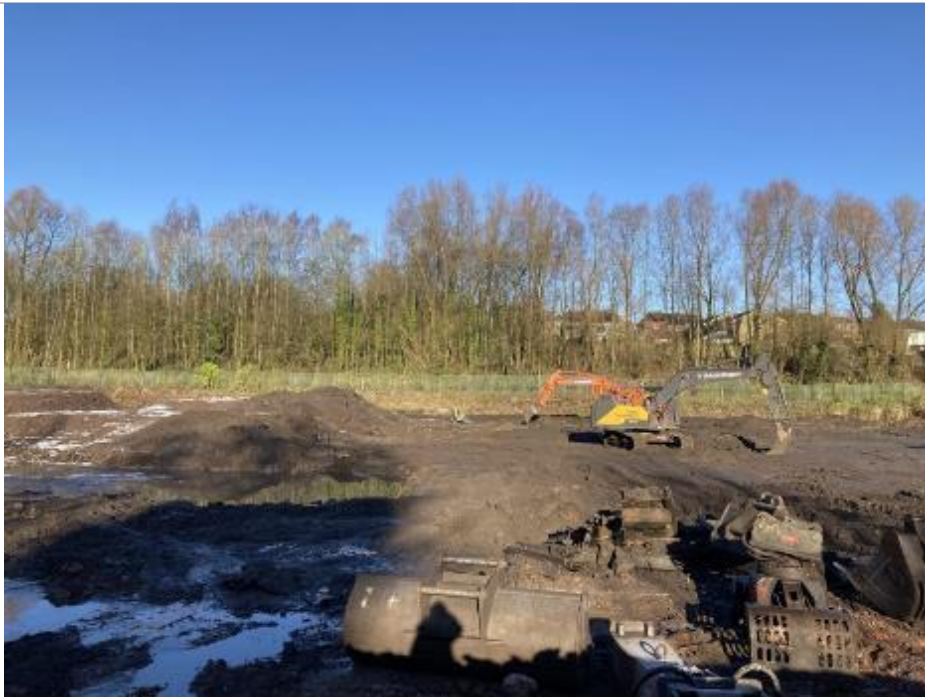
PLATE 50

CUT AND FILL IN PHASE 1

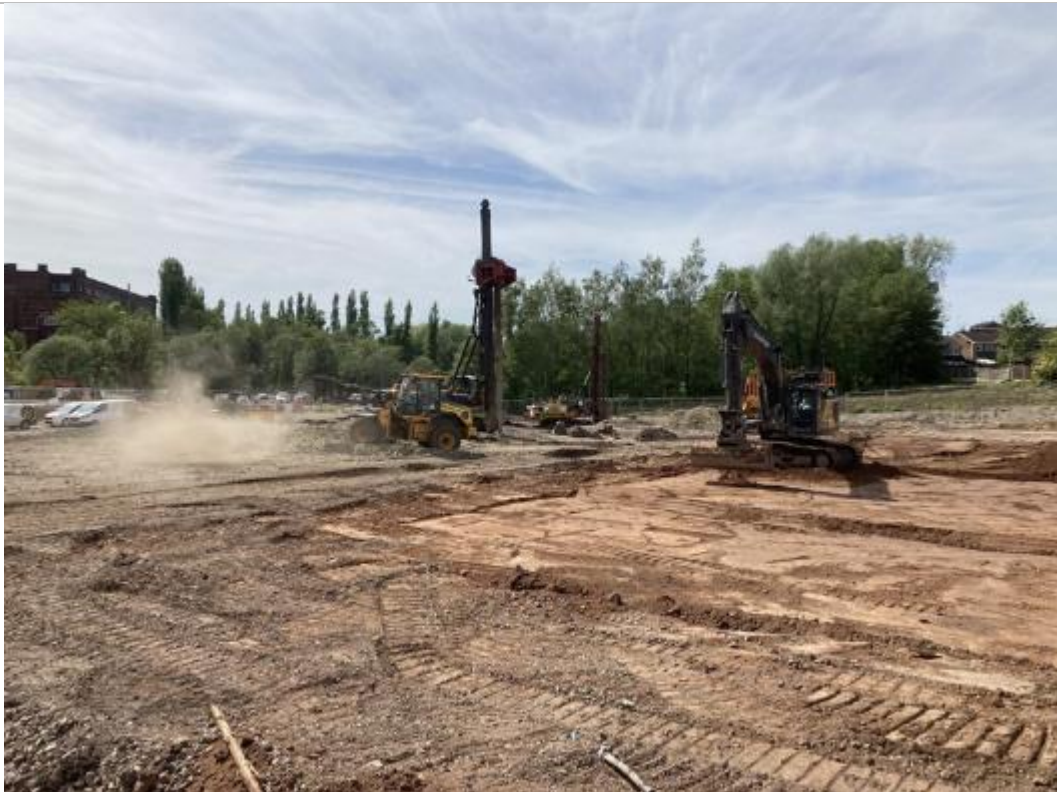
PLATE 58

CONSTRUCTION OF TEMPORARY WORKING PLATFORM PHASE 2A

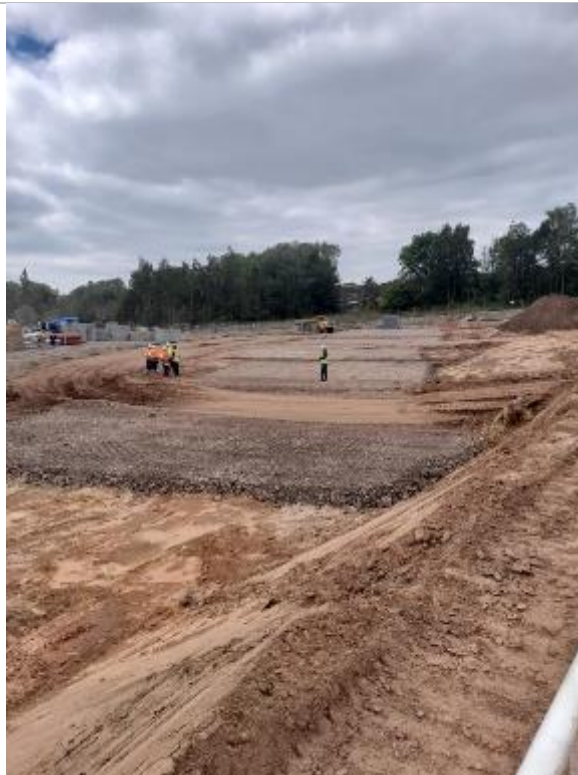
PLATE 60 PREPERATION OF GARDEN COVER SYSTEM

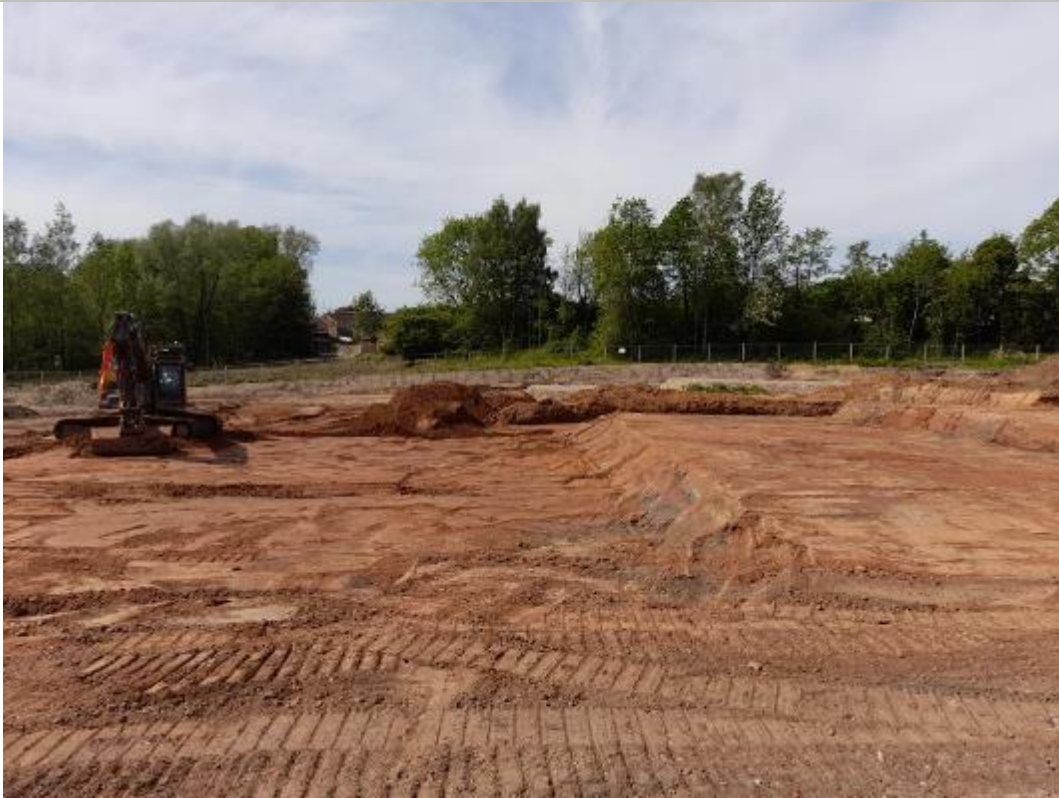
PLATE 61 PREPERATION OF GARDEN COVER SYSTEM

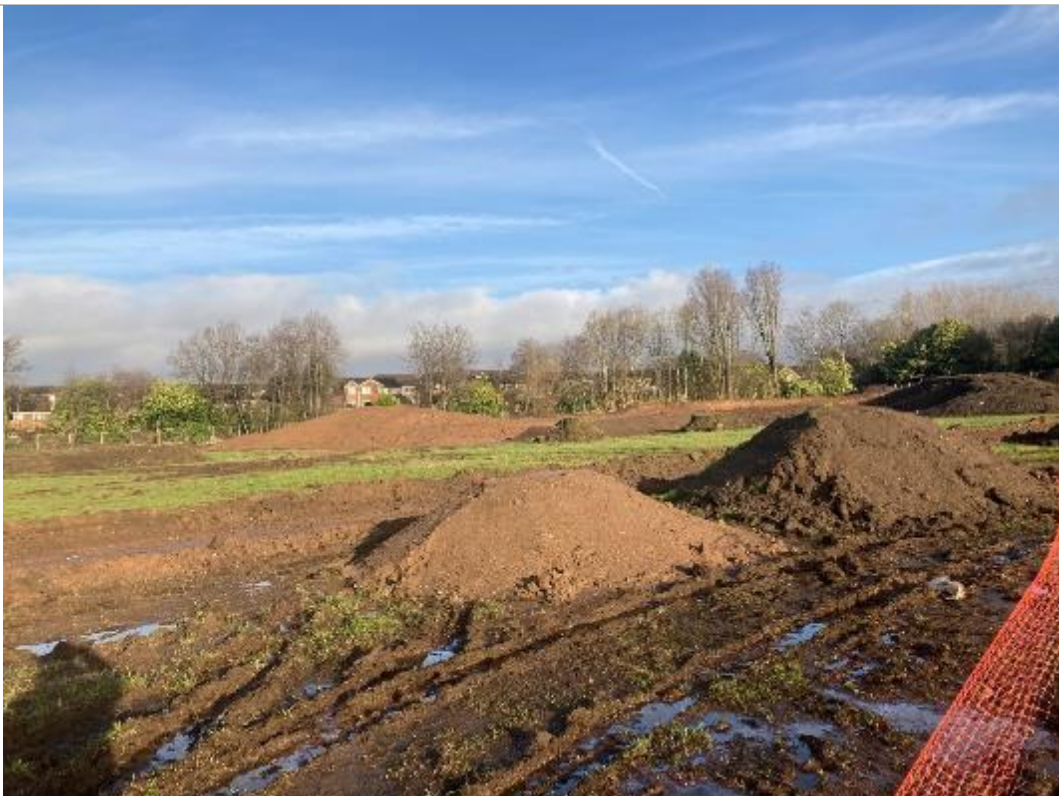
PLATE 62 PROVISION OF SUBSOL
