Validation Report  
Land off Don Street, Middleton

Reference: 14-554-R8-3  
Date: February 2025

# REMEDIATION AND ENABLING WORKS VALIDATION

Land off Don Street  
Middleton  
Greater Manchester  
M24 2DB

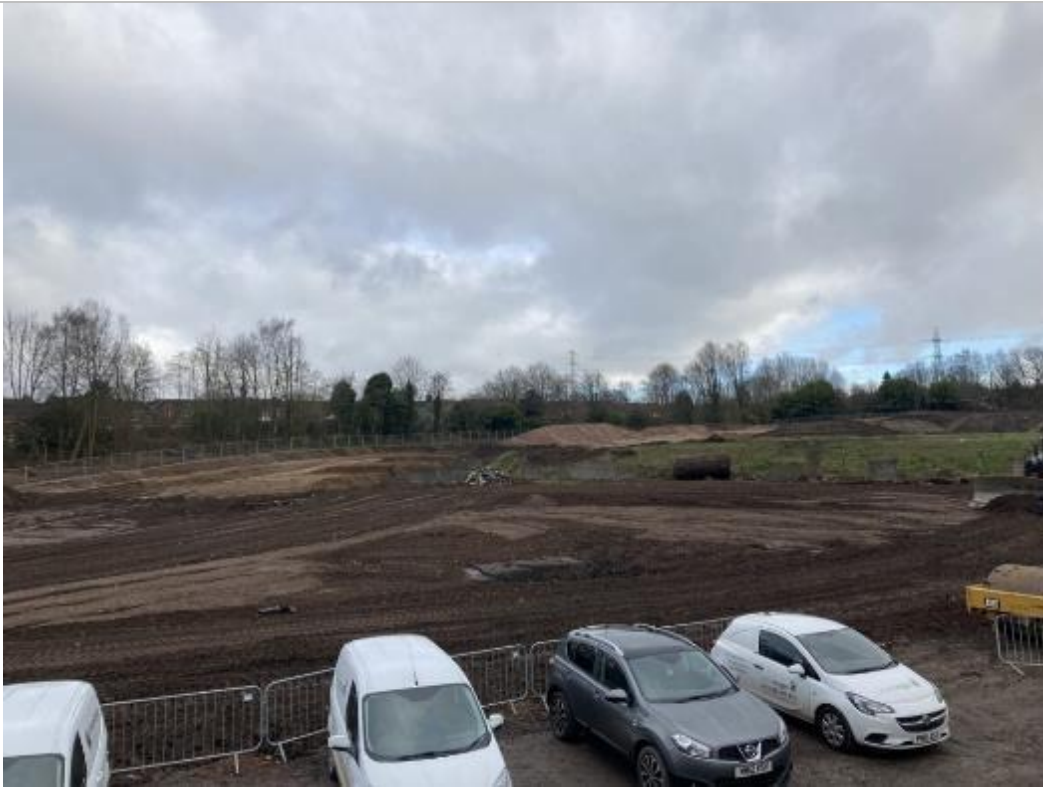
PLATE 63

SUBSOIL STOCKPILED IN PHASE 2

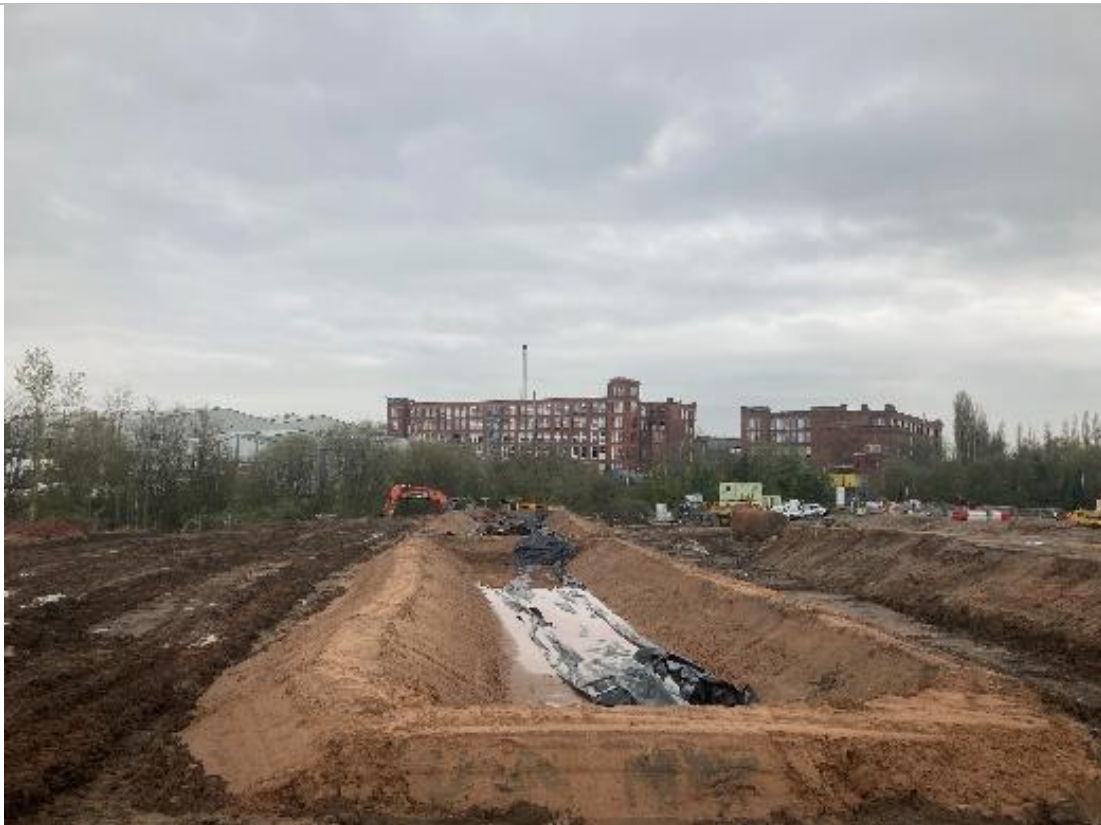
PLATE 64

LANDFILL TREATMENT

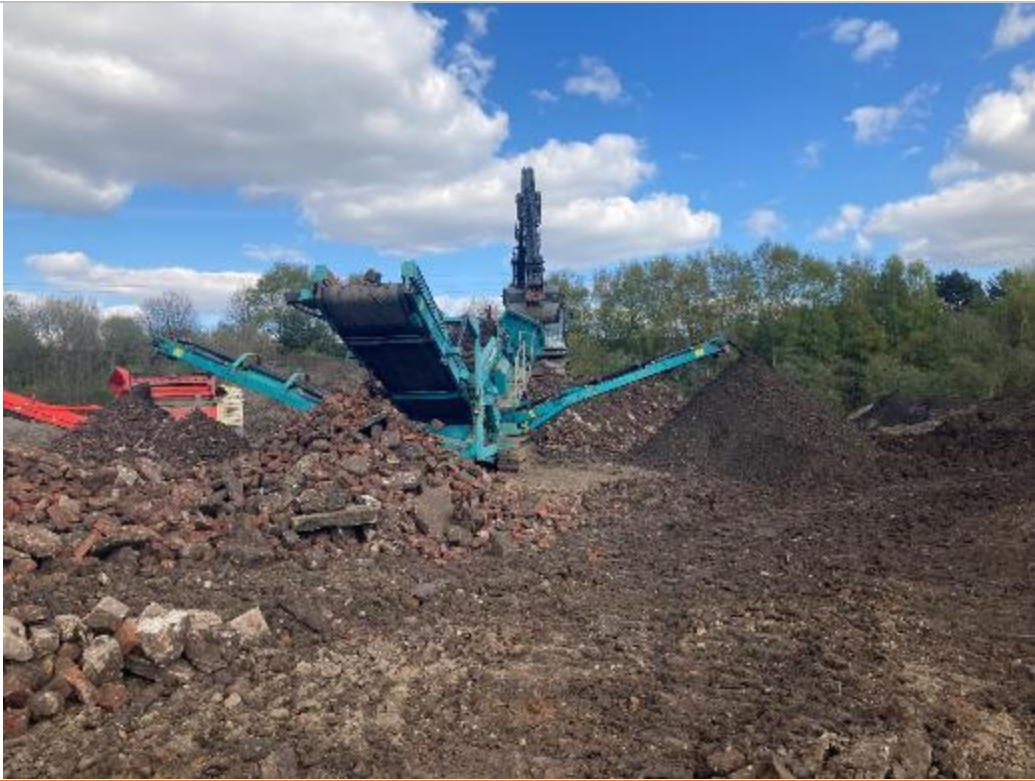
PLATE 65 LANDFILL TREATMENT

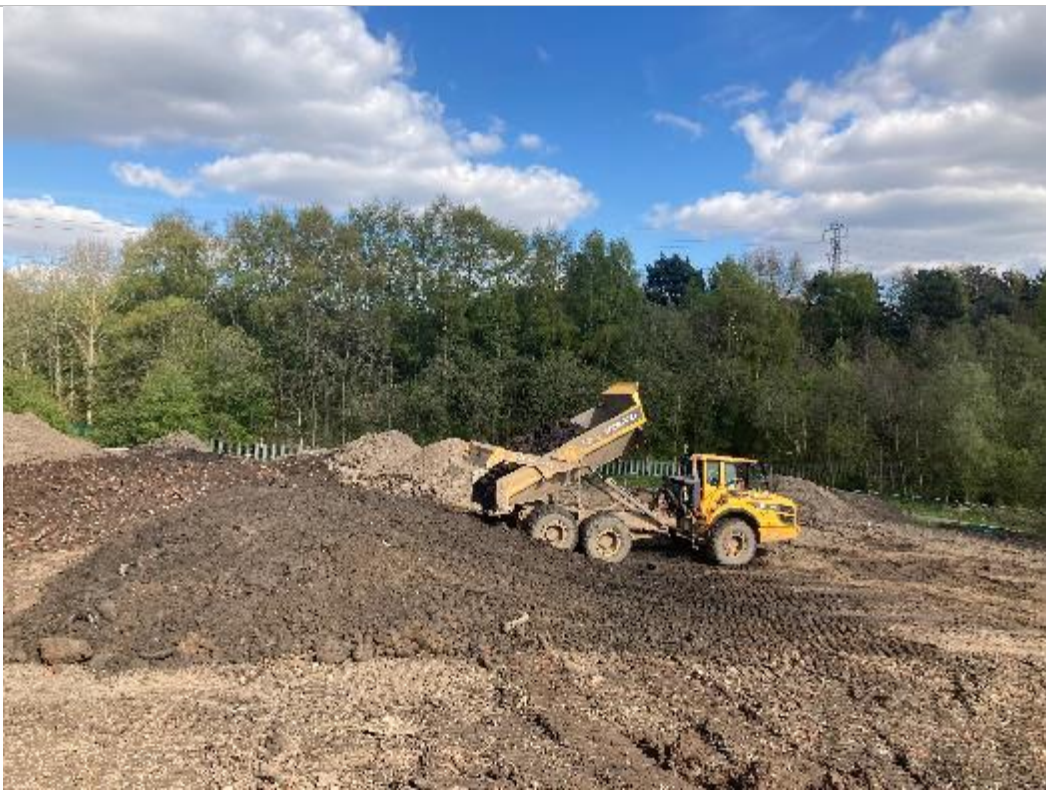
PLATE 66 LANDFILL TREATMENT

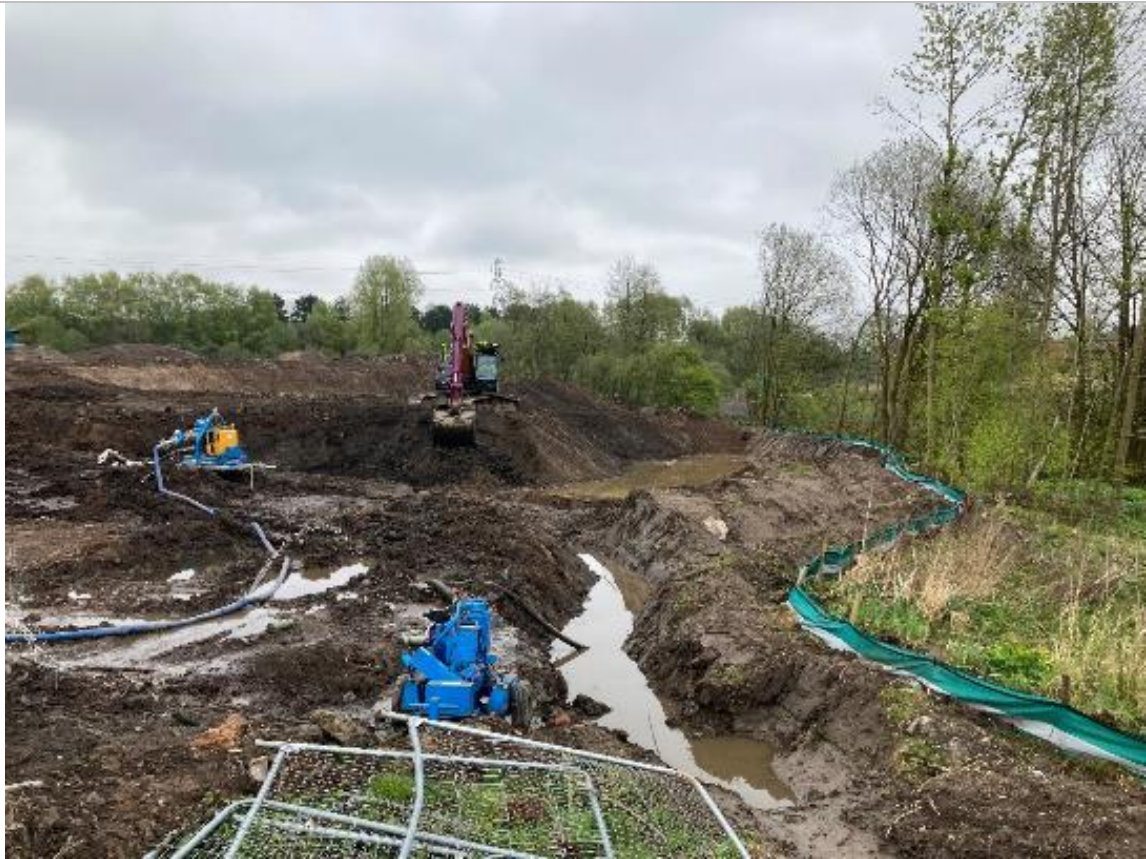
PLATE 67 LANDFILL TREATMENT

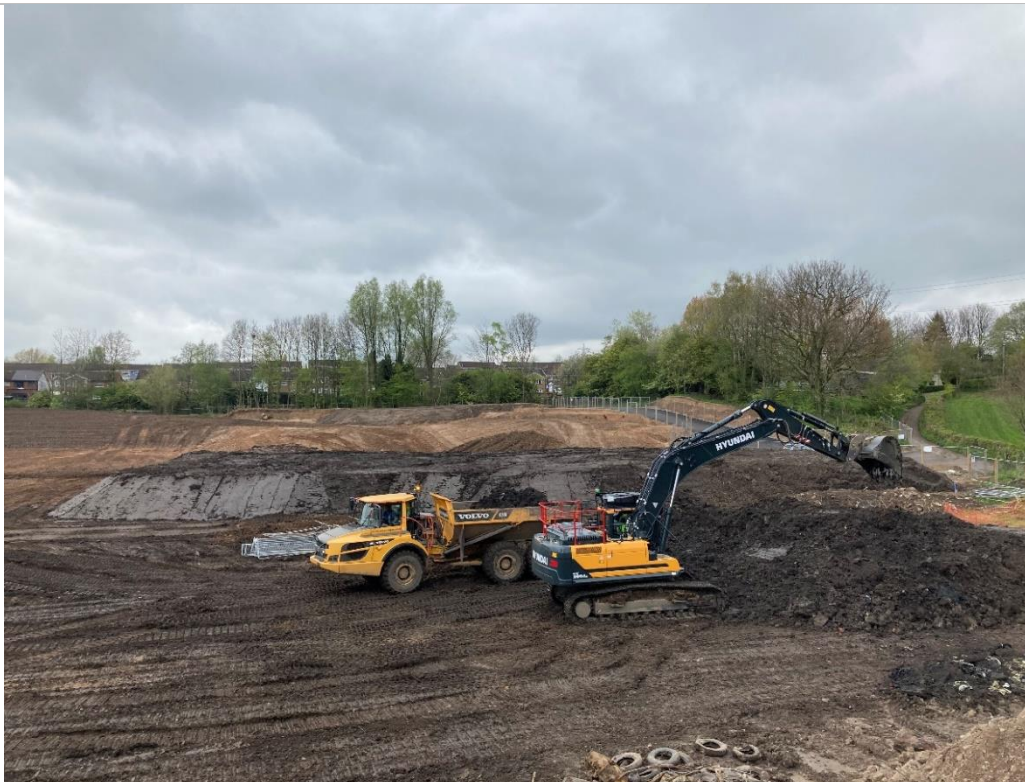
PLATE 68 LANDFILL TREATMENT

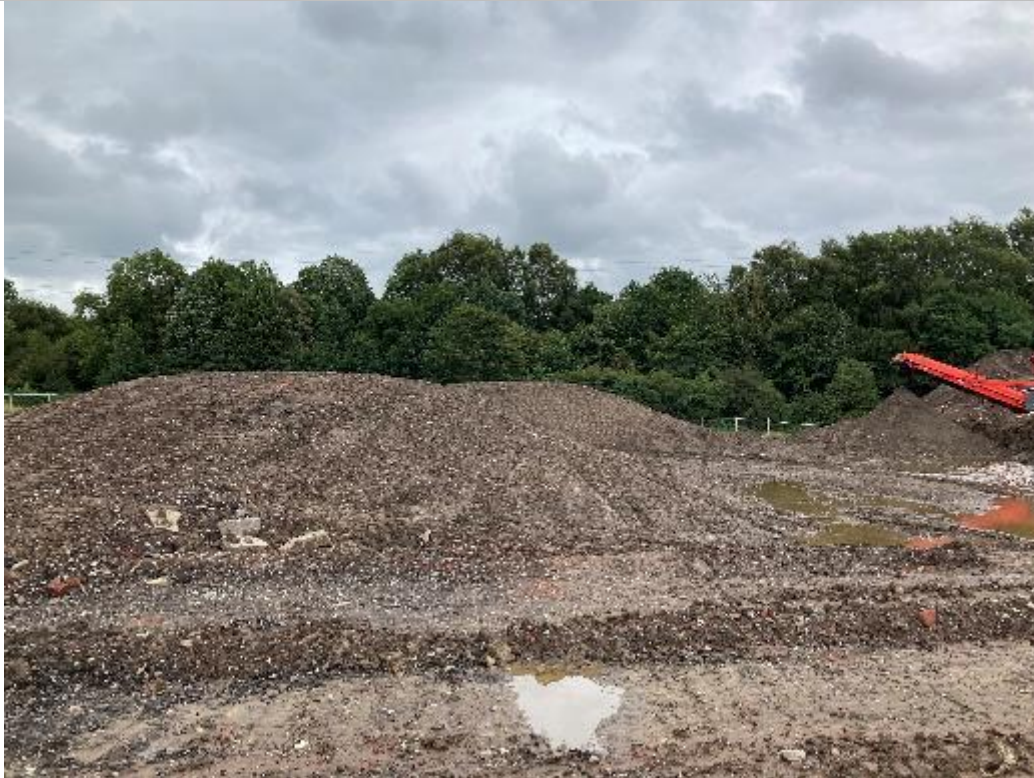
PLATE 69

LANDFILL TREATMENT

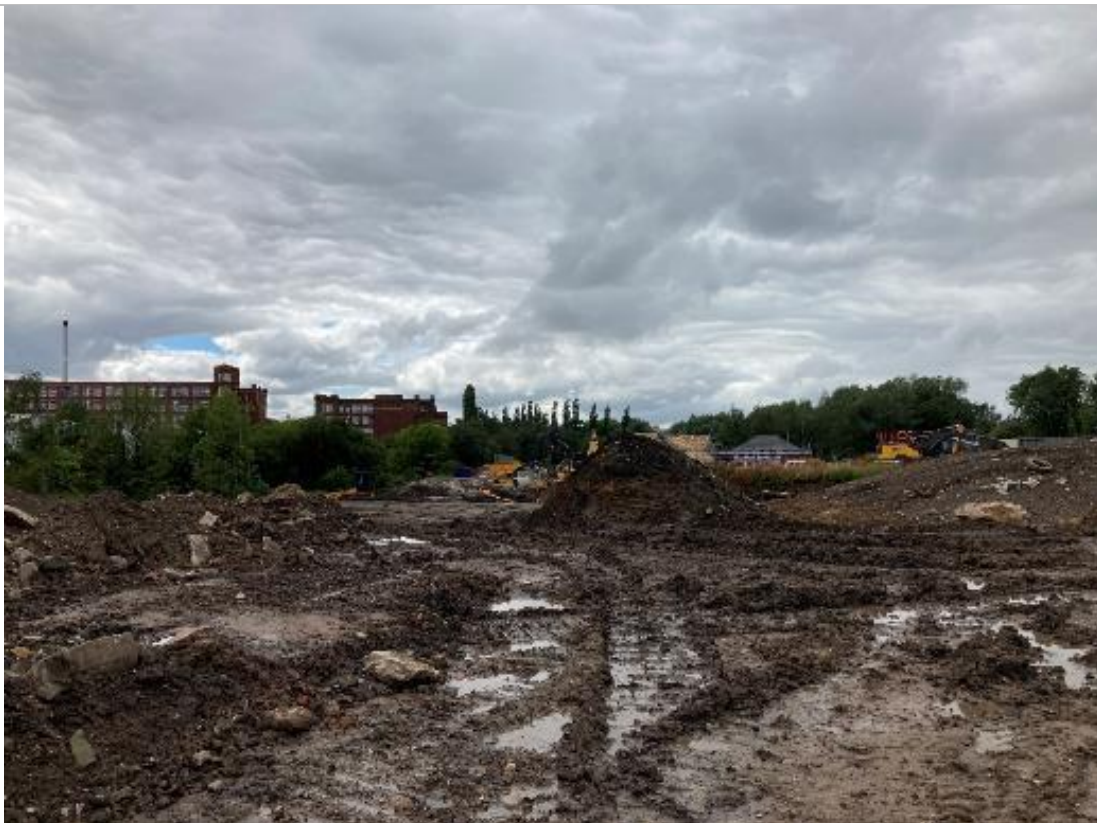
PLATE 70

LANDFILL TREATMENT

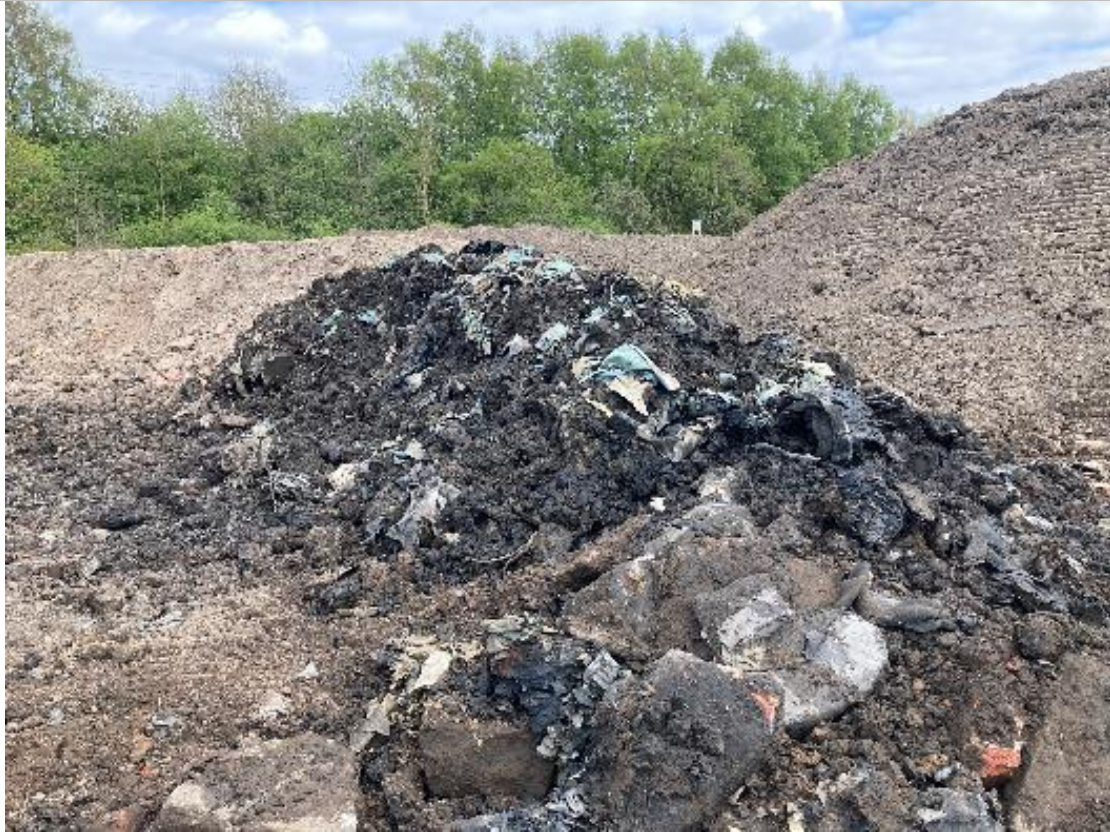
PLATE 71 LANDFILL TREATMENT

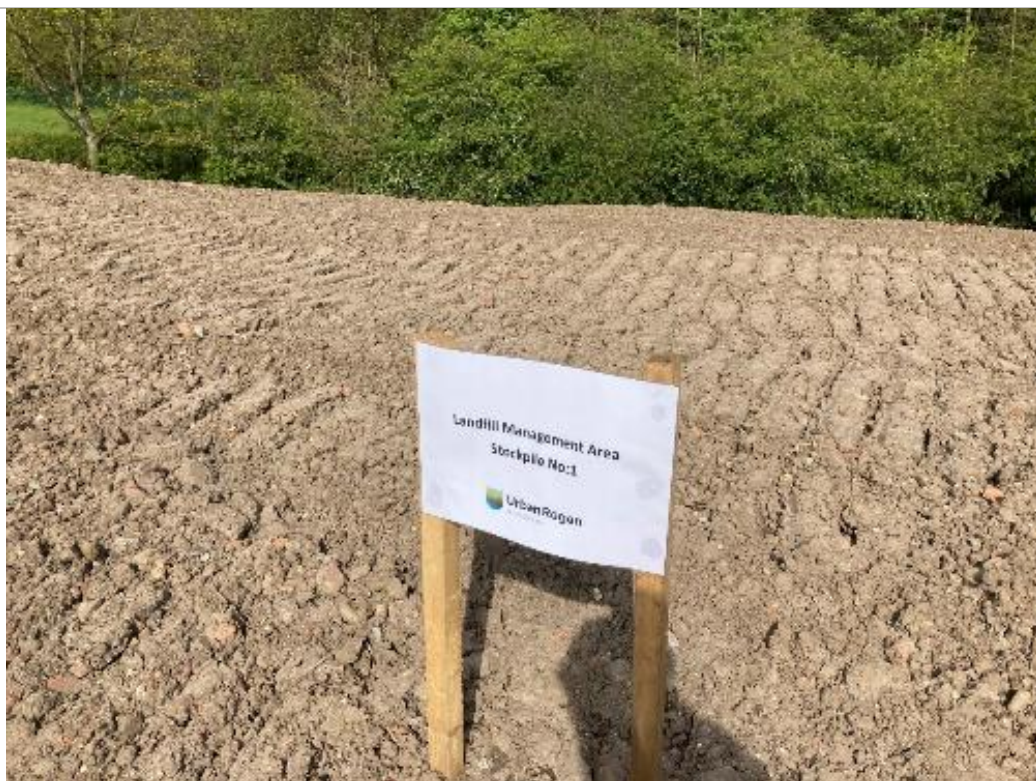
PLATE 72 LANDFILL TREATMENT

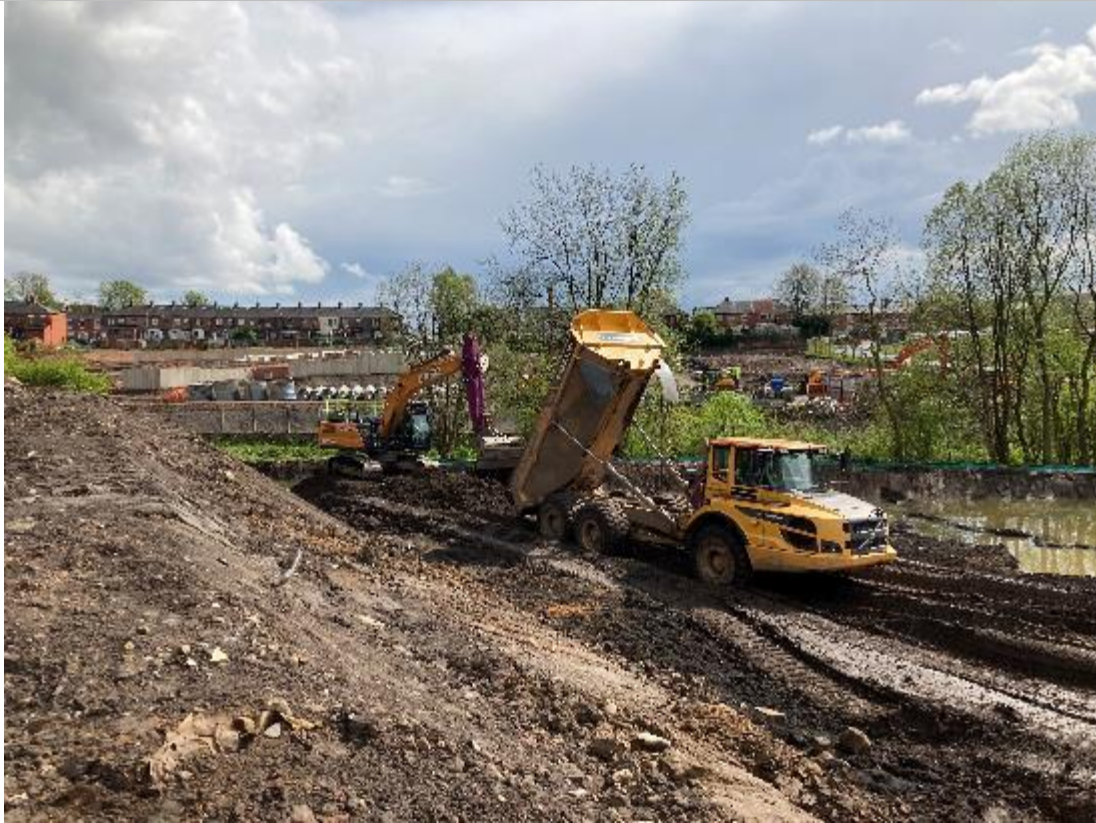
PLATE 73 LANDFILL TREATMENT

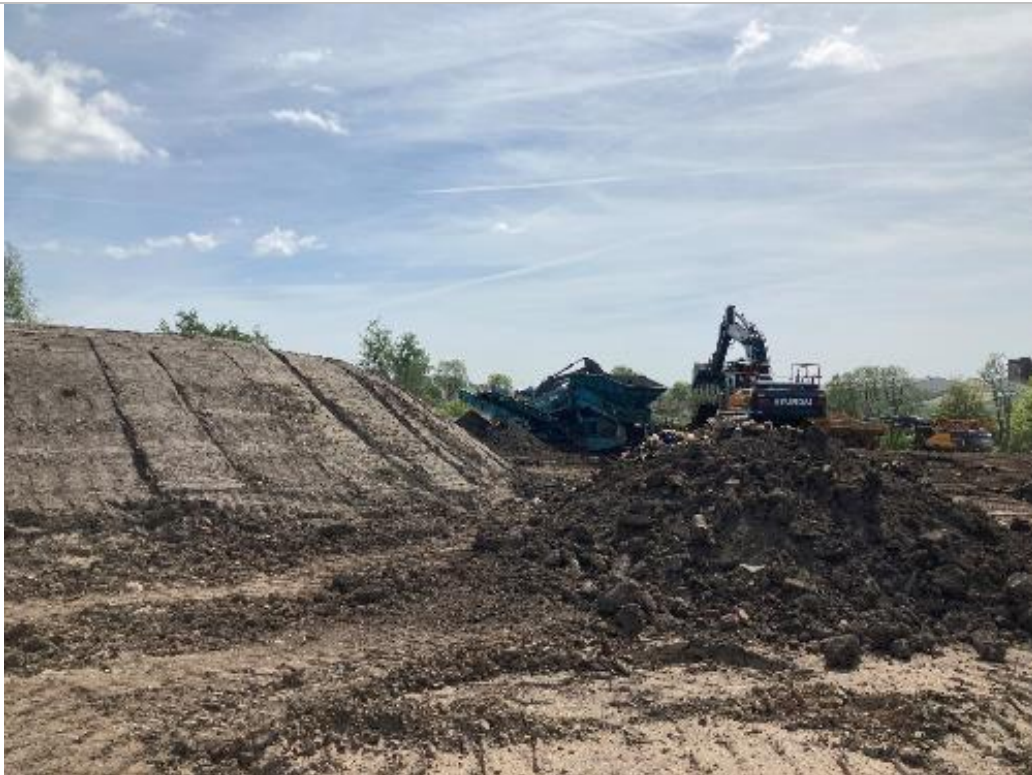
PLATE 74 LANDFILL TREATMENT

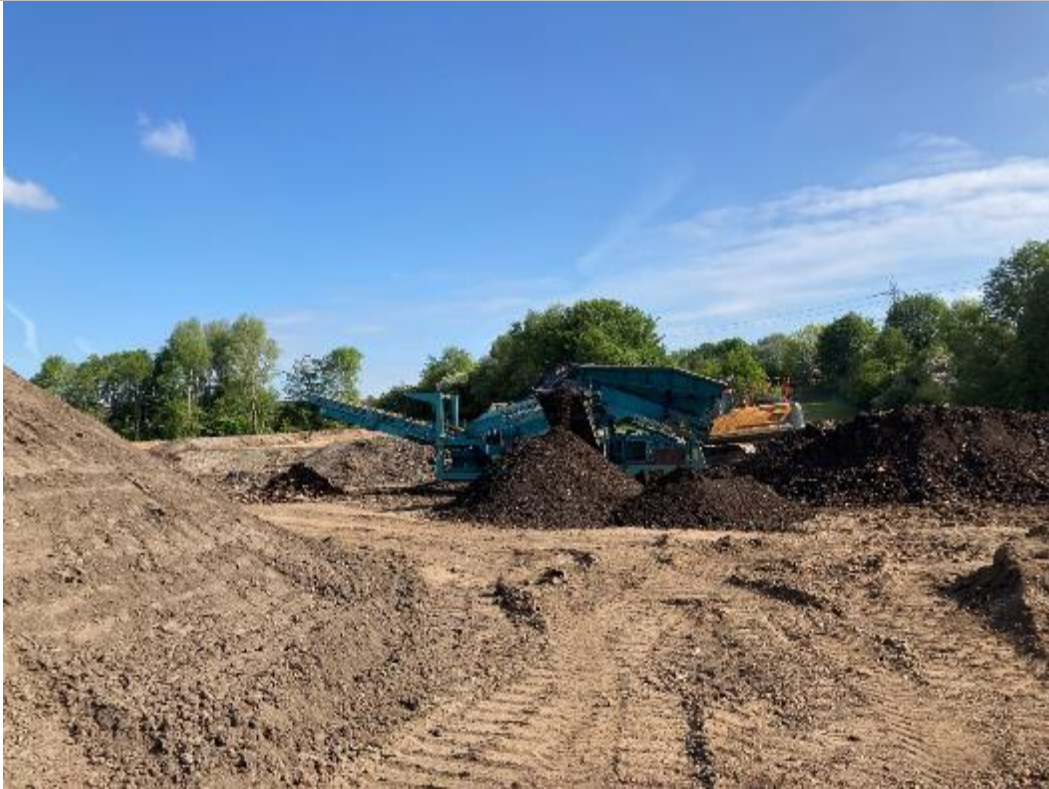
PLATE 75 LANDFILL TREATMENT

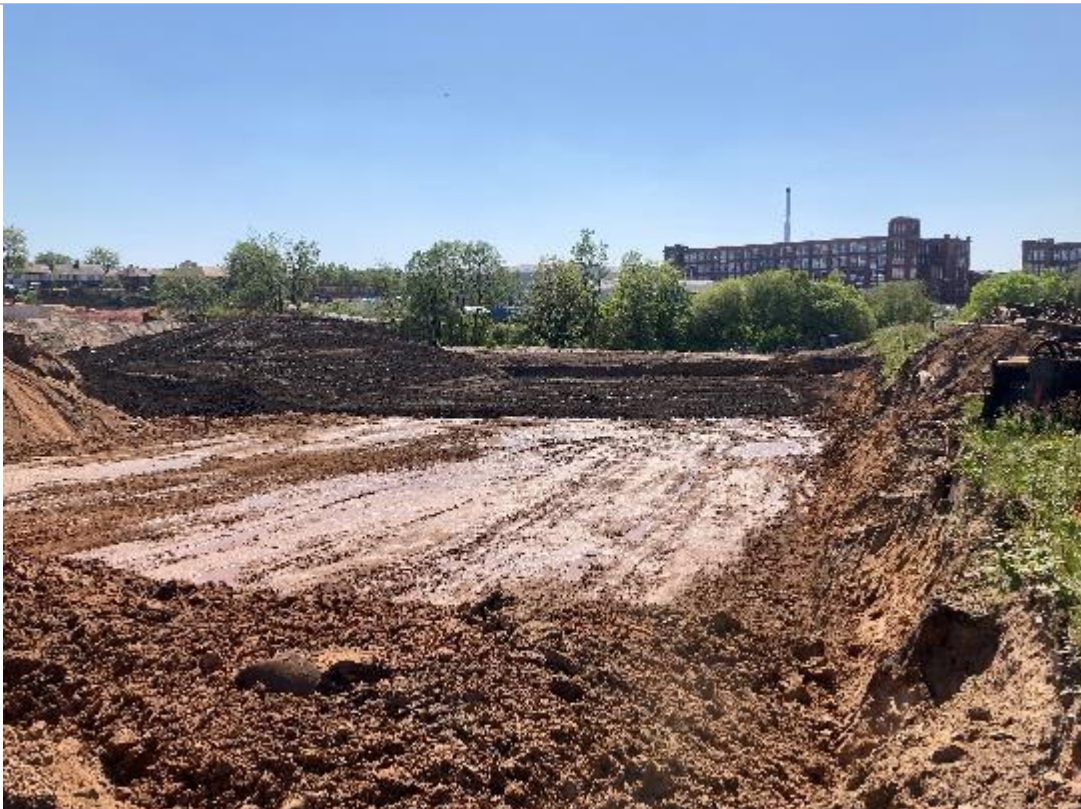
PLATE 76 LANDFILL TREATMENT

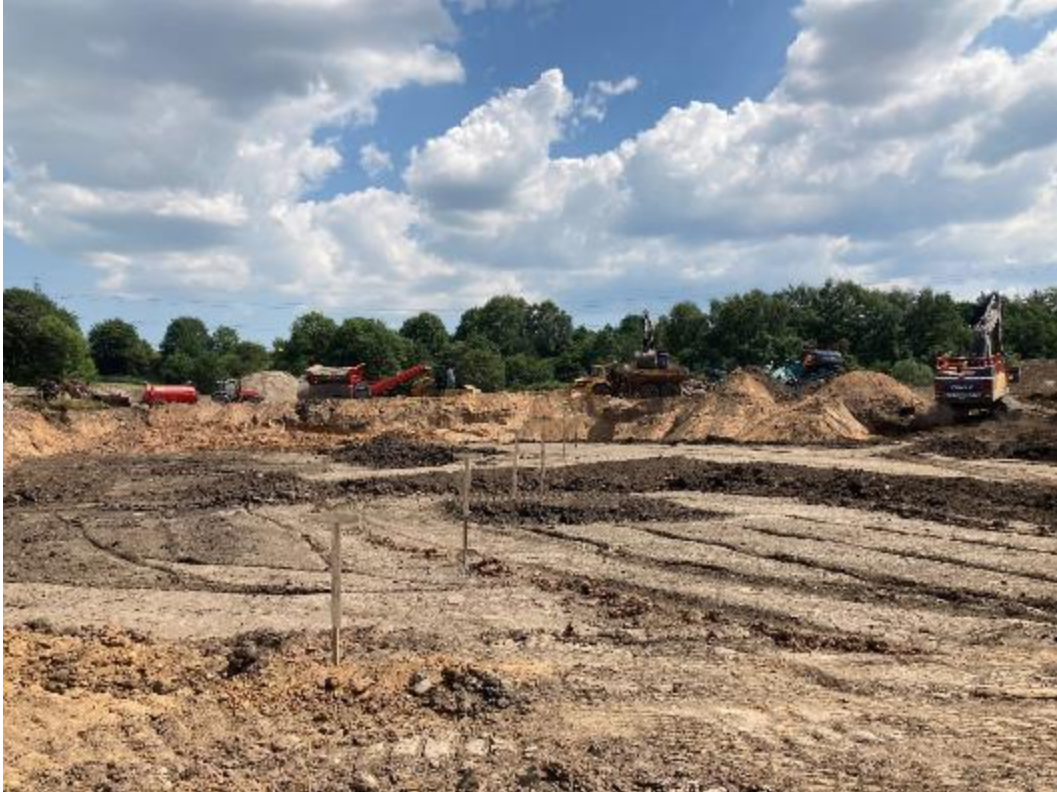
PLATE 77 LANDFILL TREATMENT

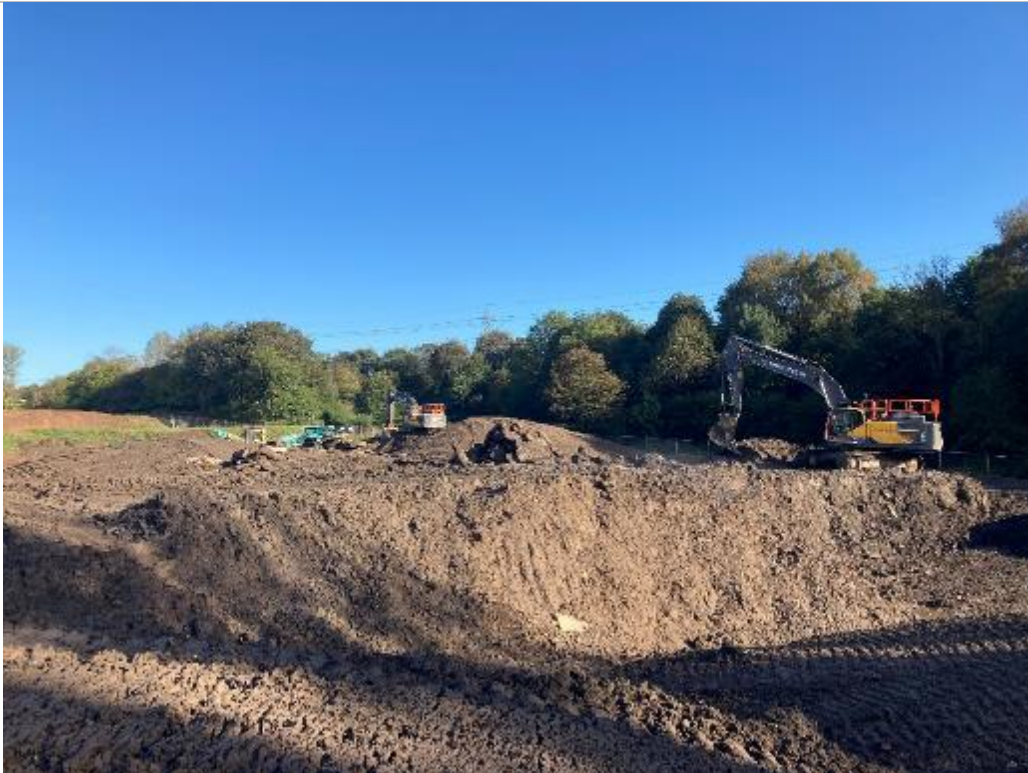
PLATE 78 LANDFILL TREATMENT

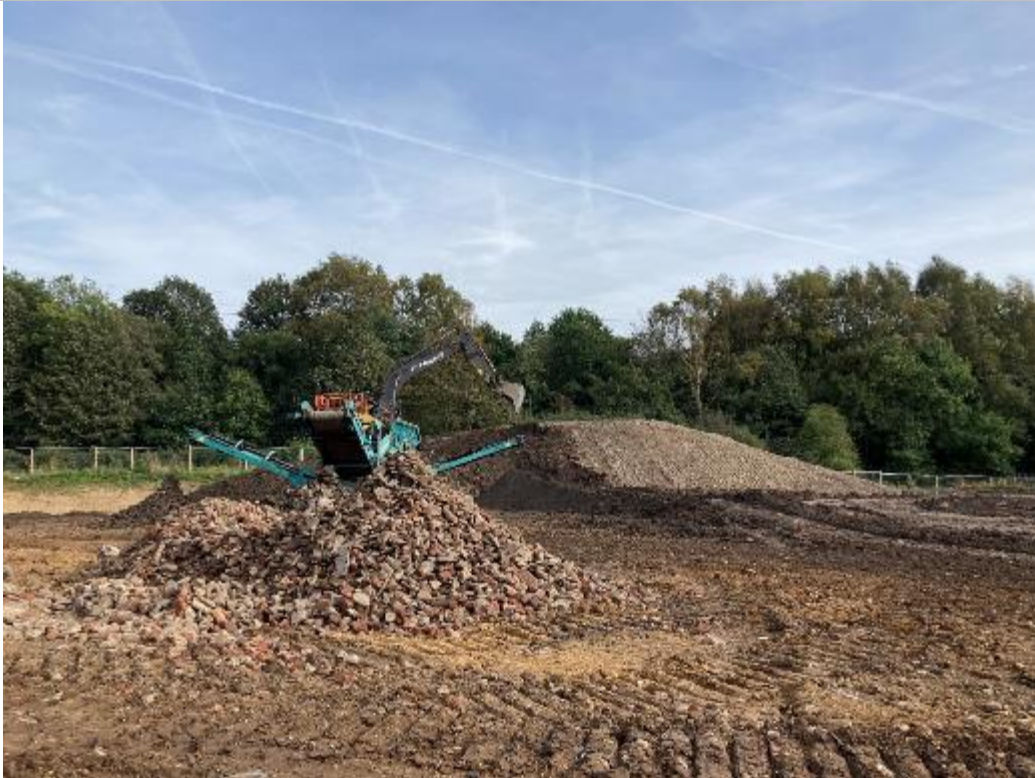
PLATE 79 LANDFILL TREATMENT

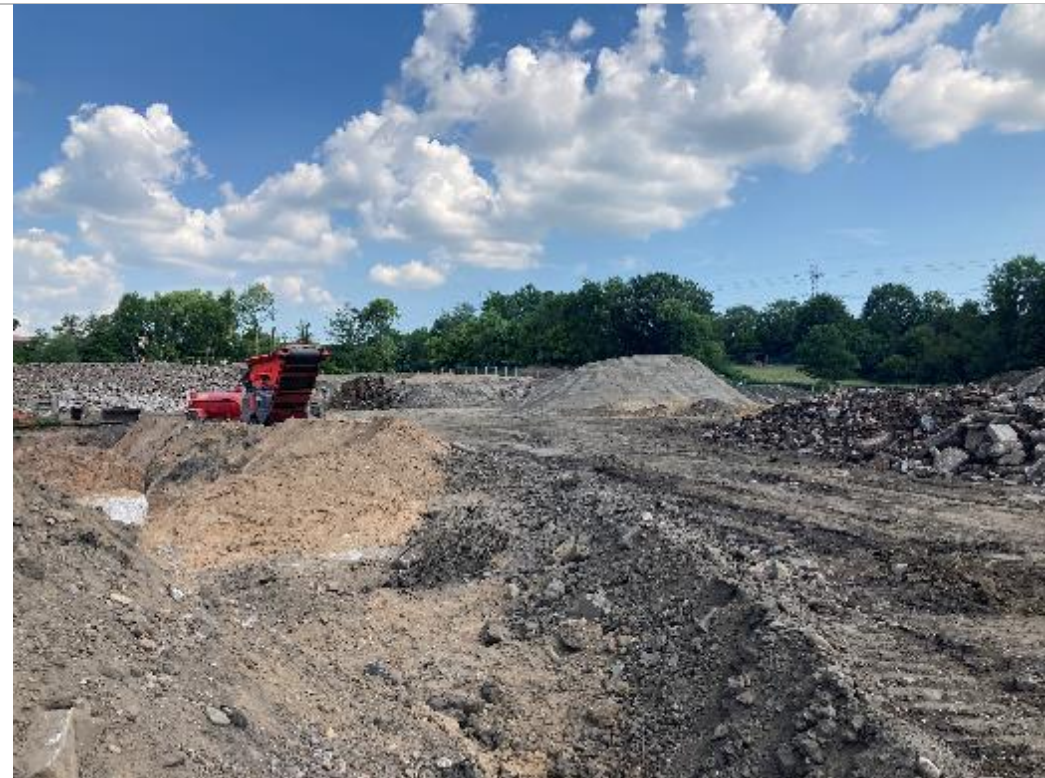
PLATE 80 LANDFILL TREATMENT
