MILNROW LIBRARY  
SPECIALIST INVESTIGATIONS  
January 2022

**Bradshaw Gass & Hope LLP**  
**Architects Consulting Engineers Quantity Surveyors**  
**21 Silverwell Street Bolton BL1 1PR**

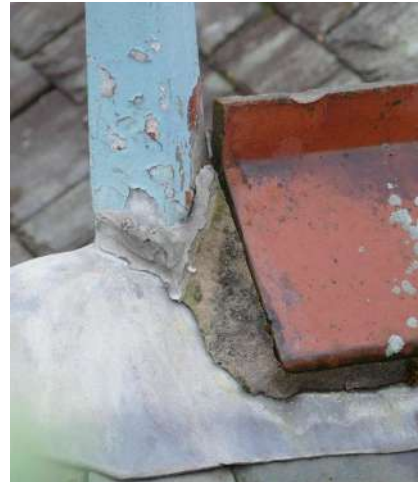
Welded lead gutter lining/apron excessively long and vulnerable to thermal movement. The welded joints show hairline cracks.

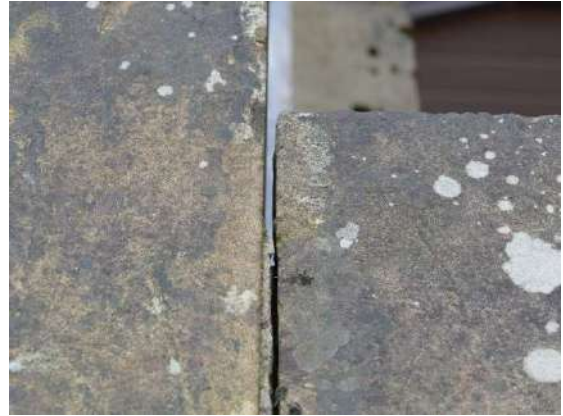
Opened weathered joints in the copings

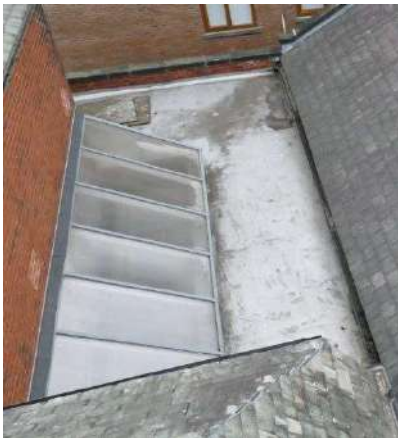
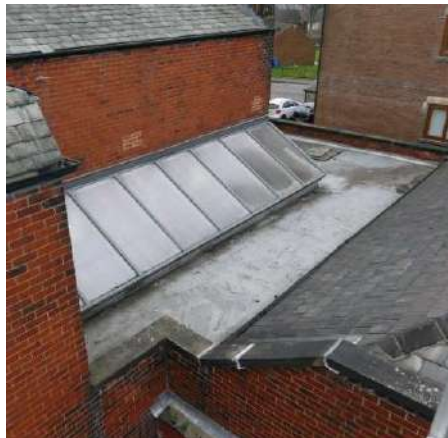
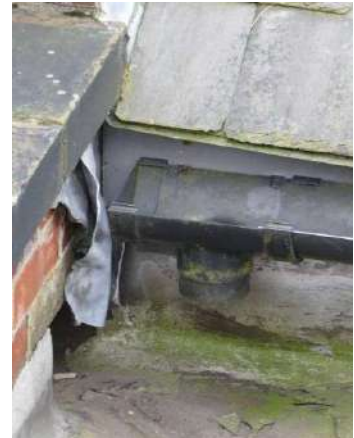
Asphalt covered flat roof over the reception area. The outlet flashings are lifted following theft of adjacent flashings. Skylight no longer illuminating the reception.

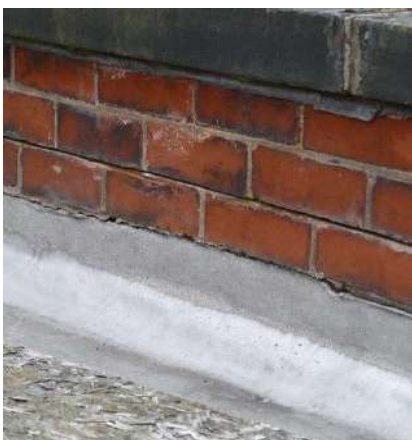
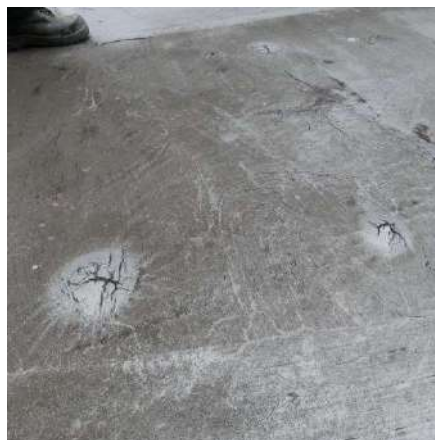
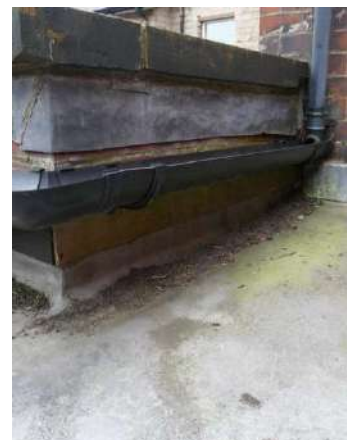
Open joint where the asphalt cover flashing has been stolen and not replaced. Blisters and splits in the surface of the asphalt and unpainted fascia detail for mounting the gutter to the library roof.

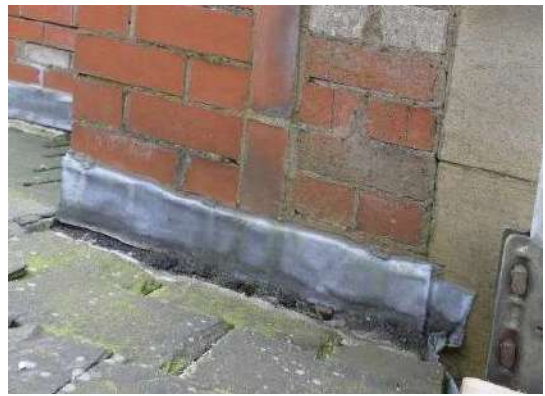
Poorly finished detail to adjoining verge. Open gaps will allow bird and insect access. Poorly finished detail where the back flashing to the abutment meets the verge.

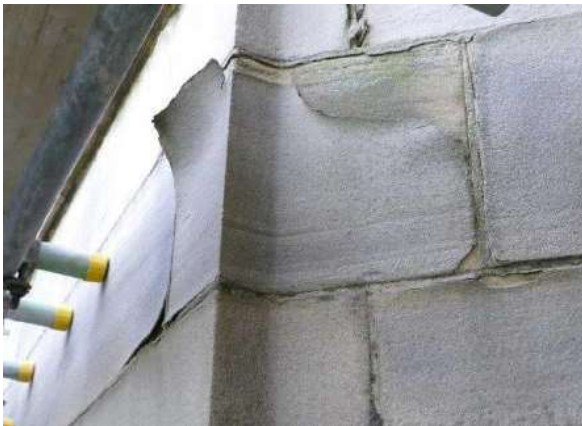
Spalling facings and past cementitious pointing..

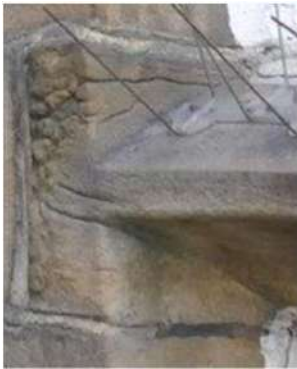
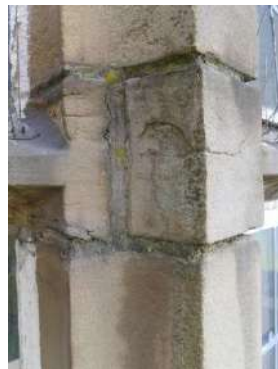
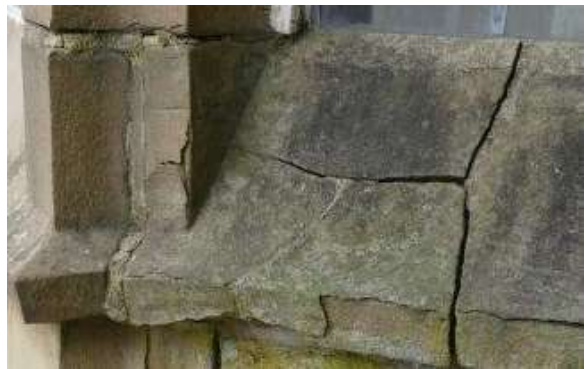
Damage to the transoms may be from corroding dowels, stress fracturing or a result of adjacent cement pointing. Dressing back may not be sufficient to address this. The cill requires to be replaced.

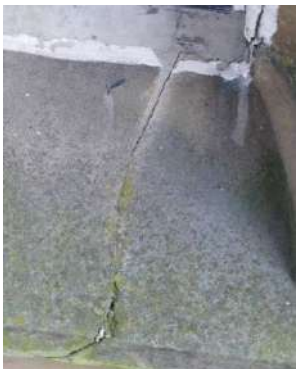
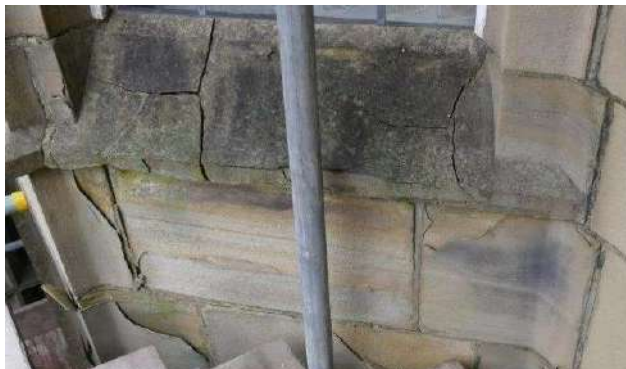
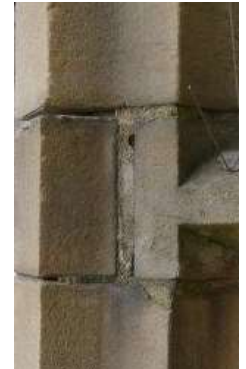
Fractures to the cills and lintols require stitch repairs and new stone to be put in place. The displacement needs to be arrested before the stone is replaced.

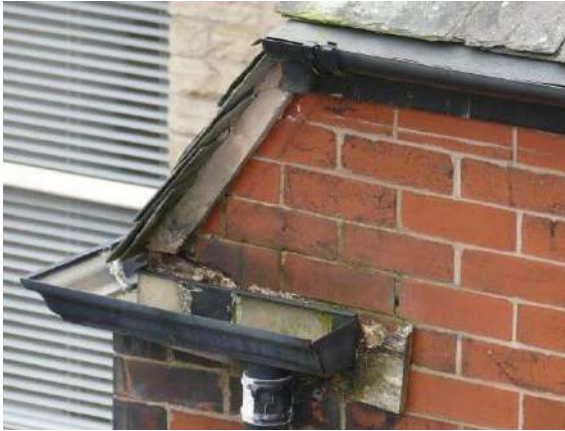
The fall pipe from the east gable of the stair roof down to the south gutter is missing and water simply cascades down the wall. All fascias are in need of repair/replacement and re-decoration.

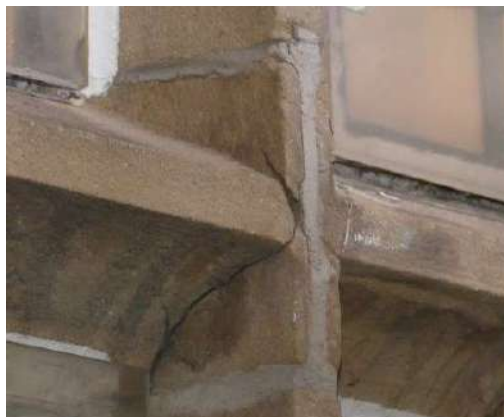
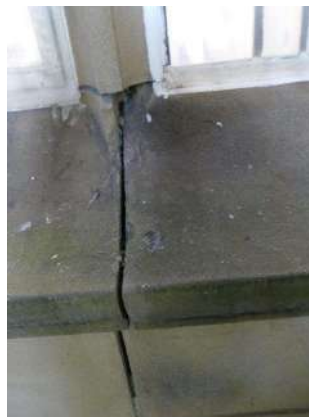
Splitting and spalling of the mullions/cill/transom to the Diocletian window. Possible impact of corroding ferrous dowels or of stress fractures linked to movement above. Some careful cutting out required to determine the extent of an indent that is required.

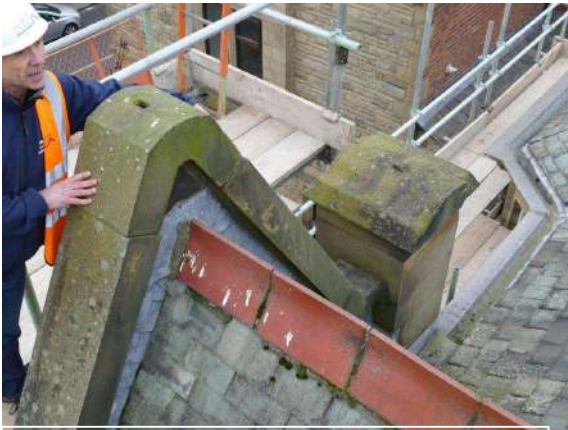
The top panel of the entrance gable can be rocked on its bed joint, three metres below at the head of the stair window.

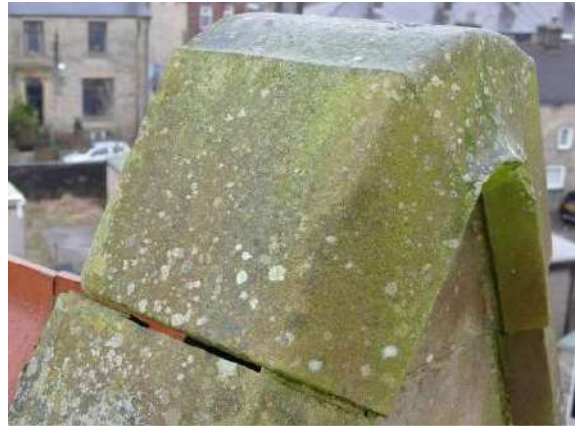
The apex capping stone is de-bonded and remains in position by gravity. It can easily be lifted off the gable. An open joint is visible above.

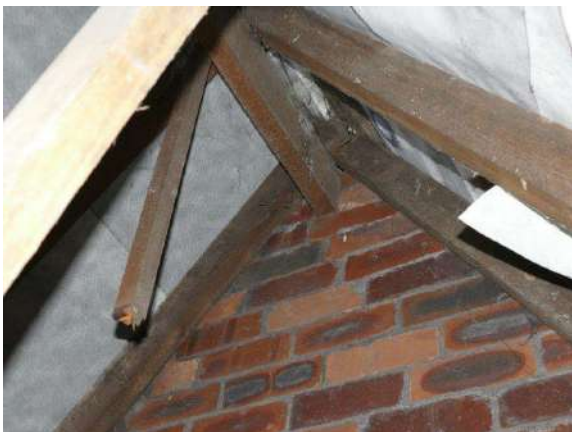
Roof spars offer little real support to the gable and appear not to be strapped or tied to the gable in any way..

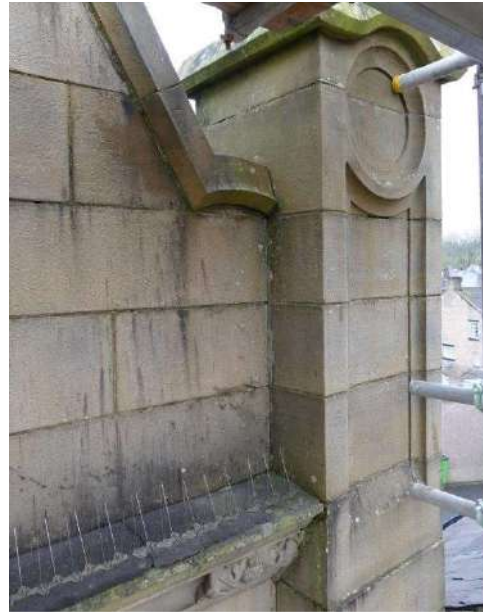
The south pier and finial has a distinct lean to the south which has further opened the joint to the gable panel

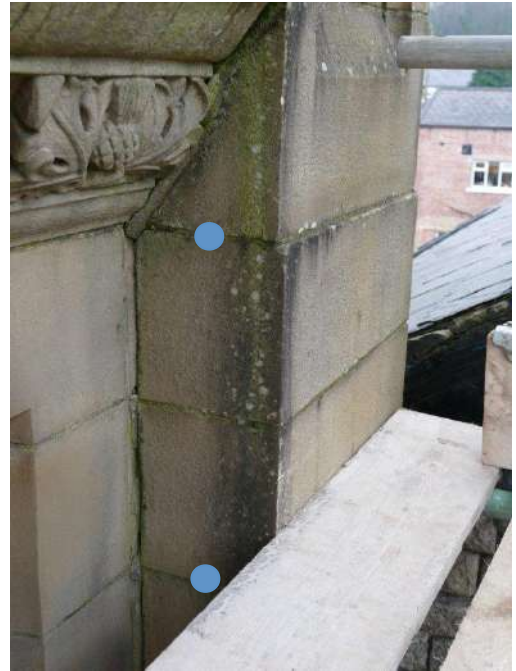
The existing stone pillars are not bonded to the stone face. There is a vertical mortar joint that has broken down and is allowing water to enter.

Each pillar to have 3 No restraint anchors. Consisting of 6mm dia stainless steel threaded bars, in a 10mm dia hole, anchored full depth with a Hilti resin applied under hand pressure from an application gun.

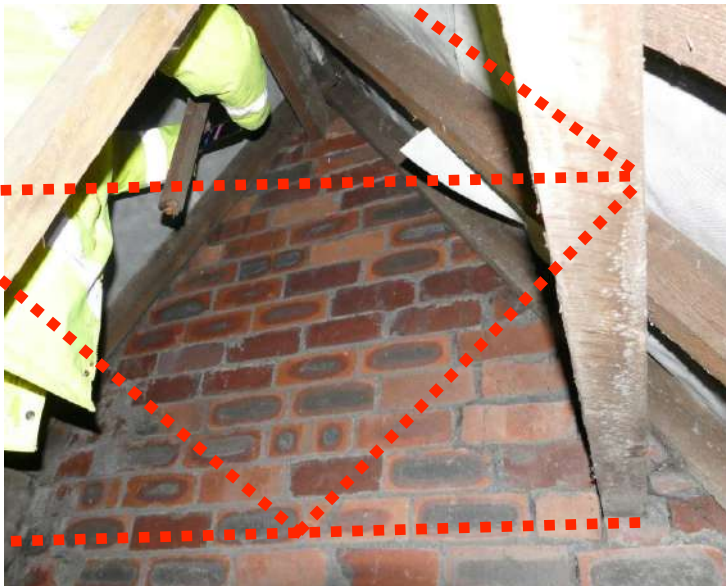
The stone face, brick backed existing gable can be rocked and is unstable. There is insufficient lateral restraint from the roof structure and this now needs to be enhanced.

Angle at the face of the brick to be fixed with 6No M10 x 150mm long Hilti HAS-U A4 stainless steel anchor rods, each with a Hilti HVU-TZ capsule resin.

Angle to angle connections to be achieved using M10 grade 4.6 black bolts, 1No per member end.

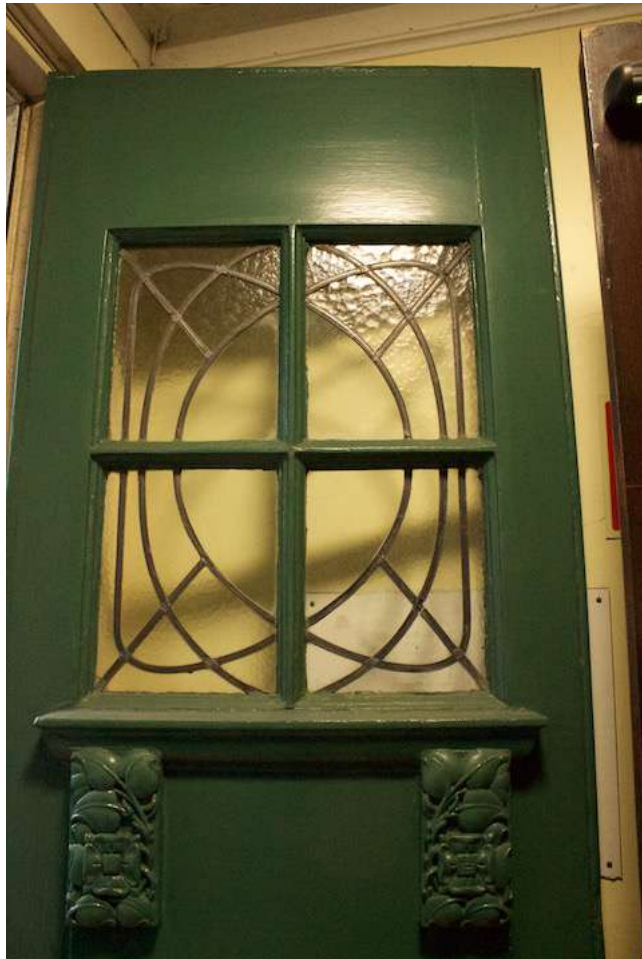
**Right door**

**Condition** – Glass / lead is quite poor

All panels have broken solders

1 cracked pane to inside right door

**Recommendation** – Remove all panels, re-lead and re-fit

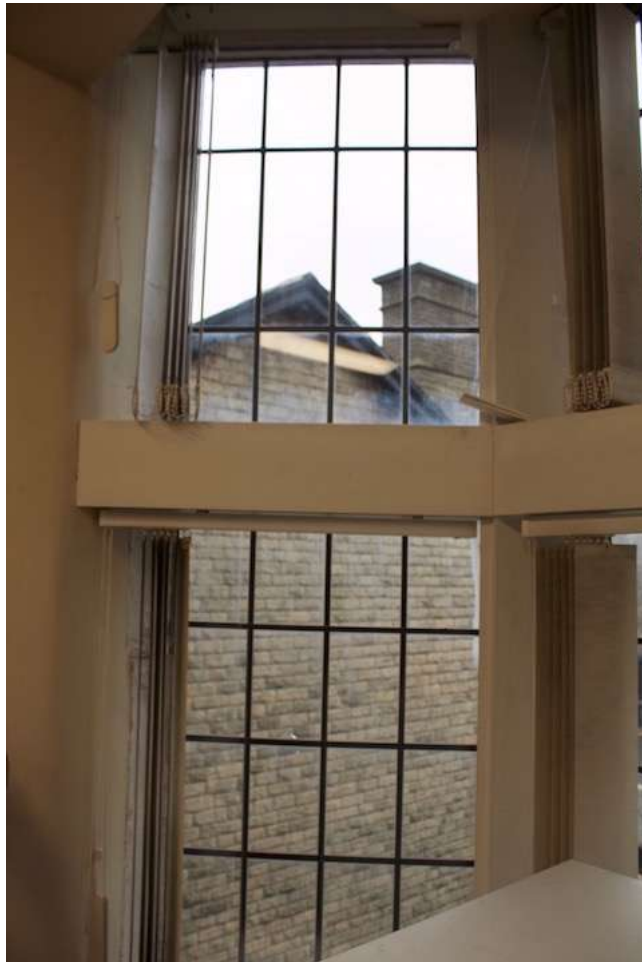
**WF2**

**Condition** – Bottom panel to WF2 has a small crack

**Recommendation** – Remove and replace with leaded lights (as they would have been originally)

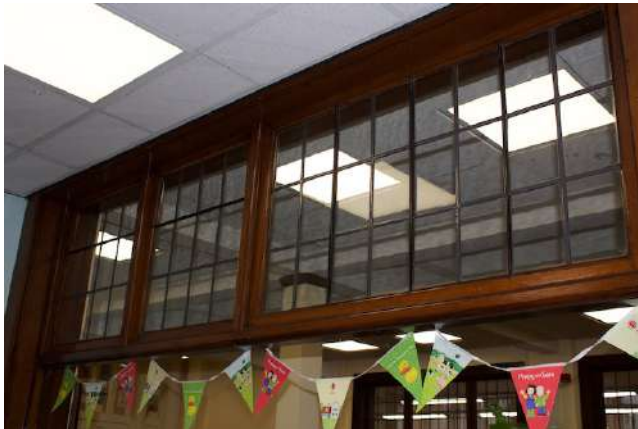
**Internal windows**

There are quite a few square-leaded internal windows in the main library rooms these are all in satisfactory condition. There is one damaged pane to one of the windows between the two rooms (this could be repaired in-situ although it is not in danger of falling out). The door to the staff room has had some previous in-situ repairs and the panel is slightly loose, this needs monitoring. The only panel that needs work is the door to the computer room mentioned earlier in this report

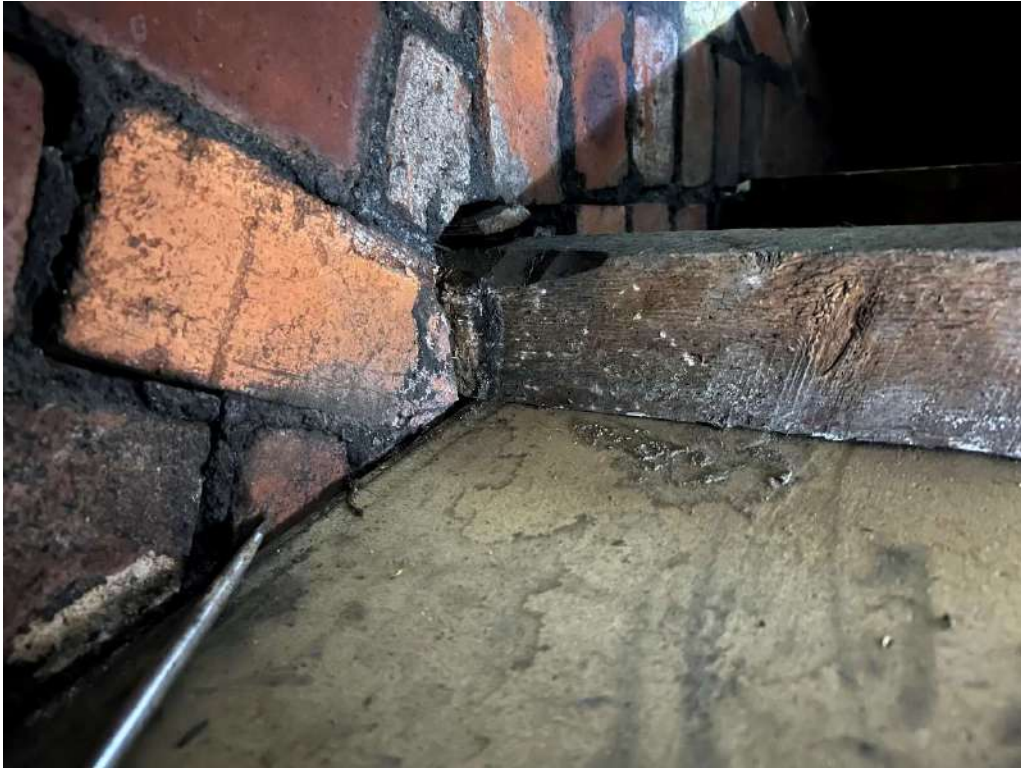
Ceiling joists and purlin above curved ground floor library ceiling  
Photo 2

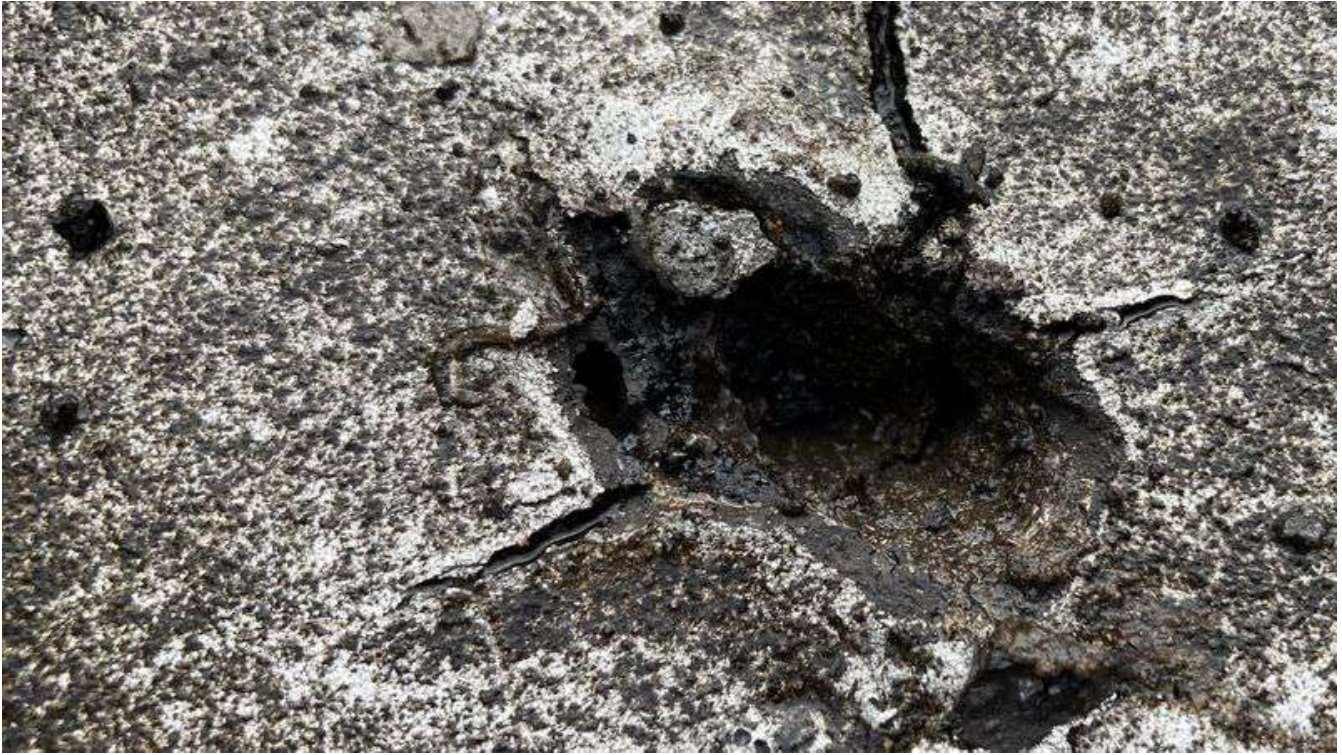
**General Overview:** Asphalt roof with solar paint that has been patch repaired and now needs a new system overlay.

**Core :** taken to assess the build-up and condition of the roof, this was found to be as follows;

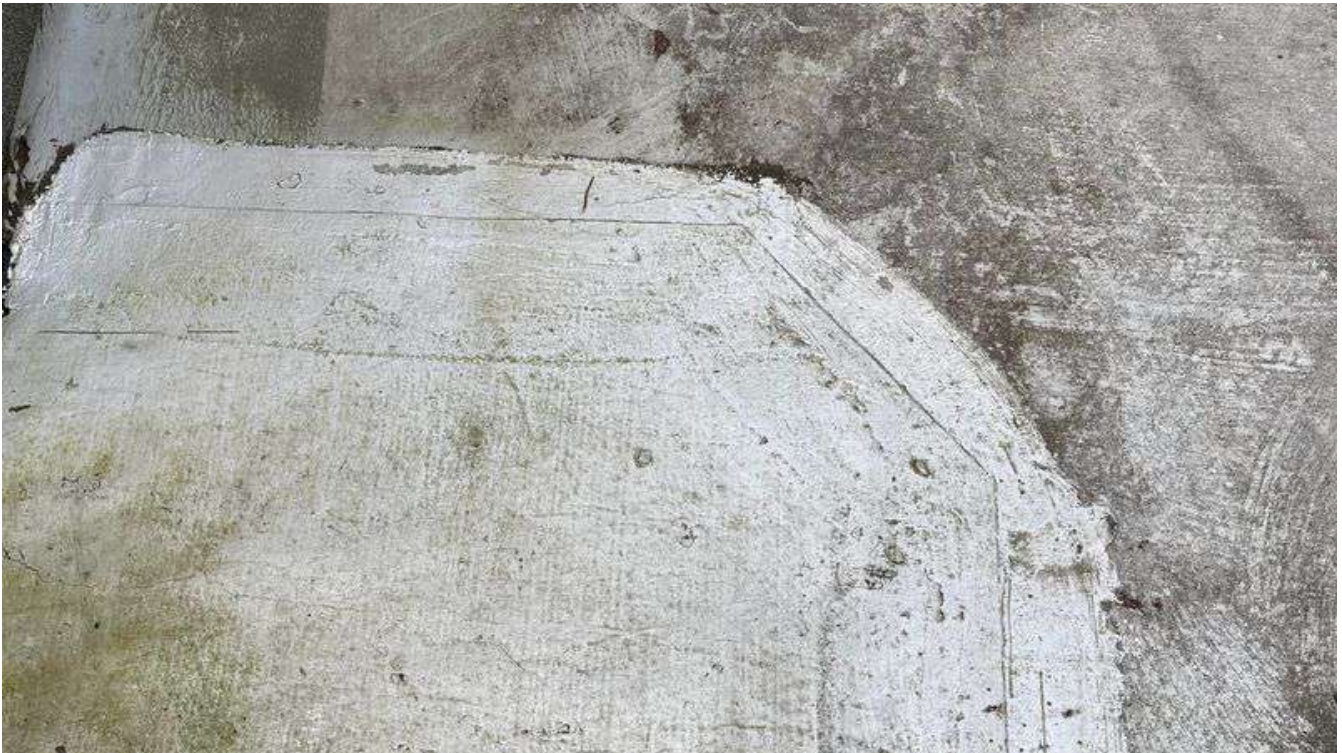
### 1.2.3 SUBSTRATE CONDITION

Sikalastic metal primer is required prior to waterproofing.

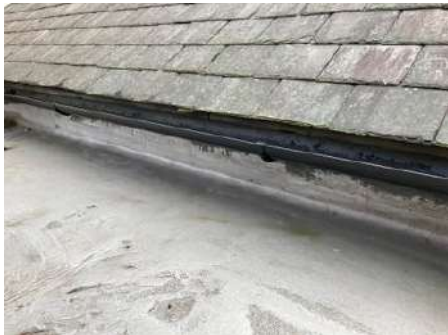
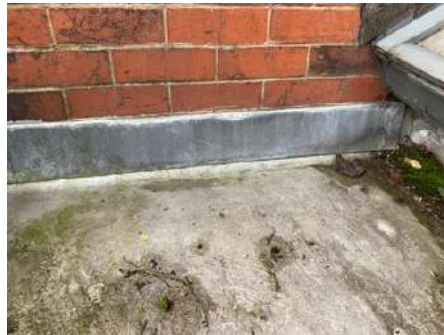
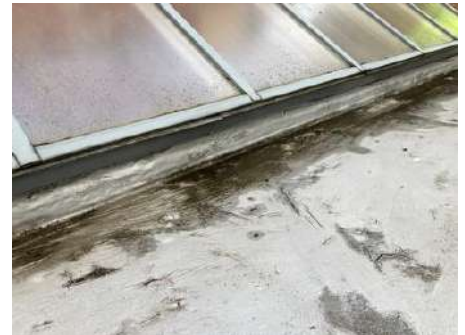
## 1.2.4 UPSTANDS

There is a brick wall upstand with a usable flashing detail, a glazing detail to terminate tight up to and a tile overhang to finish under.

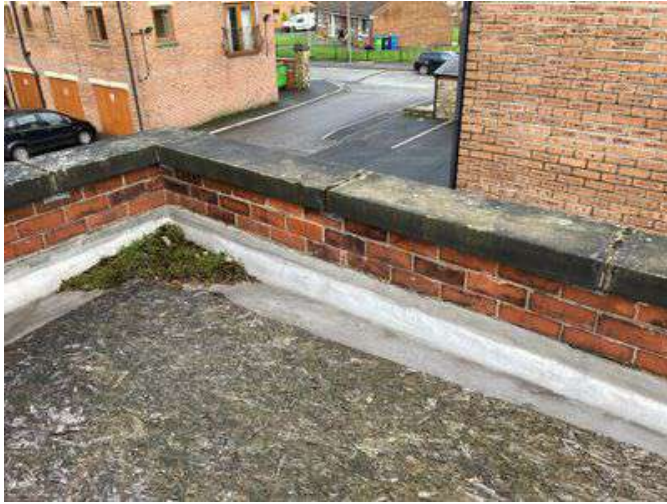
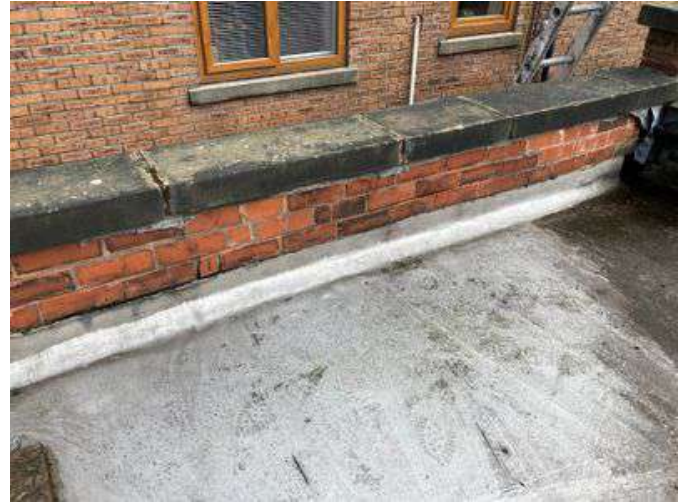
## 1.2.5 PARAPETS

**Existing Coping Stones:** There is a potential for water ingress to the cavity as a result of open joints, poor installation or porosity of the coping stones.

It is good roofing practice that the underlying cavity is closed. If this is not possible then we suggest that the coping stones, the cavity and associated parapet walls are assessed by a competent person(s). Sika Ltd will take no responsibility, for any water ingress that should occur as a consequence of the cavity not being closed.

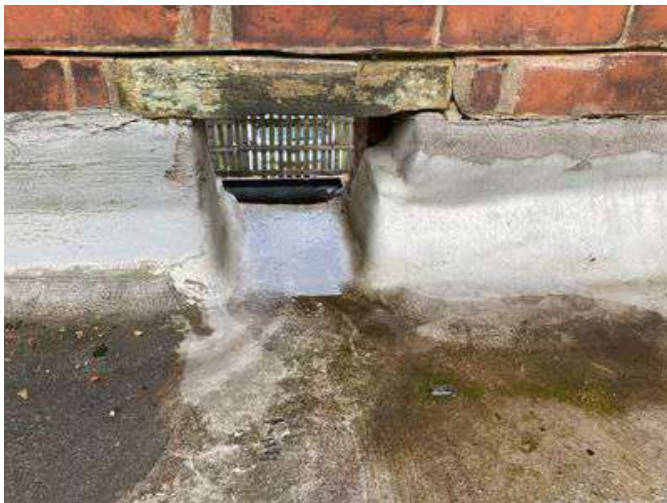
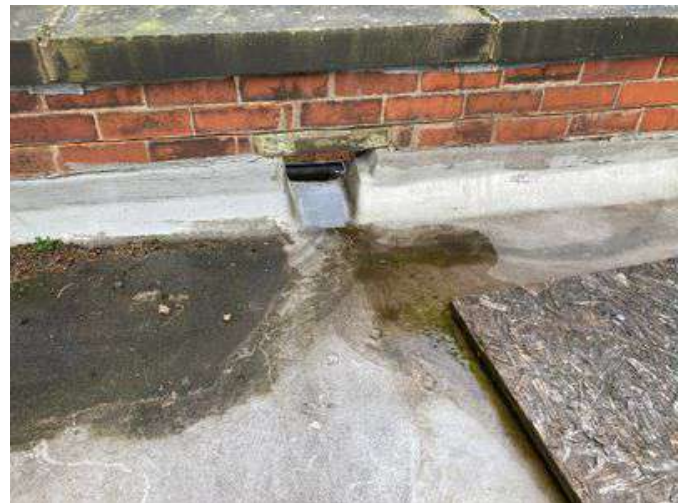
## 1.2.6 DRAINAGE

**Internal Outlets:** The outlets appear to be in a reasonable condition and are suitable for coating.

**Note:** The required flow capacity of each outlet should be determined and if necessary, surplus materials cut back to reinstate the original flow capacity.

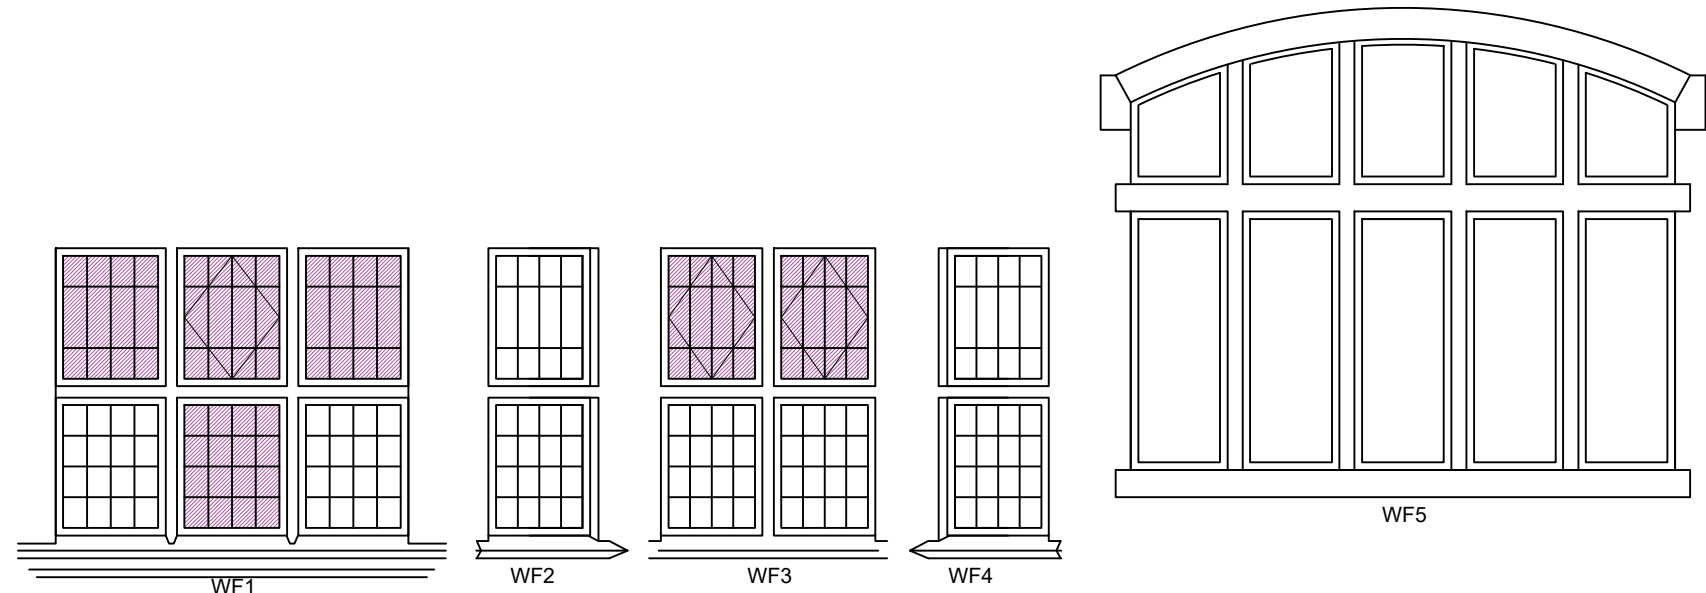
| WINDOW & DOOR SCHEDULE | | | |
|---|---|---|---|
| Further specialist close up assessment of timber frames required to provide a more accurate assessment of the repairs required and the extent of rot. | | | |
| References in brackets refer to photographs that accompany this Condition Report. W 5 shows a typical example of the deterioration of cill and lower sash rails following failure of decoration. | | | |

Initial assessment of compromised timber that will need to be cut out and replaced.
