**ENGINEERING REPORT 8874**

**GREENGATE HILL FARM  
ASHWORTH ROAD  
ROCHDALE  
OL11 5UN**

**CLIENT: MR C CAMPBELL**

**11.04.2023 MP/CH**

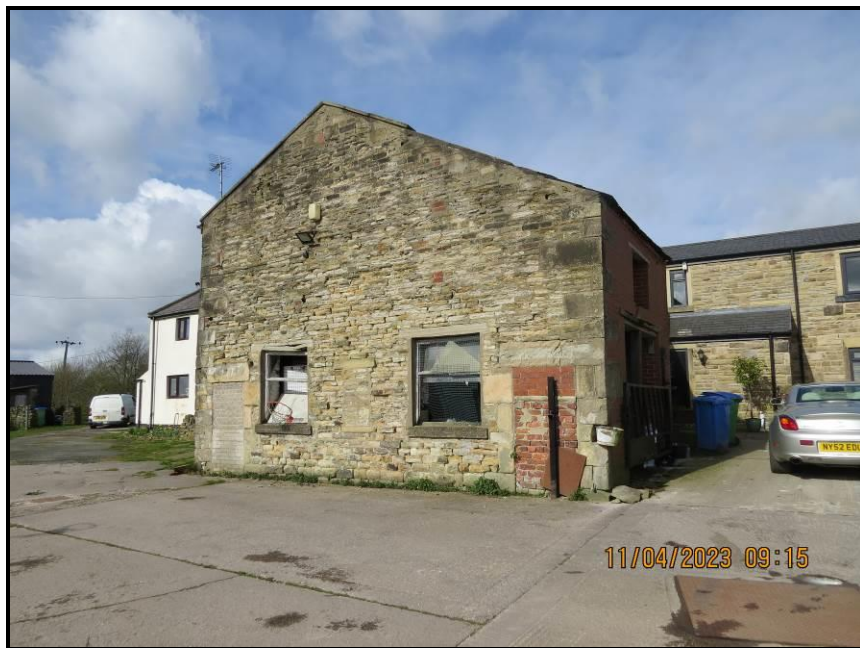
**Photograph 001 South East gable**

- 3.4 The outshoot is aligned on a North West/South East orientation with the original stone gable extending for a width in the order of 8.5 metres. The original barn is in excess of 130 years old. (Photograph 001).

- 5.1 The South Eastern gable of the original barn is completed in a randomly coursed local stonework with evidence of significant weathering particularly in the mid-section. (Photograph 001).
- 5.2 The elevation incorporates original personnel doors at the left and right hand corners, doorways supported on 300mm deep stone lintels infilled with Crowthers common brick, between chainage 0.5 – 1.5 and in seconds facing brick between chainage 7 – 8 metres. (Photographs 008, 020, 021).

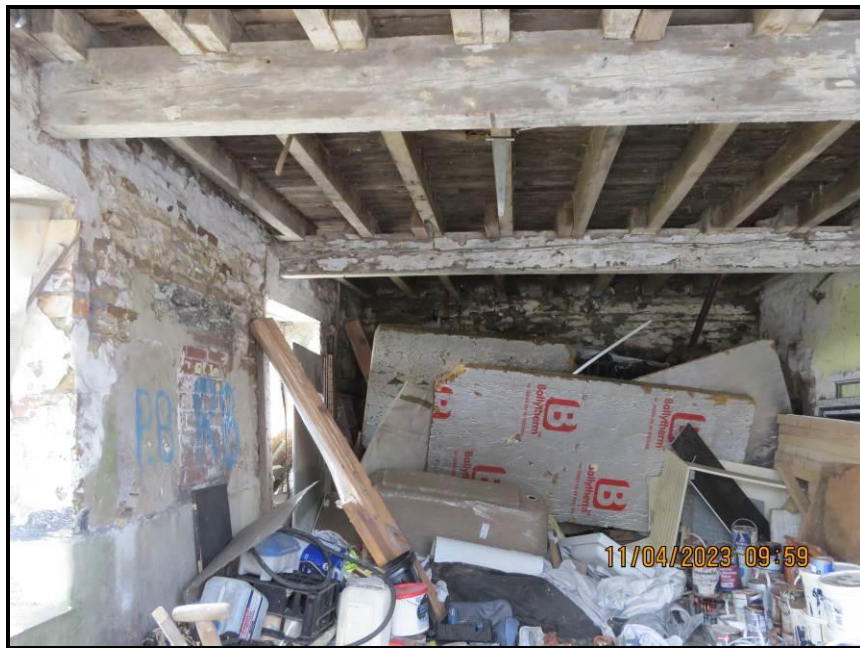
**Photograph 043 Ground floor, South East**

- 7.1 The South Eastern section, a clear span (4.5 metres) with the first floor on two lateral timber beams circa 300mm x 75mm supporting 150mm x 75mm joists at approximately 450mm centres. (Photographs 043, 044, 045).

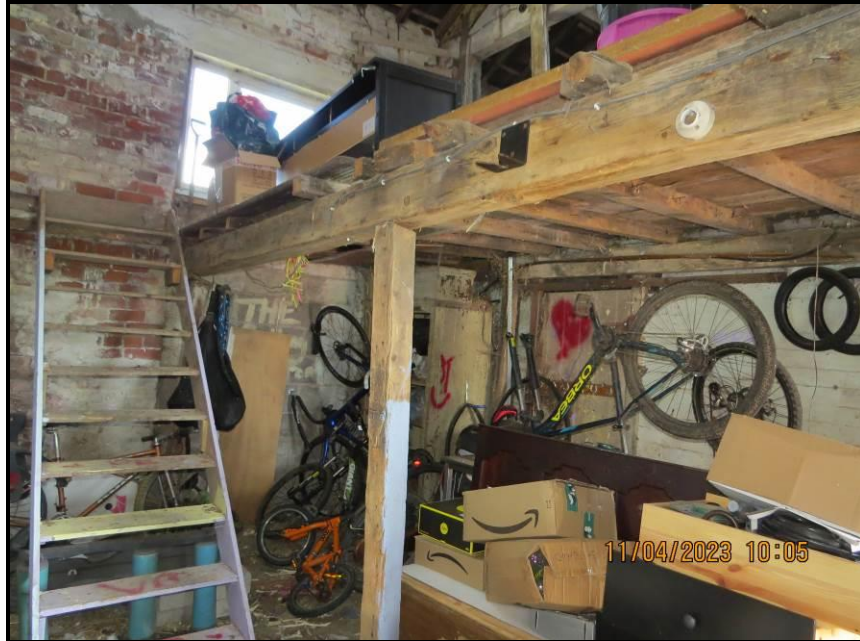
Photograph 052 North West bay

- 8.1 The room extends for a width in the order of 7 metres laterally by 4.5 metres long, a single beam spanning the full length supported on a 75mm x 50mm prop supporting the timber floor at first floor level. (Photograph 052, 053, 054).

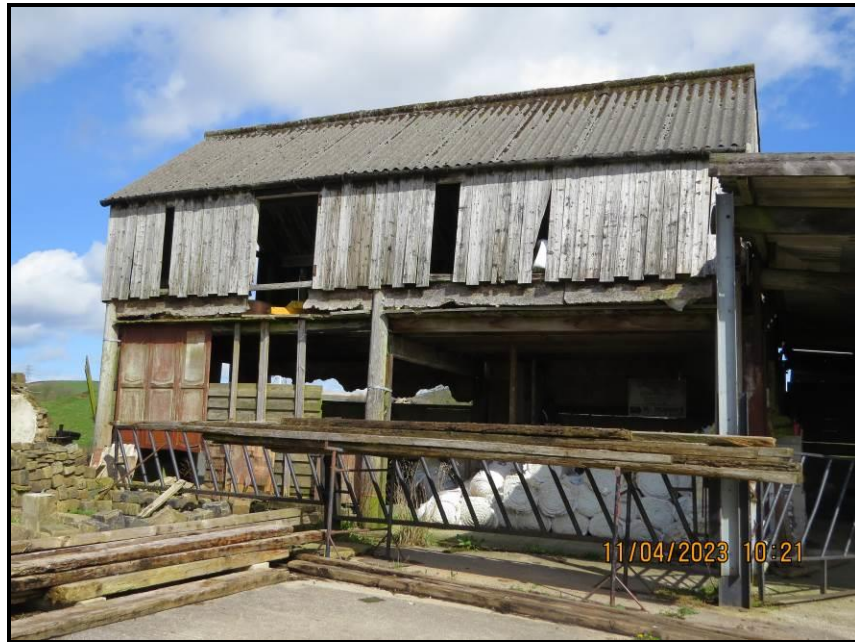
**Photograph 071 Two storey shippon**

- 11.1 The two storey barn incorporates an open plan shippon or stalls beneath a timber suspended first floor with a pitched slated roof construction. (Photograph 071).

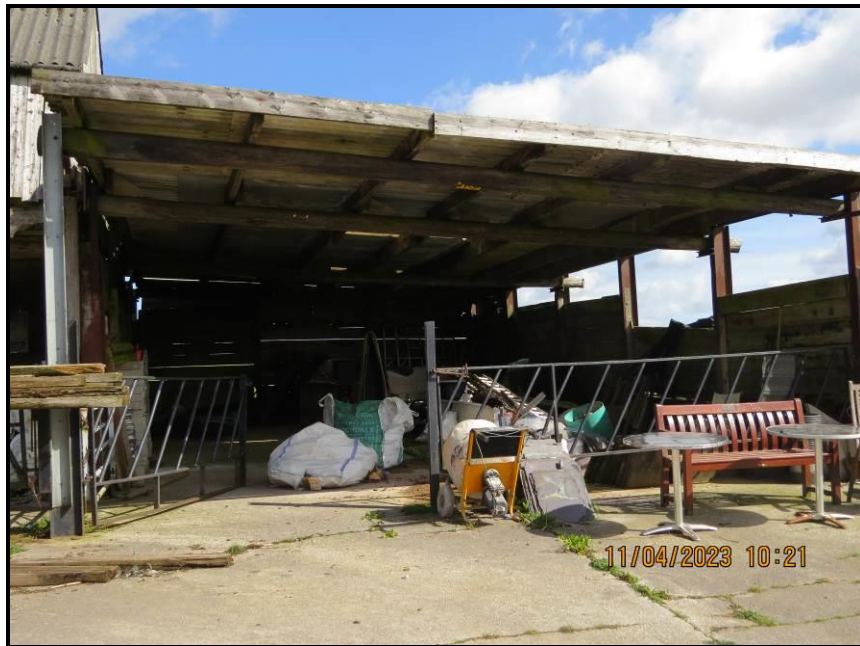
**Photograph 072 Lean-to shippon**

- 12.1 The lean-to shippon adjoins the South East gable of the two storey barn, aligned on a North East/South West orientation, with the lean-to roof falling from left to right (North West – South East) extending for a length in the order of 13 metres by 8 metres wide, with RSJ stanchions at 3 metre centres supporting random section timber whaling sections between stanchions. (Photograph 072).

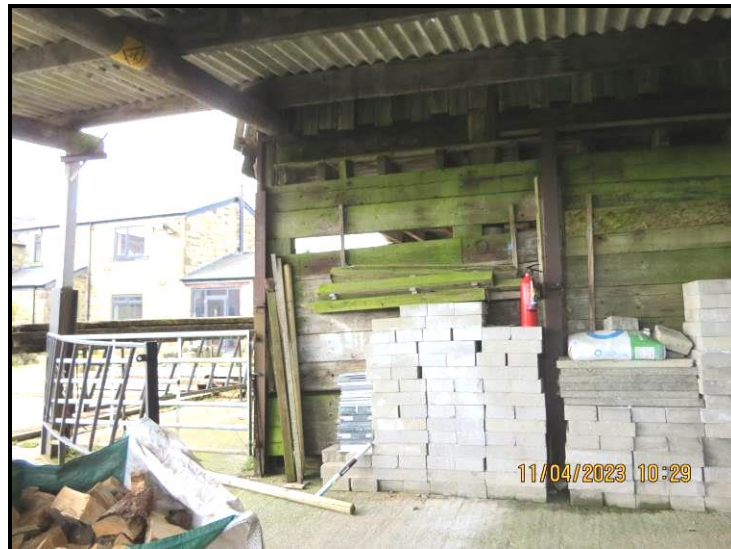
**Photograph 084**

- 12.5 The front bay project past the line of the adjoining two storey barn by a distance in the order of 1.5 metres (probable addition to original structure). (Photograph 084).

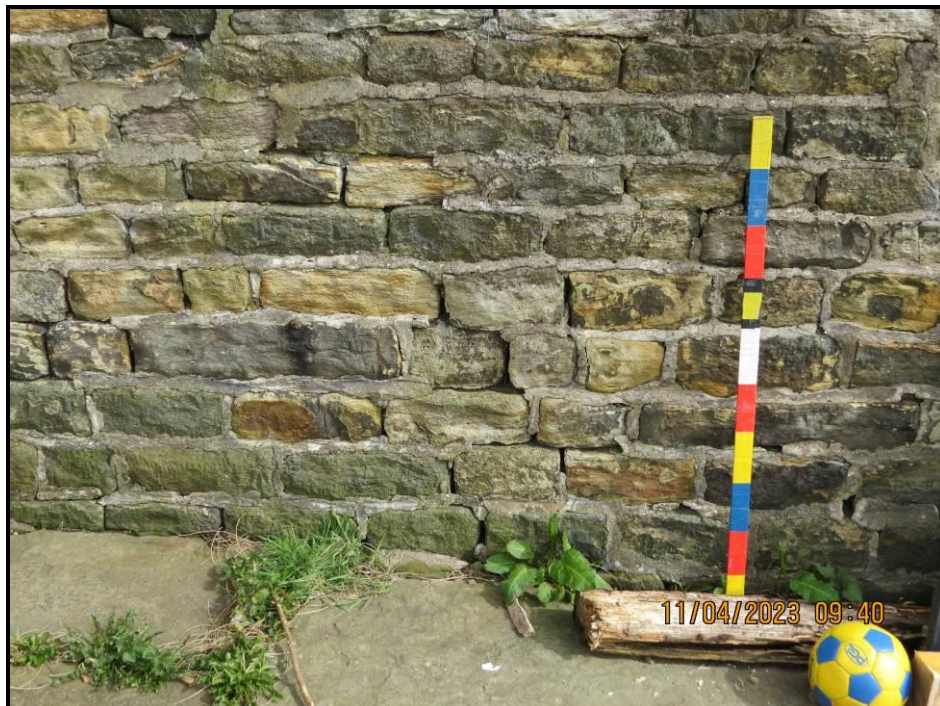
- 4.4 The ground level slopes towards the South Eastern aspect with an increase in height from the paviour to the gable in the order of 700mm. (Photograph 011).
- 4.5 The elevation is constructed in watershot coursing, the pointing is poor and there is evidence of some minor lateral movement in the lower coursing around chainage 4.5. (Photograph 015).

015 Minor lateral movement (historic)

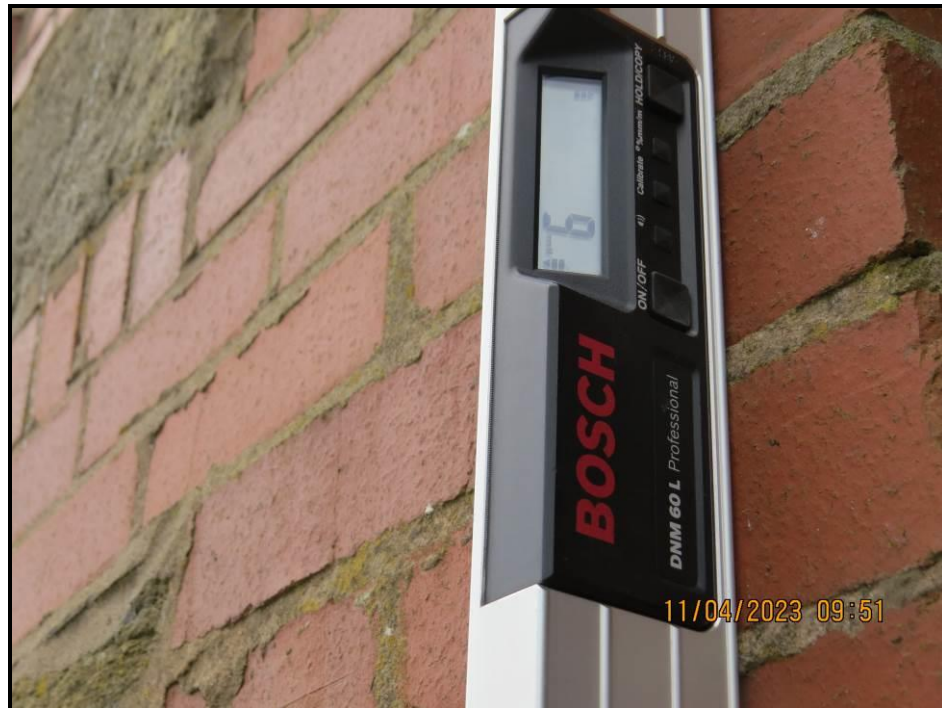
035 Satisfactory vertical alignment

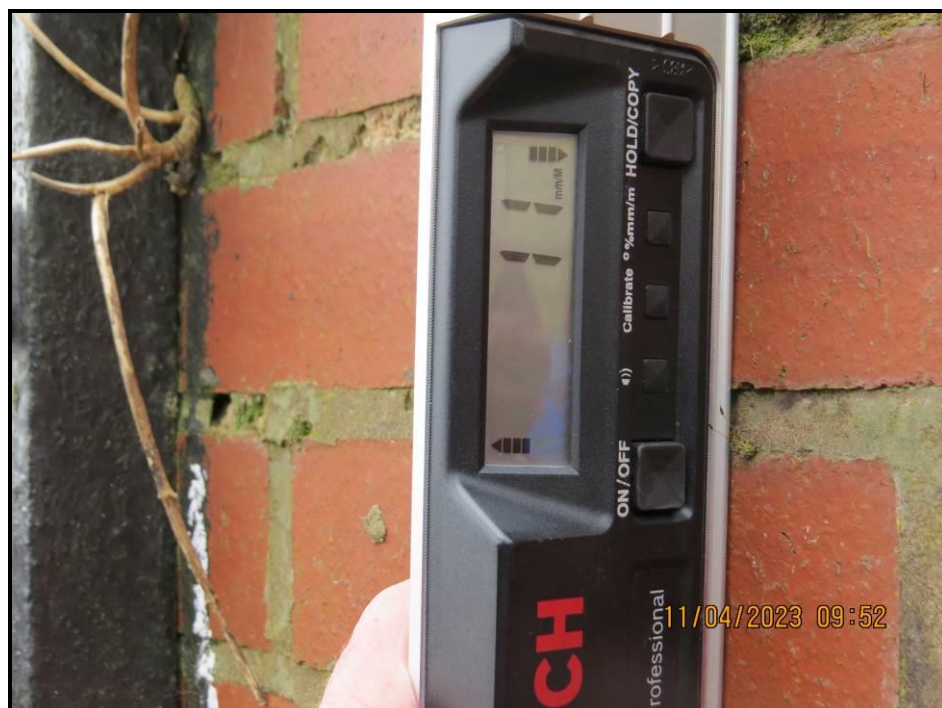
036 Satisfactory vertical alignment, chainage 4 metres

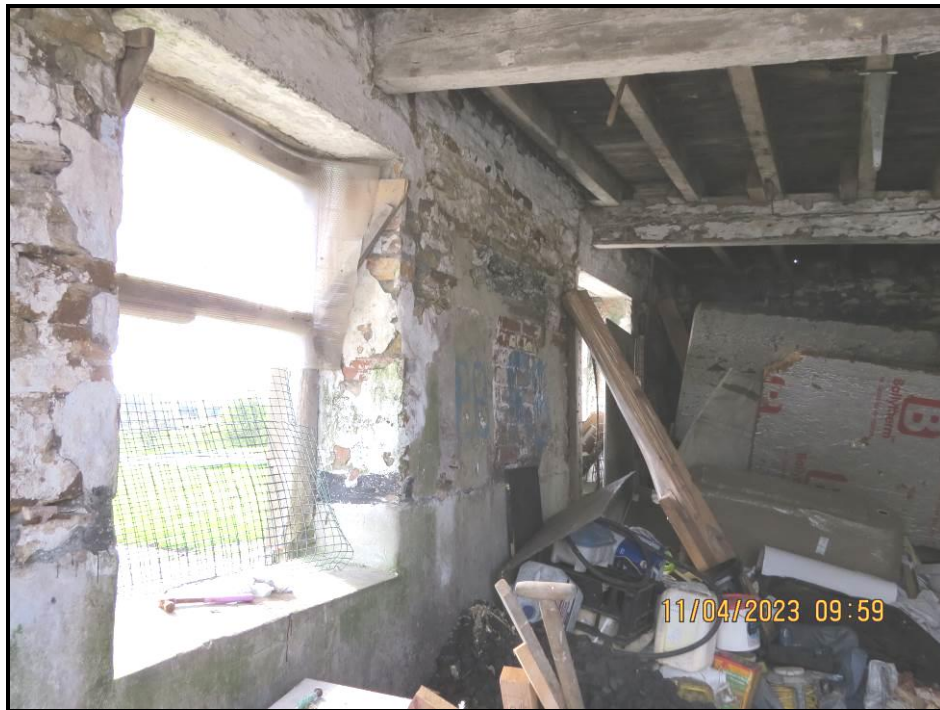
047 Satisfactory beam seating

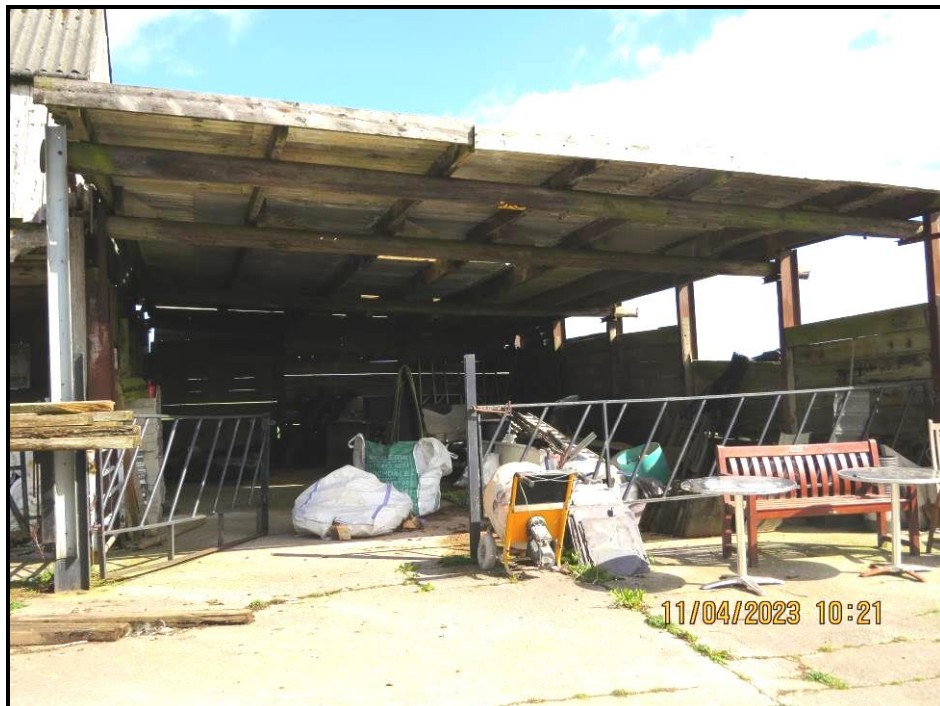
073 Satisfactory roof profile

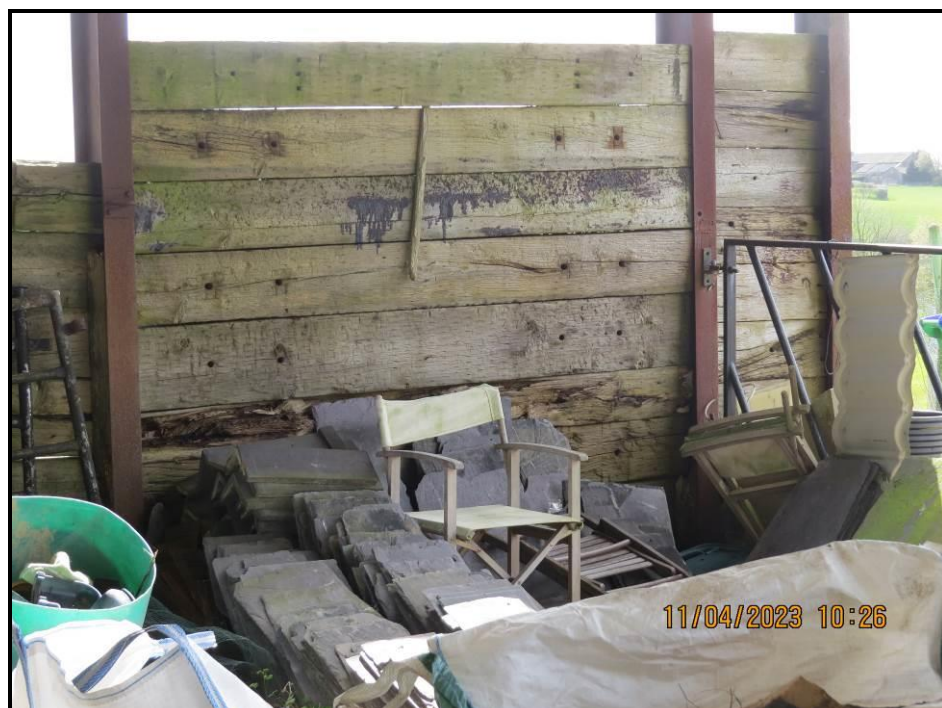
074 North East flank, stanchion – whaling detail

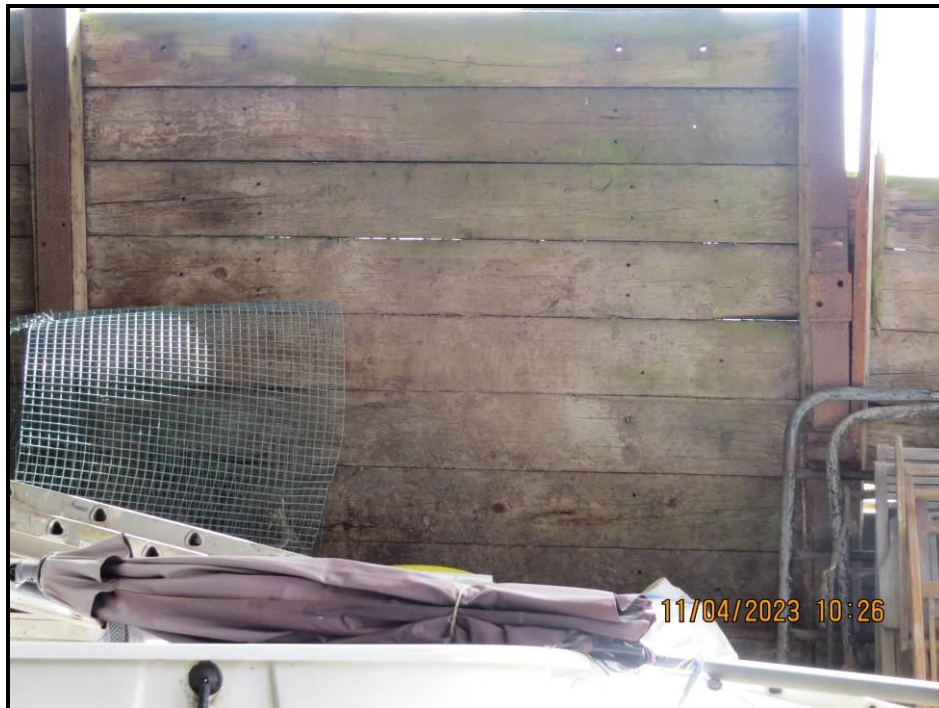
075 South East flank, chainage 0 – 3 metres

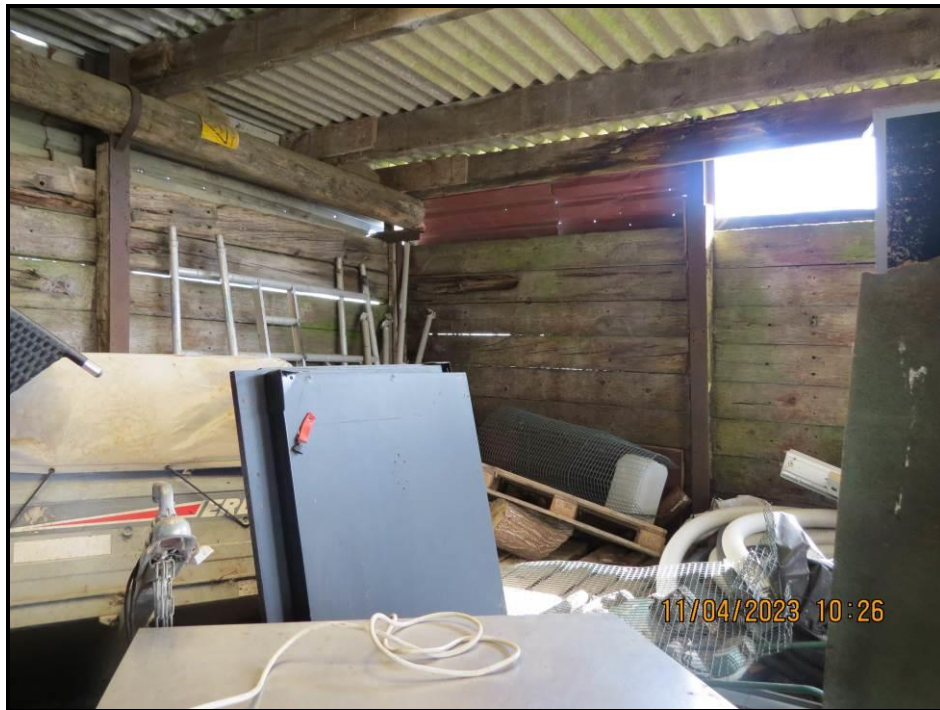
077 South East flank looking East

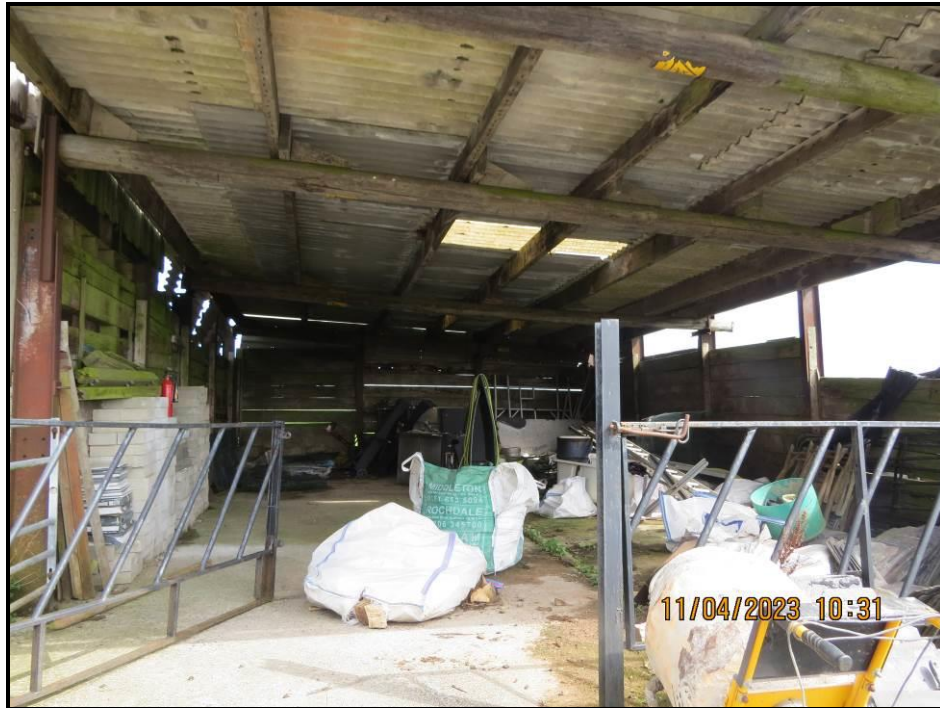
085 Lean-to shippon, South West – North East

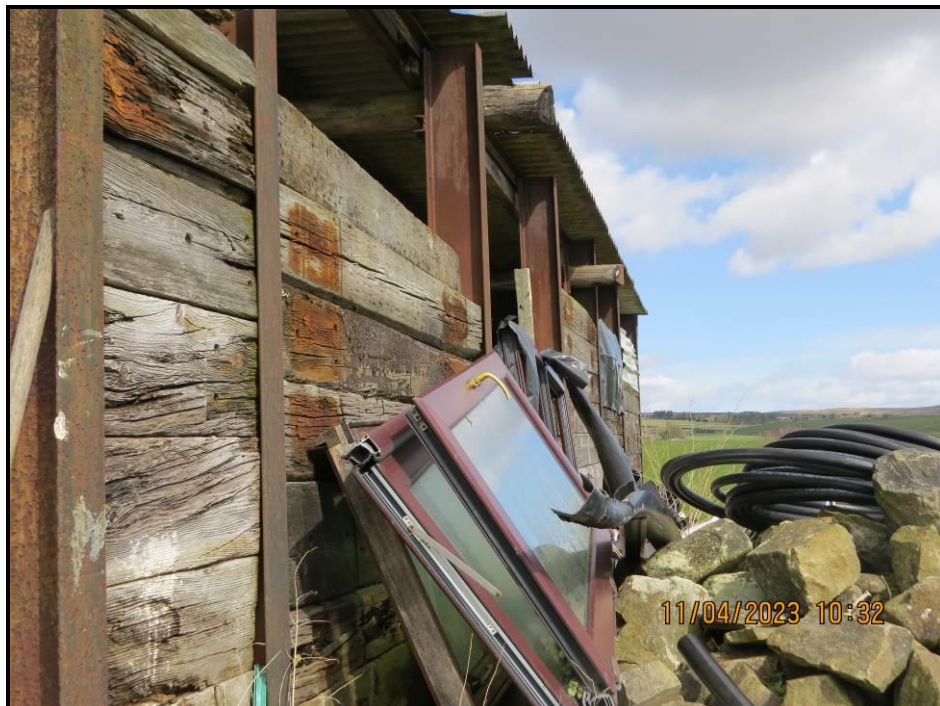
086 South East external face to shippon

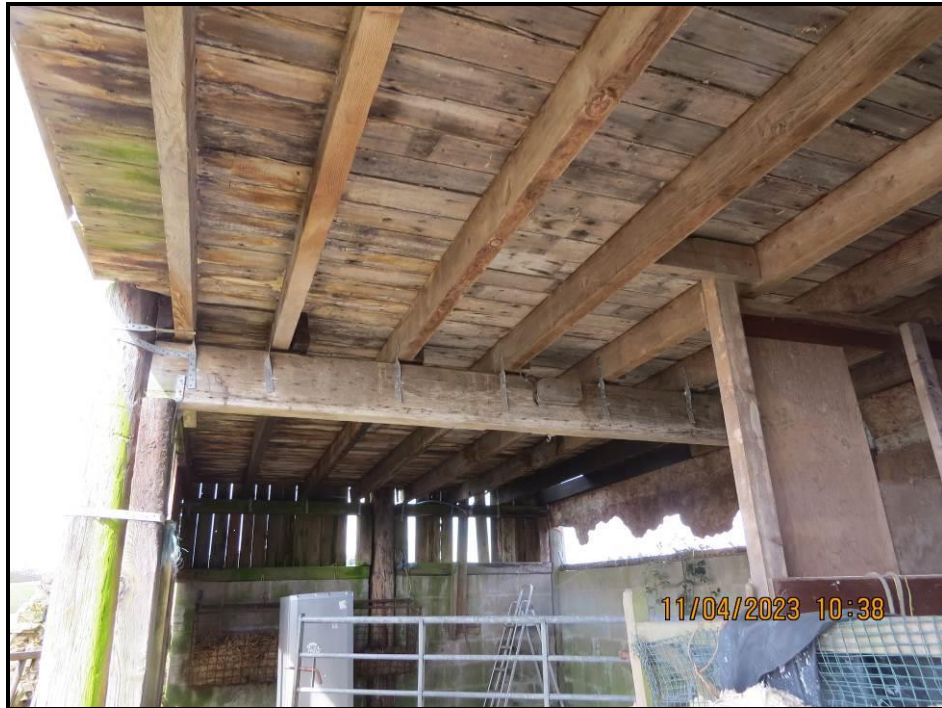
091 Main stanchion and first floor support

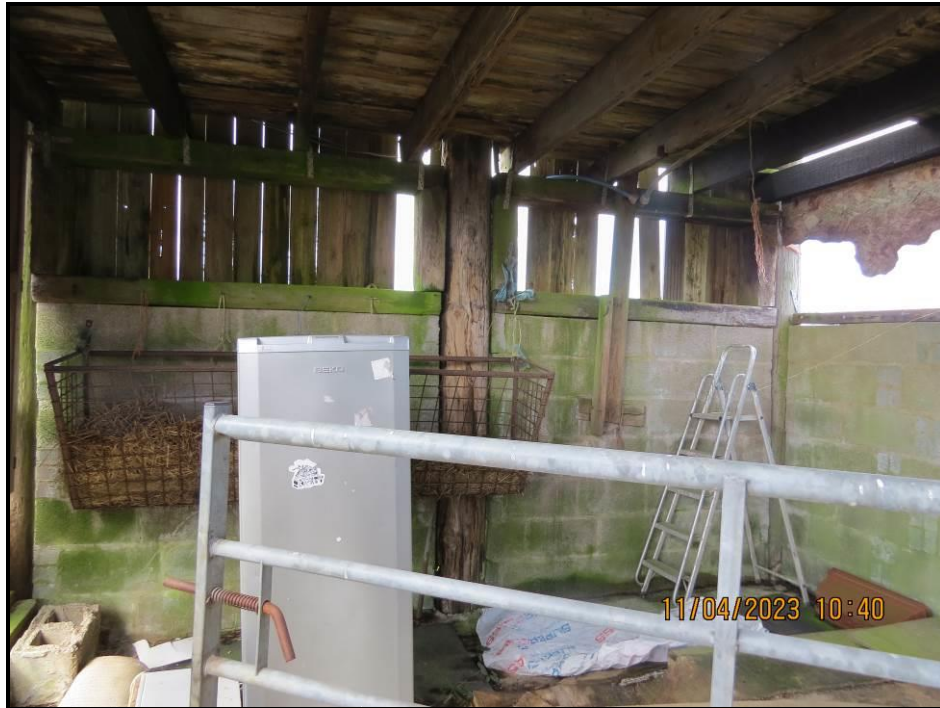
093 Rear wall, North East

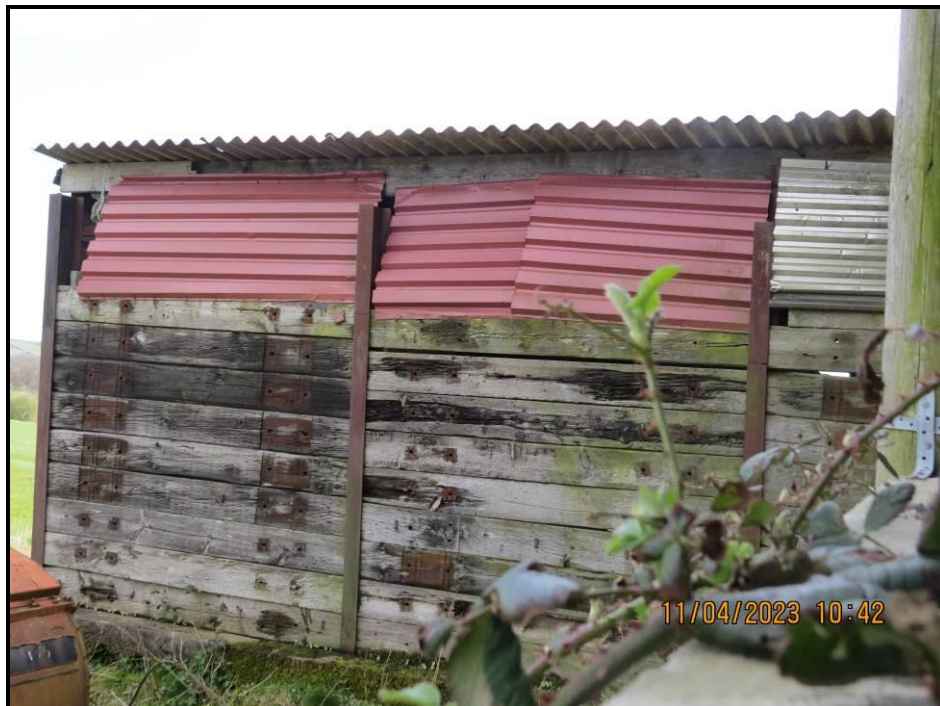
096 External rear elevation (East)

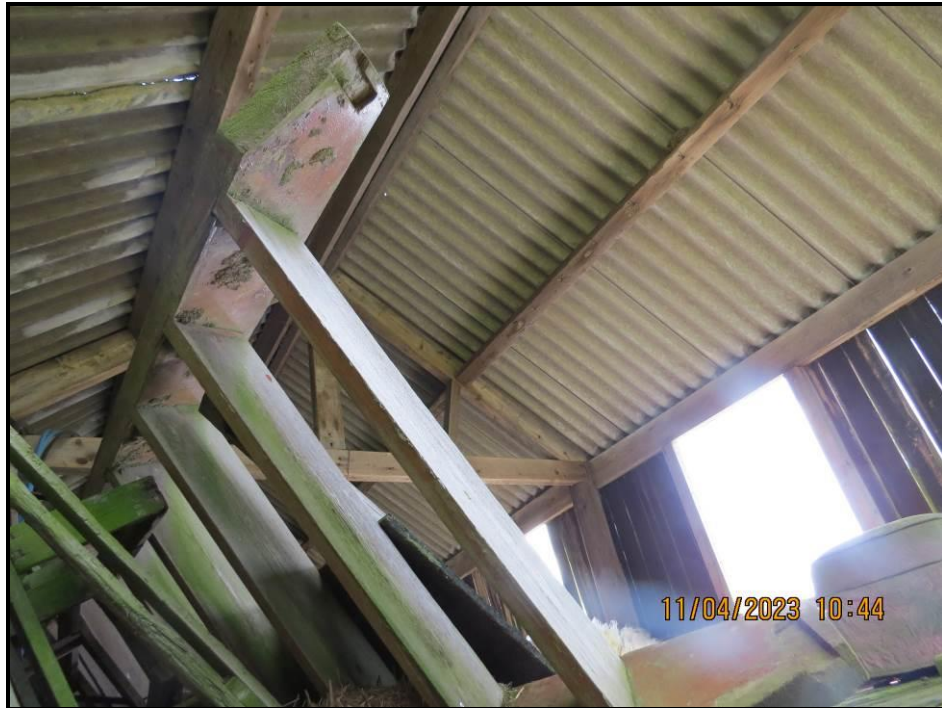
098 Roof, general arrangement

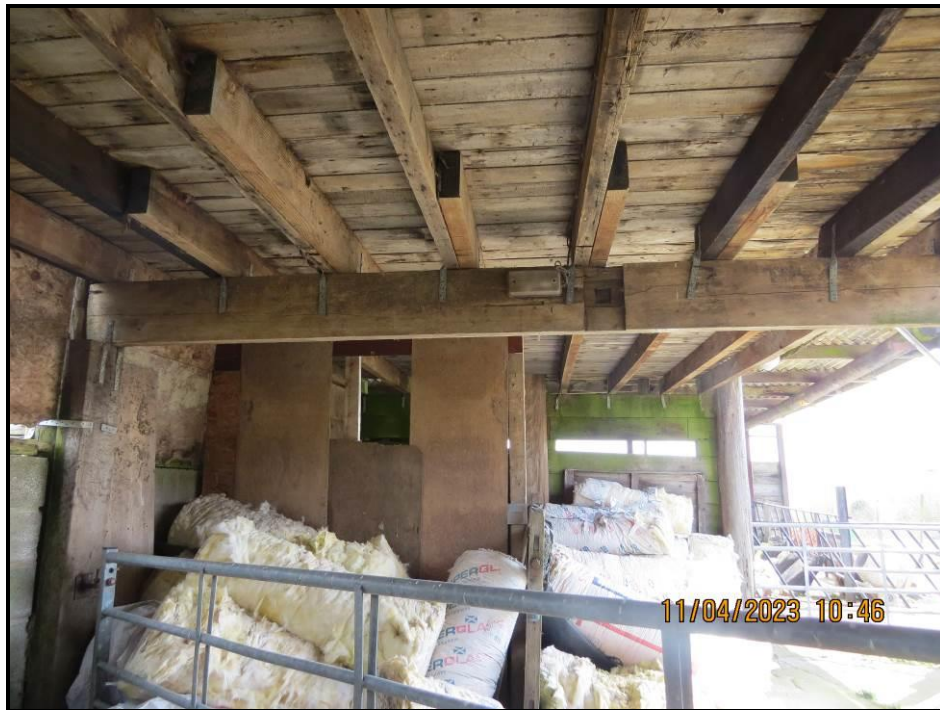
100 First floor, main joists

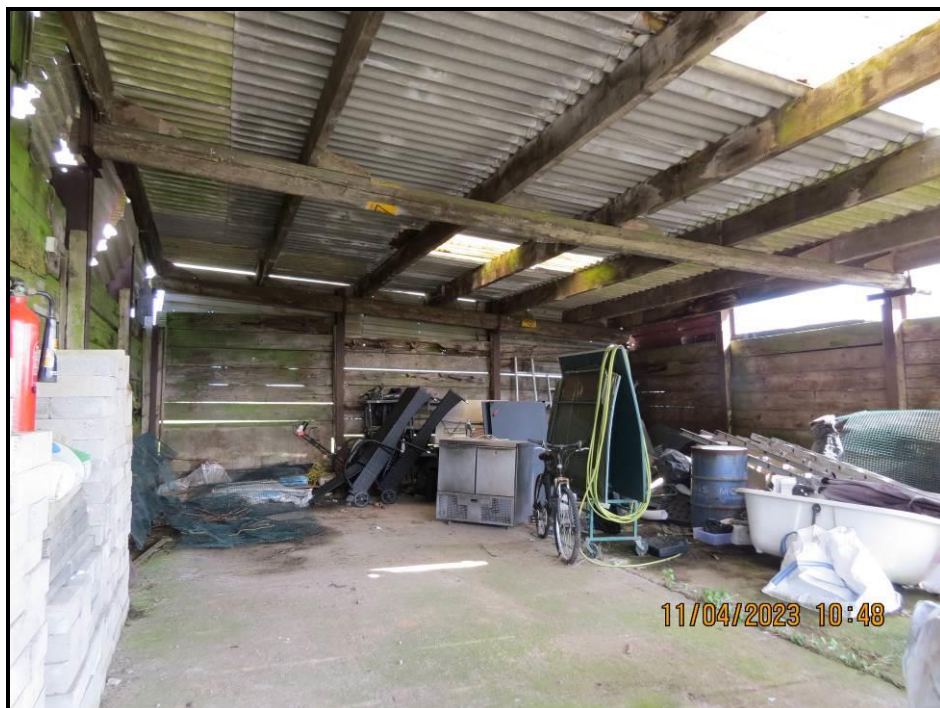
101 Internal layout to rear wall

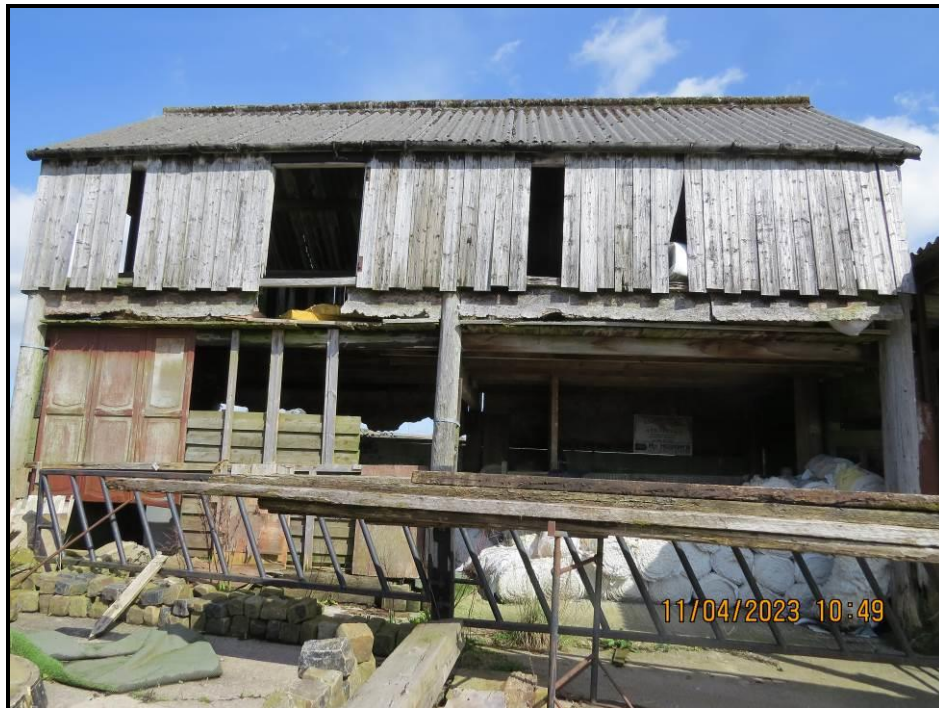
102 Two storey shippon

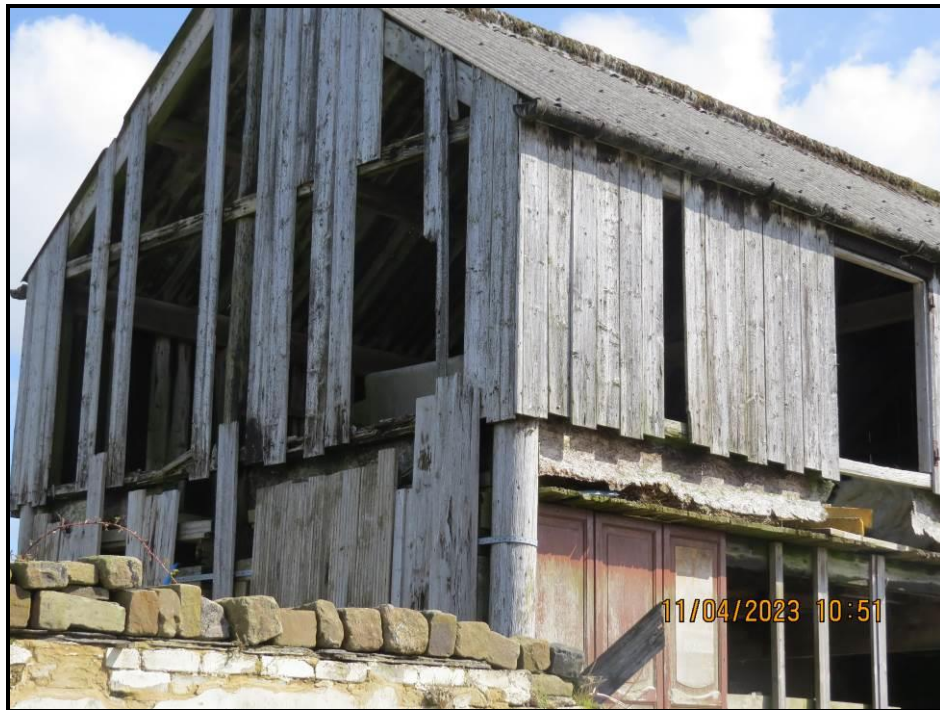
- 11.6 The floor beams spanning between the front and rear walls is a 300mm x 150mm timber section supporting 150mm x 75mm floor joists at 400mm – 450mm centres.
- 11.7 The horizontal alignment of the main beam and floor joists is good.
- 11.8 The ground floor cladding retains the six course deep concrete plinth wall to the rear and both gables with a weathered vertical boarding on the North Western gable with damage and weathering to the timber on the North West rear elevation. (Photographs 103, 104).

104 Two storey shippon

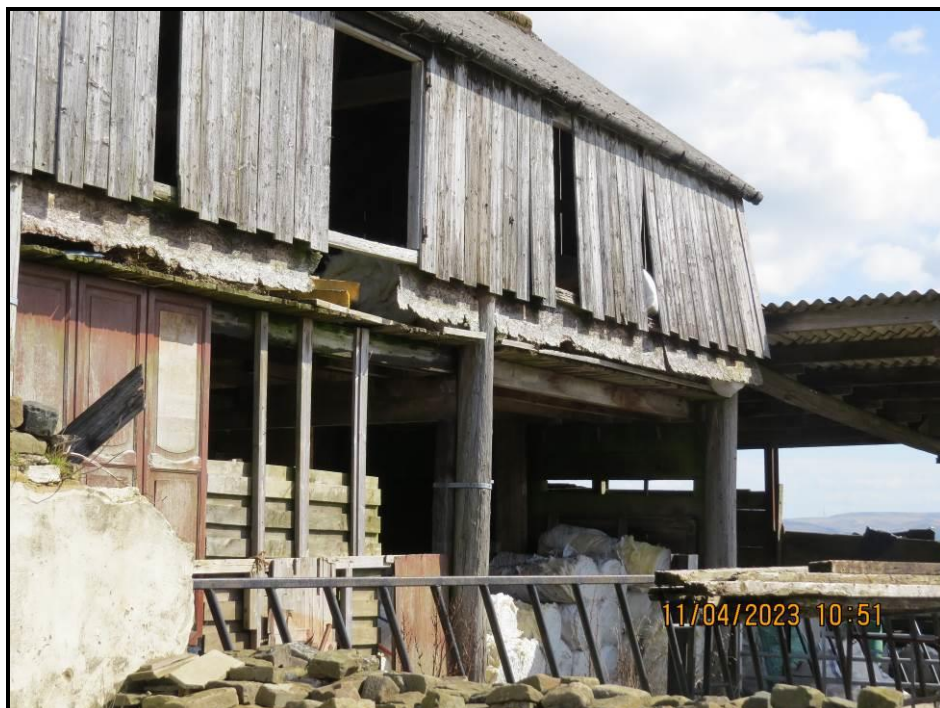
105 Front elevation

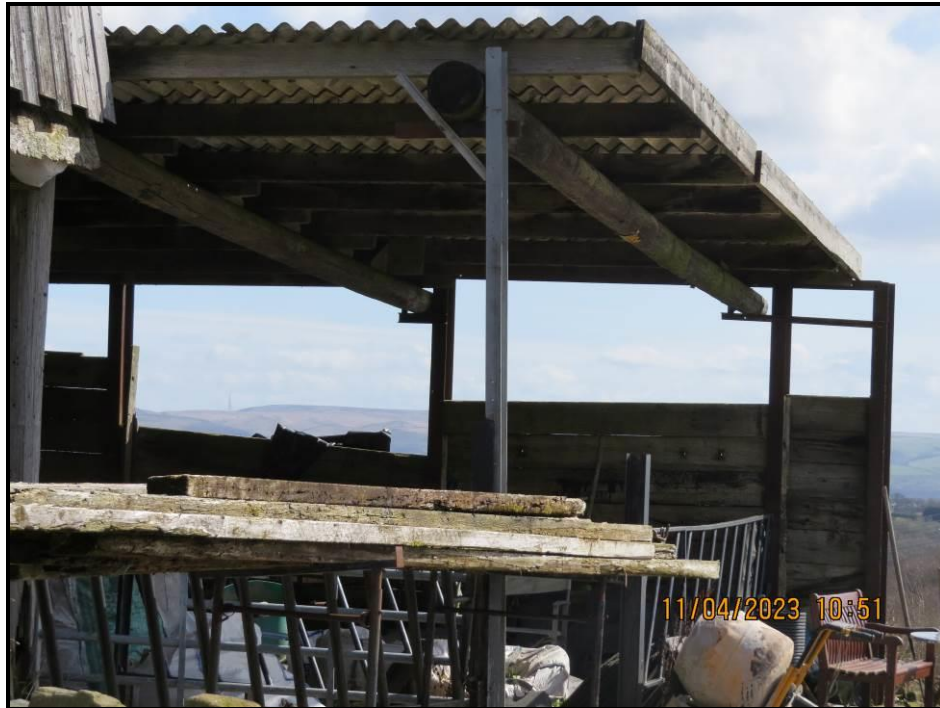
106 Shippon looking to front South East flank

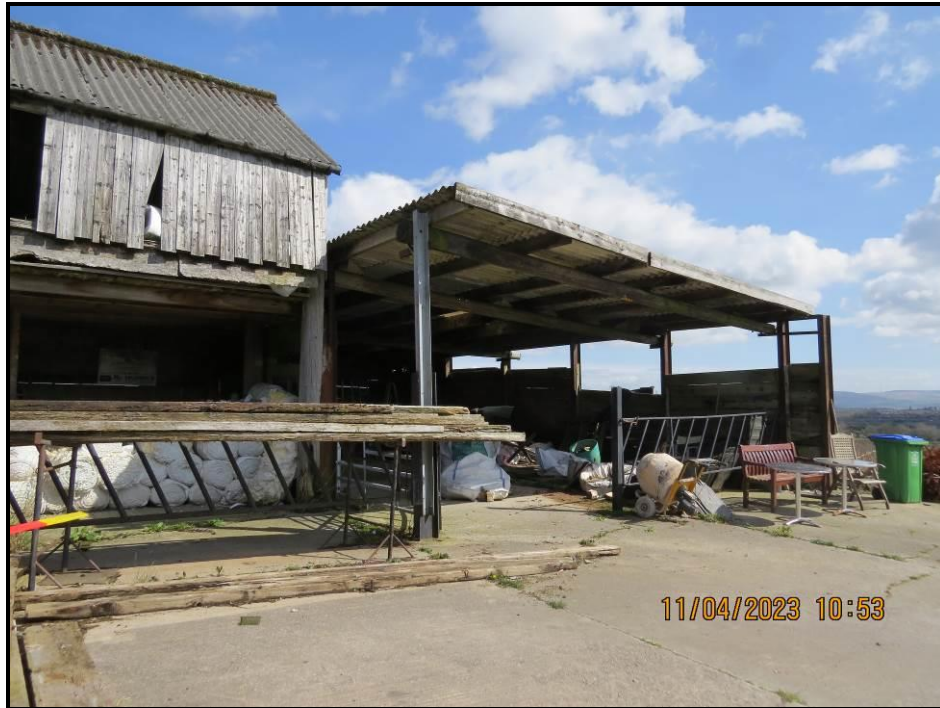
108 South East corner – front elevation

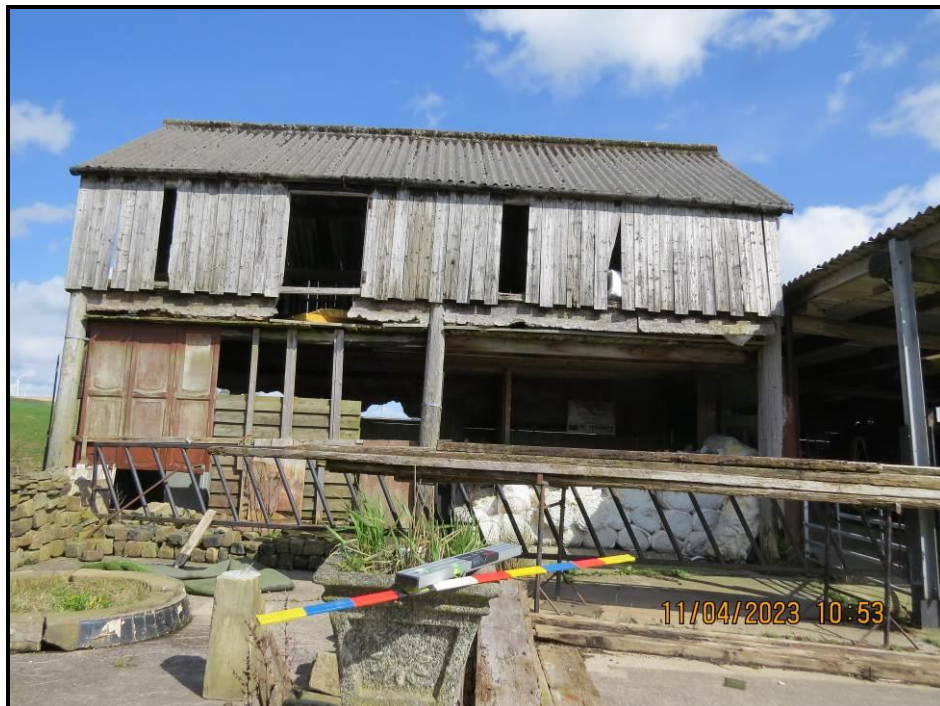
109 Front elevation

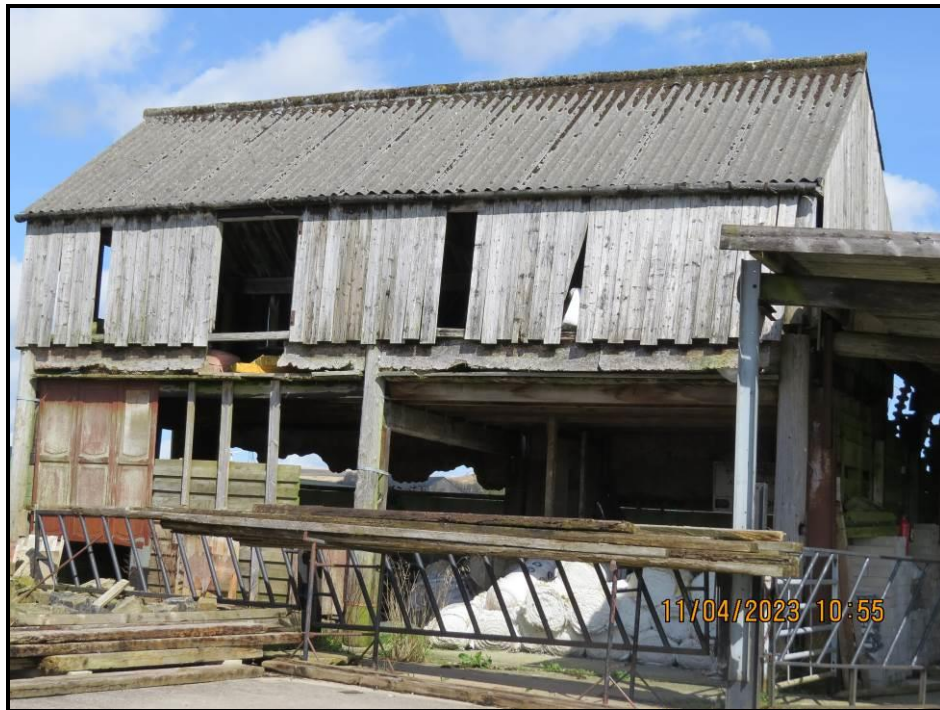
110 Front elevation
