**ENGINEERING REPORT 9179**

**ROBINSONS EQUESTRIAN CENTRE  
HARWOOD FIELD FARM  
CASTLE HILL ROAD  
BURY  
BL9 6UL**

**CLIENT: STEPHEN ROBINSON**

**24.11.2023 MP/CH**

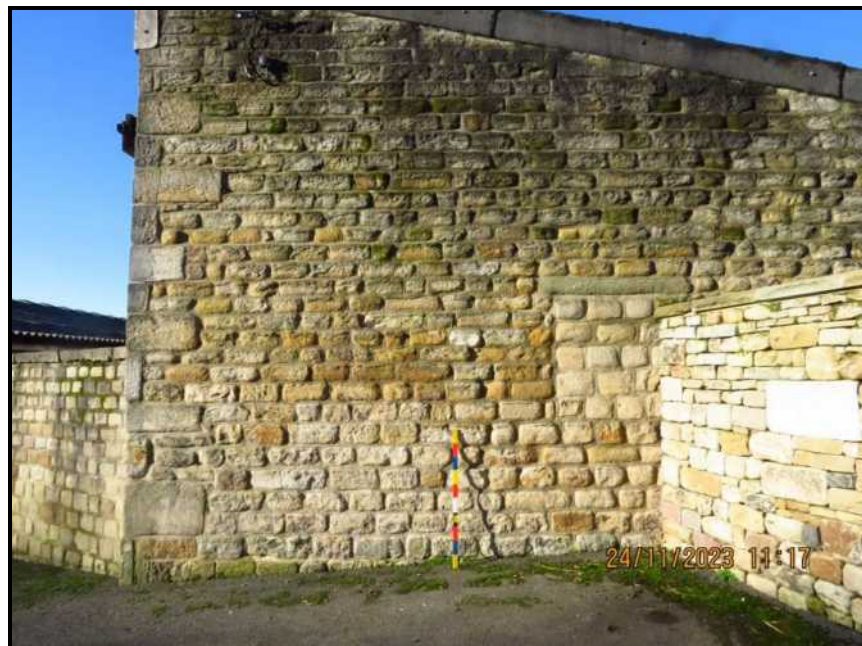
**Photograph 004 Chainage 0 – 5 metres**

- 4.1 The Eastern elevation is half gabled constructed in a randomly coursed stonework, with larger stone sections to the quoins on the front and rear corners, completed with a mono pitched roof.
- 4.2 The Eastern half gable elevation is completed in well maintained coursed stonework with quoin returns on the front and rear wall returns. The wall extends for a length in the order of 9 metres wide, sloping from 5 metres high on the front (South Eastern corner) to 2.5 metres high on the rear North Eastern corner.
- 4.3 The existing ground level rises approximately 1 metre from front to rear. (Photographs 001, 002, 004, 005).

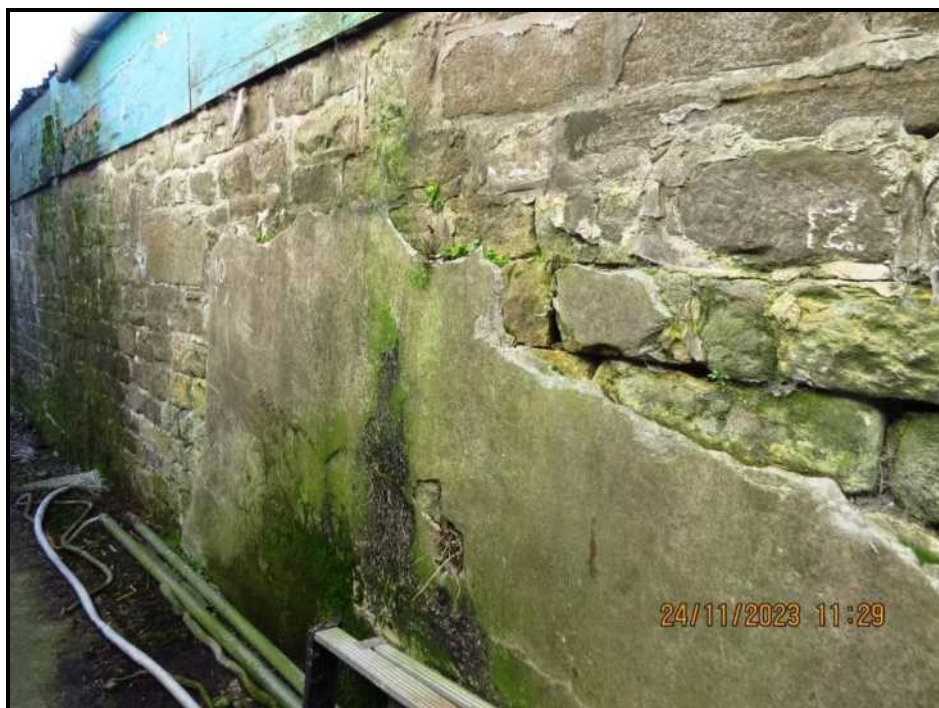
- 5.3 The vertical alignment at chainage 7 metres is good with irregularities in the order of 7mm per metre.
- 5.4 The rear wall terminates with a vertical joint between the North Eastern section and the North Western section. (Photographs 019, 020).
- 5.5 Between chainage 8 – 12 metres the wall is completed with a 25mm rendered panel extending for a height between 1 – 1.2 metres and the rendering is generally in a satisfactory sound condition with good vertical alignment. (Photographs 015, 017, 018).

017 Lower rendering, chainage 8 – 12 metres

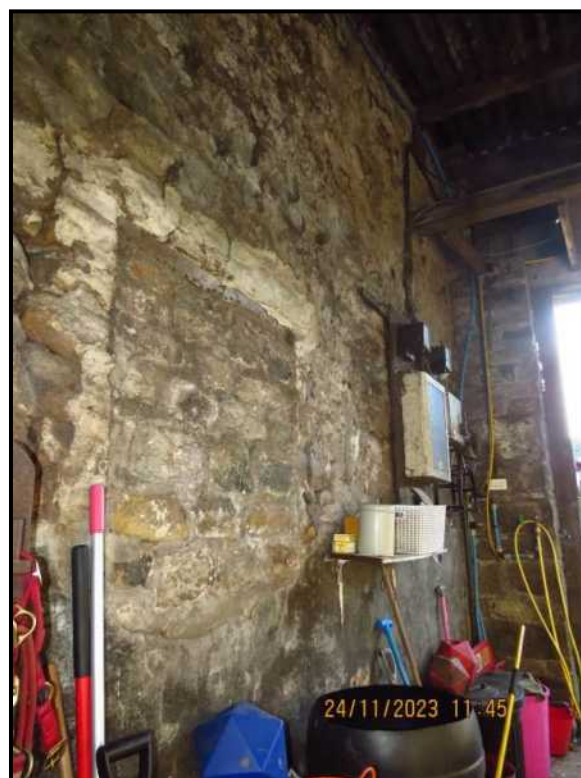
053 Internal corner South/East (former window)

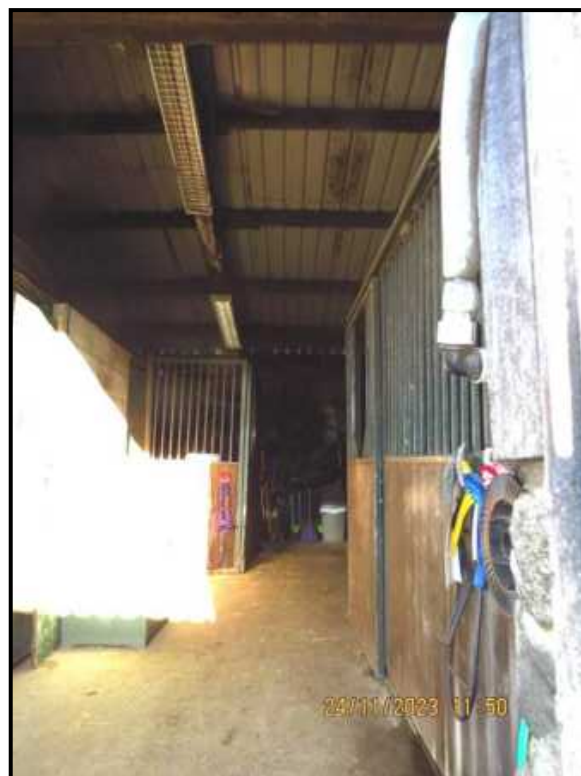
067 Entrance – Stable No. 2

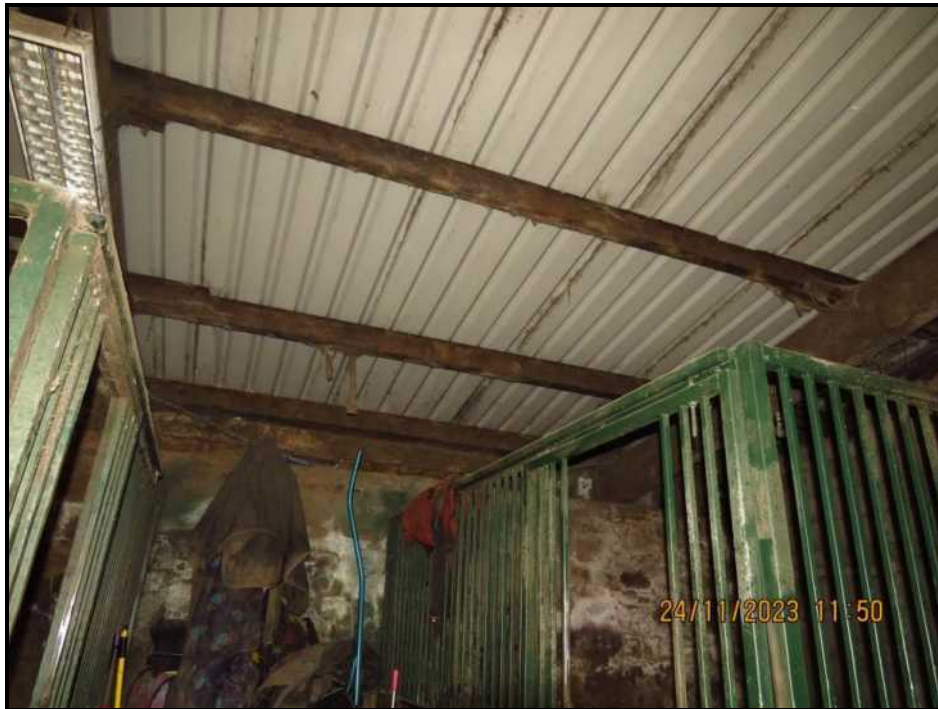
069 Roof detail

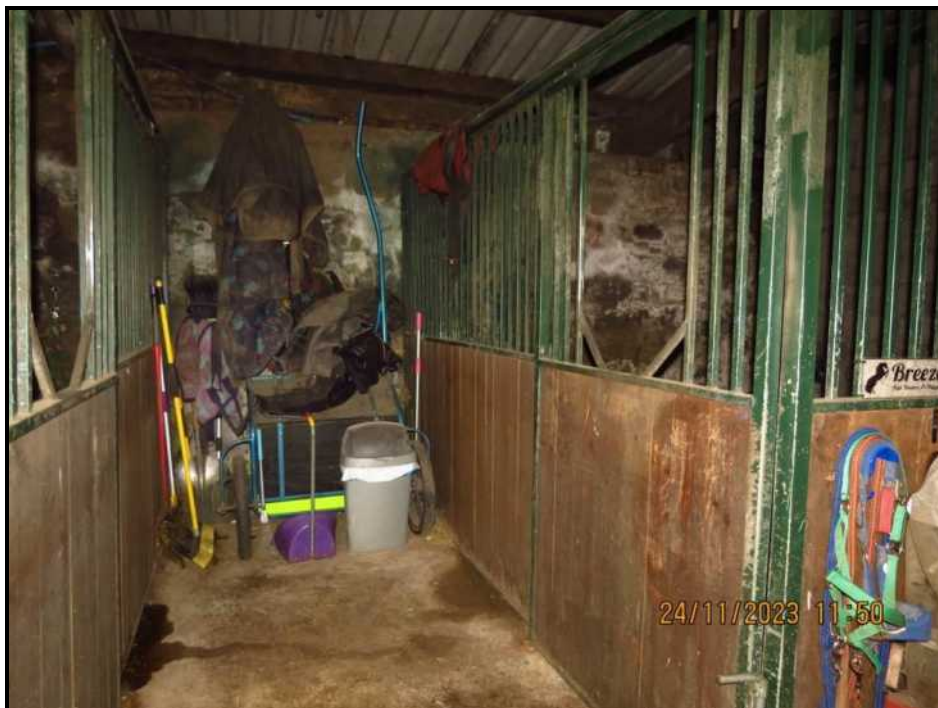
- 7.10 Stable No. 2 incorporates two Tack Rooms with limited access to the rear walls. (Photographs 070, 071).
- 7.11 The rear wall of the original building is finished with a weathered and stained render finish, with a reasonable vertical alignment, with the internal party wall completed in satisfactory blockwork.
- 7.12 There are no signs of any separation where the blockwork cross wall adjoins the original rear and front elevations. (Photographs 072, 073, 074).

070 Tack Rooms

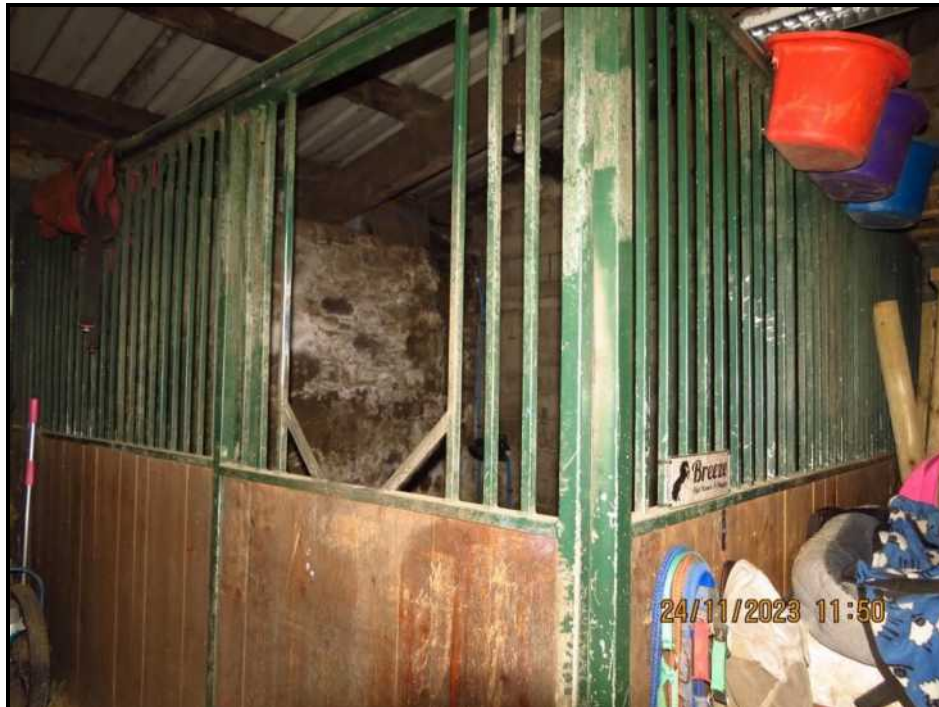
071 Stable No. 2 rear wall

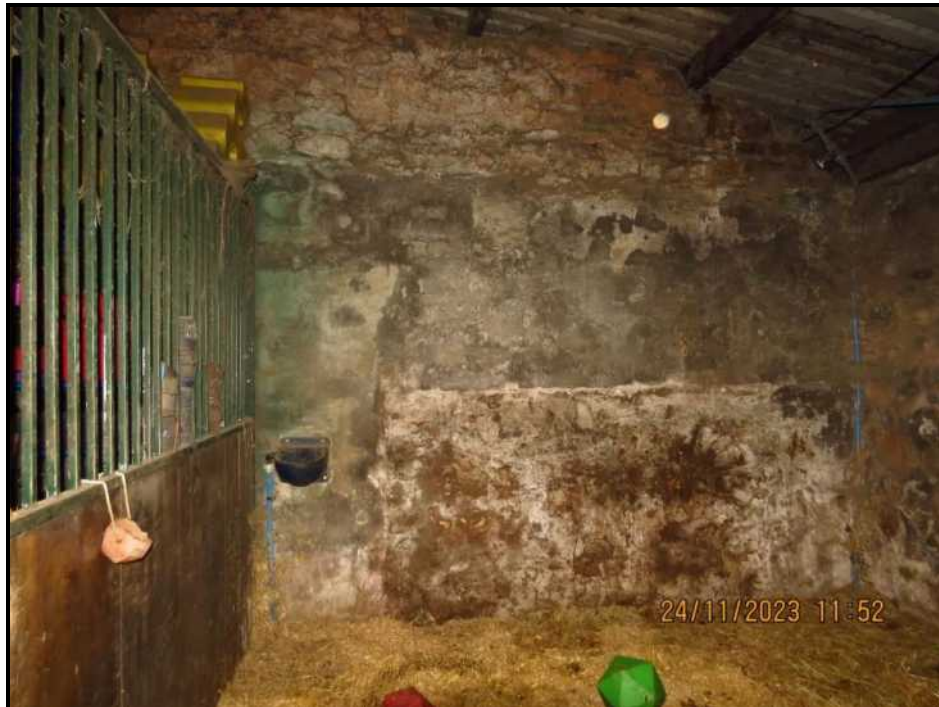
077 Party wall Unit 2/1

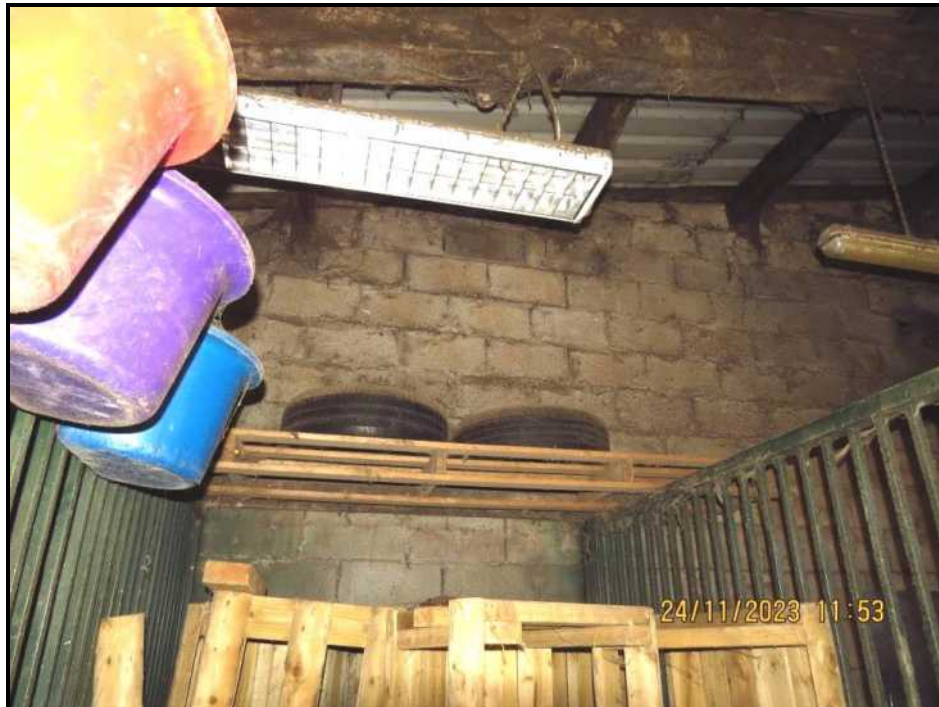
080 Party wall front

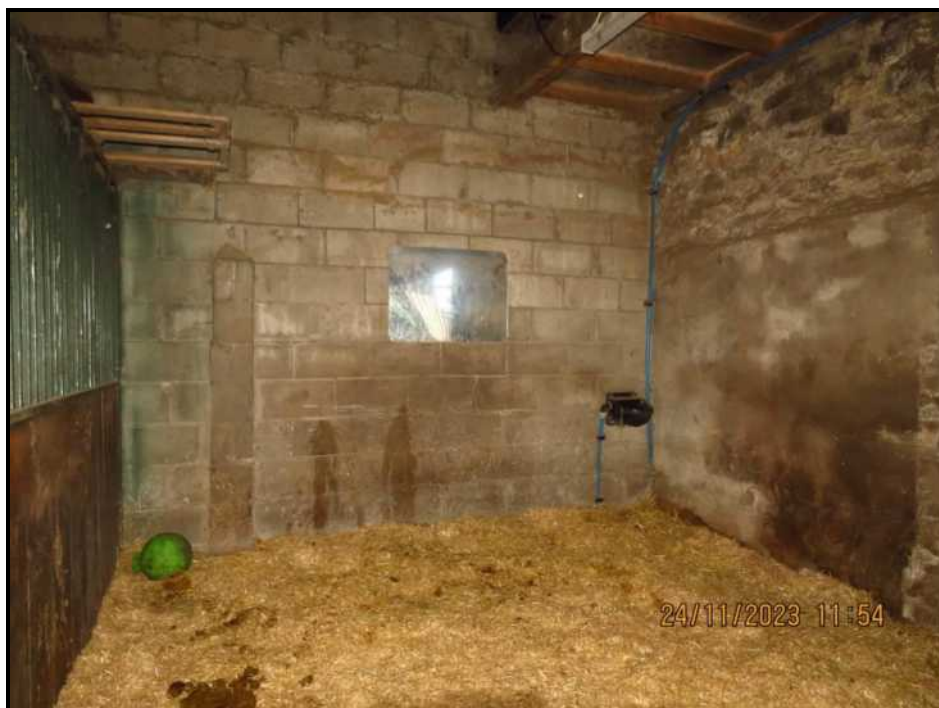
081 Front stall, party wall No. 1

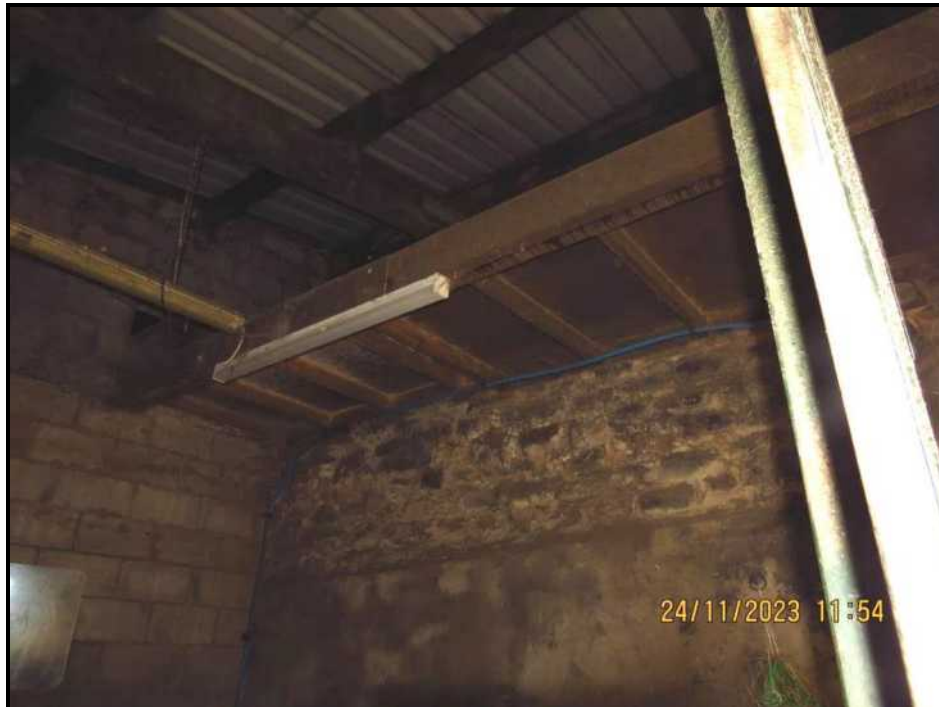
085 Front wall

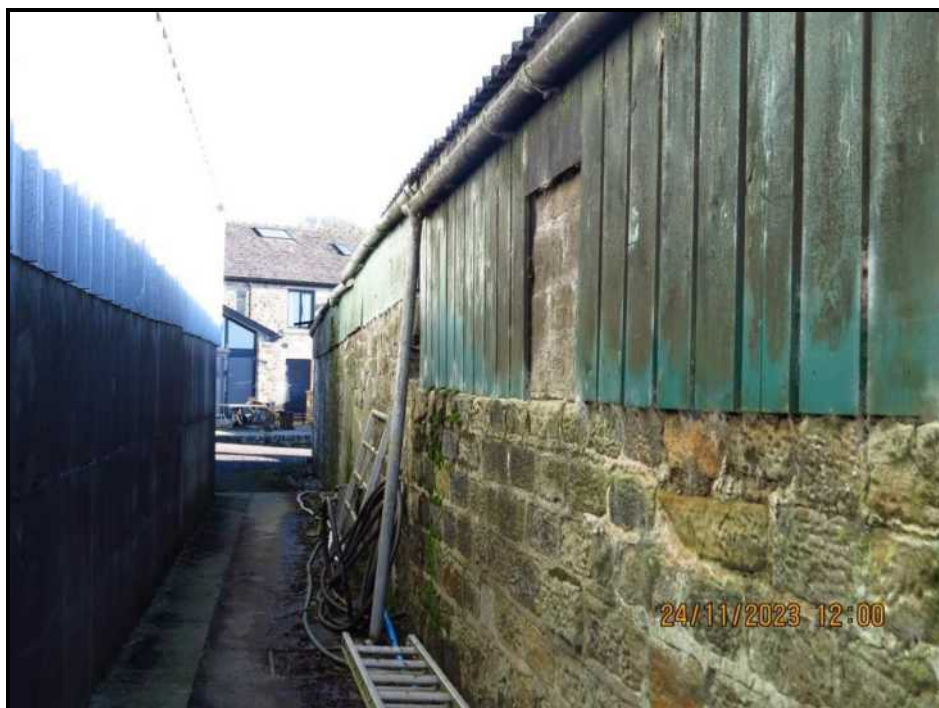
094 Rear elevation
