# Historic Building Record

## Level 3

# Parkfield House,

Manchester Old Road, Middleton, M24 3EB

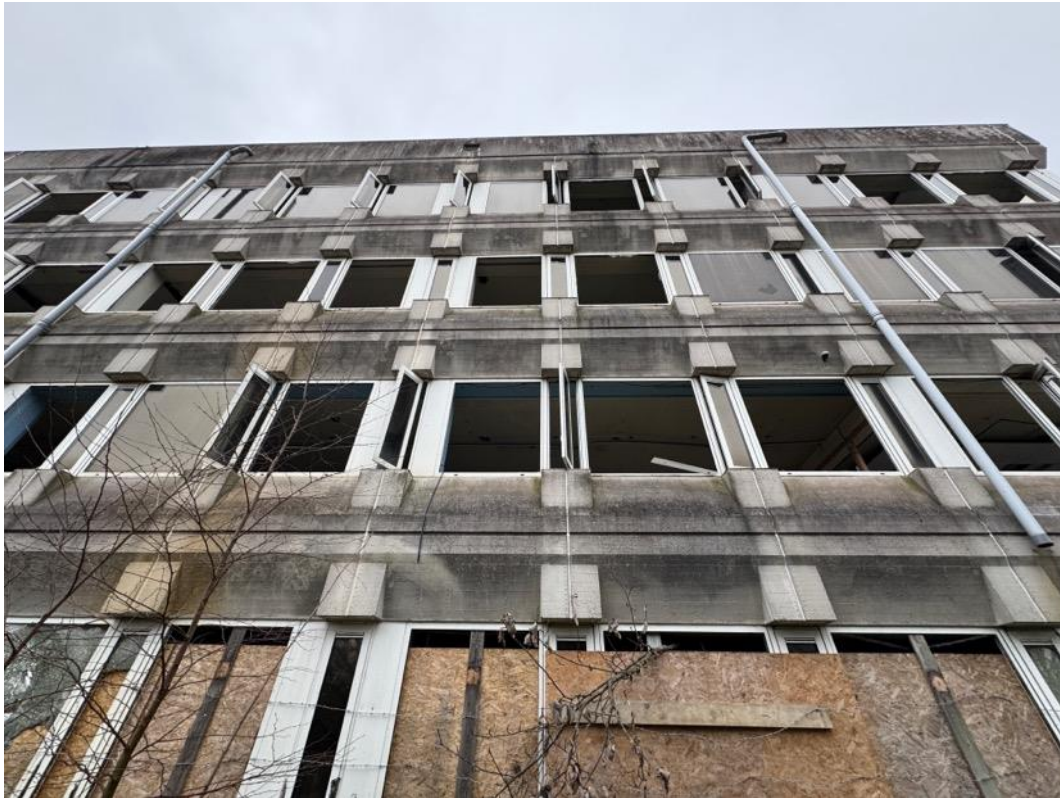
*Image 16 – View looking up at the northeast corner.*

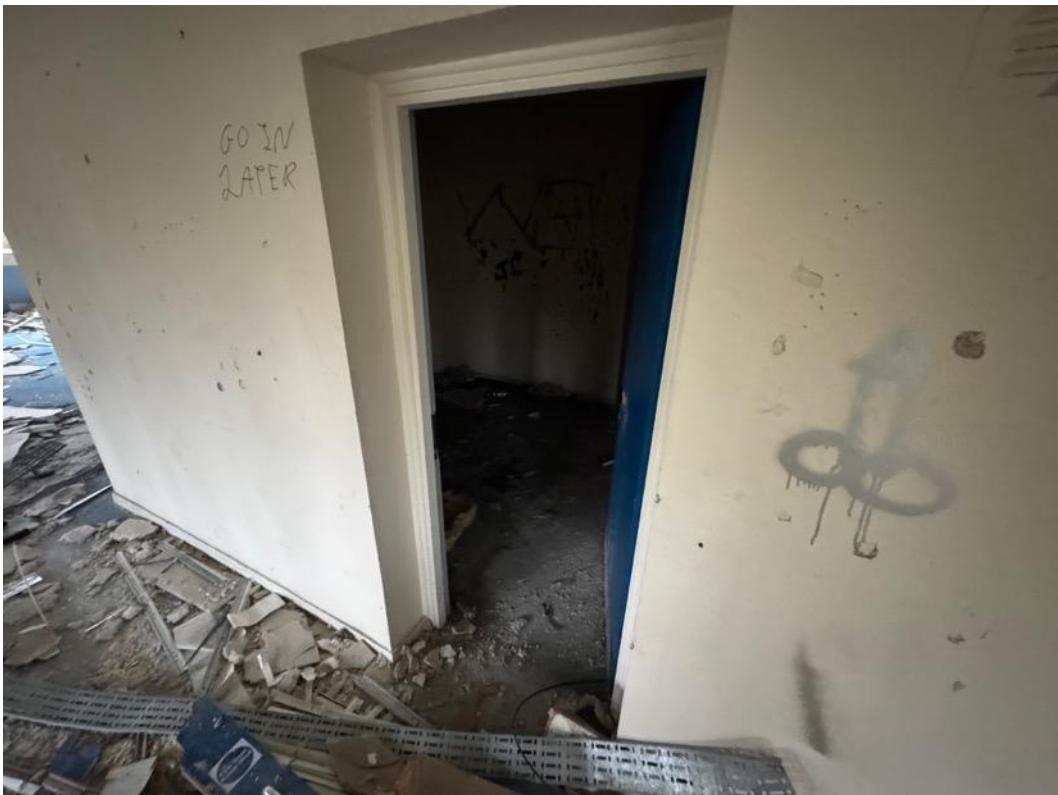
*Image 68 – View into separate office, first floor, walls largely destroyed.*

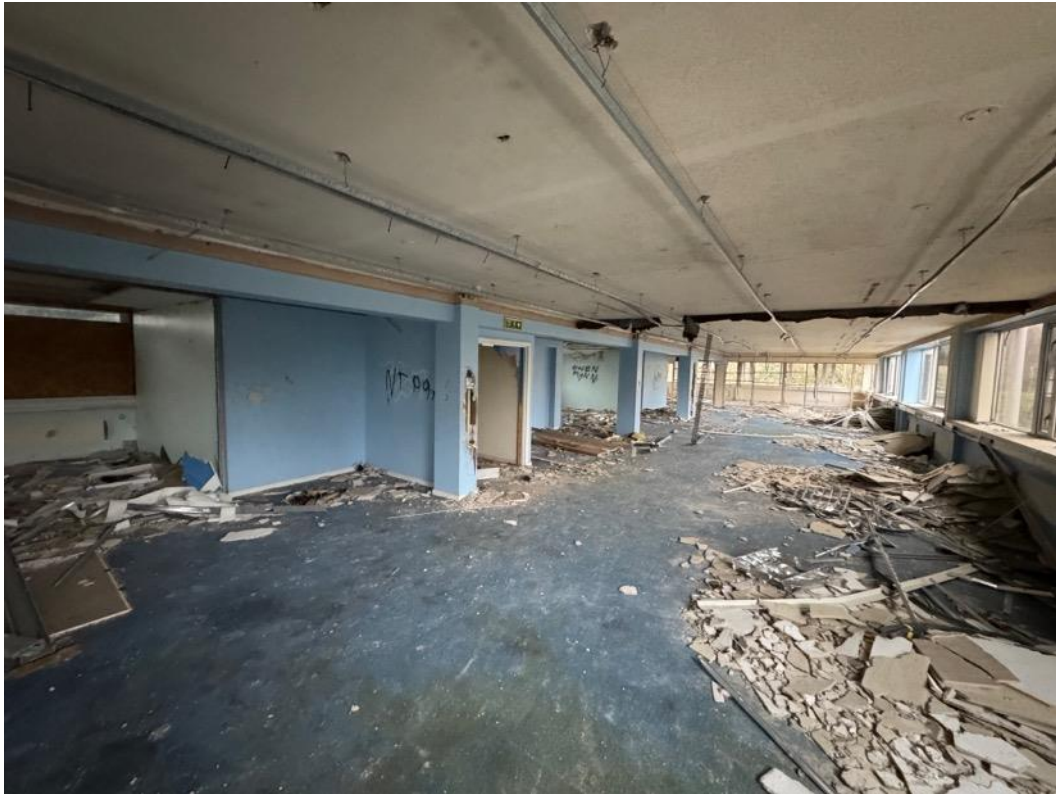
*Image 73 – Former separate room to western edge first floor, partition wall now lost.*

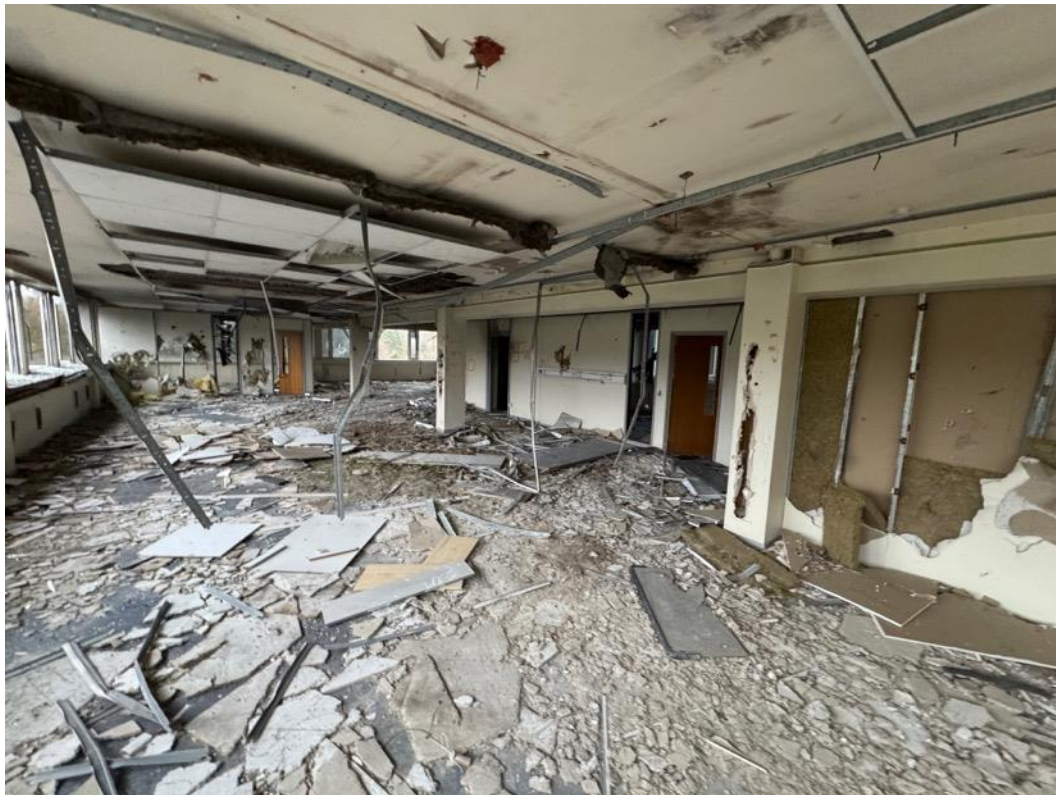
*Image 87 – Second floor, view of central area with sub-divided offices.*
