Date: 17 March 2025  
Reference: 14-768-V1

## GAS MEMBRANE VALIDATION – HAWKS VIEW, CASTLETON

| <b>Project Name:</b> | Hawks View, Castleton (formerly known as Castleton Sidings) |
| <b>Ground Gas Protection Design Report:</b> | E3P Gas Protection Design Report (14-768-R8, March 2025) |

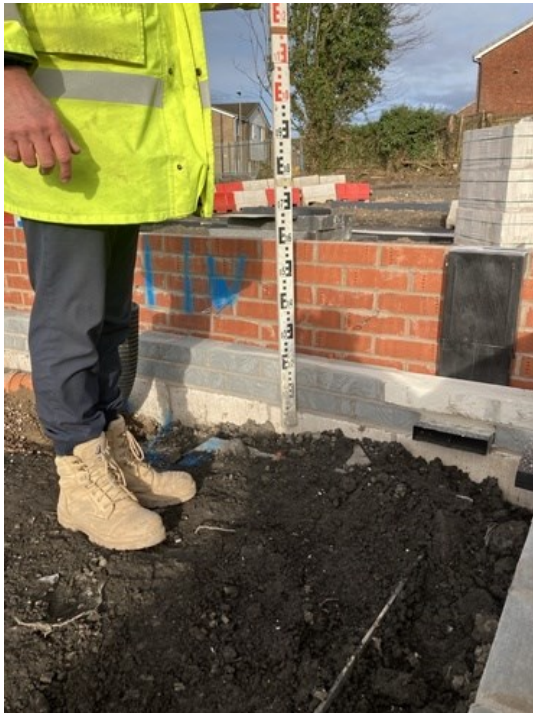
Photo 2

Is the void clear? Yes

Depth of Void 150

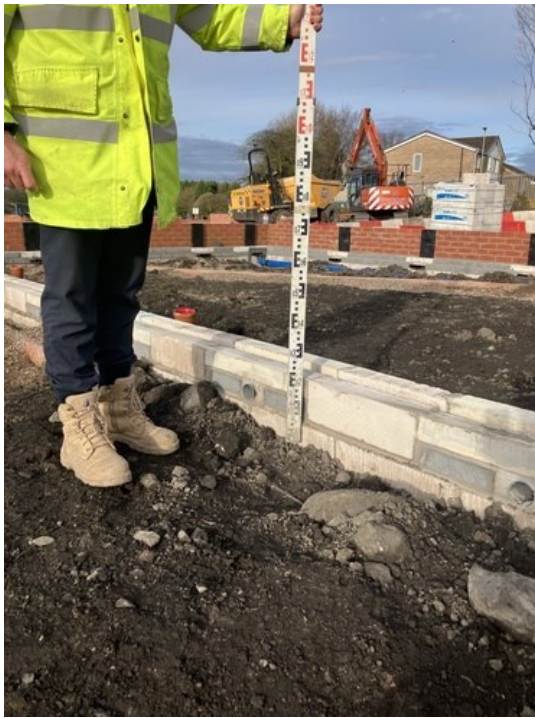
Photo 4

Are Sleeper Walls Vented? Yes

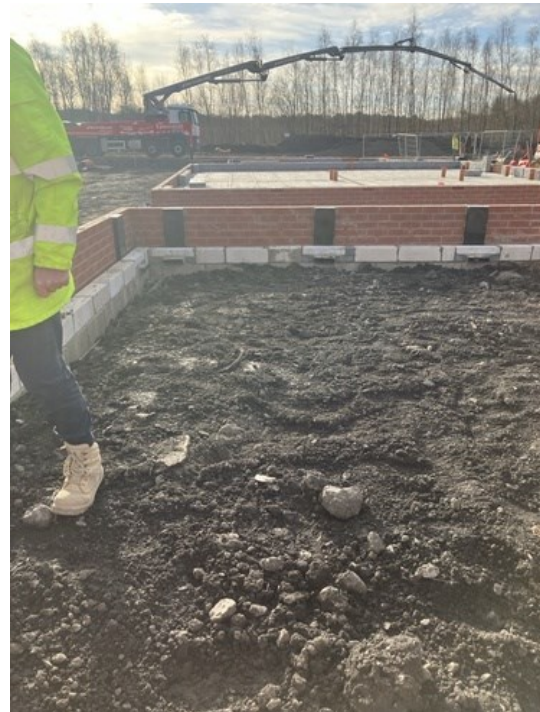
Photo 11

Yes

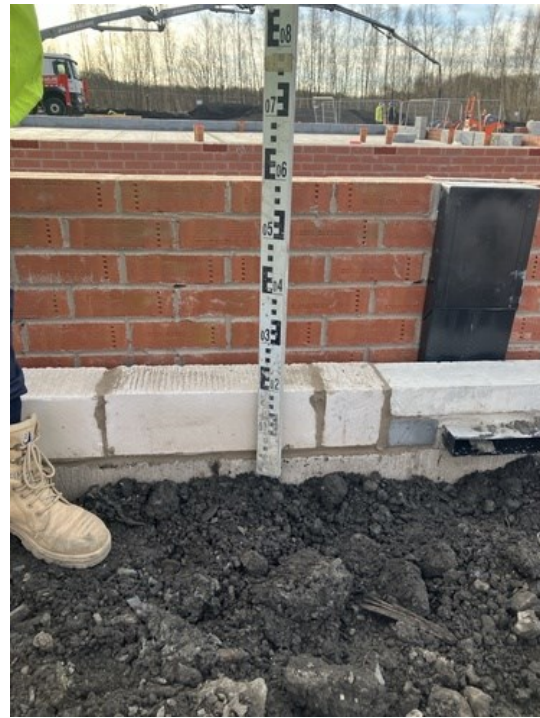
Photo 13

200
