# **Rochdale Cricket Lacross and Squash Club**

## **Flood Risk Assessment & Drainage Strategy**

**September 2026**

**Soul Padel Ltd**

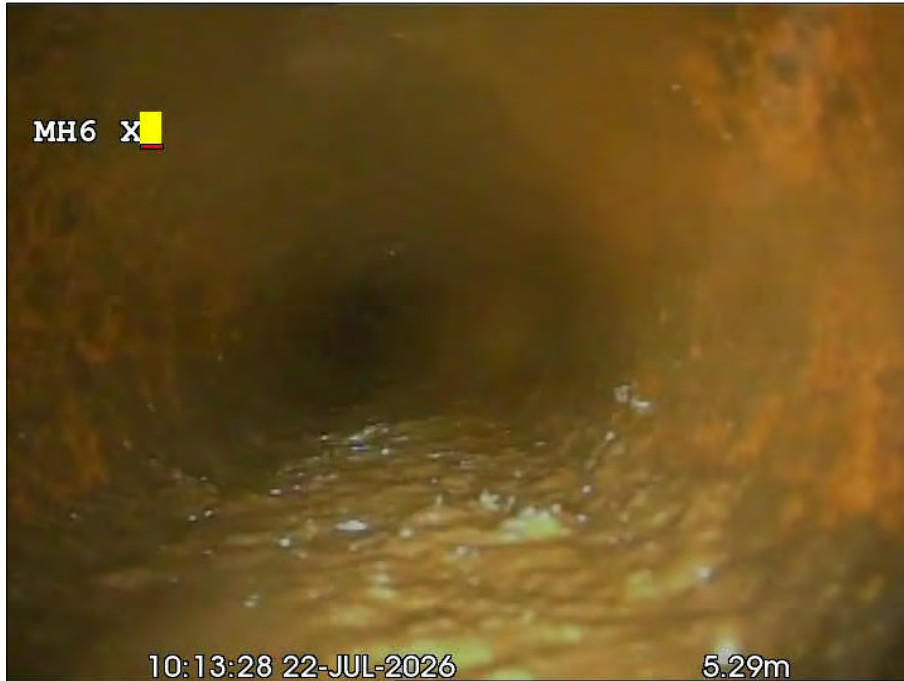
Photo: 30\_4a, 00:00:00  
5.3m, General Condition photograph

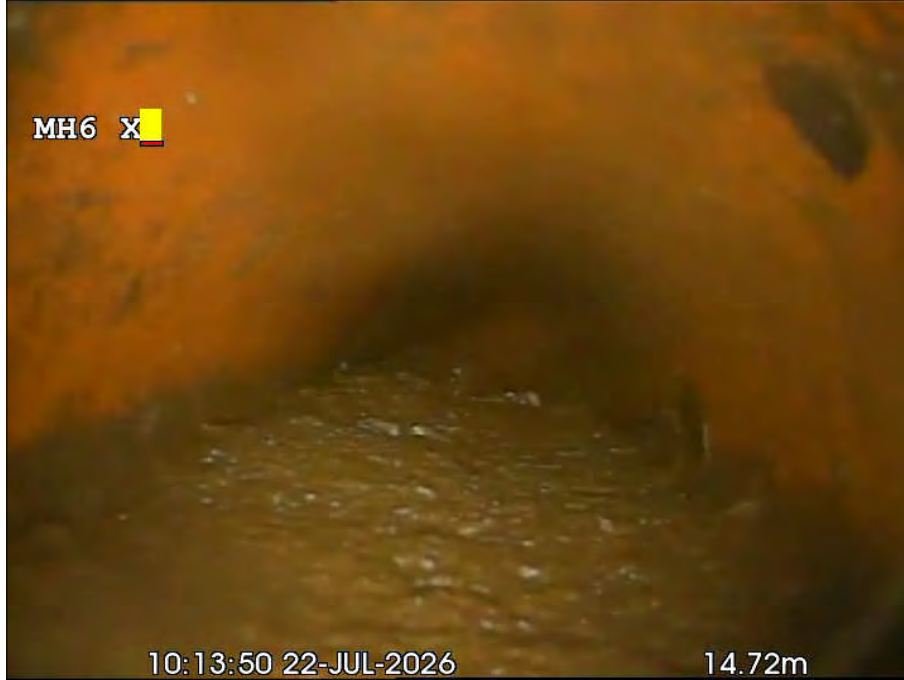
Photo: 30\_8a, 00:00:00

14m, Debris silt, 50 % cross-sectional area loss, Changed

The sewers with high levels of silt or blockages to be jetted to extend the CCTV drainage survey, if any of these areas are deemed critical or of high importance. We recommend full statutory record information be obtained to confirm site findings and to position undetectable services which may be present.

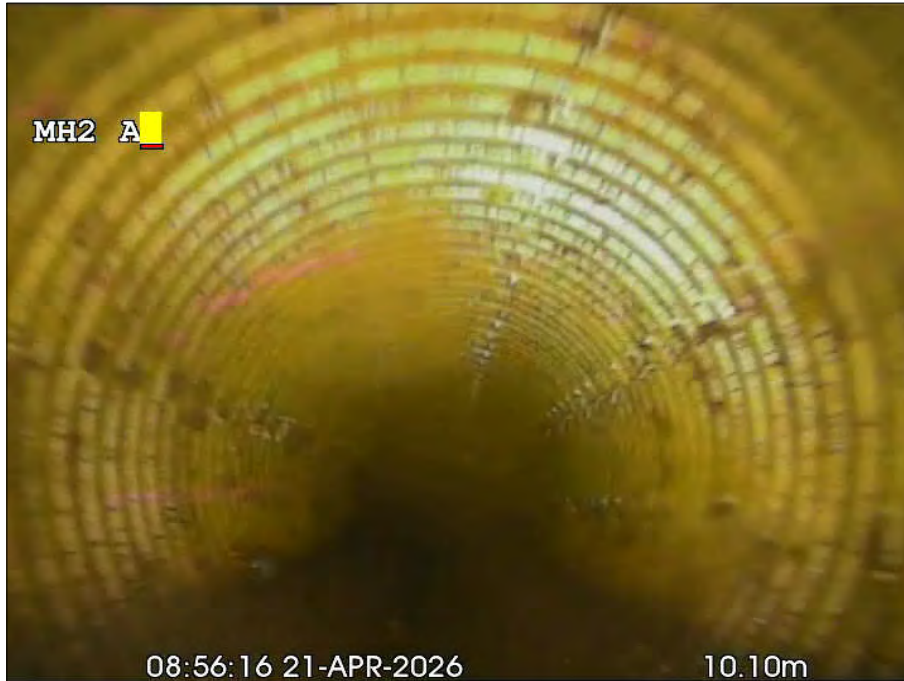
Photo: 269\_4a, 00:00:00  
10.1m, General Condition photograph

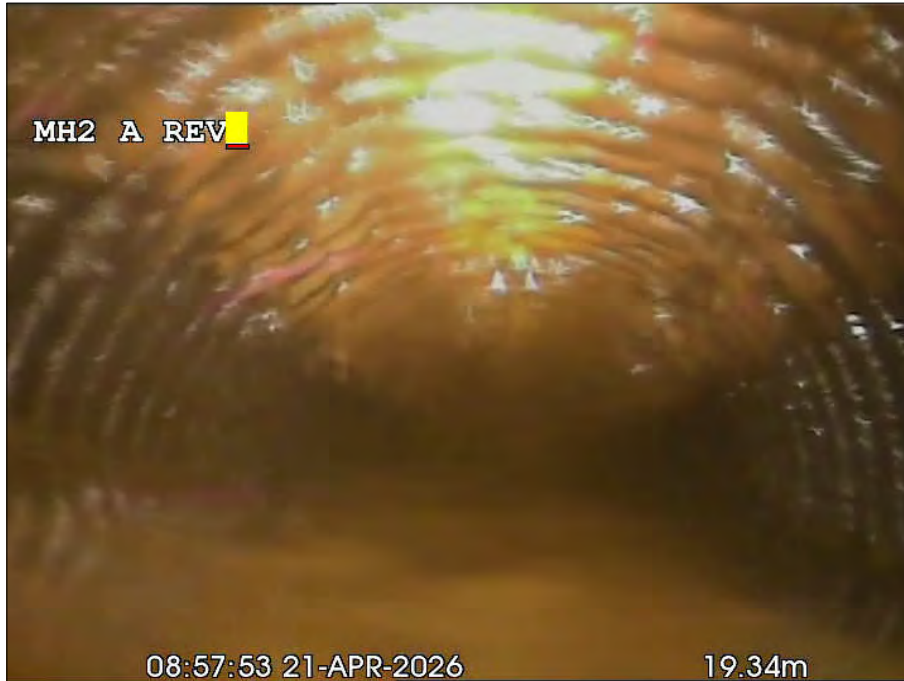
Photo: 31\_8a, 00:00:00  
19.3m, General Condition photograph

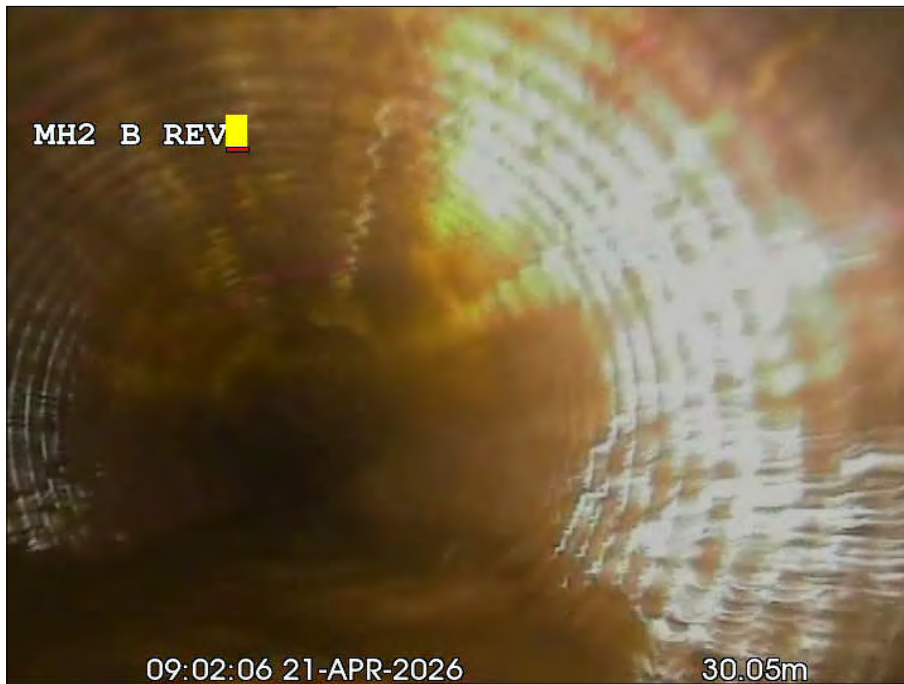
Photo: 32\_13a, 00:00:00  
30m, General Condition photograph

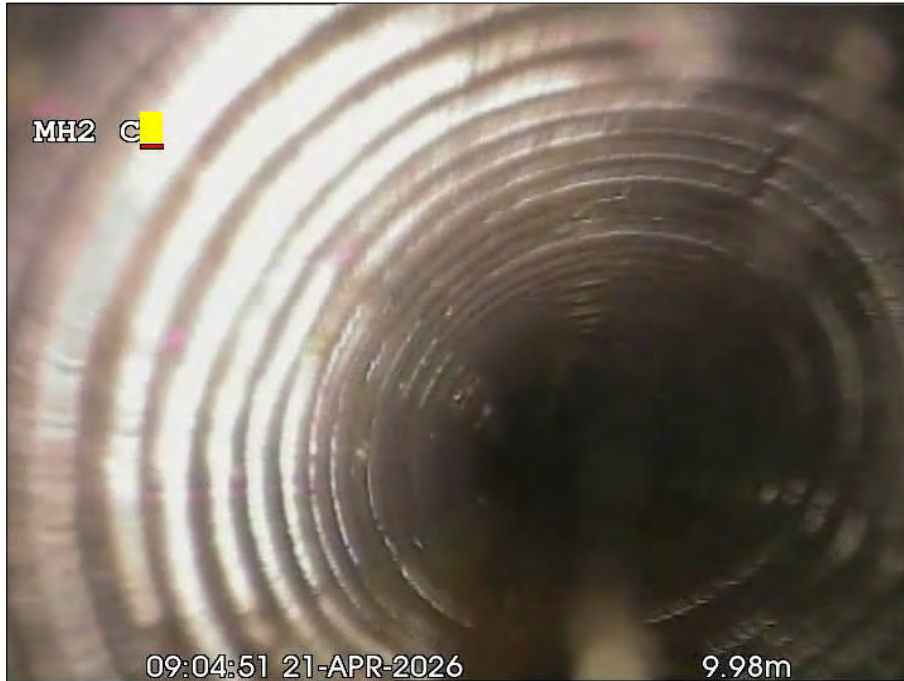
Photo: 294\_4a, 00:00:00  
10m, General Condition photograph

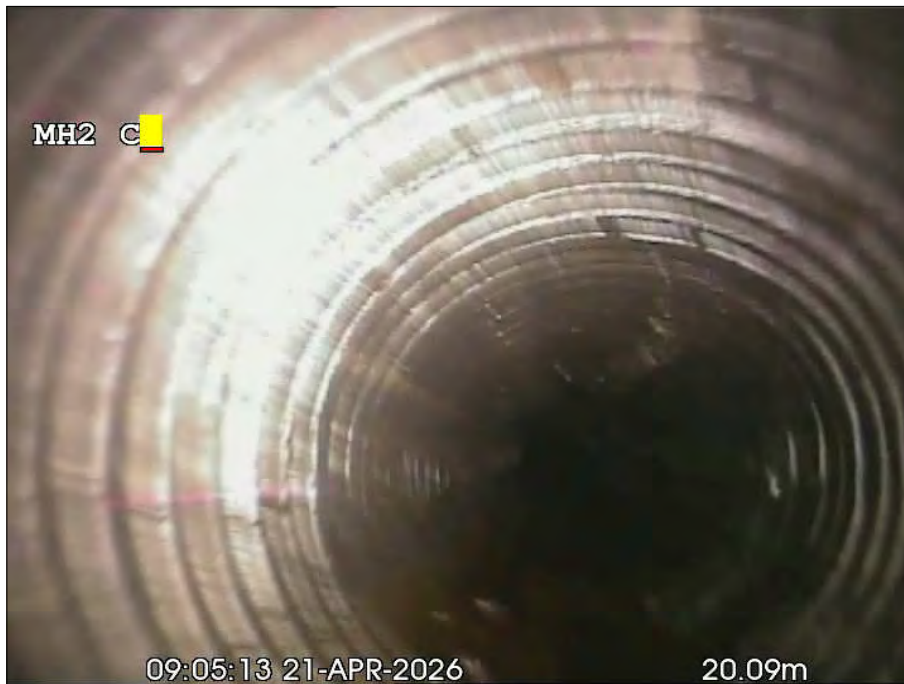
Photo: 295\_5a, 00:00:00  
20.1m, General Condition photograph
